Monitoring Report – Year 6
FINAL VERSION
Edwards-Johnson Mitigation Project
Calendar Year of Data Collection: 2023

NCDEQ DMS Project Identification # 97080
NCDEQ DMS Contract # 6825
Neuse River Basin (Cataloging Unit 03020201)
USACE Action ID Number: SAW-2016-00883
NCDEQ DWR Project # 2016-0404 V2
Johnston County, NC
Contracted Under RFP # 16-006477
Data Collection Period: March and October
2023 Submission Date: December 29, 2023

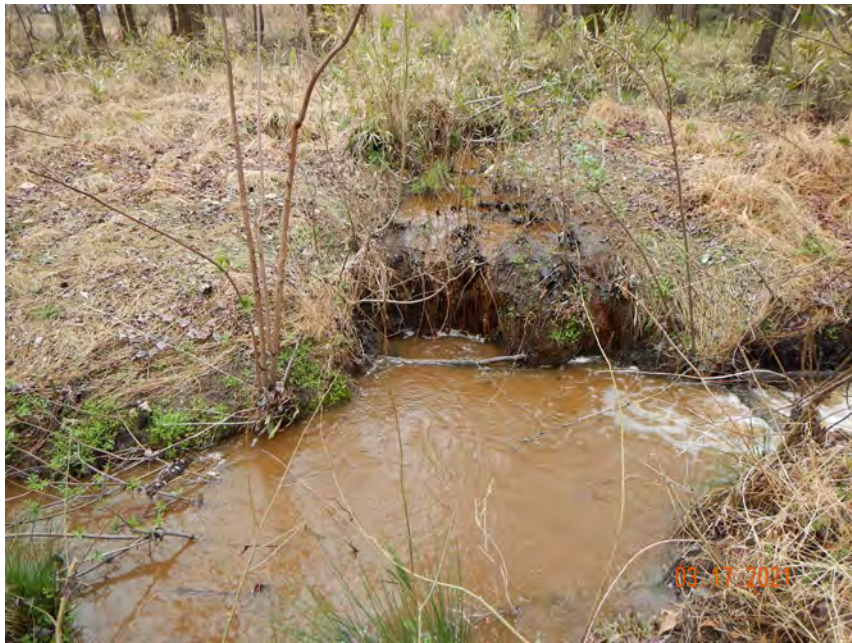
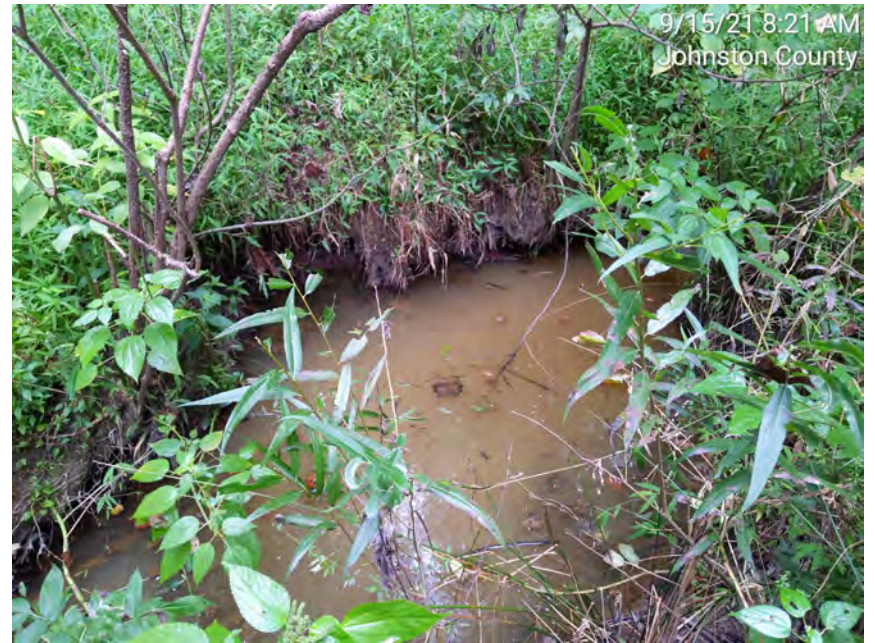
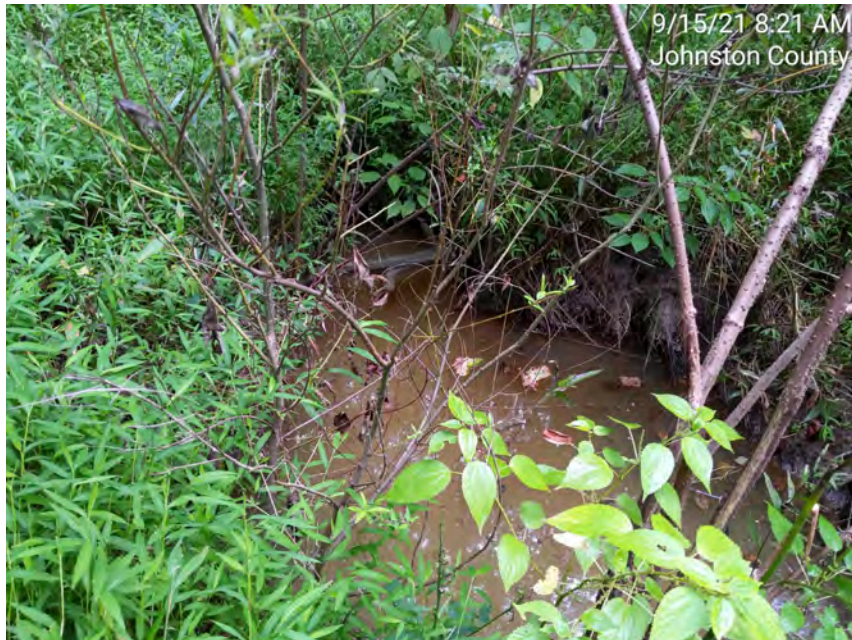
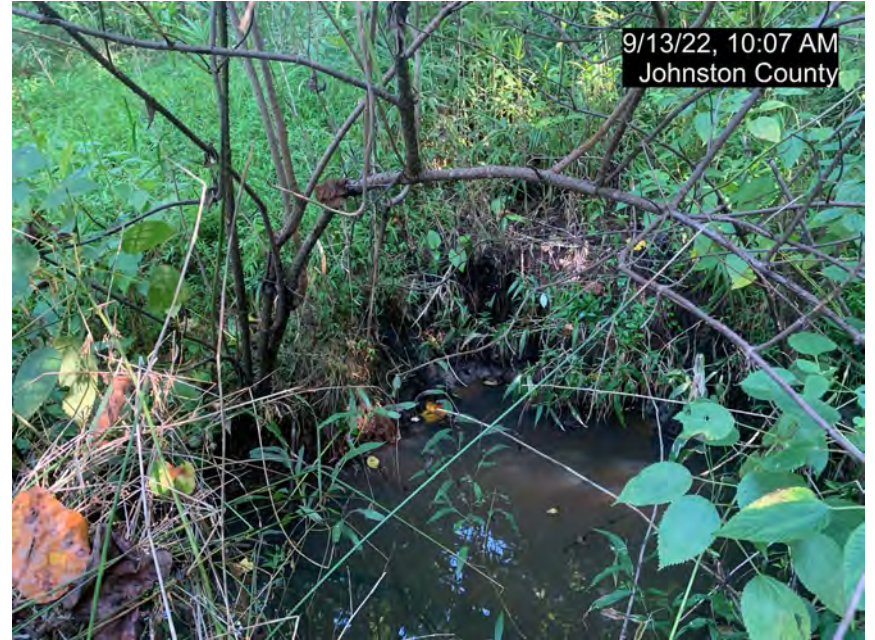
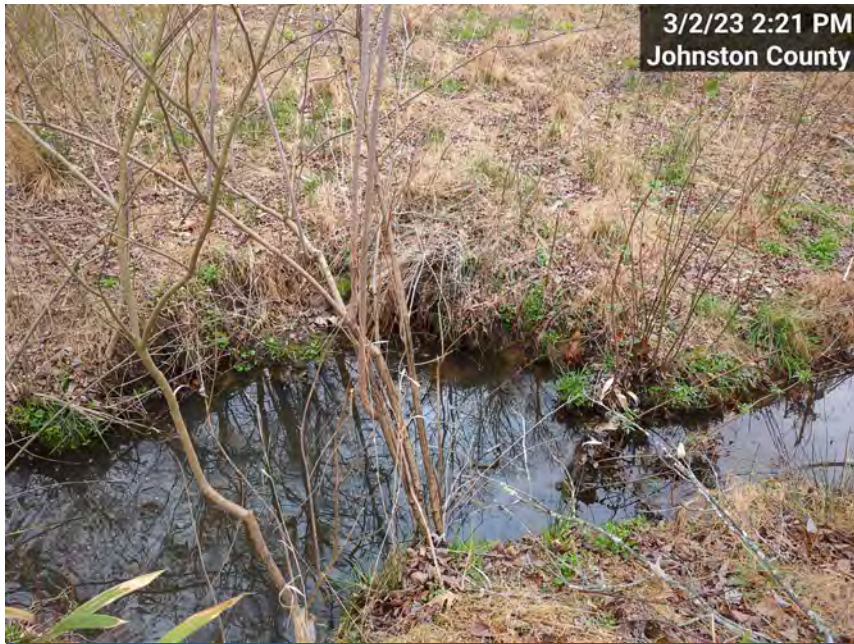
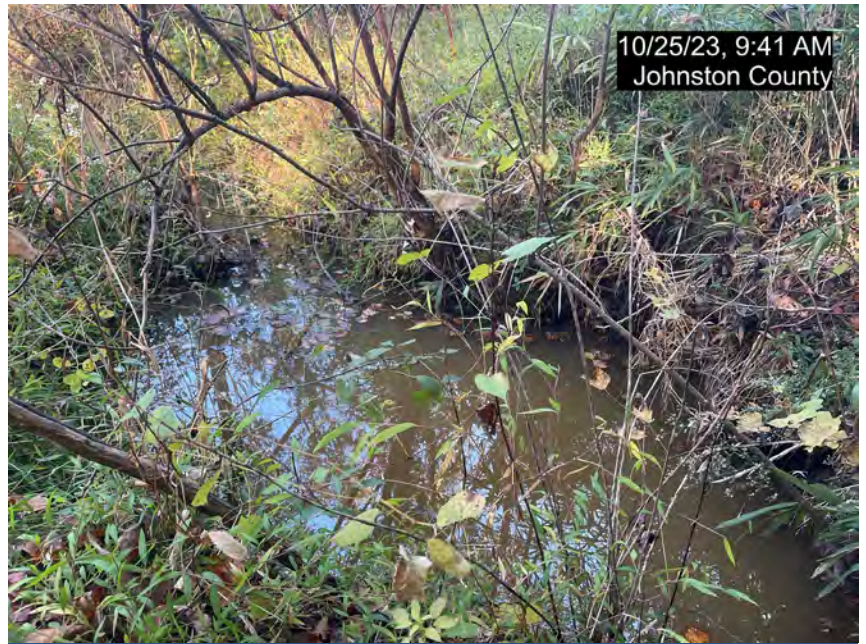
An area on the right bank of R2 located at the transition of R1 to R2 at station 16+13 has approximately 10 linear feet of undercut bank and was noted during a MY3 visual assessment (SPA1). This area is where the transition from preservation to restoration occurs. This area was planted with live stakes in MY4 and has stabilized throughout MY4/MY5/MY6 and will continue to be monitored in MY7. Photographs of the area can be found in Appendix B.

SPA1, Erosion on R2, March 17, 2020 (MY-03)

SPA1, Erosion on R2, September 15, 2021 (MY-04)

SPA1, Erosion on R2, September 13, 2022 (MY-05)

SPA1, Erosion on R2, March 2, 2023 (MY-06)

SPA1, Erosion on R2, October 25, 2023 (MY-06)

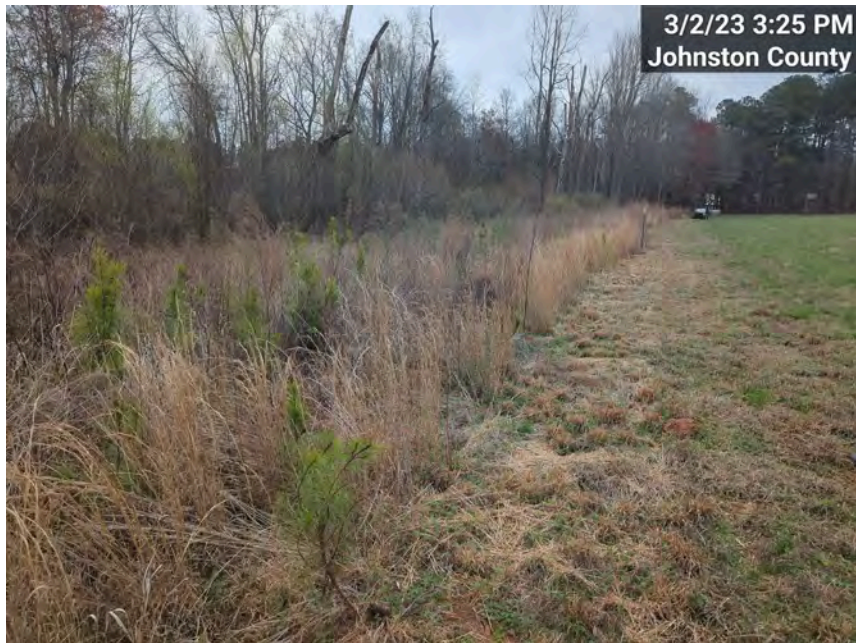
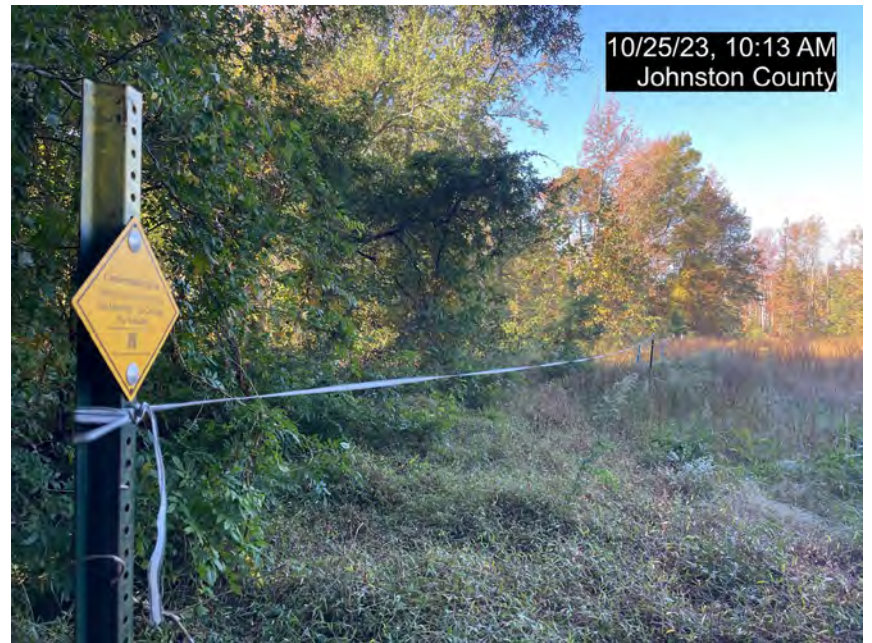
Three small encroachment areas were noted along the hay field on the left side of R2 and right side of R4 totaling 0.05 acres. WLS added additional posts and horse tape along the area. The encroachments were small and did not require any replanting of native stems.

VPA1, Encroachment Area , March 2, 2023 (MY-06)

VPA1, Encroachment Area, October 25, 2023 (MY-06)

- 2. Recommend adding supplemental posts/horse tape markings at the field encroachment areas. Communication should be initiated between the provider and the farmer to minimize the potential for future/ongoing encroachment.** WLS response: Posts and horse tape were added along field edge in encroachment areas. The total encroachment areas added up to approximately 0.05 acres. WLS will continue to monitor these areas during site visits to ensure no encroachments continue and will contact the landowner as a precaution.

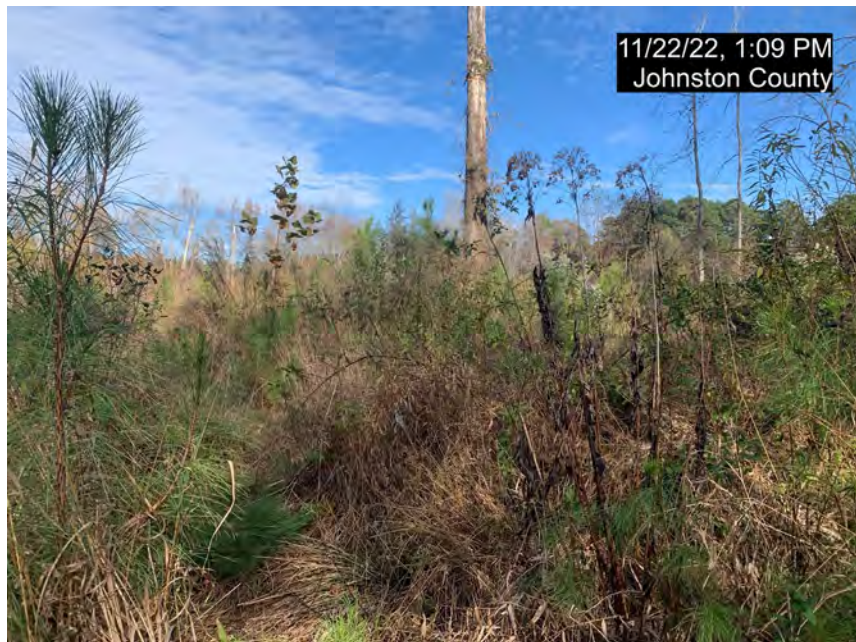
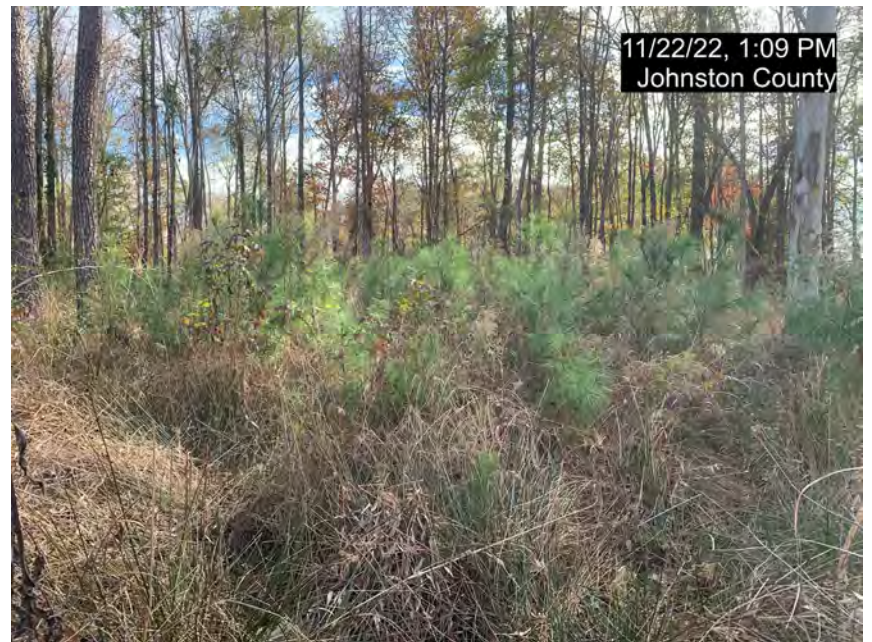
Vegetation plot surveys were not required during MY6 per the mitigation plan; surveys will continue in MY7. The MY6 vegetation monitoring was conducted utilizing visual assessment throughout the easement. An area of pine establishment (~0.82 acres) was noted during the IRT site visit in October 2022. Pine in this area were thinned on November 22nd, 2022, using hand tools to allow desirable planted and volunteer species to establish. Future management in this area will be documented in annual reports as needed. The results of the visual assessment did not indicate any additional significant negative changes to the existing vegetation community.

Pine management area along R4, November 22, 2022 (MY-05)

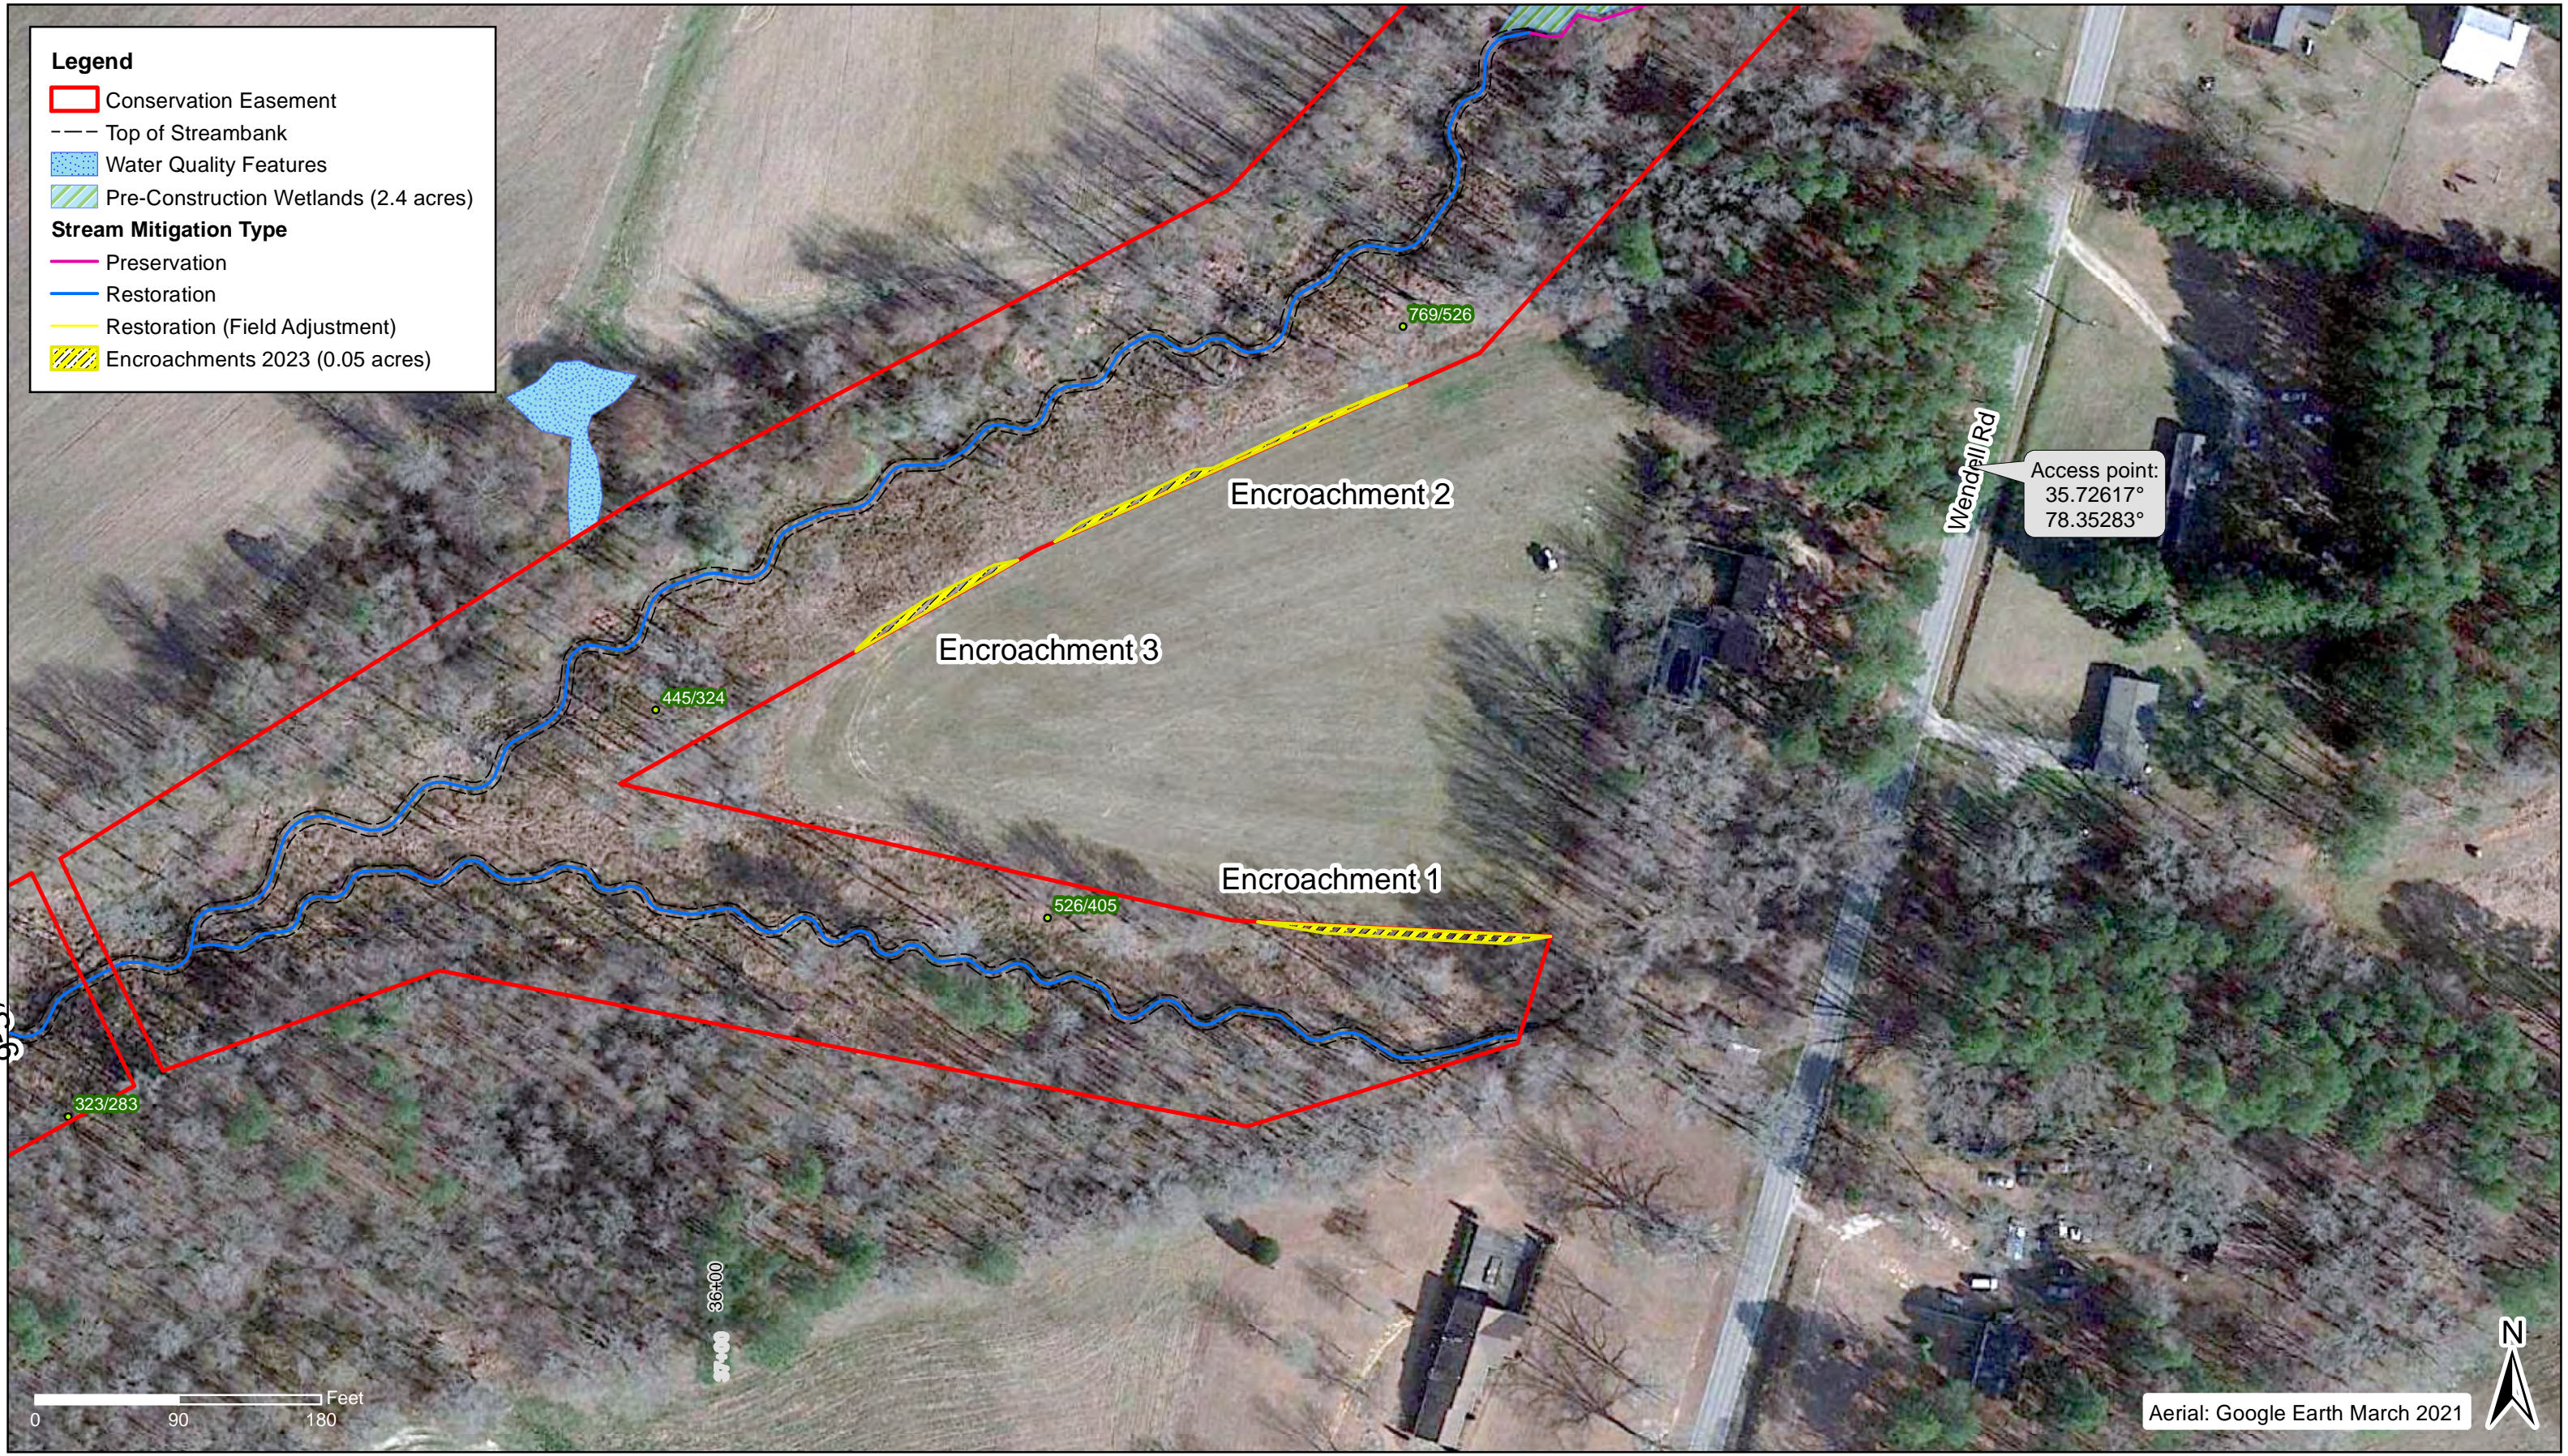
- Preservation
- Restoration
- Restoration (Field Adjustment)
- Encroachments 2023 (0.05 acres)
