Monitoring Report
FINAL VERSION
Edwards-Johnson Mitigation Project
Monitoring Year 1
Calendar Year of Data Collection: 2018

NCDEQ DMS Project Identification # 97080
NCDEQ DMS Contract # 6825
Neuse River Basin (Cataloging Unit 03020201)
USACE Action ID Number: SAW-2016-00883
NCDEQ DWR Project # 2016-0404
Johnston County, NC
Contracted Under RFP # 16-006477
Data Collection Period: April-June 2018, Submission Date: March 2019

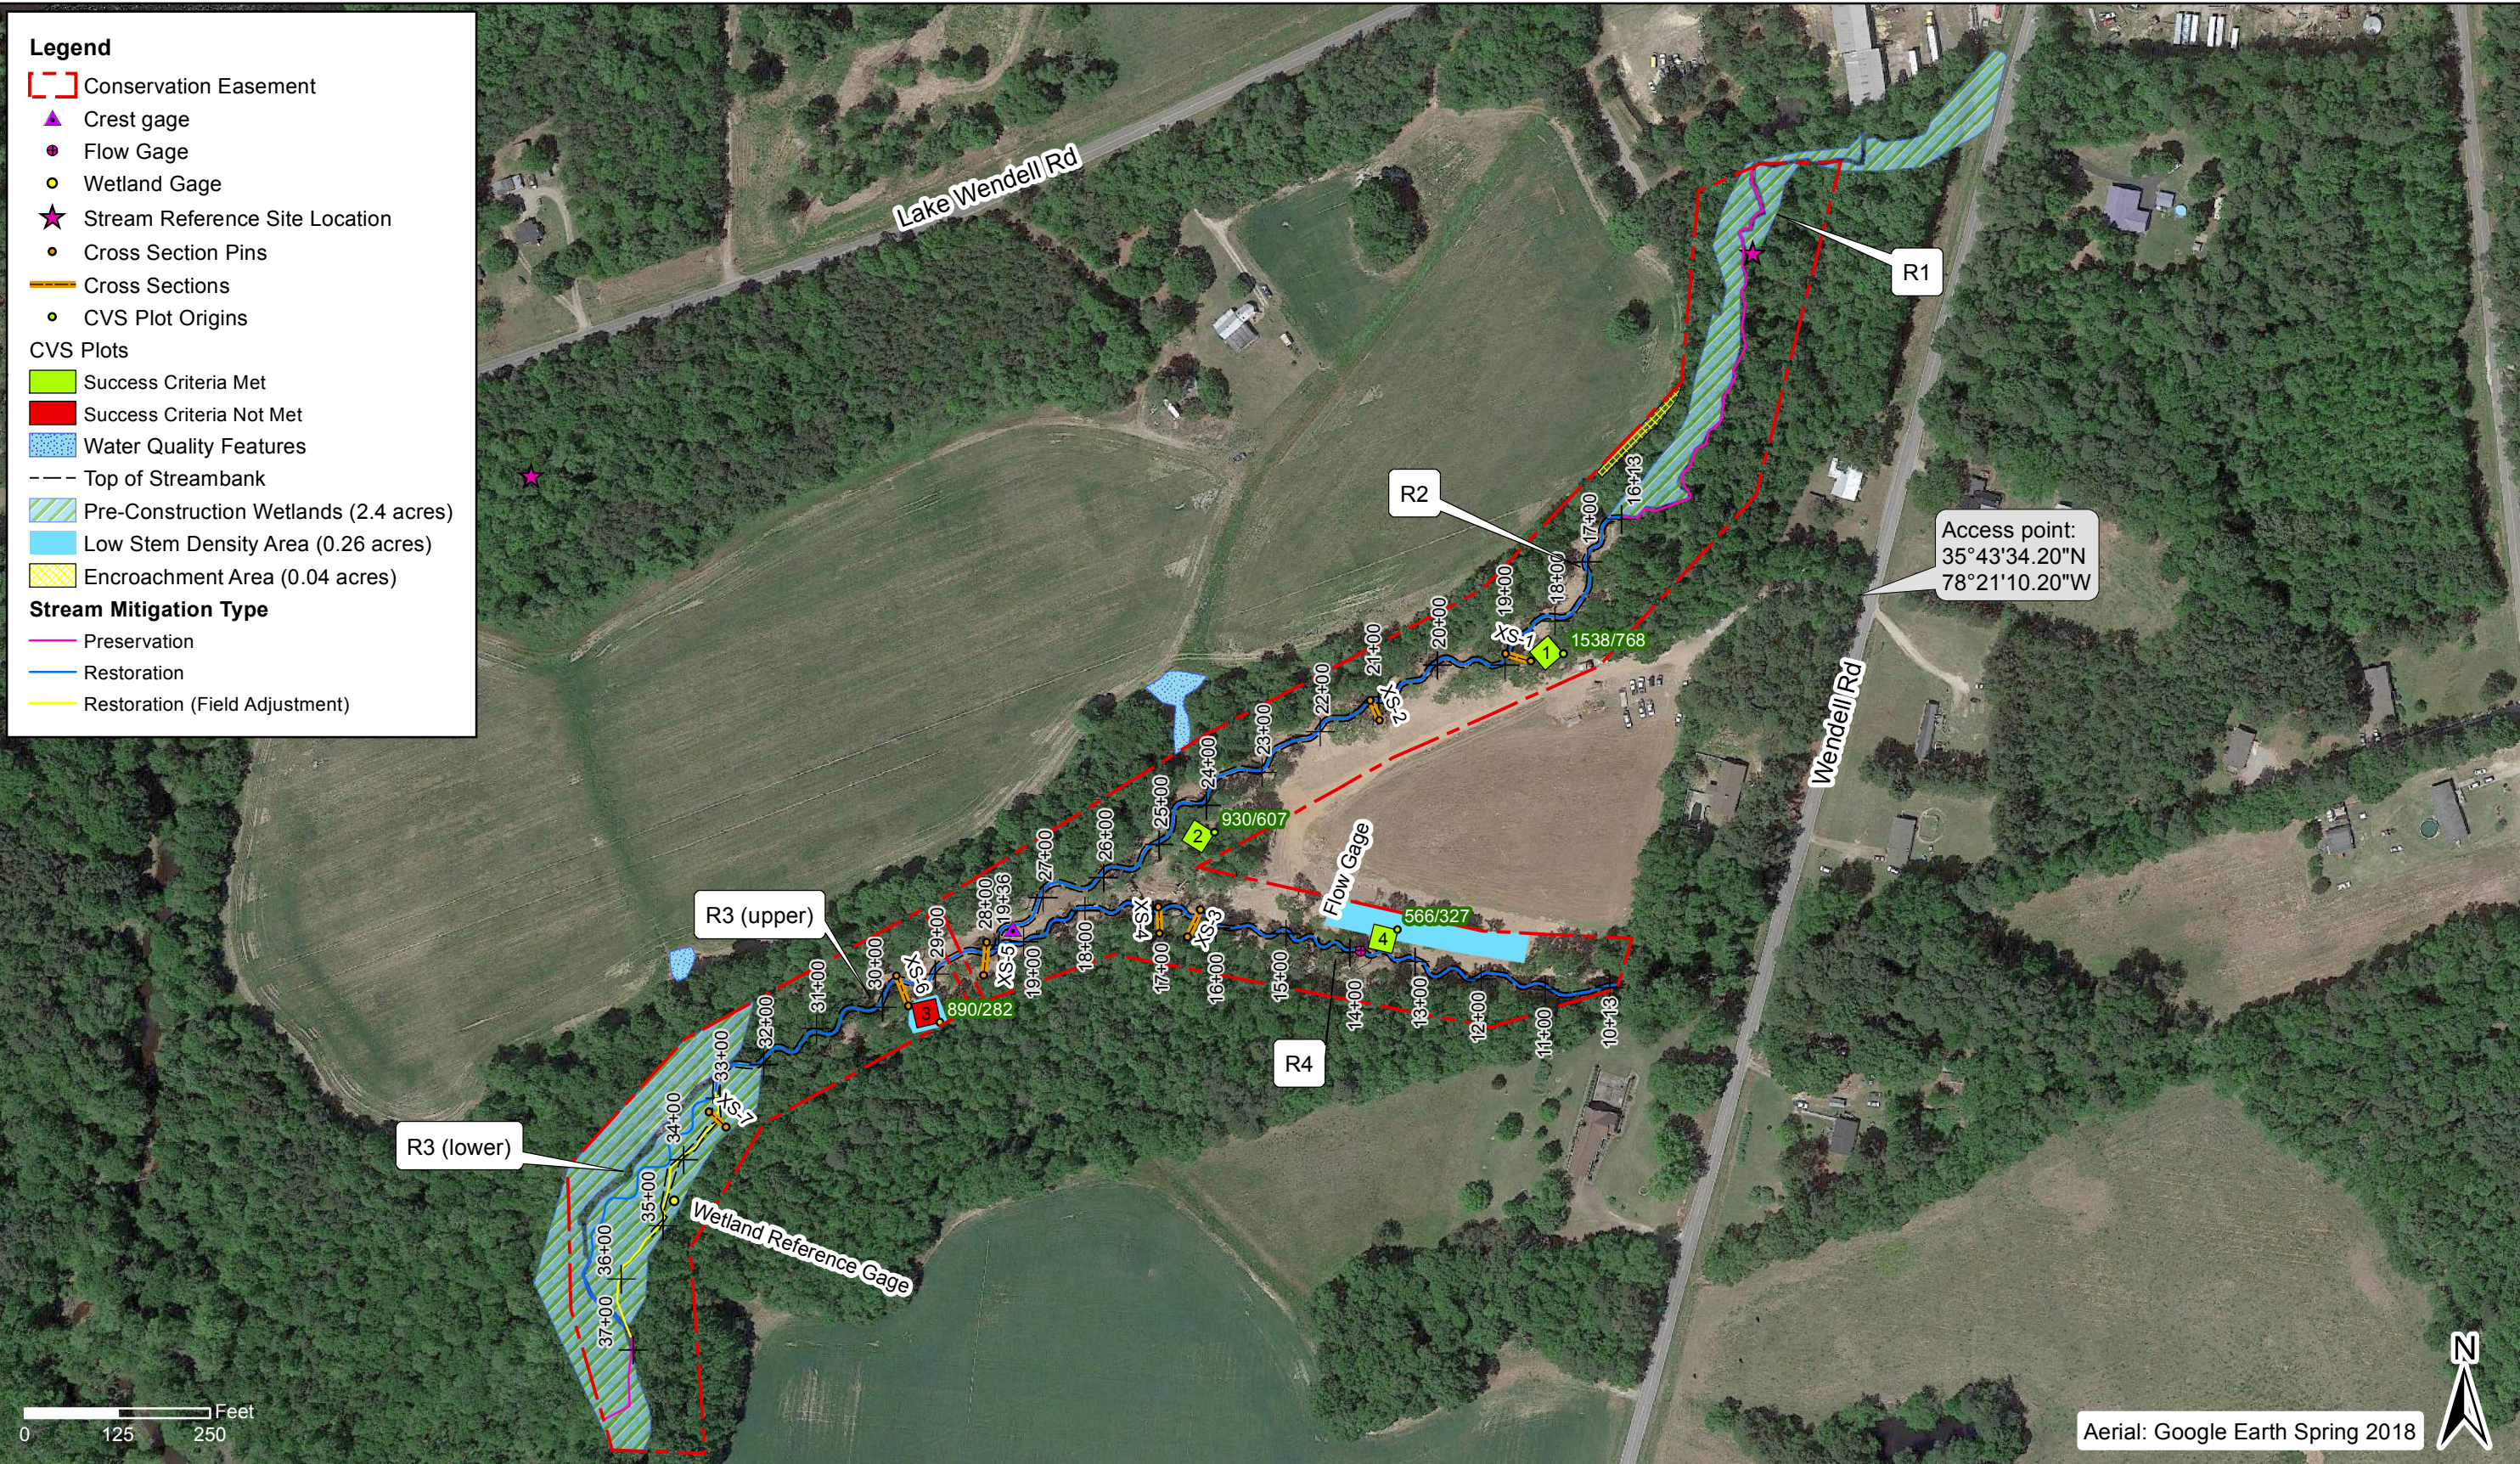
Current Conditions
Plan View
Monitoring Year 1
NAD 1983 2011 State Plane
North Carolina FIPS 3200 FT US

An area of concern was observed along R3 buffer near veg plot 3 as shown on the CCPV. This area was utilized as a partial haul road during construction and experienced prolonged wetness during planting activities. Veg plot 3 stem density was approximately 283 stems per acre which is below the interim success criteria. In addition, low stem density was observed along R4 near veg plot 4. These areas will be watched closely during MY2 monitoring and any remedial actions, if necessary, will be documented in the subsequent MY2 report. In addition, a slight buffer encroachment was observed along the R2 as shown on the CCPV. The conservation easement is marked in this area and the landowner has been notified. This area will be replanted in Winter 2019 and documented in the MY2 report.
