Monitoring Report – Year 2
FINAL VERSION
Edwards-Johnson Mitigation Project
Calendar Year of Data Collection: 2019

NCDEQ DMS Project Identification # 97080
NCDEQ DMS Contract # 6825
Neuse River Basin (Cataloging Unit 03020201)
USACE Action ID Number: SAW-2016-00883
NCDEQ DWR Project # 2016-0404
Johnston County, NC
Contracted Under RFP # 16-006477
Data Collection Period: June-October 2019, Submission Date: December 2019

Mitigation Project Name Edwards-Johnson
DMS ID 97080
River Basin Neuse
Cataloging Unit 03020201

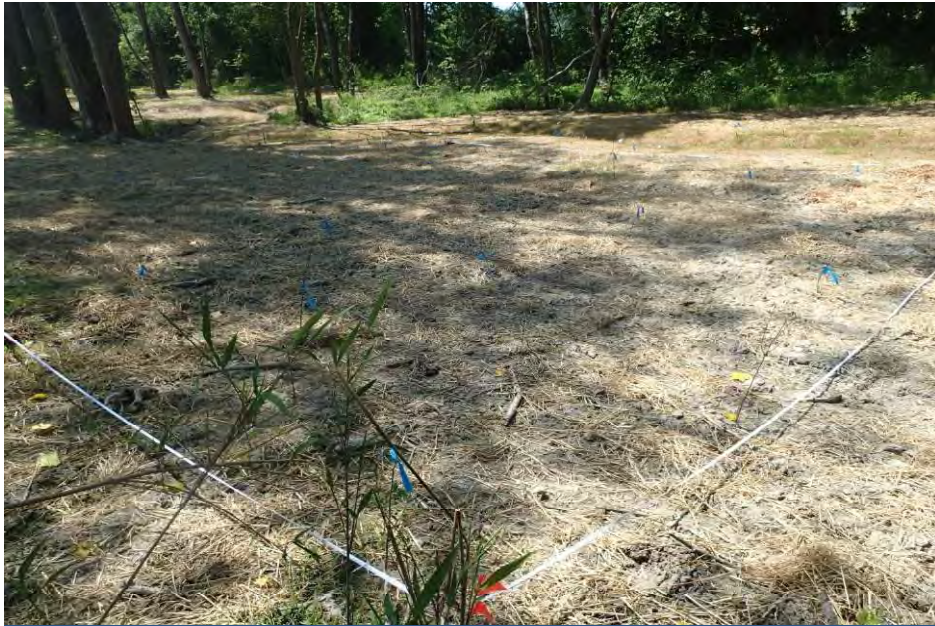
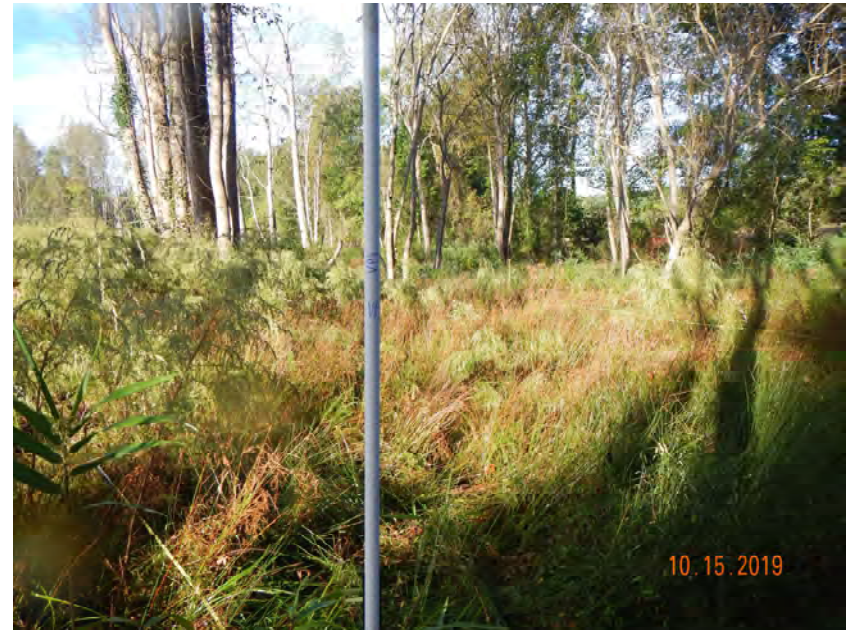
Veg Plot 1, May 14, 2018 (MY-00)

Veg Plot 1, October 15, 2019 (MY-02)

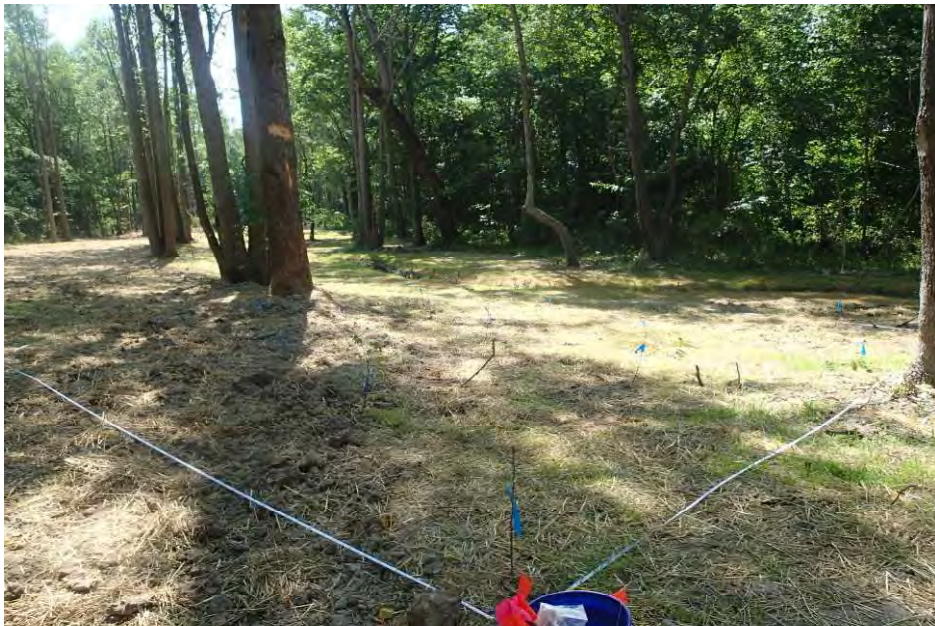
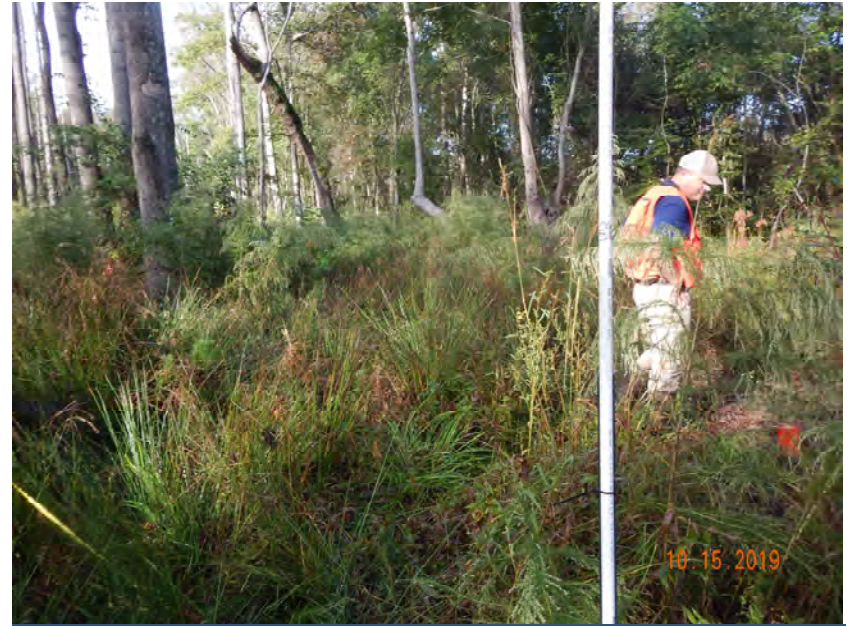
Veg Plot 2, May 14, 2018 (MY-00)

Veg Plot 2, October 5, 2019 (MY-02)

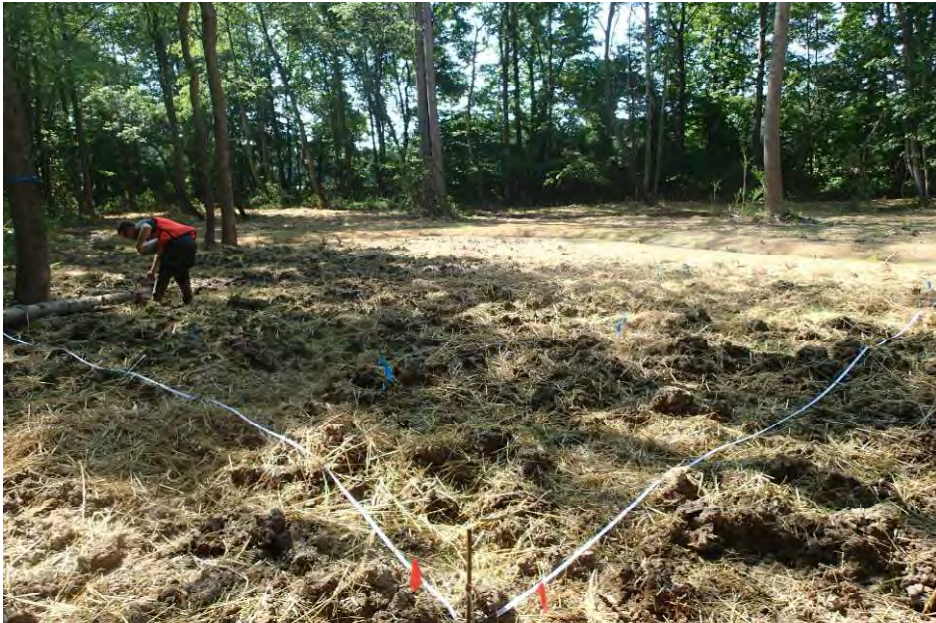
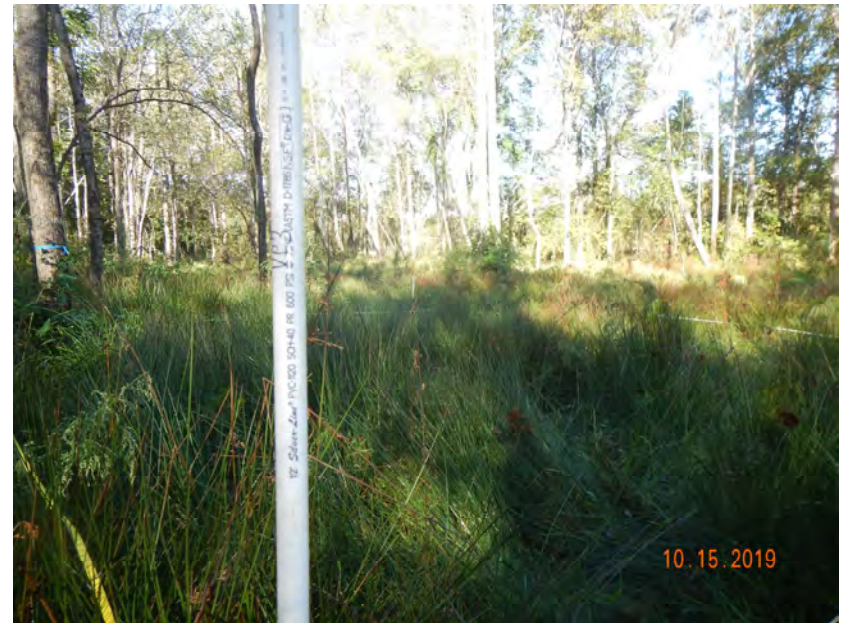
In MY2 Plots 3 and 4 failed to meet the year 3 minimum of 320 stems per acre. For Plot 3, loss in stem density from MY1 to MY2 is due to increased wetness and a dense herbaceous layer. Plot 4 saw a low survivability due to poor subsoil planting conditions.

Veg Plot 3, May 14, 2018 (MY-00)

Veg Plot 3, October 15, 2019 (MY-02)

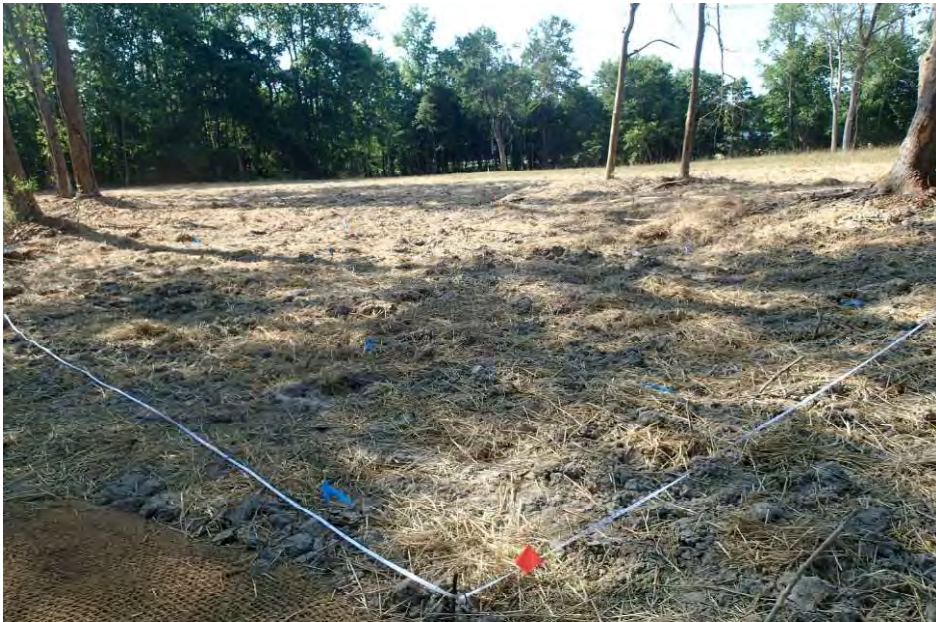
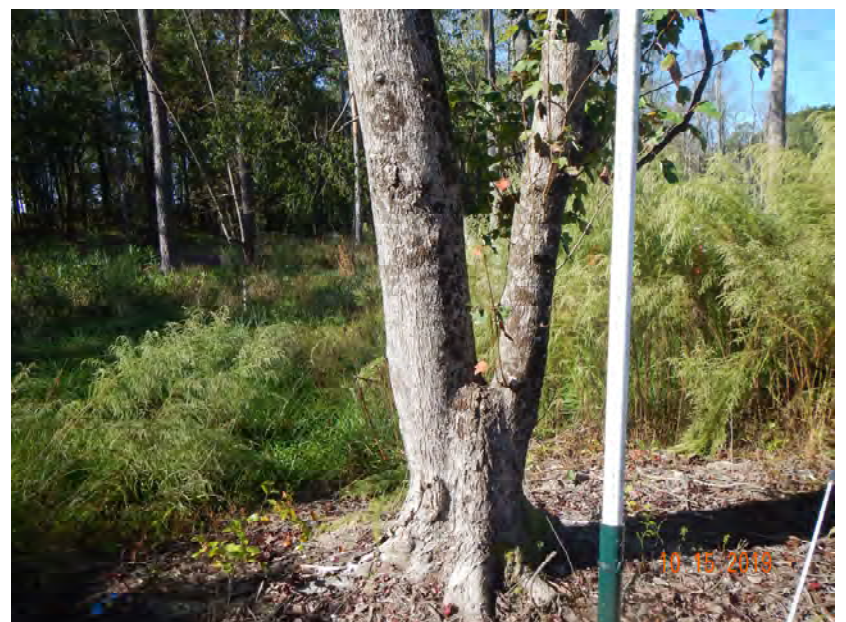
Veg Plot 4, May 14, 2018 (MY-00)
*plot origin at corner to the right

Veg Plot 4, October 15, 2019 (MY-02)

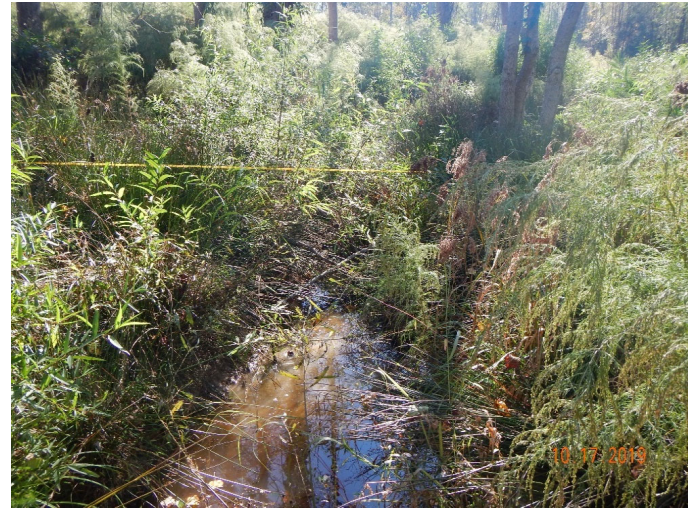
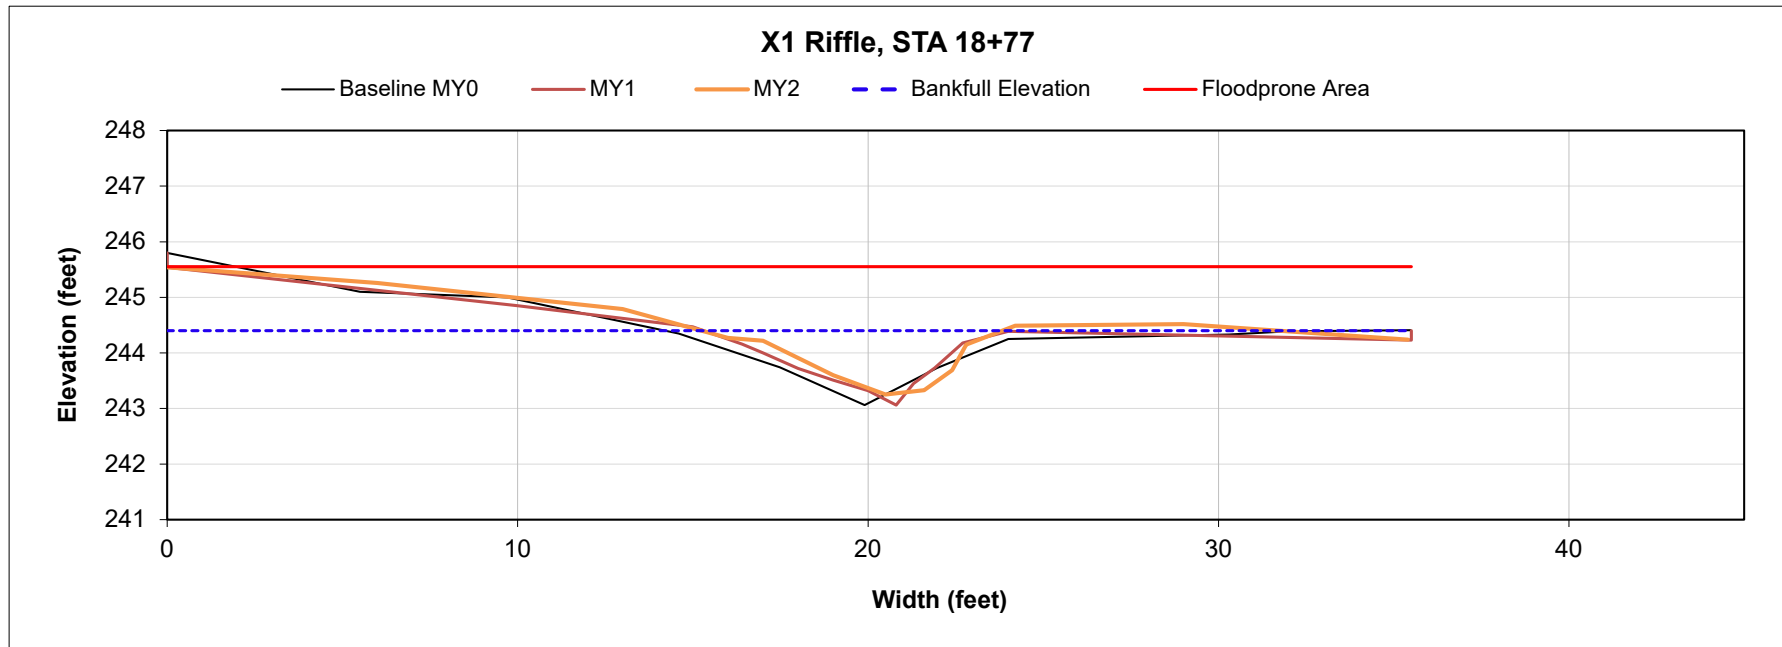
Project Name	Edwards-Johnson Mitigation Project
Project ID	97080
Reach ID	R2
Cross Section ID	X1
Field Crew	K. Obermiller, E. Dunnigan

Dimension Data Summary: MY2 2019	
Bankfull Elevation (ft)	244.4
Low Bank Height Elevation (ft)	244.3
Bankfull Max Depth (ft)	1.2
Low Bank Height (ft)	1.3
Bank Height Ratio	0.9
Bankfull X-section Area (ft²)	4.9
% Change Bank Height Ratio	10.0%

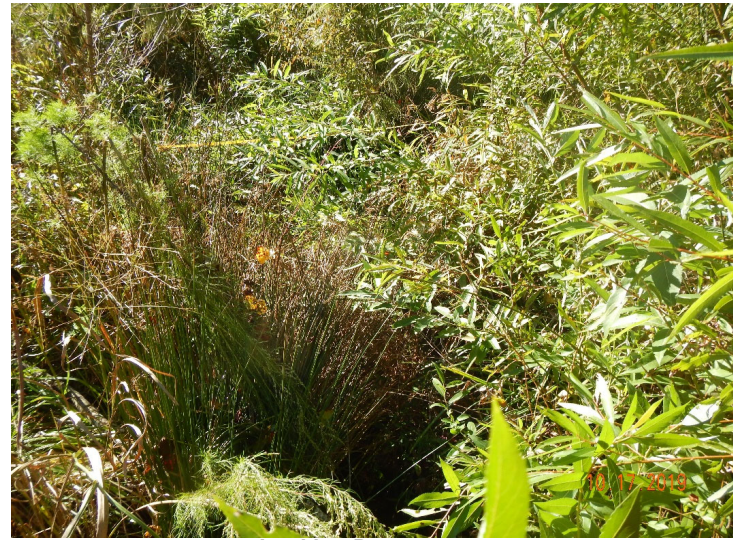
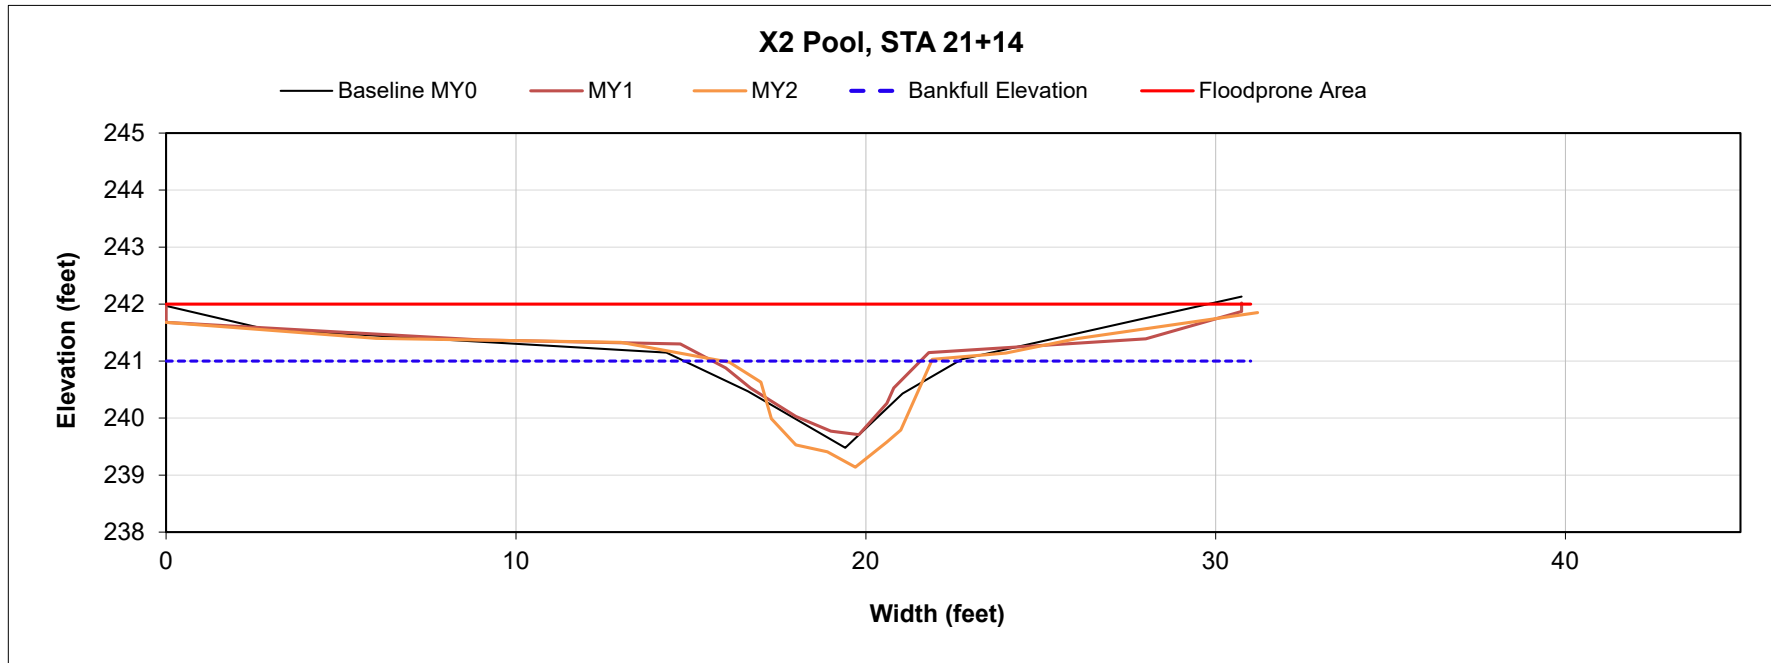
Project Name	Edwards-Johnson Mitigation Project
Project ID	97080
Reach ID	R2
Cross Section ID	X2
Field Crew	K. Obermiller, E. Dunnigan

Dimension Data Summary: MY2 2019	
Bankfull Elevation (ft)	241.0
Low Bank Height Elevation (ft)	241.0
Bankfull Max Depth (ft)	1.8
Low Bank Height (ft)	1.8
Bank Height Ratio	1.0
Bankfull X-section Area (ft ²)	6.5
% Change Bank Height Ratio	0.0%

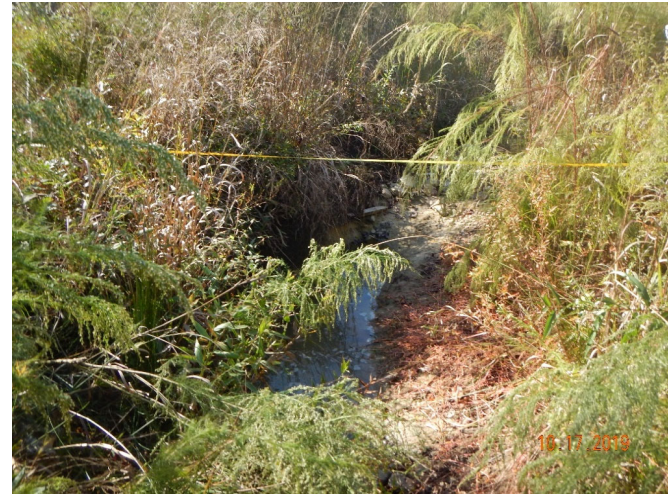
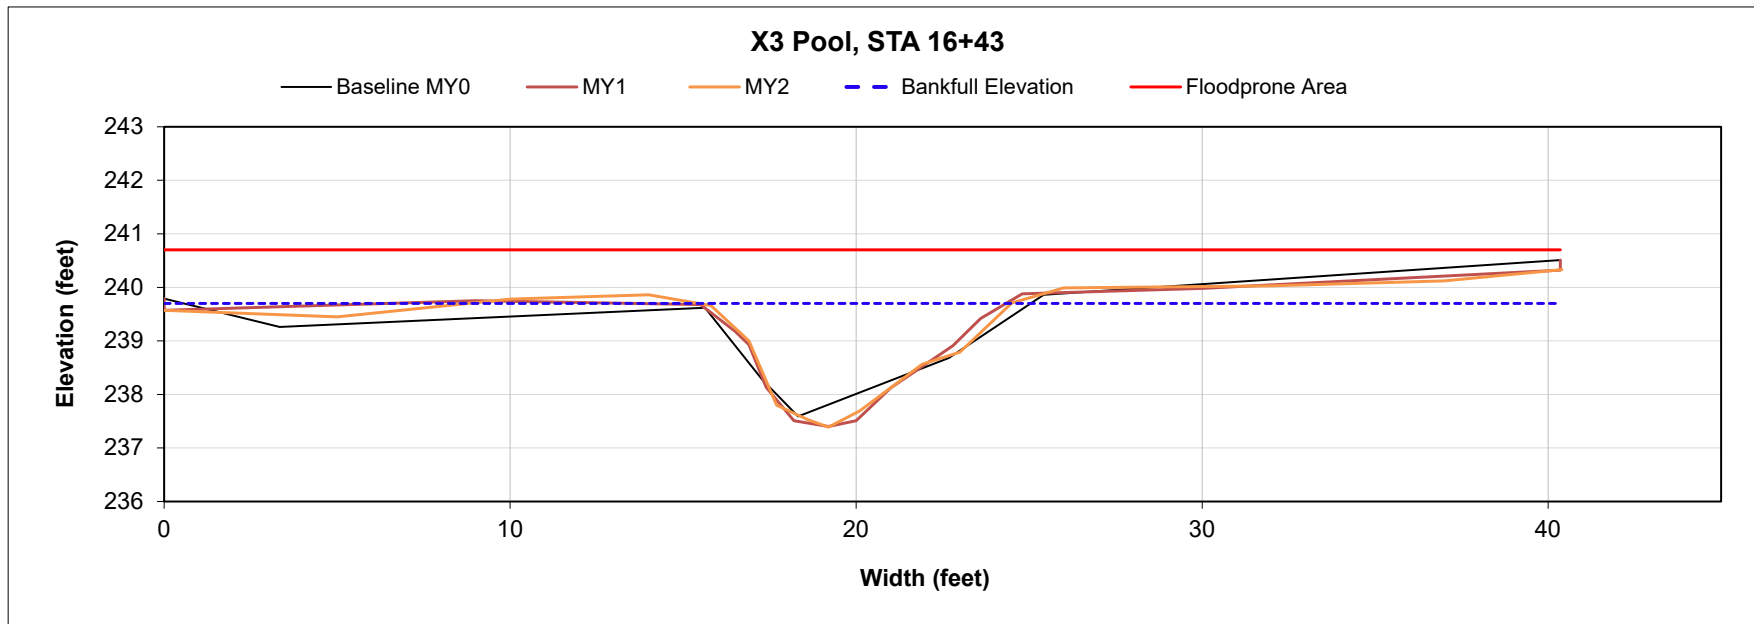
Project Name	Edwards-Johnson Mitigation Project
Project ID	97080
Reach ID	R4
Cross Section ID	X3
Field Crew	K. Obermiller, E. Dunnigan

Dimension Data Summary: MY2 2019	
Bankfull Elevation (ft)	239.7
Low Bank Height Elevation (ft)	239.7
Bankfull Max Depth (ft)	2.3
Low Bank Height (ft)	2.3
Bank Height Ratio	1.0
Bankfull X-section Area (ft ²)	11.0
% Change Bank Height Ratio	0.0%

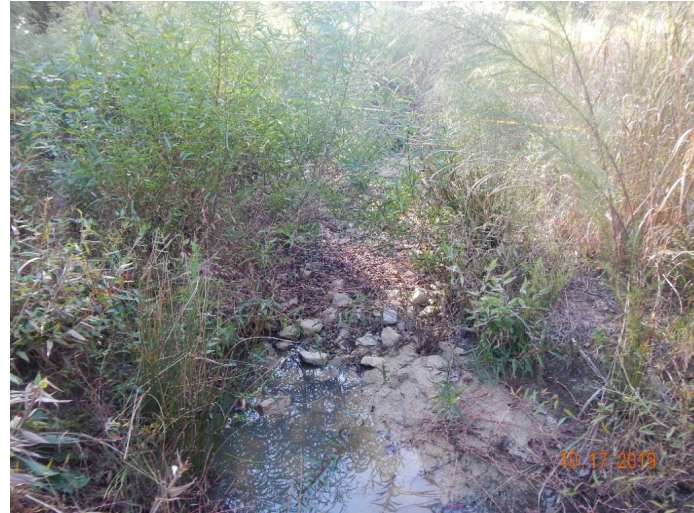
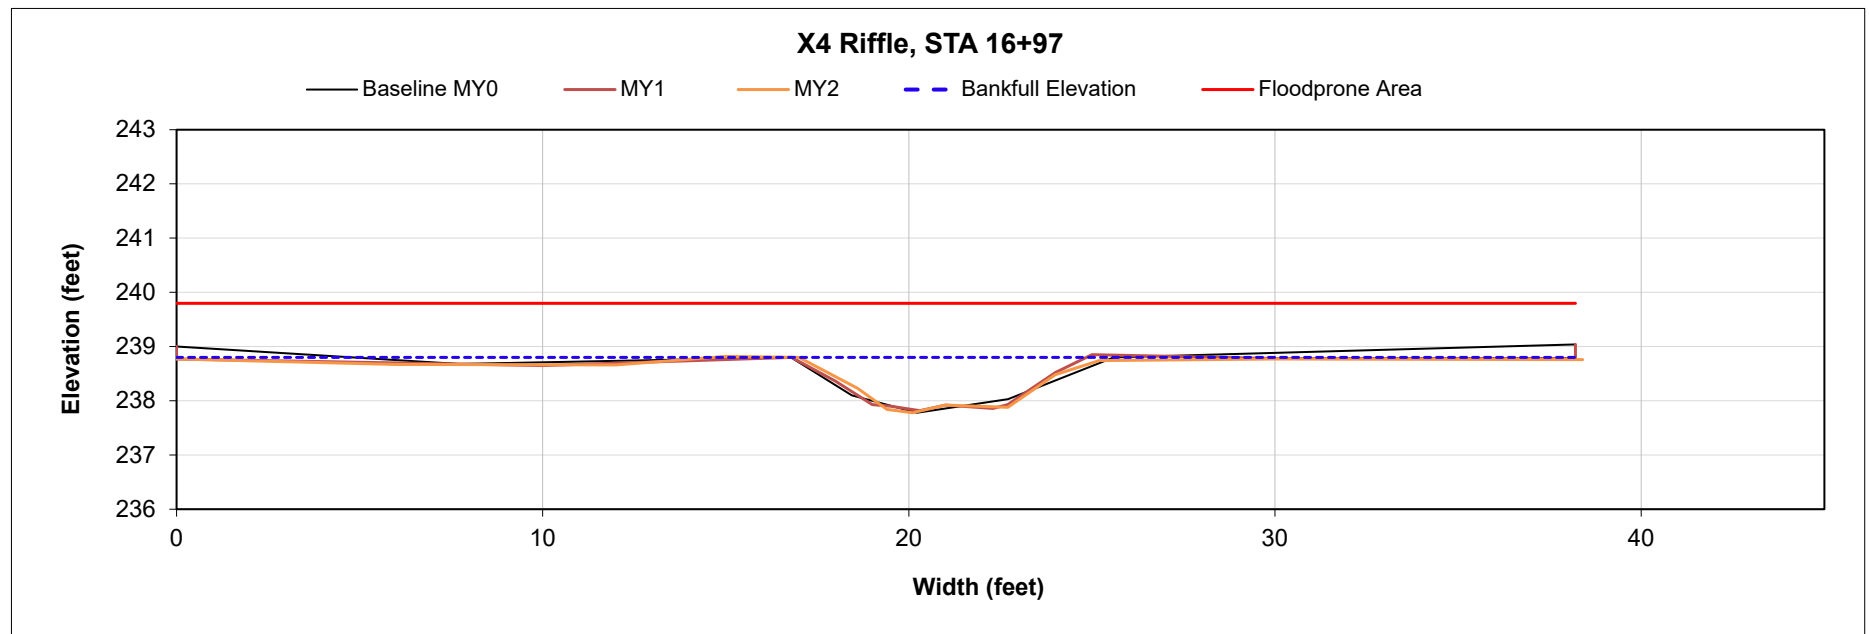
Project Name	Edwards-Johnson Mitigation Project
Project ID	97080
Reach ID	R4
Cross Section ID	X4
Field Crew	K. Obermiller, E. Dunnigan

Dimension Data Summary: MY2 2019	
Bankfull Elevation (ft)	238.8
Low Bank Height Elevation (ft)	238.7
Bankfull Max Depth (ft)	1.0
Low Bank Height (ft)	0.9
Bank Height Ratio	0.9
Bankfull X-section Area (ft²)	5.2
% Change Bank Height Ratio	10.0%

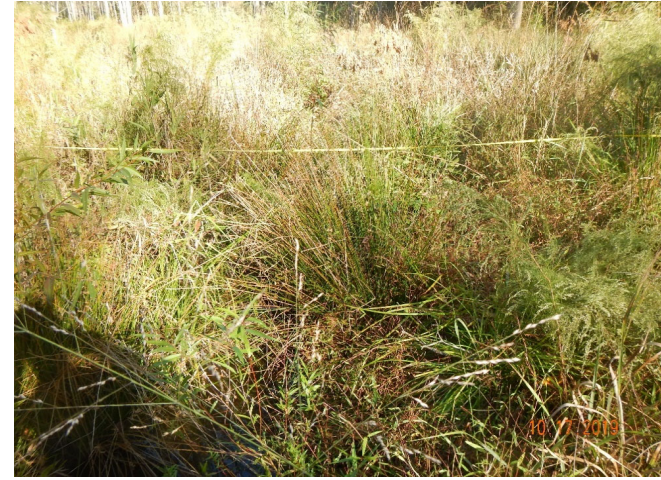
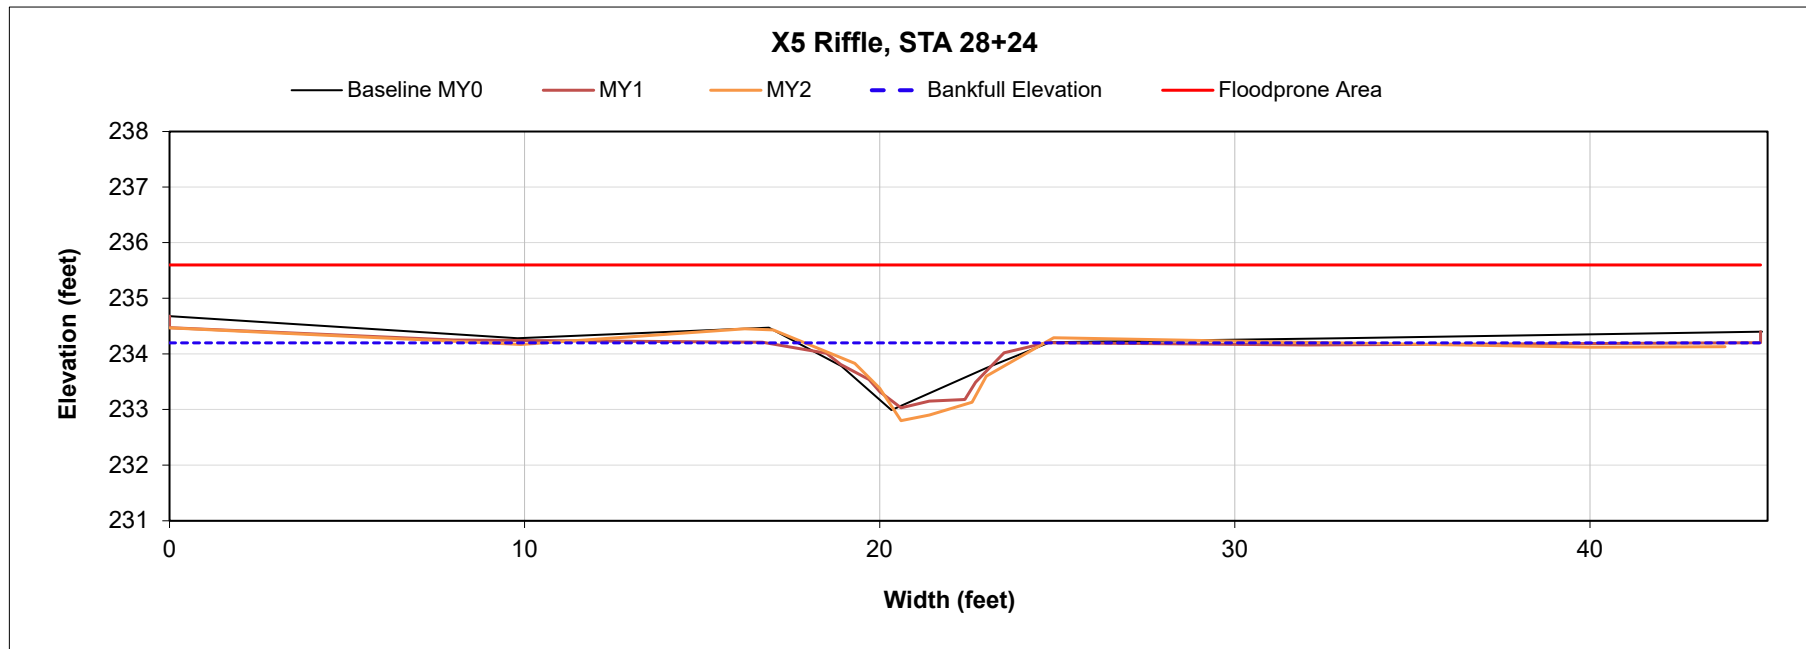
Project Name	Edwards-Johnson Mitigation Project
Project ID	97080
Reach ID	R3
Cross Section ID	X5
Field Crew	K. Obermiller, E. Dunnigan

Dimension Data Summary: MY2 2019	
Bankfull Elevation (ft)	234.2
Low Bank Height Elevation (ft)	234.3
Bankfull Max Depth (ft)	1.4
Low Bank Height (ft)	1.5
Bank Height Ratio	1.1
Bankfull X-section Area (ft²)	4.7
% Change Bank Height Ratio	10.0%

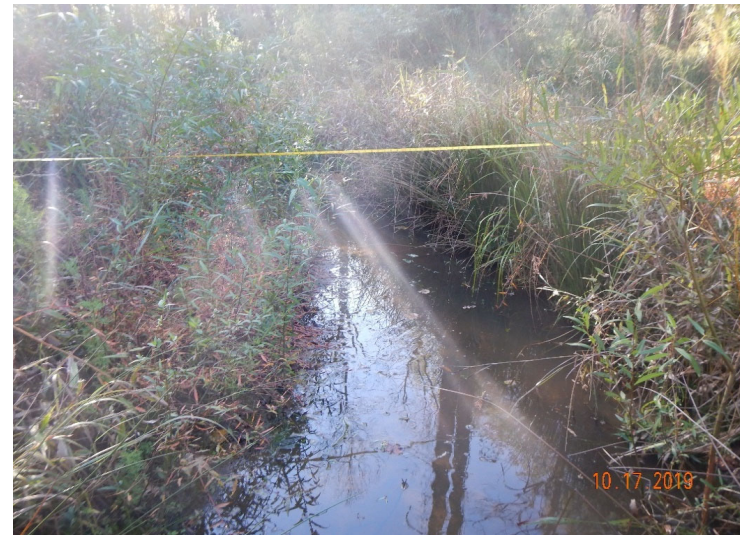
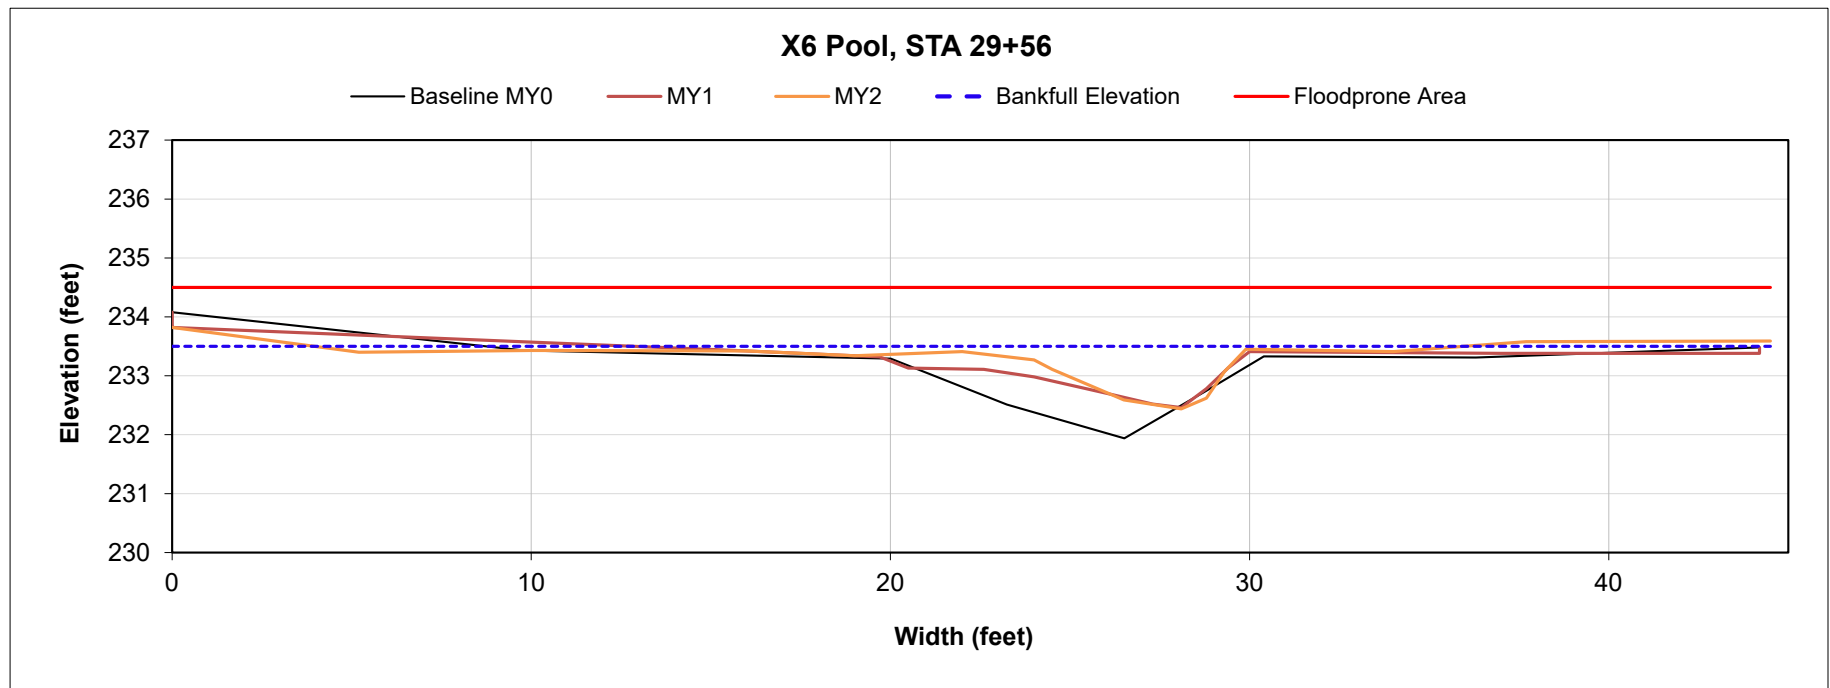
Project Name	Edwards-Johnson Mitigation Project
Project ID	97080
Reach ID	R3
Cross Section ID	X6
Field Crew	K. Obermiller, E. Dunnigan

Dimension Data Summary: MY2 2019	
Bankfull Elevation (ft)	233.5
Low Bank Height Elevation (ft)	233.4
Bankfull Max Depth (ft)	1.0
Low Bank Height (ft)	0.9
Bank Height Ratio	0.9
Bankfull X-section Area (ft²)	5.6
% Change Bank Height Ratio	10.0%

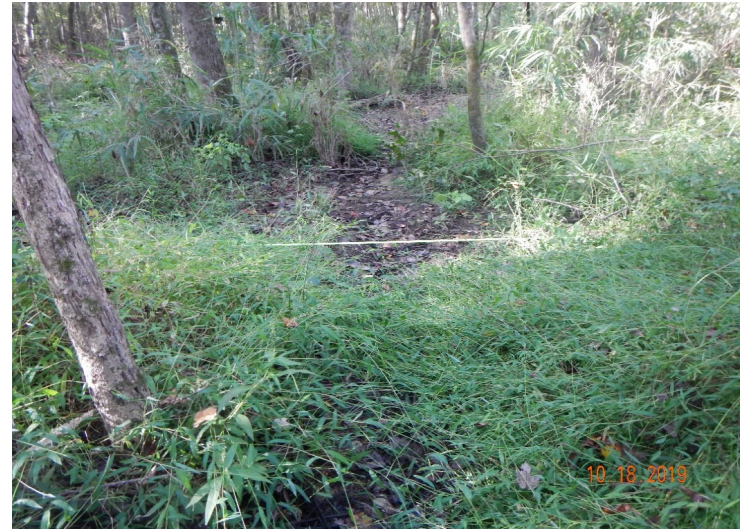
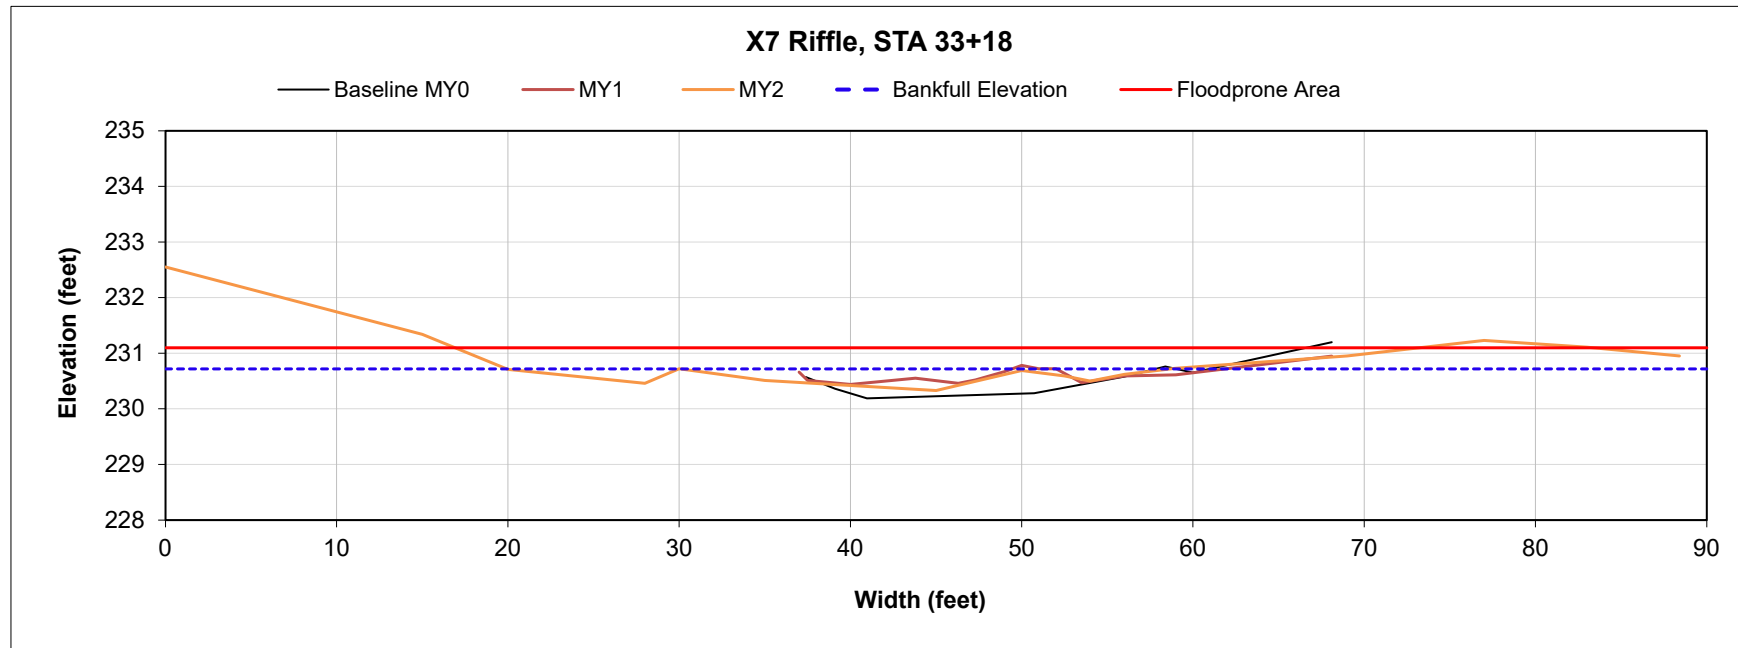
Project Name	Edwards-Johnson Mitigation Project
Project ID	97080
Reach ID	R3 (Multi-Thread Channel)
Cross Section ID	X7
Field Crew	K. Obermiller, E. Dunnigan

Dimension Data Summary: MY2 2019	
Bankfull Elevation (ft)	230.7
Low Bank Height Elevation (ft)	230.8
Bankfull Max Depth (ft)	0.4
Low Bank Height (ft)	0.5
Bank Height Ratio	1.1
Bankfull X-section Area (ft²)	4.7
% Change Bank Height Ratio	10.0%

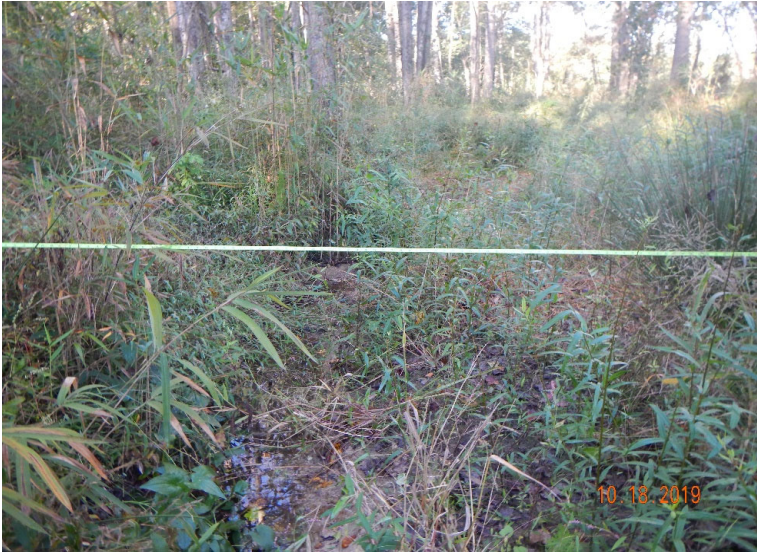
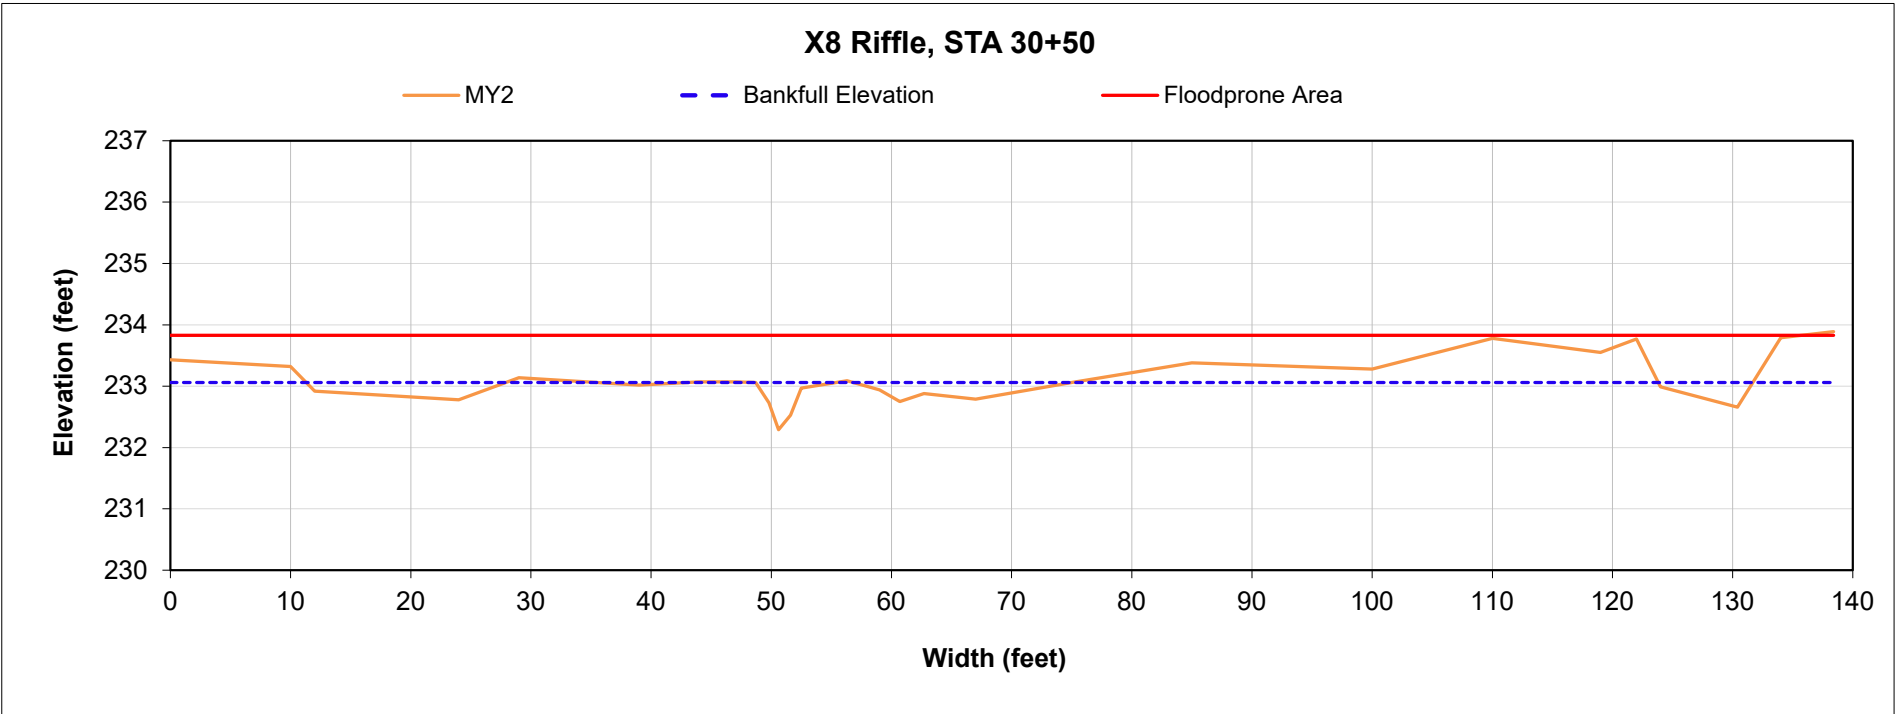
Project Name	Edwards-Johnson Mitigation Project
Project ID	97080
Reach ID	R3 (Multi-Thread Channel)
Cross Section ID	X8
Field Crew	K. Obermiller, E. Dunnigan

Dimension Data Summary: MY2 2019	
Bankfull Elevation (ft)	238.1
Low Bank Height Elevation (ft)	238.1
Bankfull Max Depth (ft)	0.8
Low Bank Height (ft)	0.8
Bank Height Ratio	1.0
Bankfull X-section Area (ft²)	4.7
% Change Bank Height Ratio	0.0%

*X8 added during MY1 post-monitoring site visit
