Monitoring Report – Year 3
FINAL VERSION
Edwards-Johnson Mitigation Project
Calendar Year of Data Collection: 2020

NCDEQ DMS Project Identification # 97080
NCDEQ DMS Contract # 6825
Neuse River Basin (Cataloging Unit 03020201)
USACE Action ID Number: SAW-2016-00883
NCDEQ DWR Project # 2016-0404
Johnston County, NC
Contracted Under RFP # 16-006477
Data Collection Period: September – October 2020
Submission Date: December 11, 2020

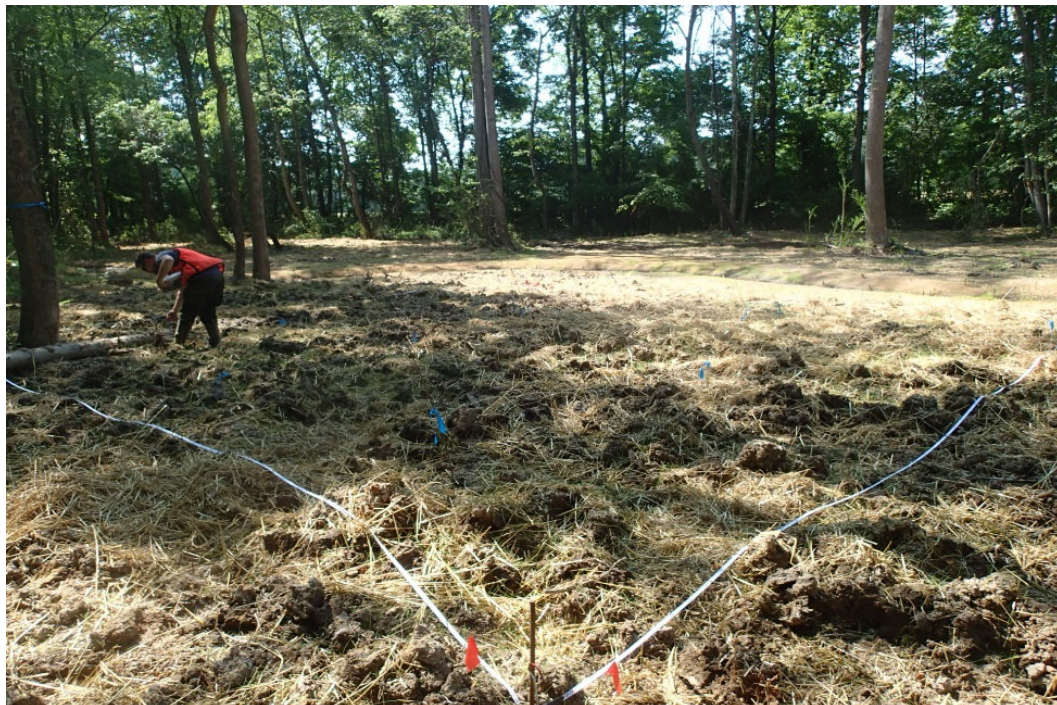
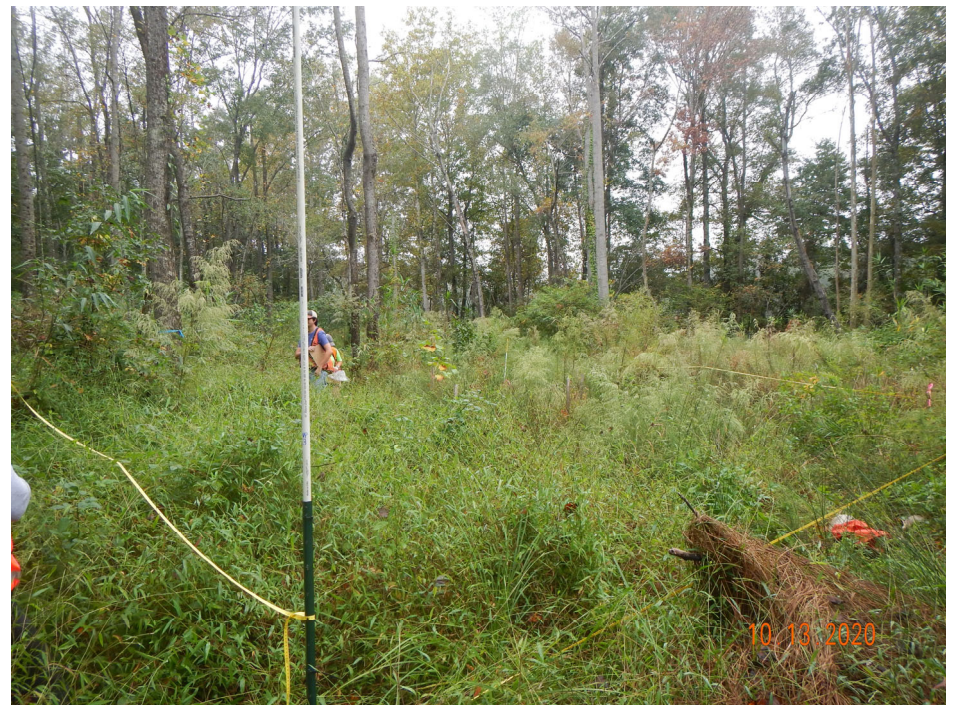
- 1. DMS Comment: The project summary states that the site is "mostly meeting" for MY3 vegetation, but the report goes on to state that plots 3 and 4 are failing. Remove that statement in the summary as it is not accurate or consider other comments below in revision.** WLS Response: The word "mostly" was removed from the project summary statement. WLS updated vegetation Plots 3 and 4 to include stems planted in MY3 and the plots are now meeting MY3 success criteria.

Veg Plot 3, May 14, 2018 (MY-00)

Veg Plot 3, October 13, 2020 (MY-03)

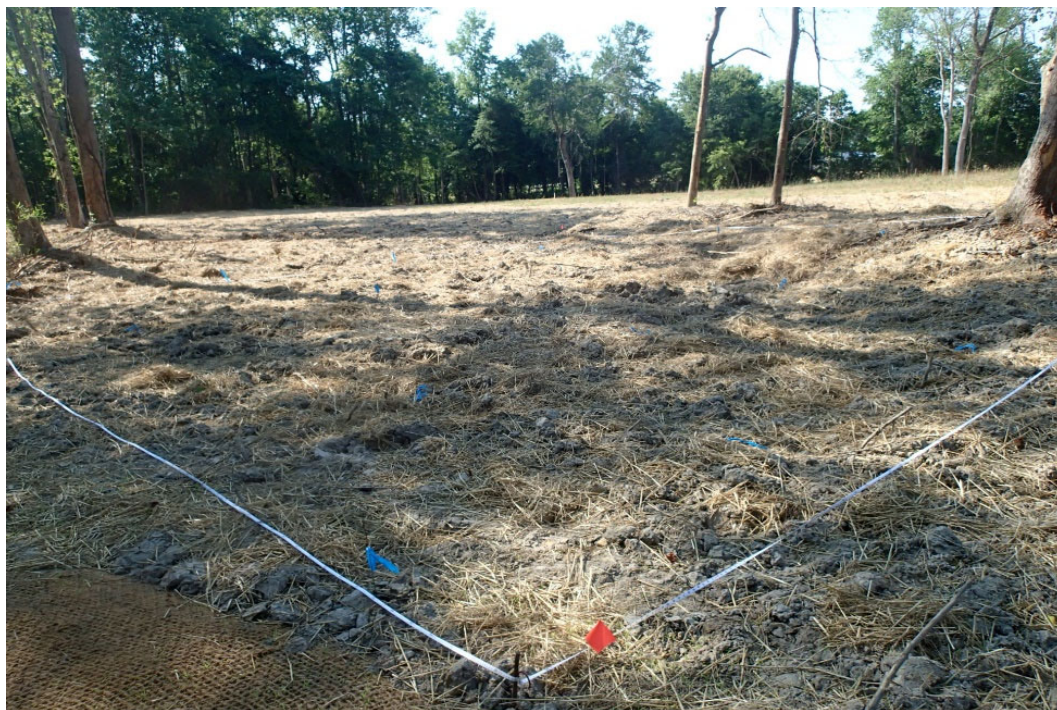
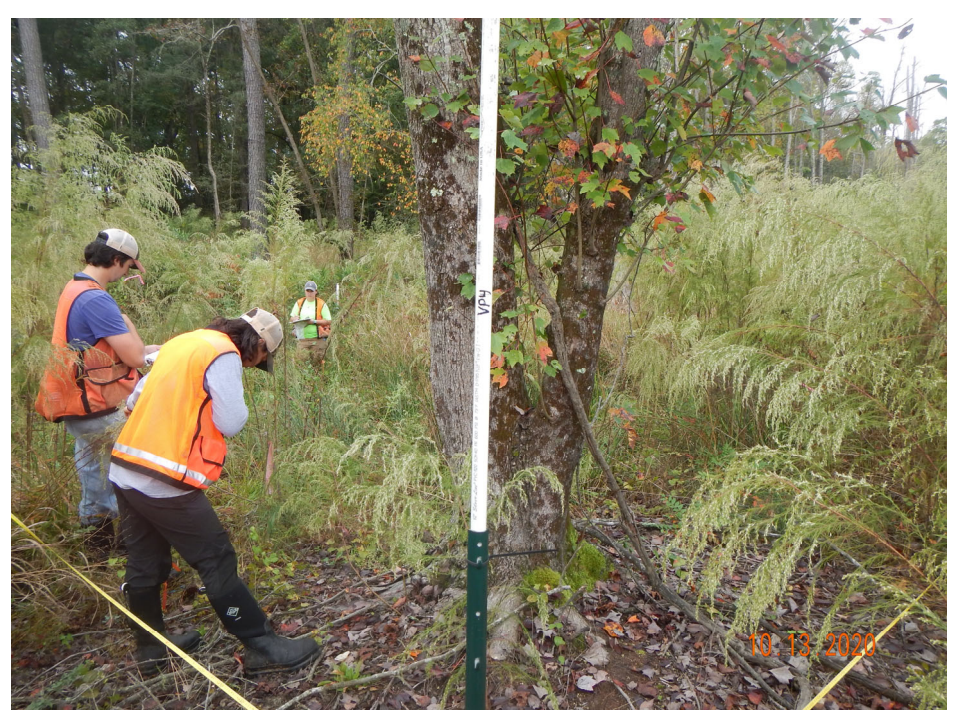
Veg Plot 4, May 14, 2018 (MY-00)
*plot origin at corner to the right

Veg Plot 4, October 13, 2020 (MY-03)

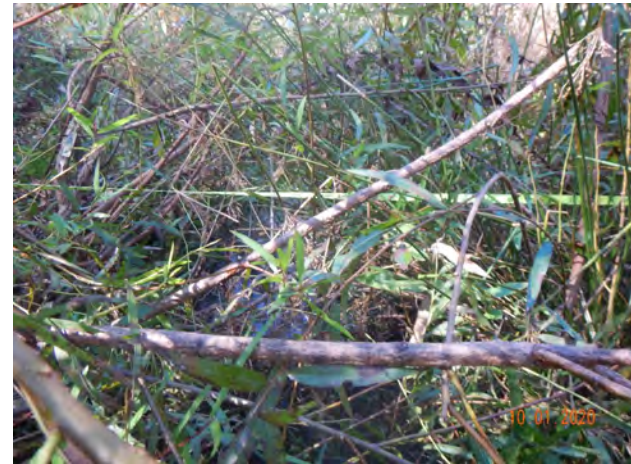
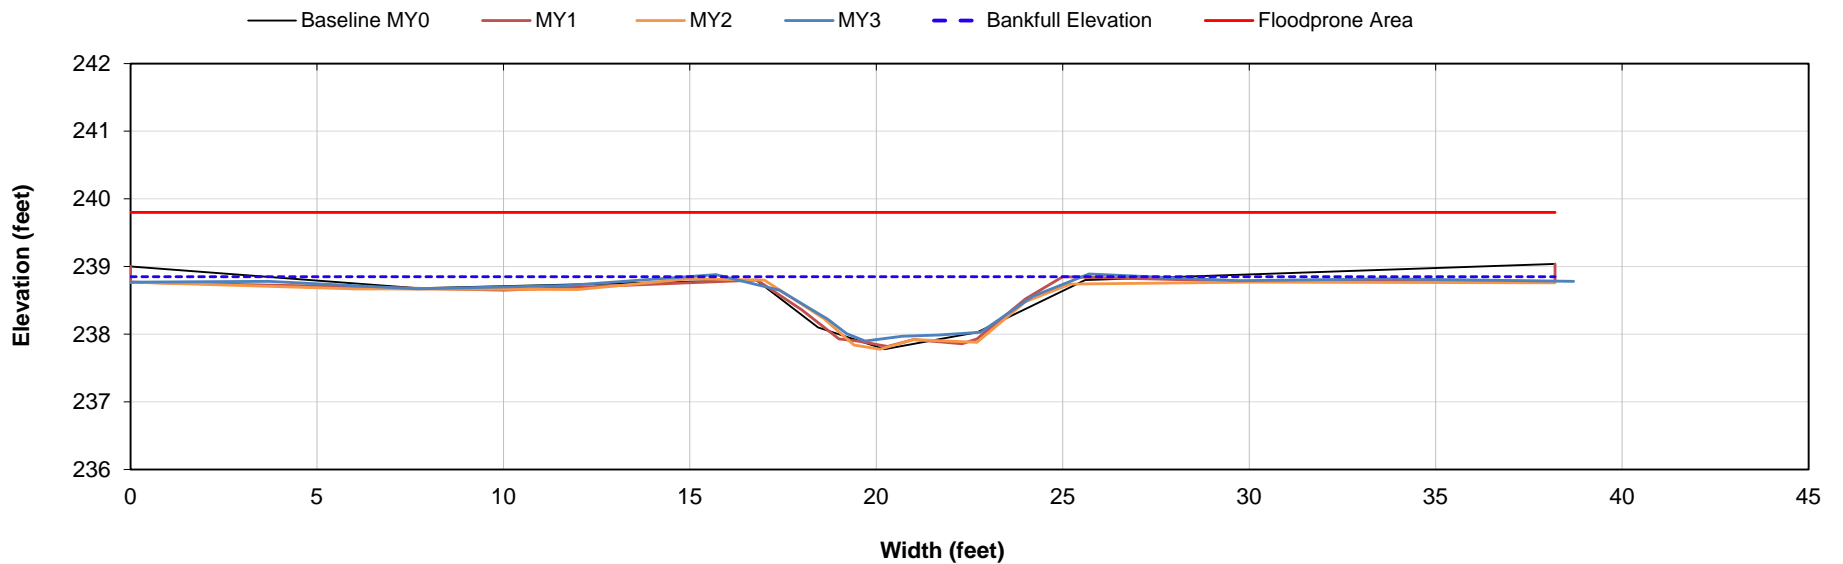
XS-4 Riffle, STA 16+97

Dimension Data Summary: MY3 2020	
Bankfull Elevation (ft)	238.9
Low Bank Height Elevation (ft)	238.9
Bankfull Max Depth (ft)	0.9
Low Bank Height (ft)	1.0
Bank Height Ratio	1.0
Bankfull X-section Area (ft ²)	5.2
% Change Bank Height Ratio	0.0%

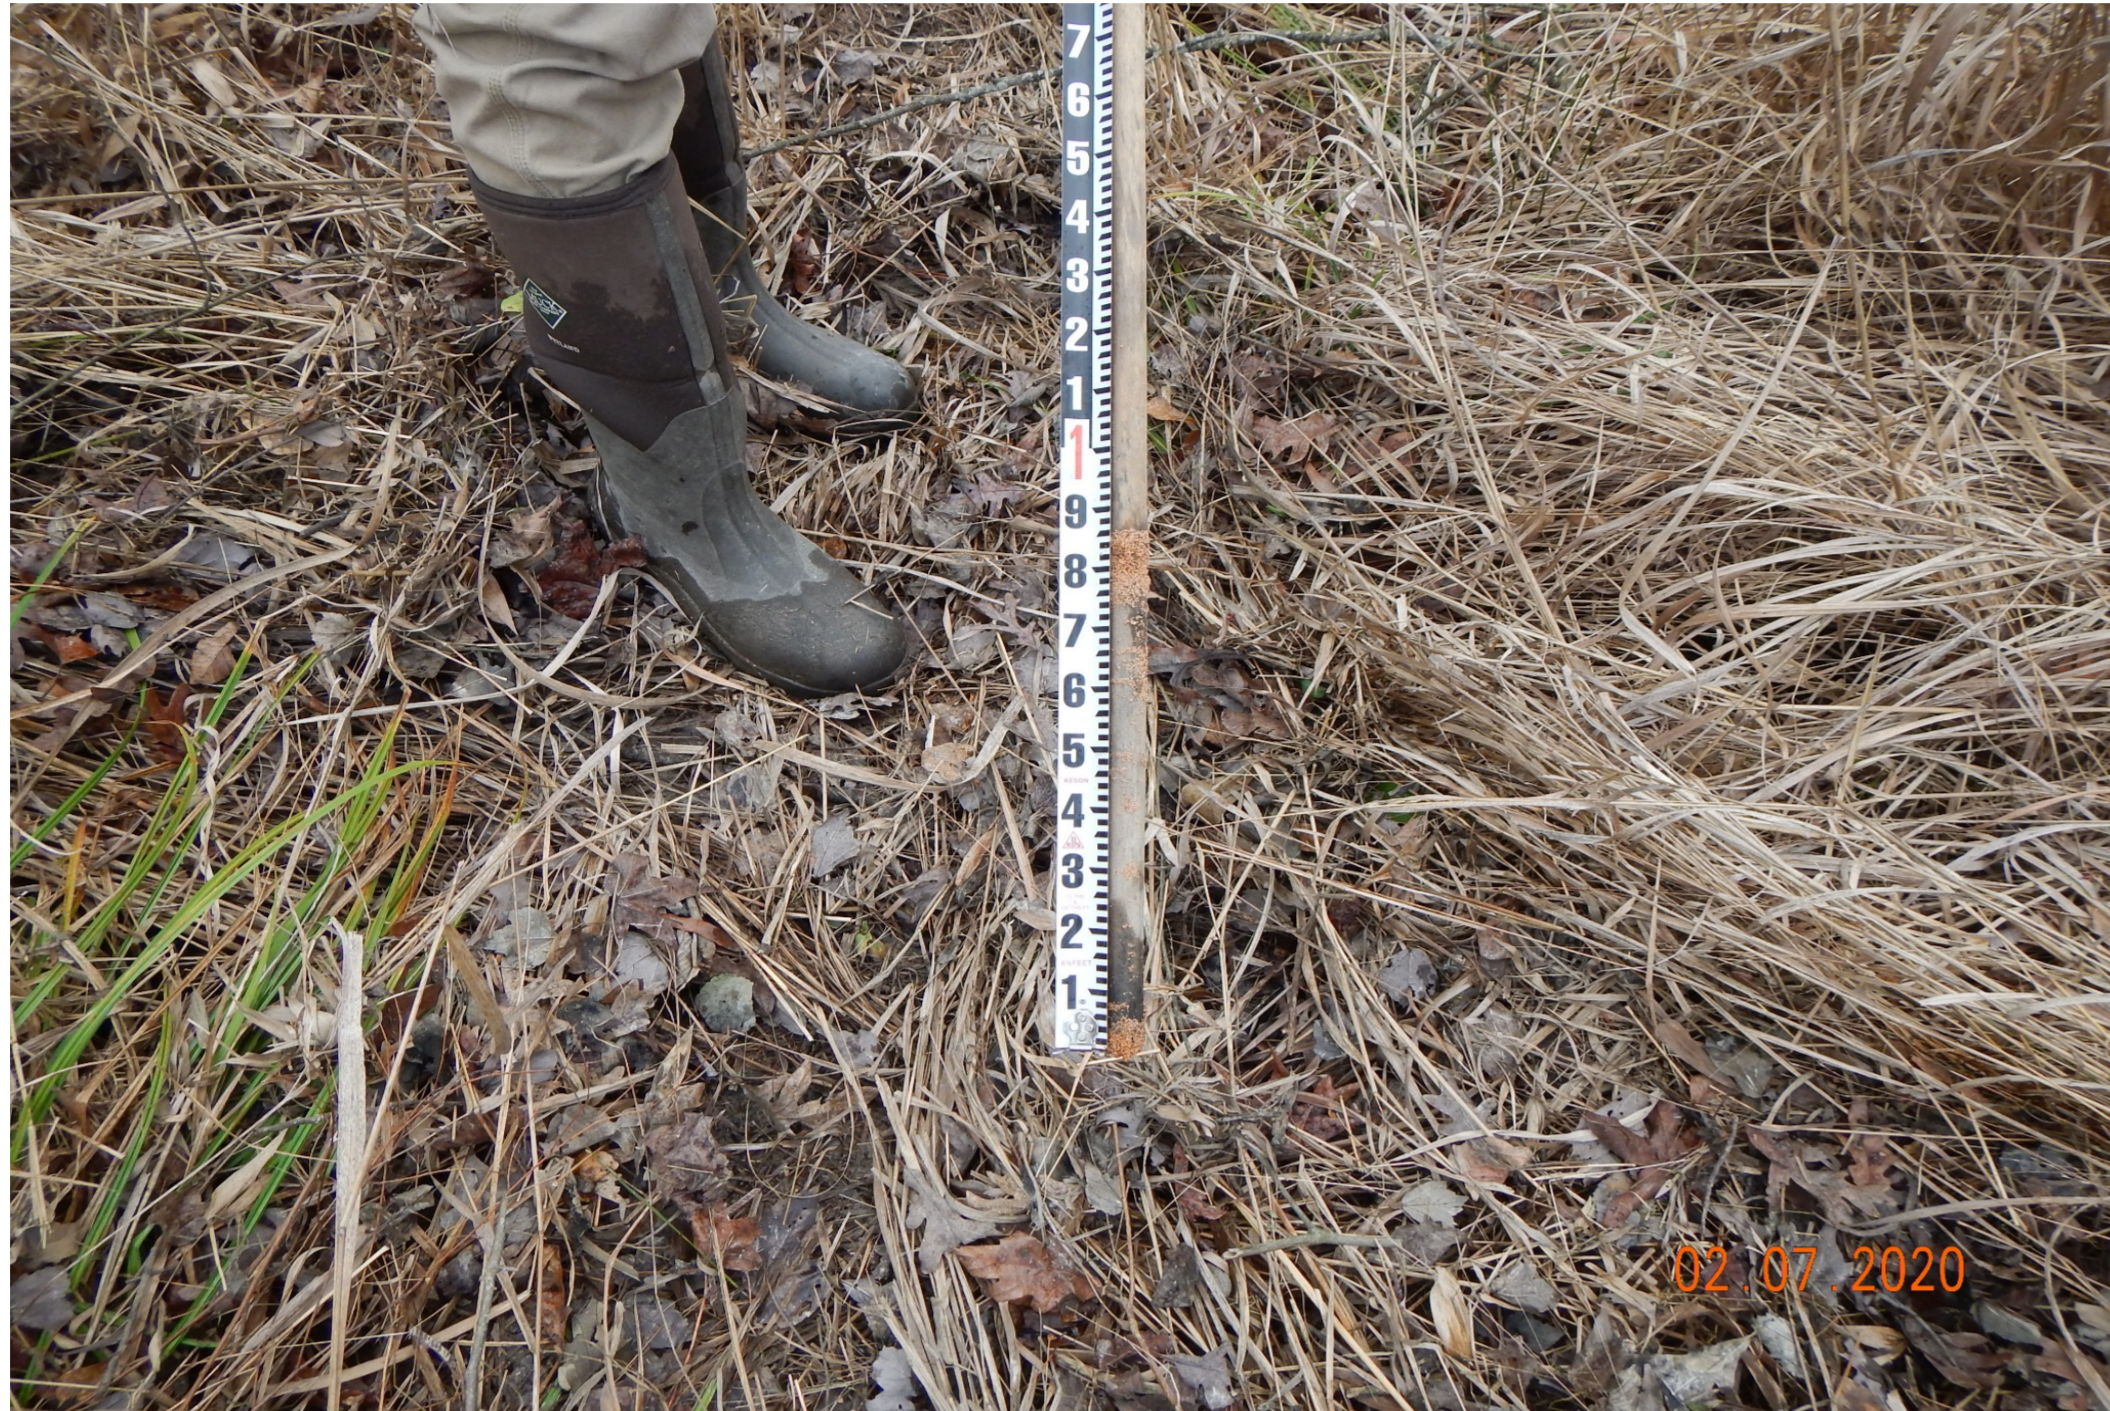
Date of Data Collection	Date of Occurrence	Method	Greater than Bankfull (Bkf) or Qgs ($Q2^{*0.66} = 50.66$ CFS) Stage?	Photo/ Notes	Measurement	Meets Requirement
9/17/2018	9/16-9/17/2018	Observed indicators of bankfull stage (wrack lines) after storm event	Bkf	Photo		No
7/26/2019	7/24/2019	Crest Gauge	Bkf	Photo	.25 ft	No
8/20/2019	unknown	Crest Gauge	Bkf	Photo	.28 ft	No
9/6/2019	9/5/2019	Crest Gauge	Bkf	Photo	.25 ft	No
9/6/2019	9/5/2019	Observed indicators of bankfull stage (wrack lines) after storm event	Bkf	Photo	NA	Yes
2/7/2020	2/6/2020	Crest Gauge	Bkf & Qgs	Photo	.85 ft	Yes
8/4/2020	8/4/2020	Crest Gauge	Bkf & Qgs	Photo	0.5 ft	Yes
