Eight Point Buffer Restoration Site

**Year 3 Monitoring Report
Guilford County, North Carolina
Cape Fear River Basin - 03030003**

**DMS Contract 7865
DMS Project Number 100113
DWR Project Number 20190647**

**Data Collected: August 2023
Date Submitted: December 2023**

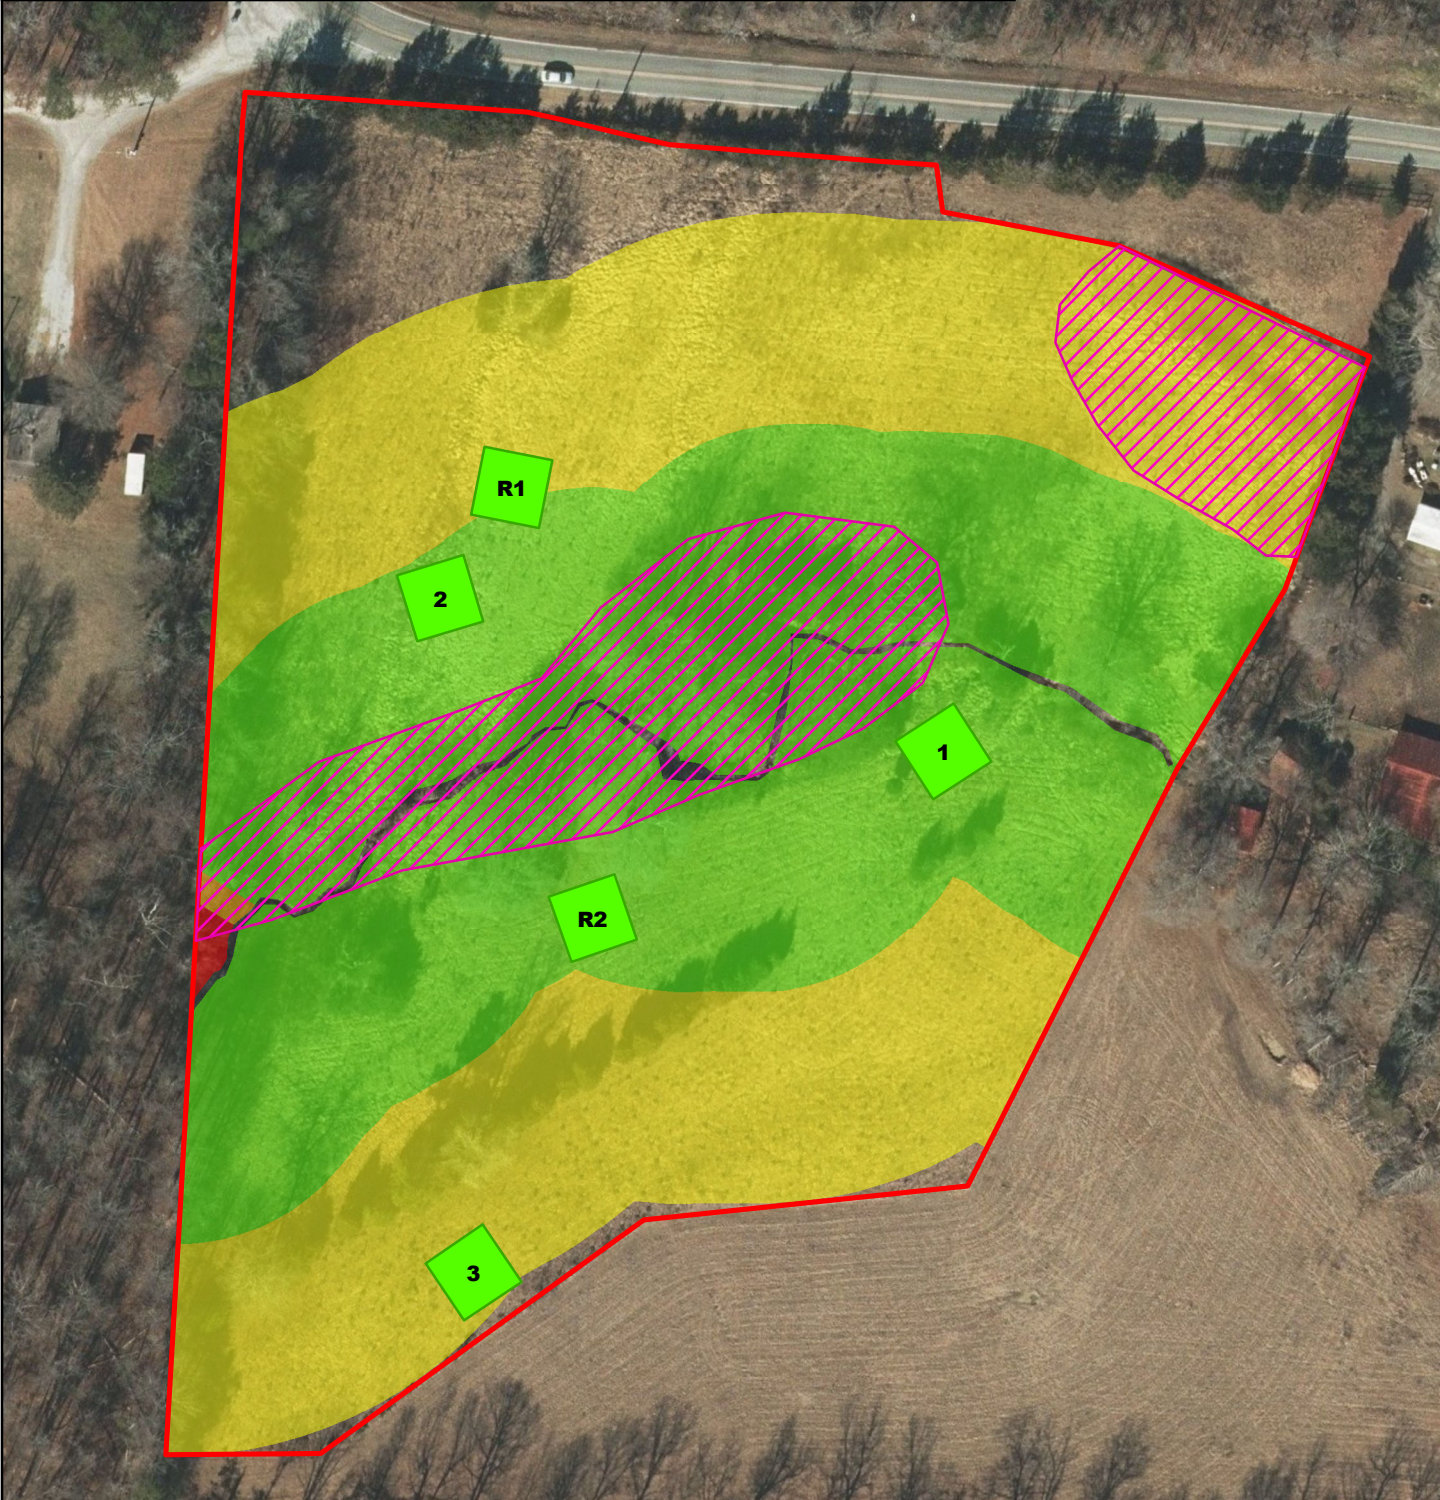
**FIGURE 2. PROJECT ASSETS and CURRENT CONDITIONS
EIGHT-POINT BUFFER RESTORATION SITE
GUILFORD COUNTY, NC**

Monitoring Year 3 vegetation data was collected on August 23, 2023. All five vegetation monitoring plots had greater than 260 stems/acre and only one plot (Plot 1F, 3 species) had less than 4 native hardwood species. Overall the site is well vegetated with extensive herbaceous coverage and many diverse volunteer woody species. During the MY02 site walk with DMS, concern was expressed about the number of sweetgum saplings growing on-site and a large, dense patch of blackberry growing near the northeast corner of the site. This treatment was completed in December 2022. The treatment consisted of cutting down the sweetgum saplings and spraying the stumps with herbicide and mowing down the blackberry, while avoiding the trees growing within this area. In December 2023, a previously undisclosed septic field within the conservation easement failed. The landowner has agreed to abandon the failed septic field and relocate a new one outside of the conservation easement.
