# Elk Branch Restoration Project

## Year 2 Monitoring Report

### Mitchell County, North Carolina

Date Submitted: February 2014

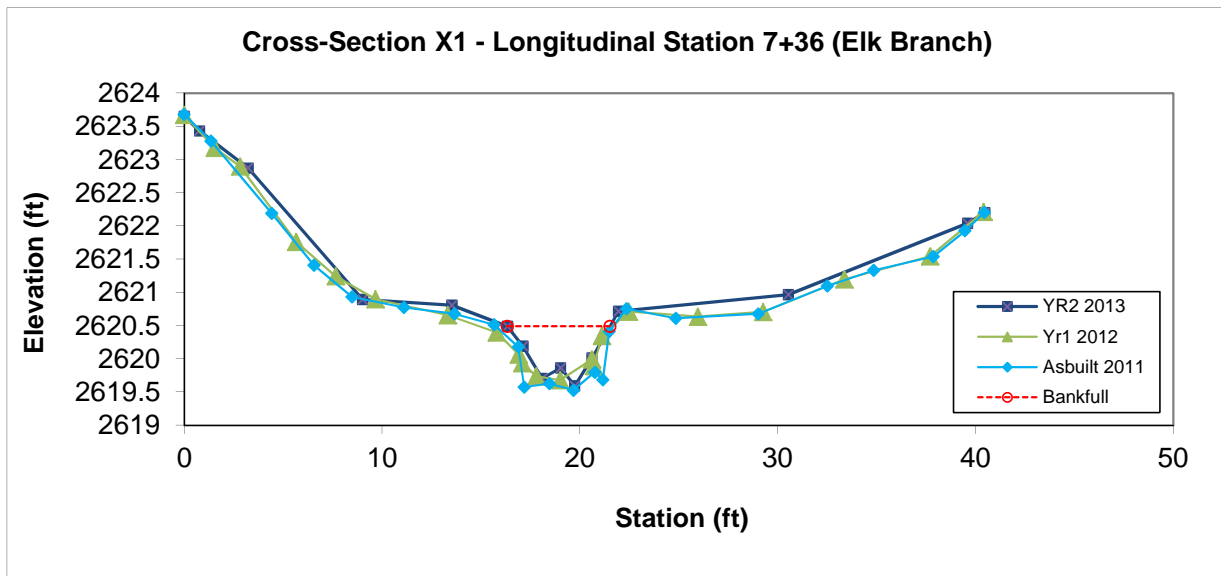
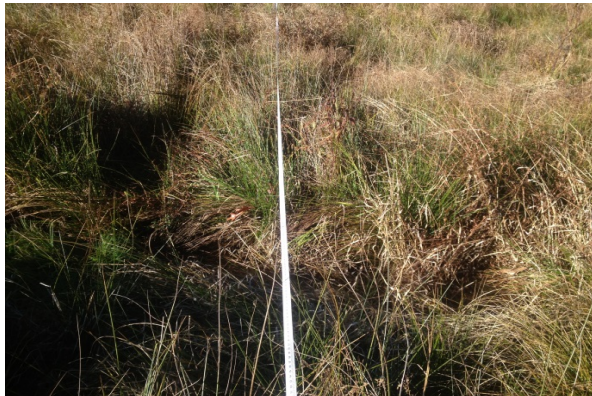
Photo 1: XS-1 facing right bank

Feature	Stream Type	BKF Area	BKF Width	BKF Depth	Max BKF Depth	W/D	BH Ratio	ER	BKF Elev	TOB Elev
Riffle	Eb	2.7	5.19	0.51	0.89	10.13	1.3	5.1	2620.49	2620.71

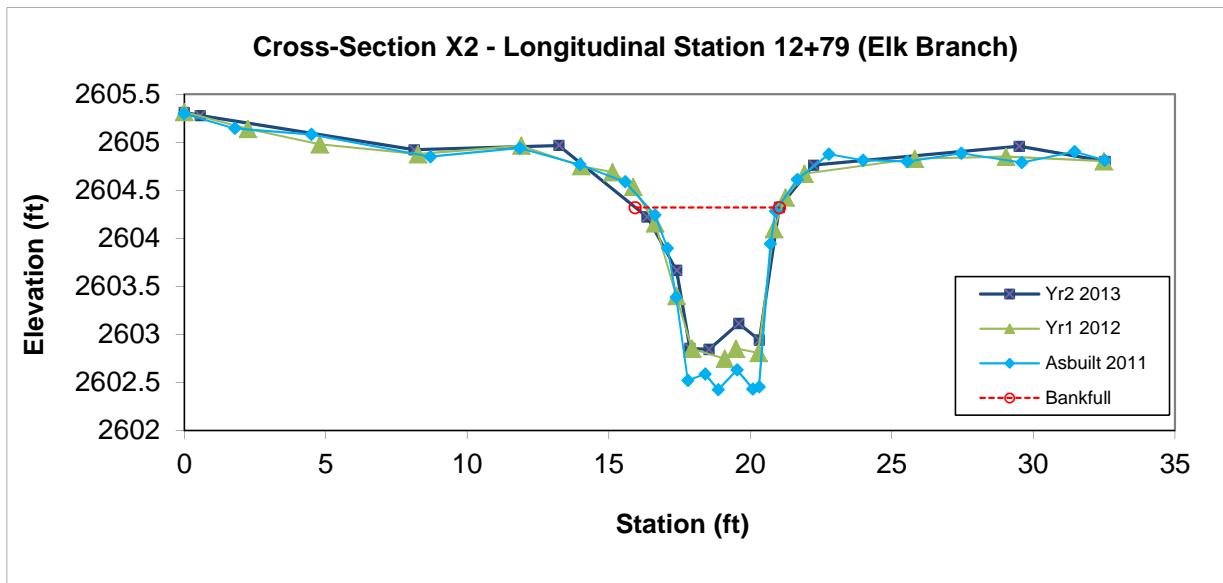
Photo 5: XS-2 facing right bank

Feature	Stream Type	BKF Area	BKF Width	BKF Depth	Max BKF Depth	W/D	BH Ratio	ER	BKF Elev	TOB Elev
Pool	-	4.8	5.1	0.93	1.48	5.46	1.3	6.4	2604.32	2604.76

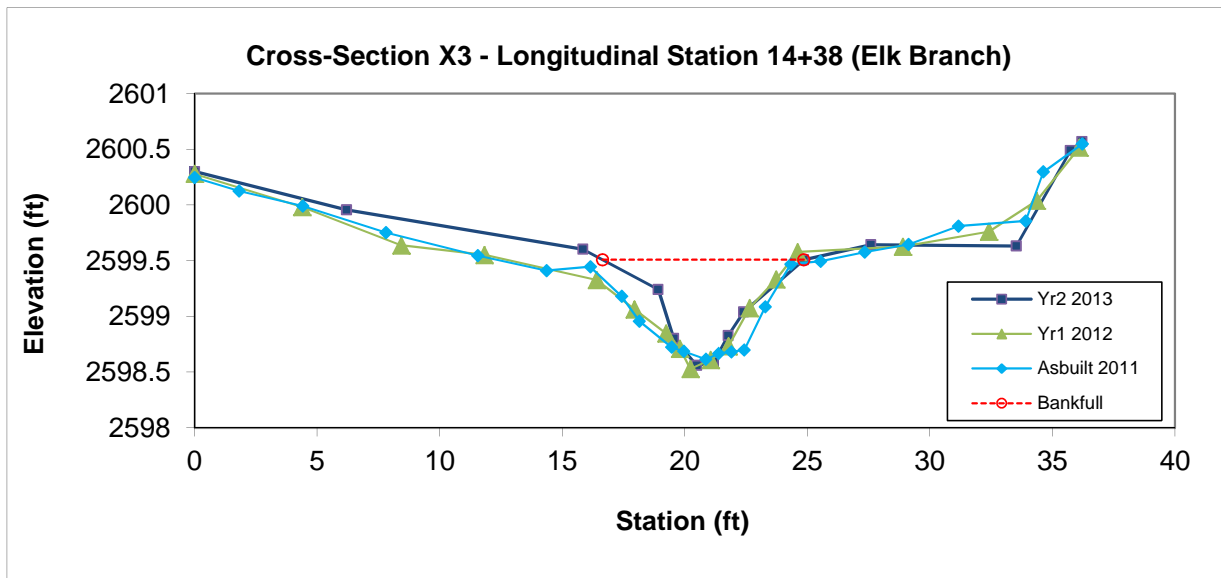
Photo 9: XS-3 facing right bank

Feature	Stream Type	BKF Area	BKF Width	BKF Depth	Max BKF Depth	W/D	BH Ratio	ER	BKF Elev	TOB Elev
Riffle	Cb	3.4	8.21	0.42	0.95	19.59	1	4.3	2599.51	2599.51

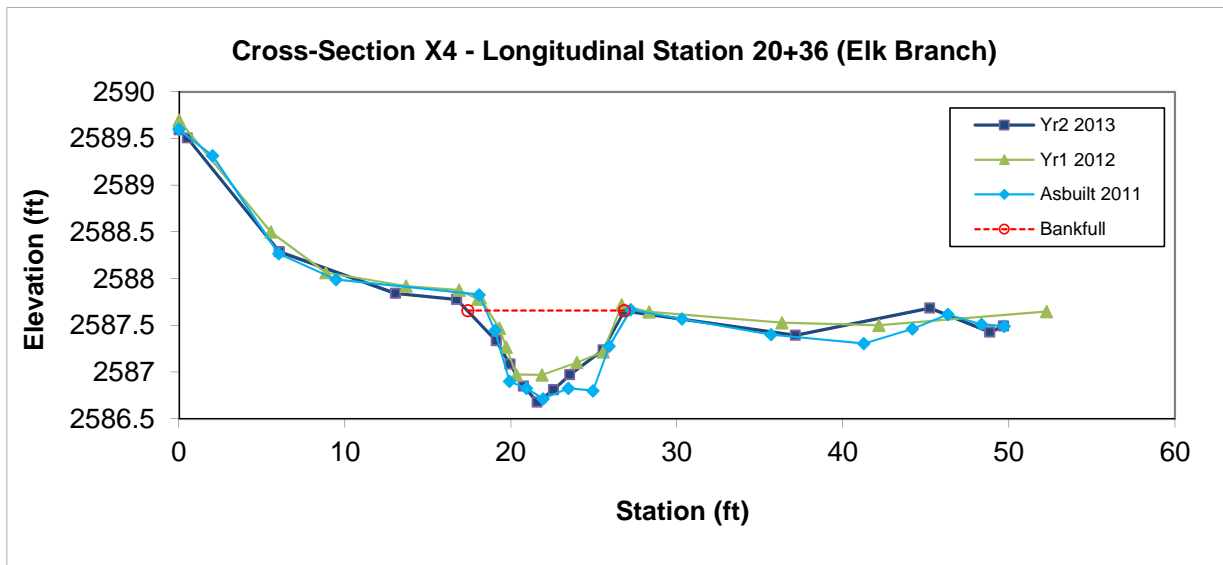
Photo 13: XS-4 facing right bank

Feature	Stream Type	BKF Area	BKF Width	BKF Depth	Max BKF Depth	W/D	BH Ratio	ER	BKF Elev	TOB Elev
Riffle	Cb	4.9	9.44	0.52	0.98	18	1	4.8	2587.66	2587.66

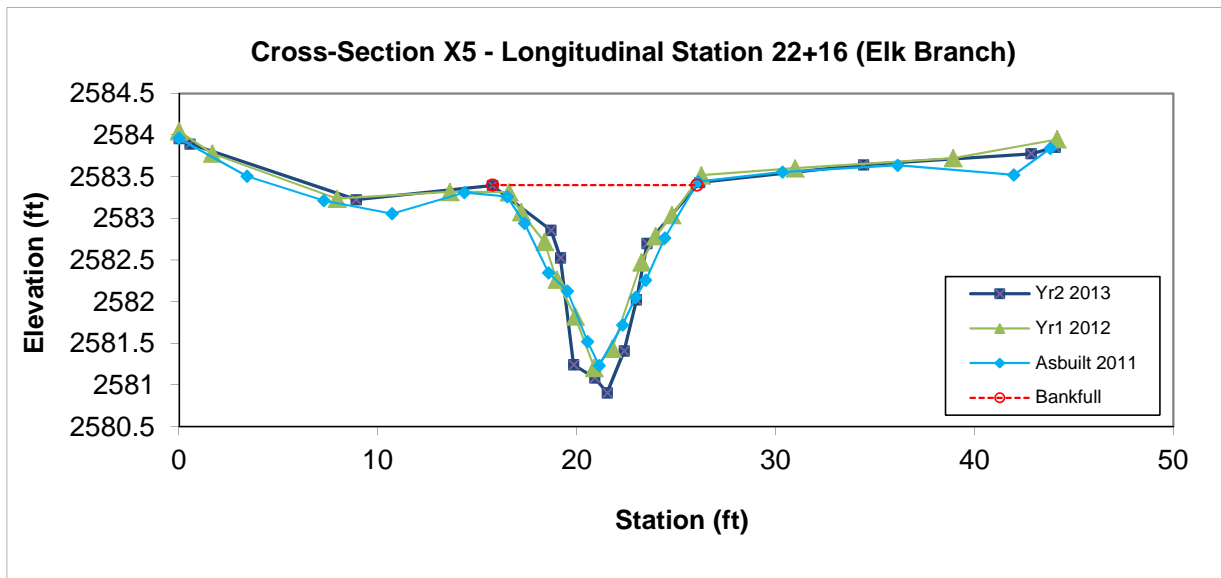
Photo 17: XS-5 facing right bank

Feature	Stream Type	BKF Area	BKF Width	BKF Depth	Max BKF Depth	W/D	BH Ratio	ER	BKF Elev	TOB Elev
Pool	-	10.4	10.29	1.01	2.49	10.21	1	4.3	2583.4	2583.4

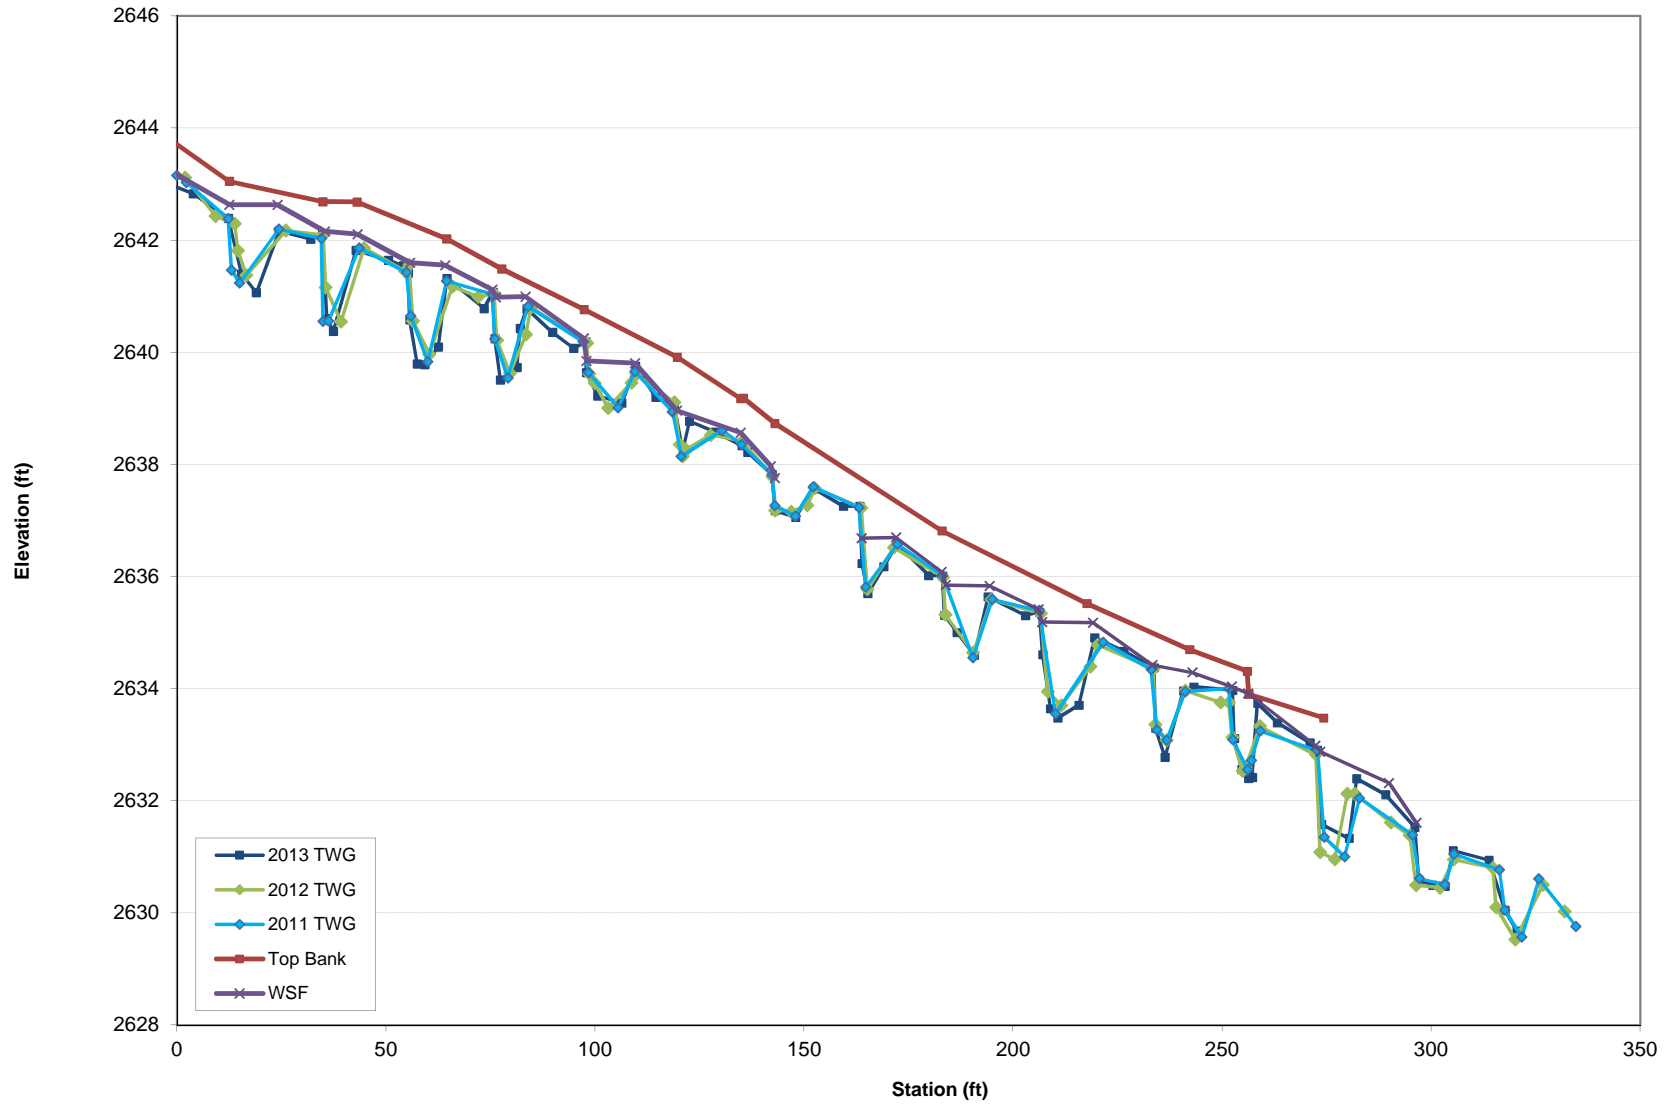
### Longitudinal Profile-UT2 Year 2 Monitoring

As the profile for UT2 demonstrates, there was one section where the flow went subsurface for 20 linear feet. This is a considerable improvement from the Year 1 Monitoring survey data that indicated UT2 flow was subsurface for 103 linear feet. Record precipitation was received during the 2013 monitoring year which provided flows that helped to move sediment and fines through the system. These increased flows helped seal any structures where water was discovering a subsurface path to follow. The area where flow goes subsurface is noted in Appendix B (Table 10). Other than the lack of continuous surface flow, UT2 appears stable. No other areas of instability were noted in the project area during Year 2 monitoring.
