Elk Branch Restoration Project

Year 3 Monitoring Report

Mitchell County, North Carolina

Monitoring Firm: Michael Baker Engineering, Inc. (Baker)

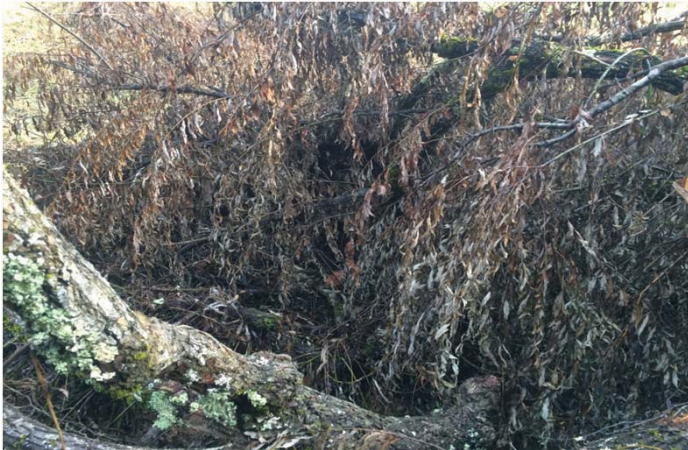
Photo 1: XS-1 facing left bank, showing fallen willow tree laying across transect, storm damage.

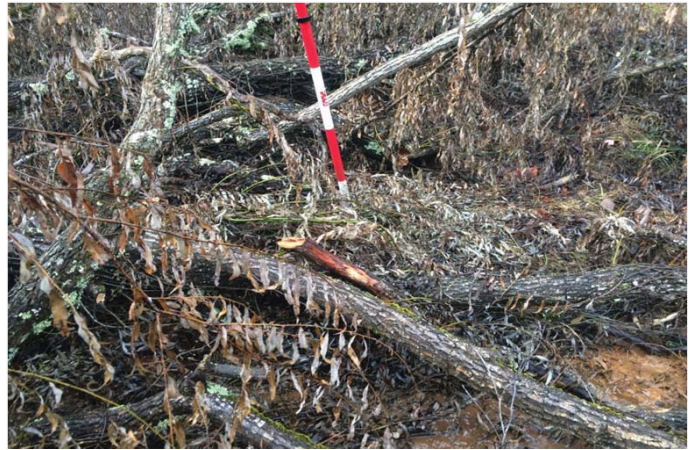
Photo 2: XS-1 facing the right bank, showing fallen willow tree laying across transect, storm damage.

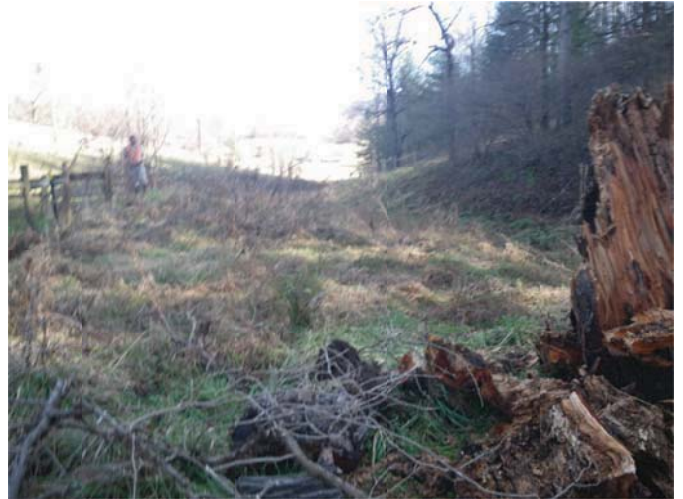
Photo Point 1: looking downstream, willow tree blown down in wind storm blocking normal photo point.
