Elk Branch Restoration Project

Year 5 ~~Half~~Monitoring Report

Mitchell County, North Carolina

Monitoring Firm: Michael Baker Engineering, Inc. (Baker)

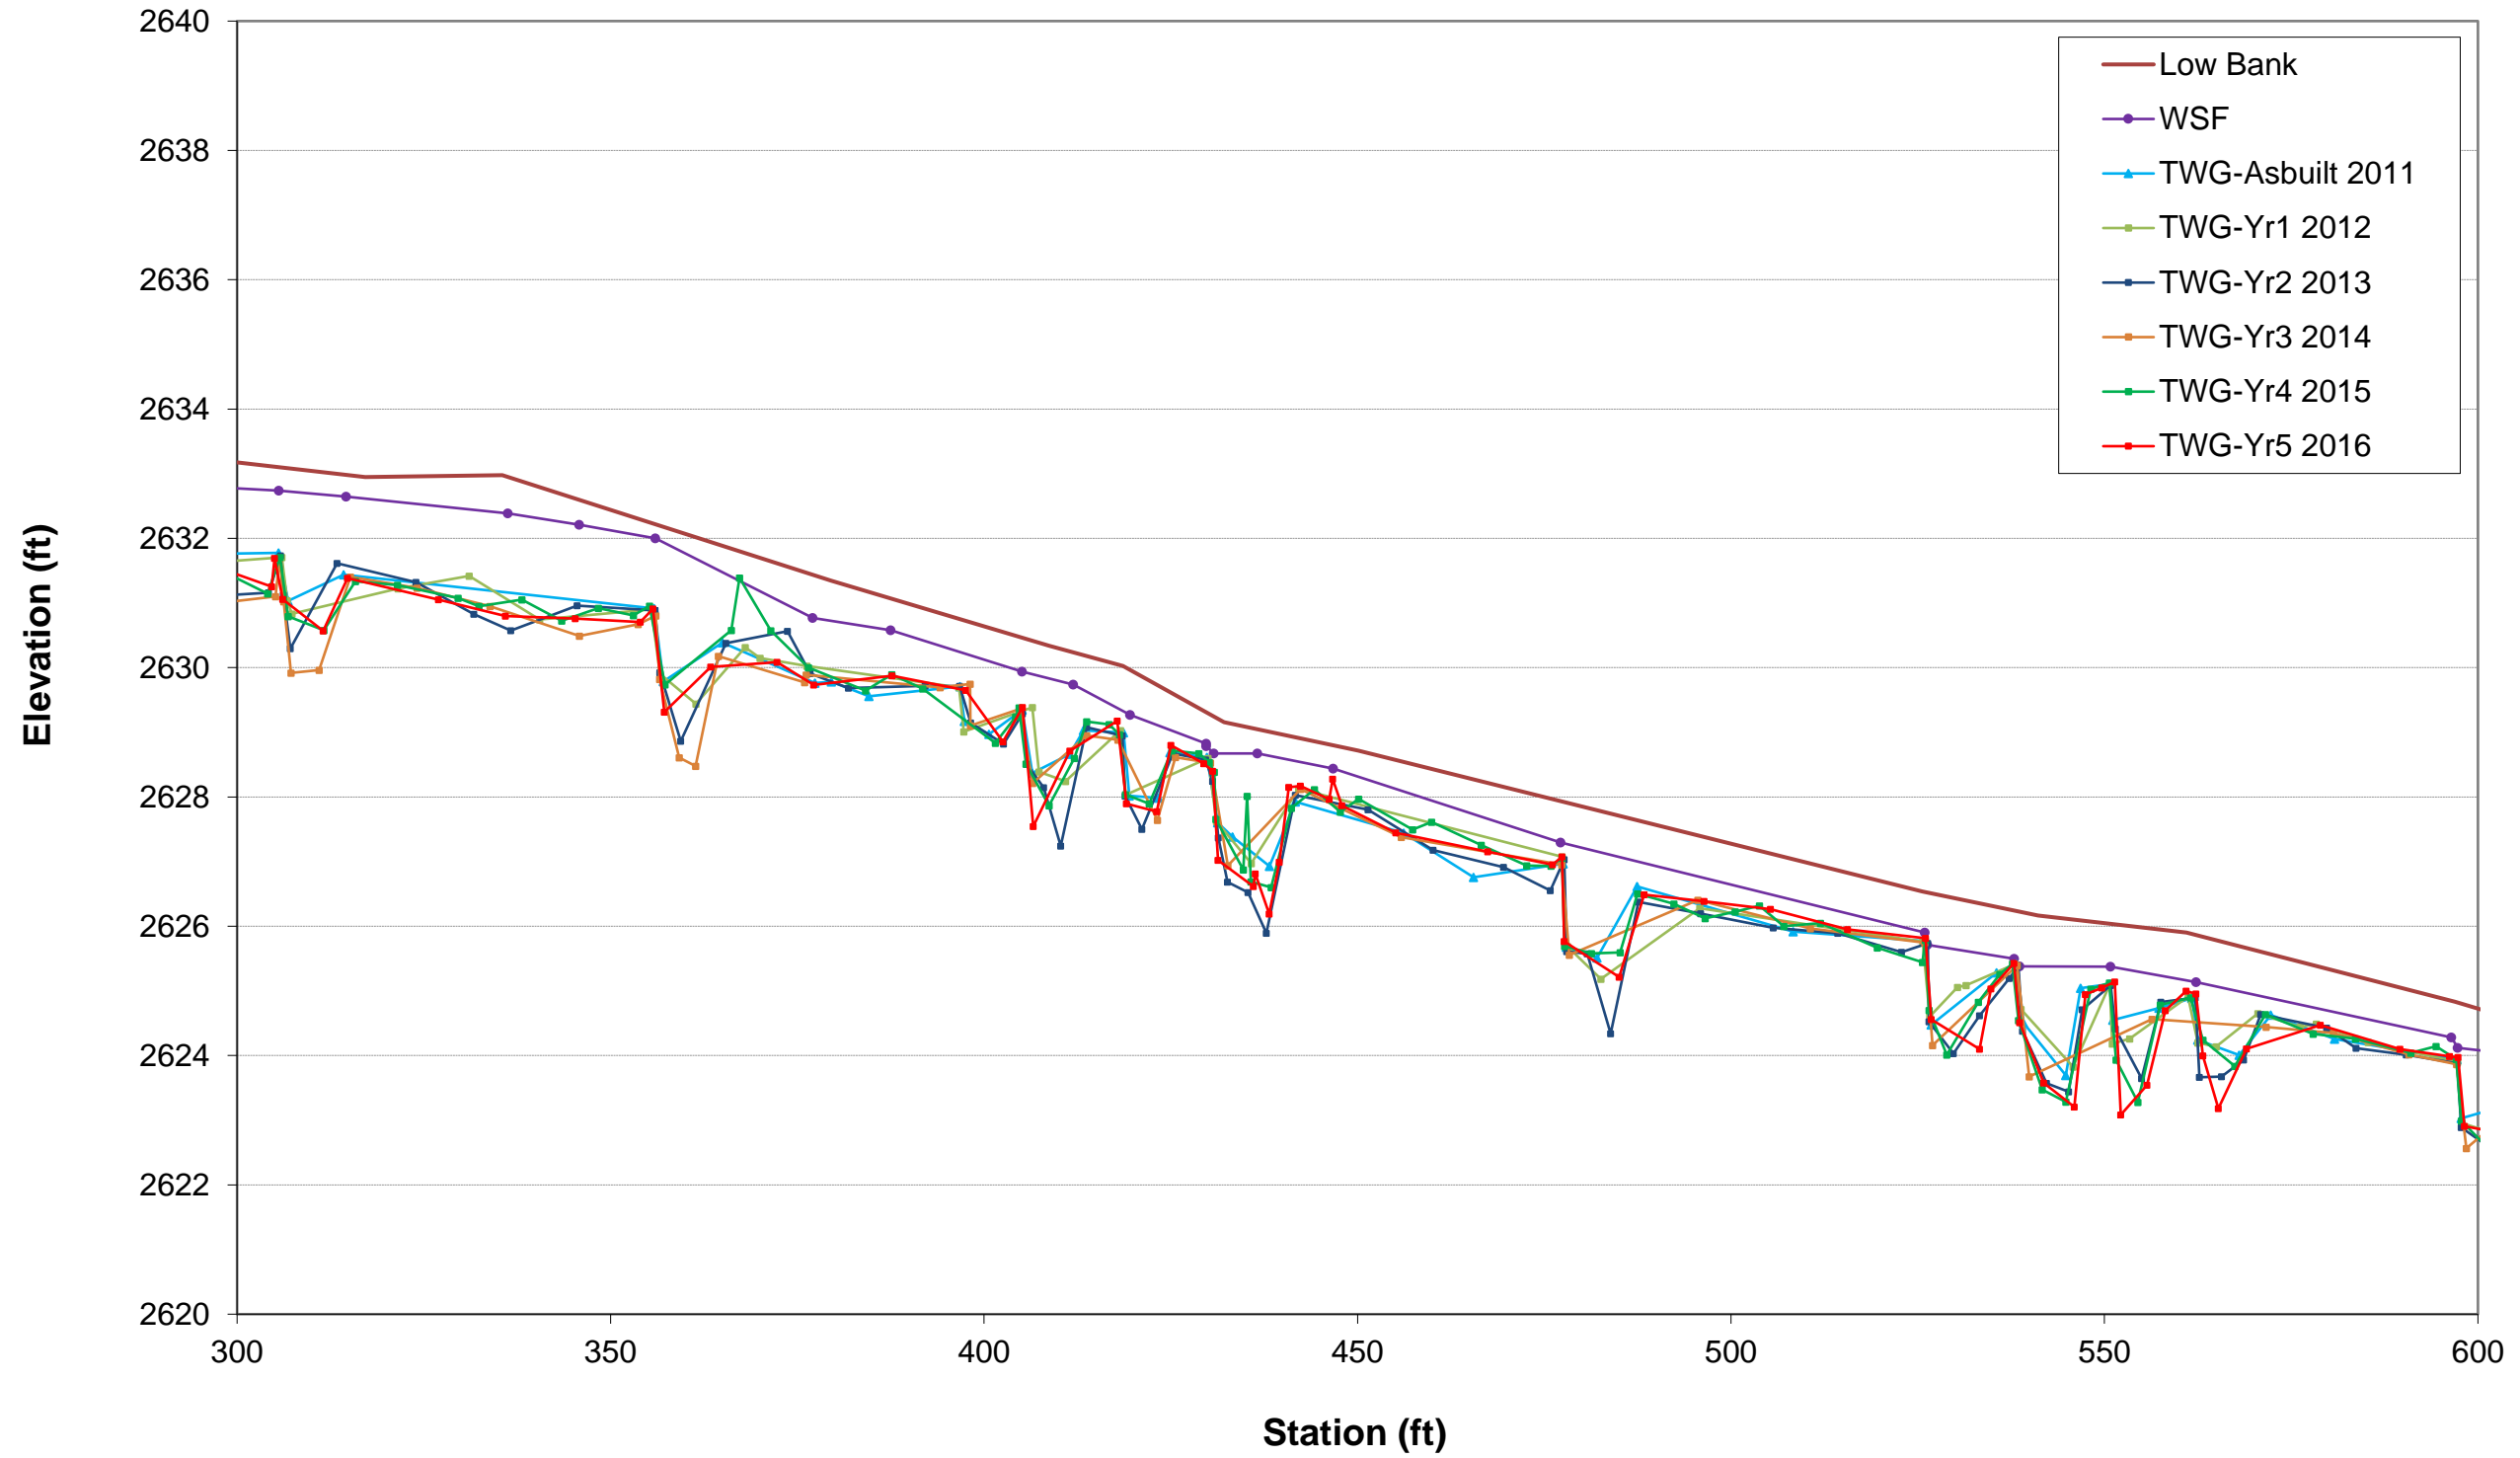
Longitudinal Thalweg Profile - Elk Branch for All Years 3+00 to 6+00

Elk Branch Profile 3+00 to 6+00
Year to Year comparison.

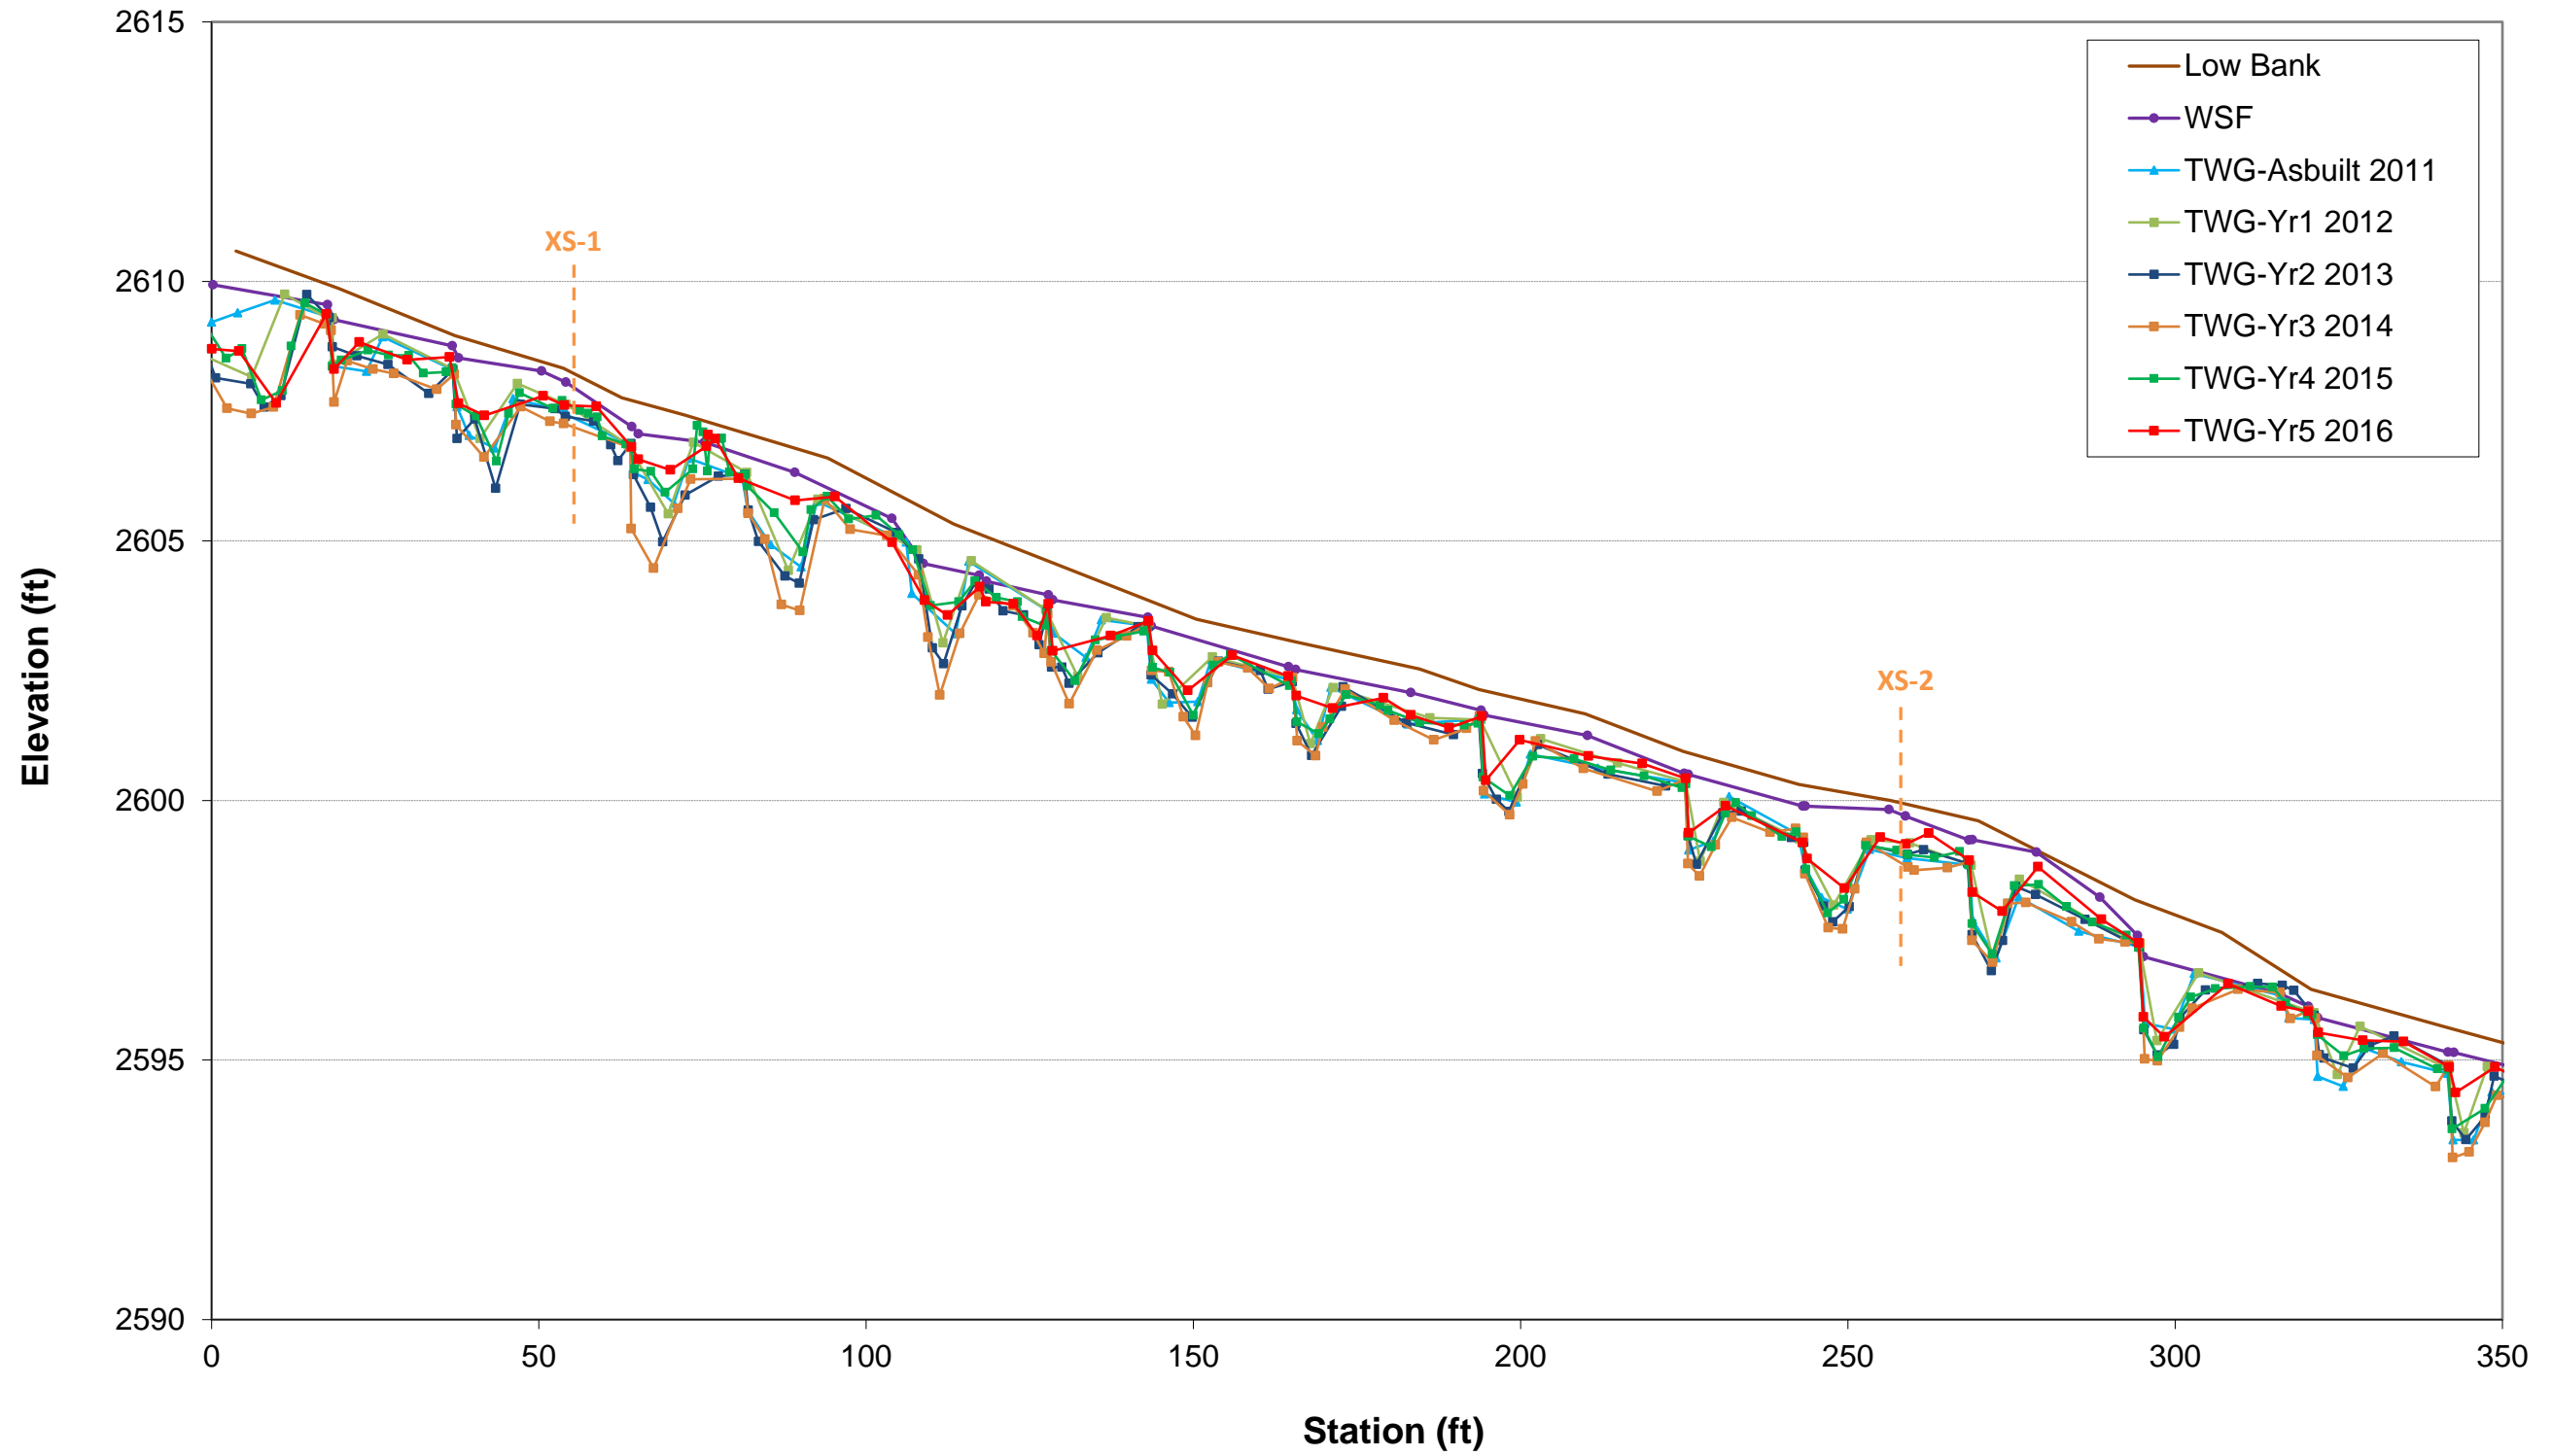
Longitudinal Profile - UT1 for All Years 0+00 to 3+50

UT1 Profile 0+00 to 3+50
Year to Year comparison.

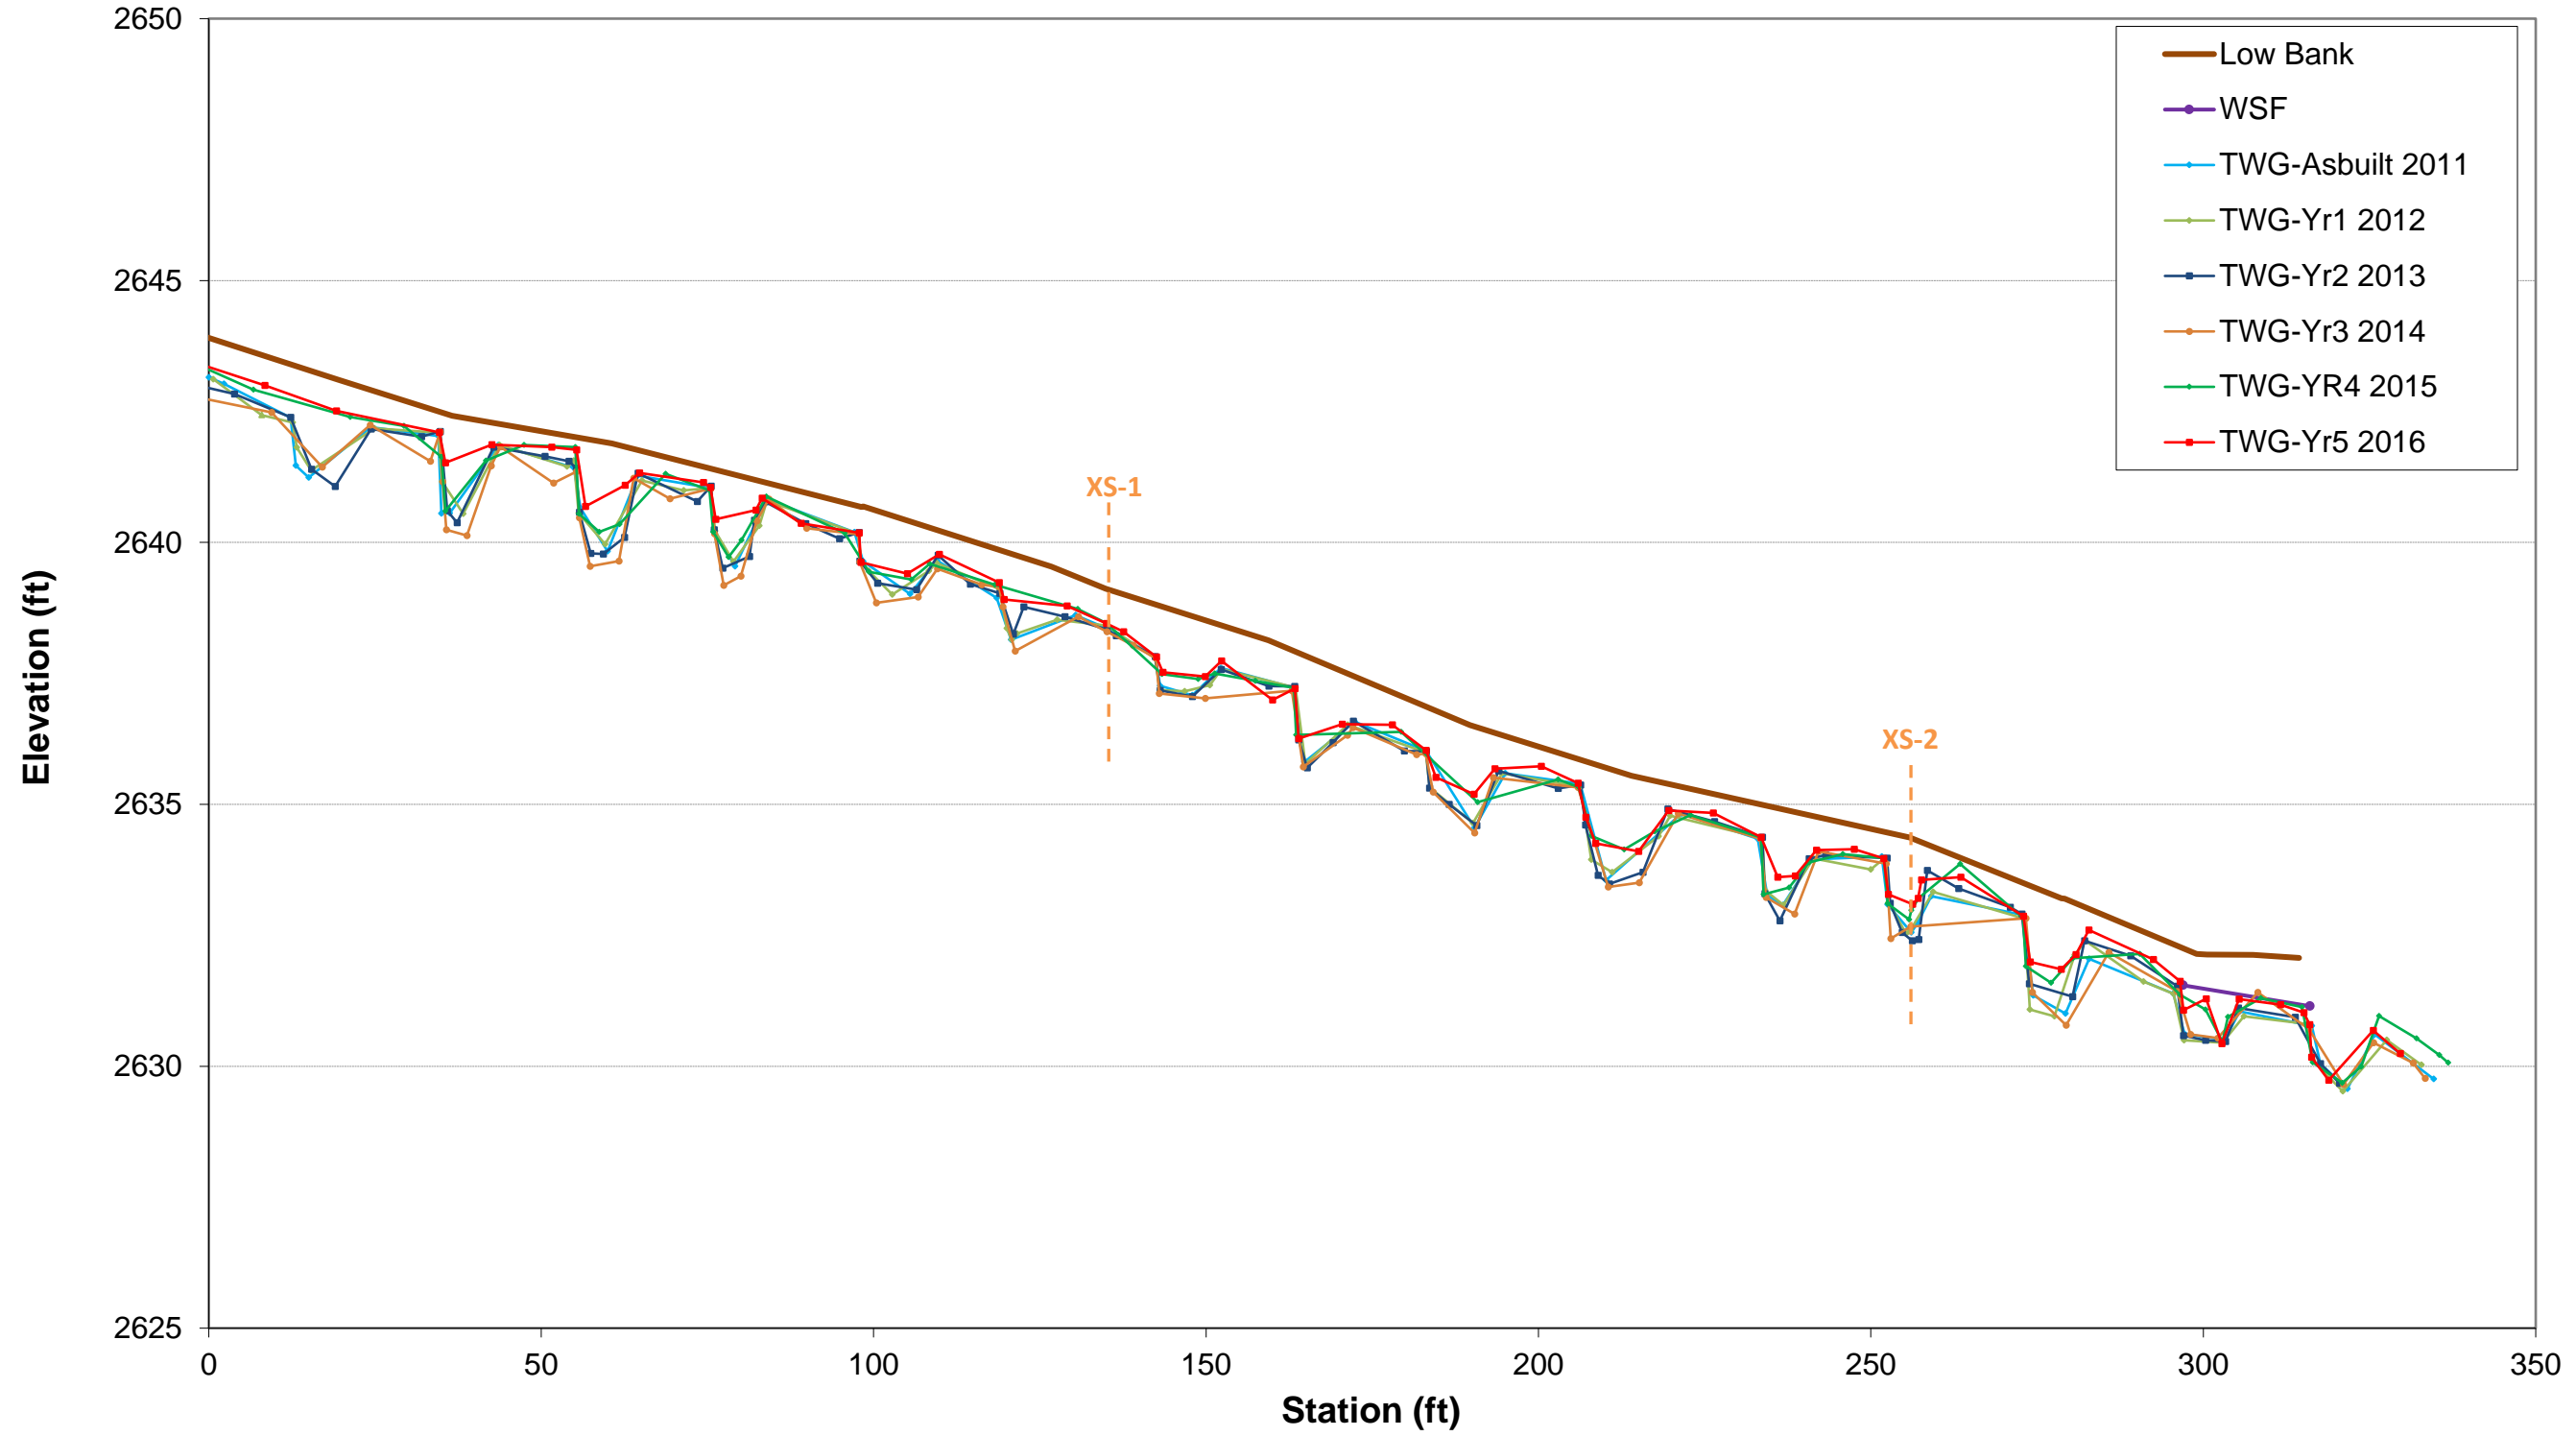
Longitudinal Thalweg Profile on UT2 for All Years

UT2 Profile 0+00 to 3+50
Year to Year comparison.
