ELK SHOALS STREAM RESTORATION SITE

ANNUAL MONITORING REPORT FOR 2007 (YEAR 3)

Baker Engineering NY, Inc.
8000 Regency Parkway
Suite 200
Cary, North Carolina 27518
Phone: 919.463.5488
Fax: 919.463.5490

November 2007

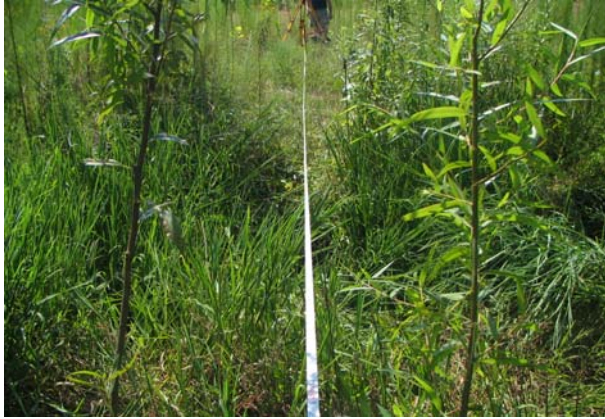
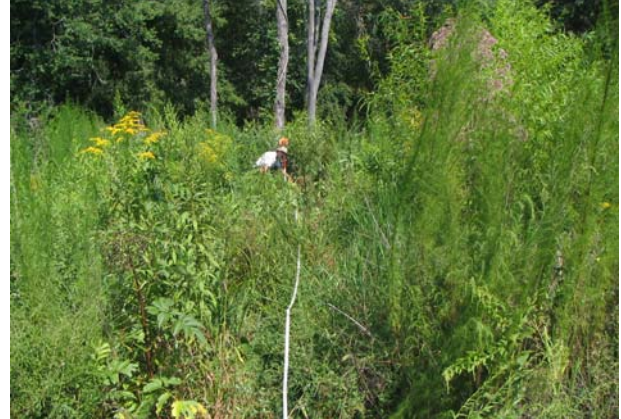
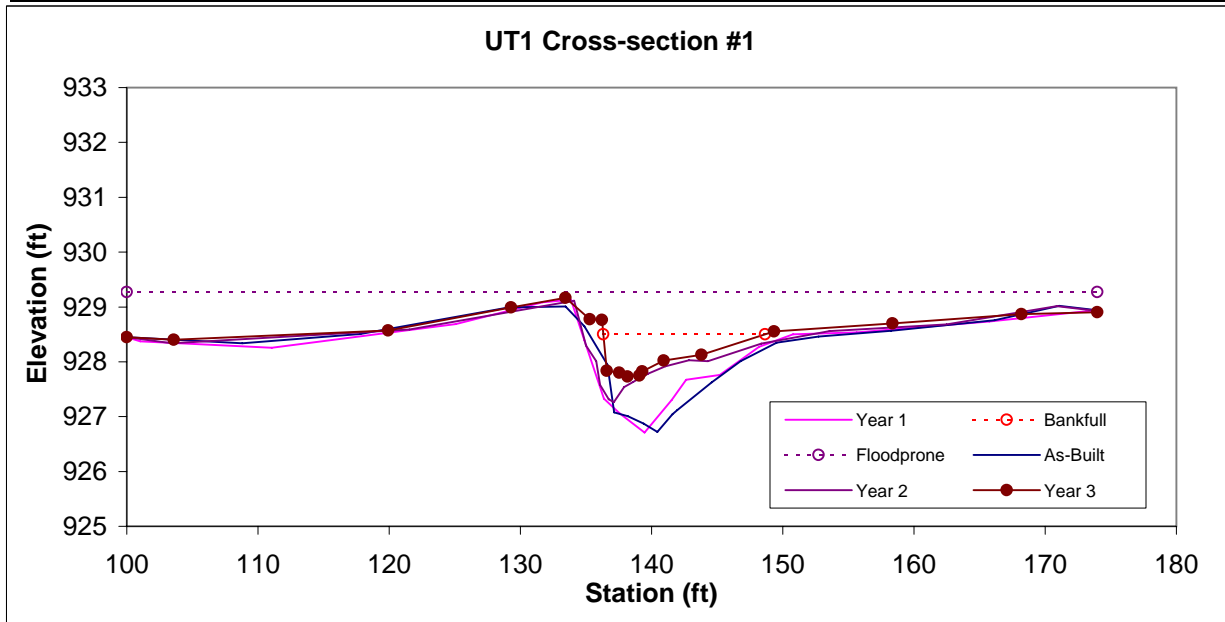
UT1 Permanent Cross-section #1

construction. Cross-sections 1 and 7 showed noticeable deposition on the inside meander bends and the pools have aggraded. Cross-sections 4 and 6 also showed noticeable deposition on the inside meander bends and the pools have deepened. Cross-Sections 1, 4, 6, 7, and 9 are located in pools found at the apex of a meander bend. Cross-Sections 2, 3, 5, 8 and 10 are located in riffles before and after pools. Survey data from all pool cross-sections indicate the continued development of point bar features on the inside bank of the meander bends. All monitored cross-sections fell within the quantitative parameters defined for “C” or “E” type channels.
