ELK SHOALS STREAM RESTORATION SITE

ANNUAL MONITORING REPORT FOR 2008 (YEAR 4)

CONTRACT NUMBER AW.03003-B

November 2008

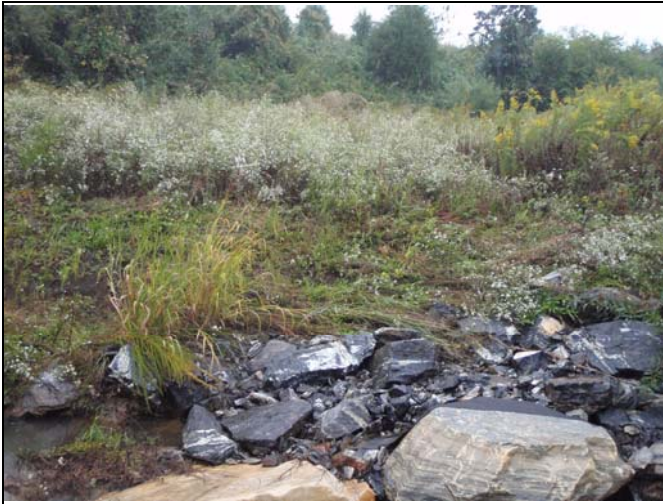
The on-site crest gauge documented the occurrence of at least one bankfull flow event during the Year 4 monitoring period. An inspection of site conditions during the October site visit revealed visual evidence of out-of-bank flow, such as debris and wrack lines, confirming the crest gauge reading. The largest onsite stream flow documented by the crest gauge during Year 4 of monitoring was in October, and was greater than 3.0 feet above the bankfull stage. Photos of the October bankfull evidence are located in Appendix A.

Bankfull evidence – Vegetation wrack line with direction of flow

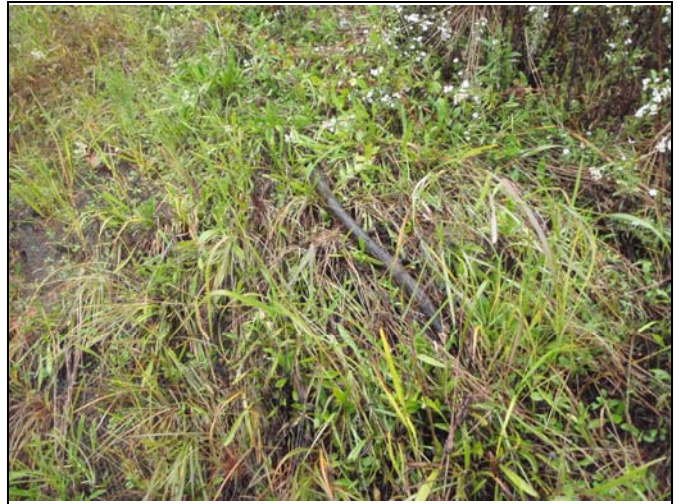
Bankfull evidence – small debris in area of

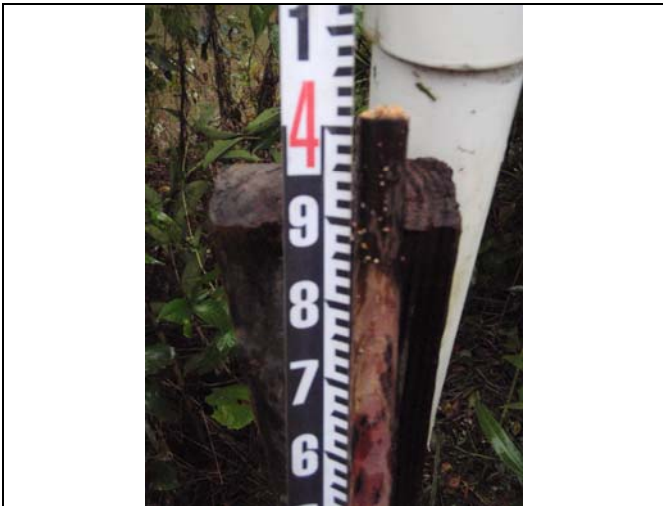
Crest gauge - reading of more than 4.0 feet

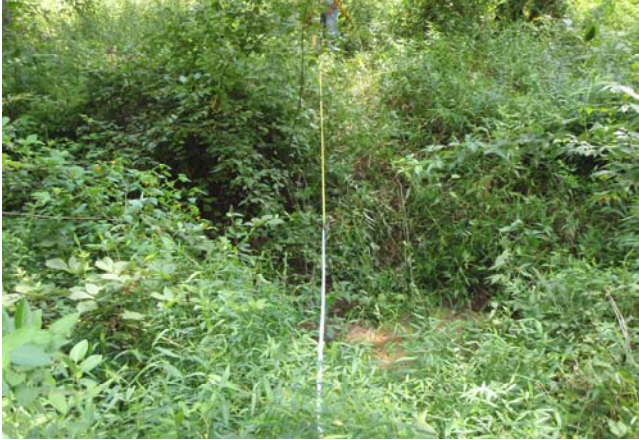
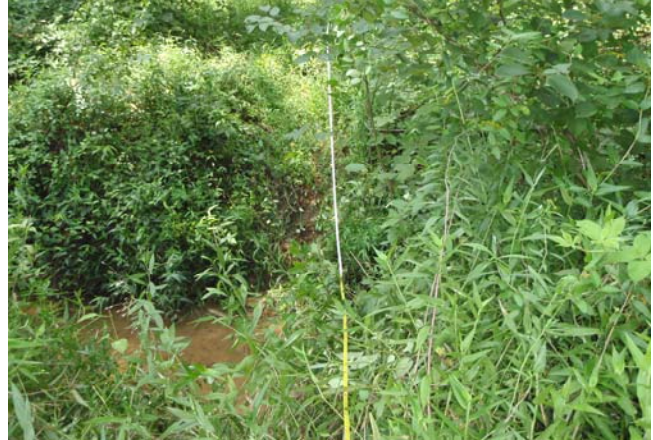
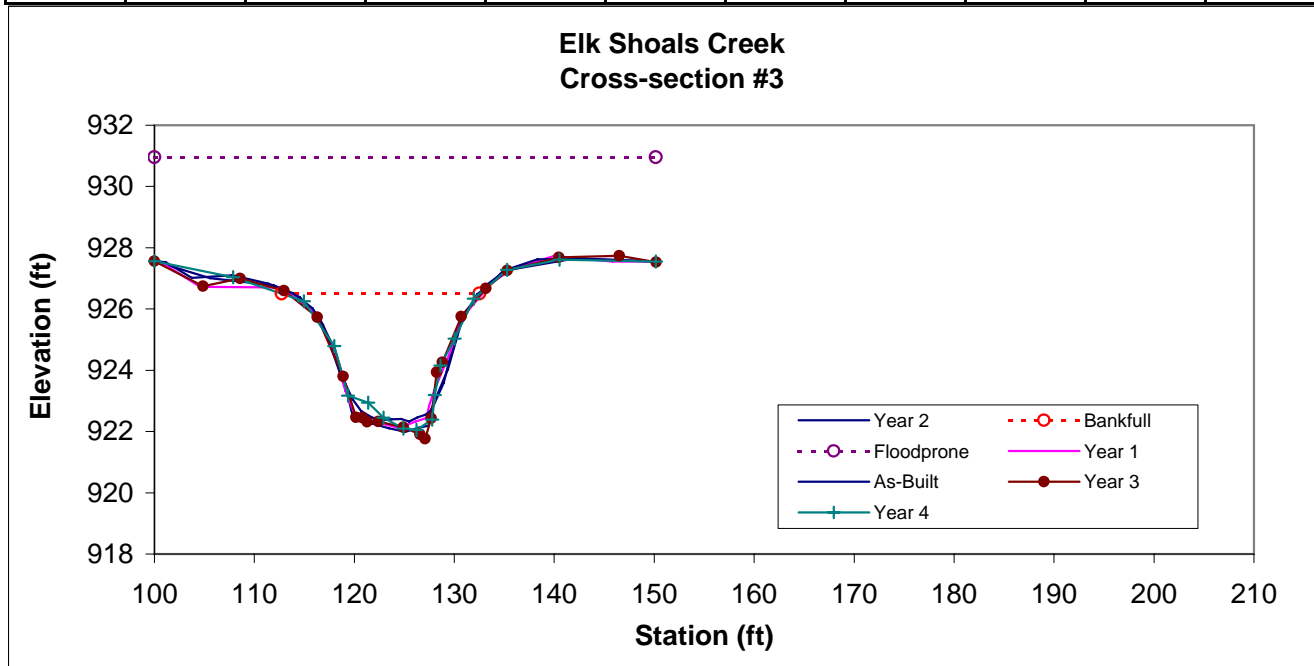
Permanent Cross-section #3
(Year 4 Data - collected August 2008)

Cross-sections 2, 3, 9 and 10 have remained very stable since as-built conditions. These cross-sections have continued to exhibit stability through Year 4. Cross-sections 1, 7 and 8 have exhibited moderate stability since as-built conditions.

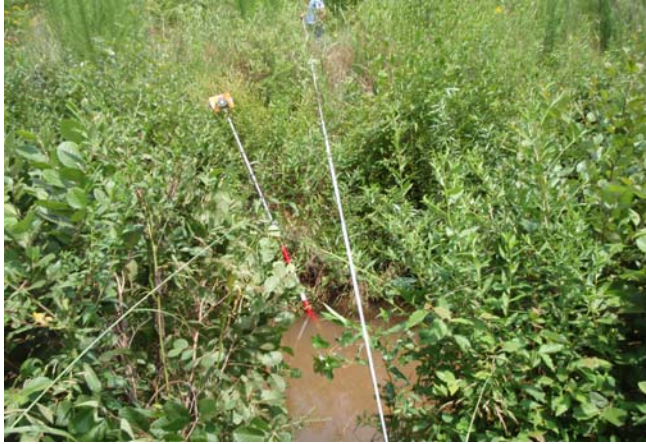
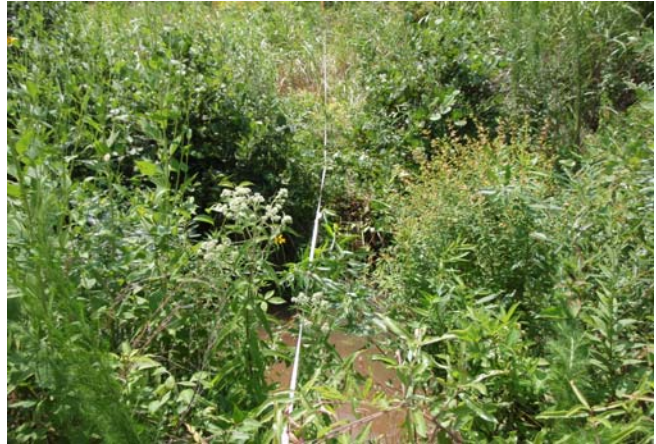
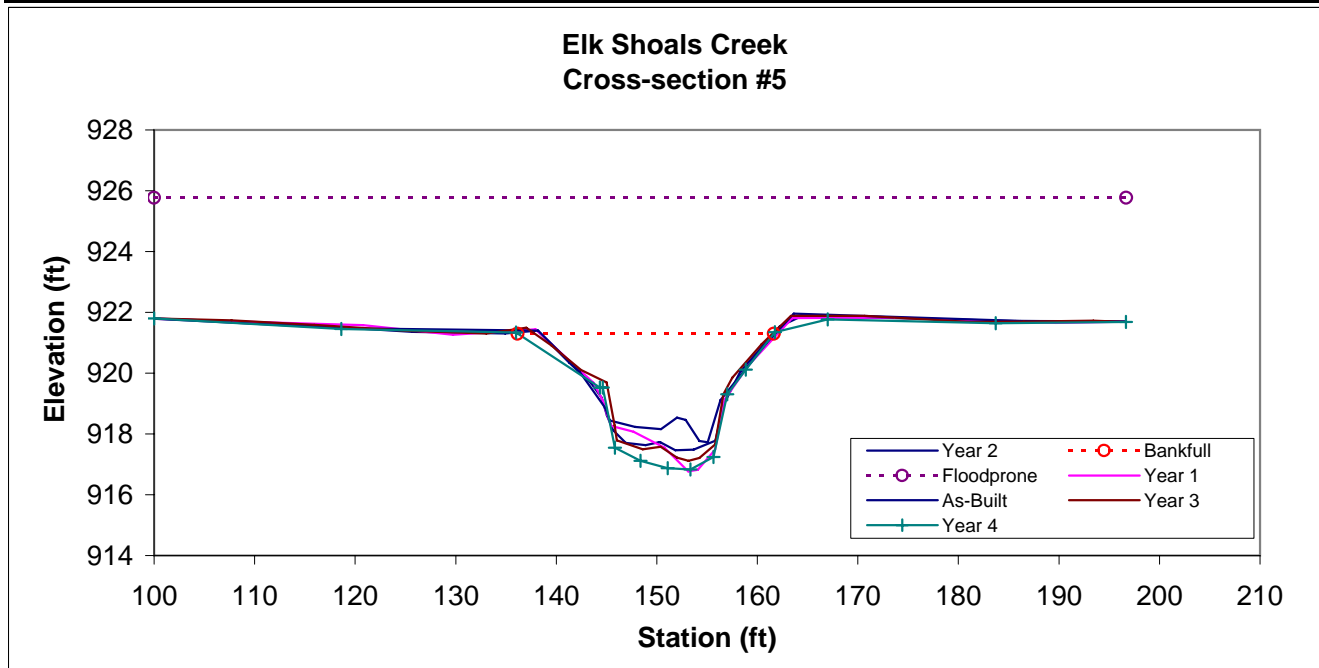
Permanent Cross-section #5
(Year 4 Data - collected August 2008)

Cross-sections 5 and 6 have been deepening slightly every year since as-built conditions. The pool in cross-section 4 has also been deepening since as-built conditions, with the exception of Year 4. During Year 4 of monitoring, the cross-section 4 thalweg was found to be at approximately the same elevation as as-built conditions.
