ELK SHOALS STREAM RESTORATION SITE
ANNUAL MONITORING REPORT FOR 2009 (YEAR 5)
CONTRACT NUMBER AW03003-B

ANNUAL REPORT FOR 2009 (YEAR 5)

Elk Shoals Stream Restoration Site

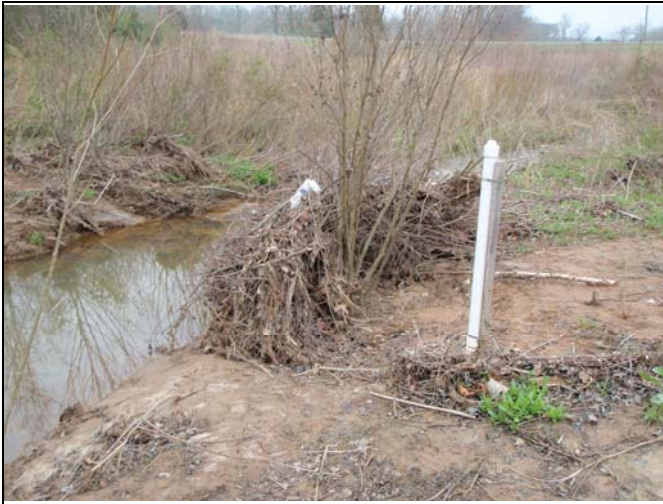
The on-site crest gauge documented the occurrence of at least two bankfull flow events during the Year 5 monitoring period. An inspection of site conditions during the April and September visits revealed visual evidence of out-of-bank flow, such as debris and wrack lines, confirming the crest gauge readings. The largest on-site bankfull flow documented by the crest gauge during Year 5 of monitoring was in April 2009, and was 1.64 feet above the bankfull stage. Photos of the April bankfull evidence are located in Appendix A.

Bankfull evidence – Wrack lines with direction of flow, photo taken 4/1/2009

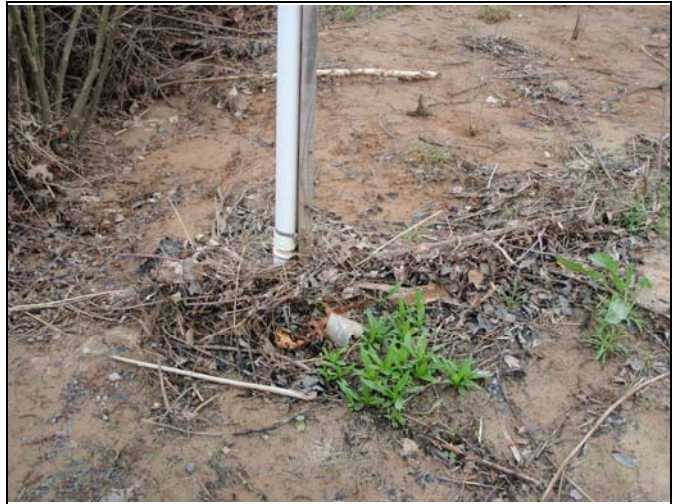
Bankfull evidence – Debris at base of crest gauge, photo taken 4/1/2009

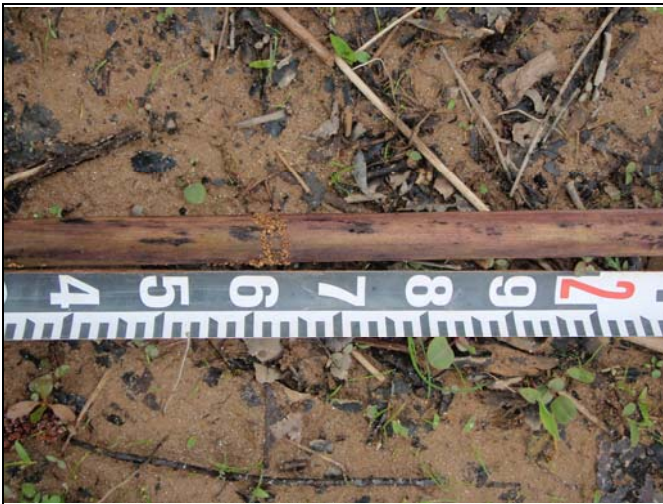
The onsite crest gauge recorded bankfull flow events during every year of monitoring. The highest onsite crest gauge recordings observed are as follows: Year 1 (0.80 feet), Year 2 (0.94 feet), Year 3 (1.8 feet), Year 4 (>4.0 feet) and Year 5 (1.64 feet).

Bankfull reading – 1.64 feet, photo taken 4/1/2009

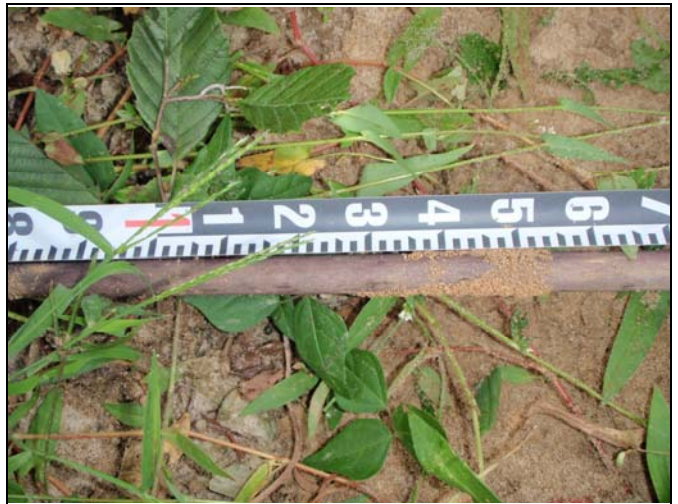
Bankfull reading – 1.54 feet, photo taken 9/15/2009

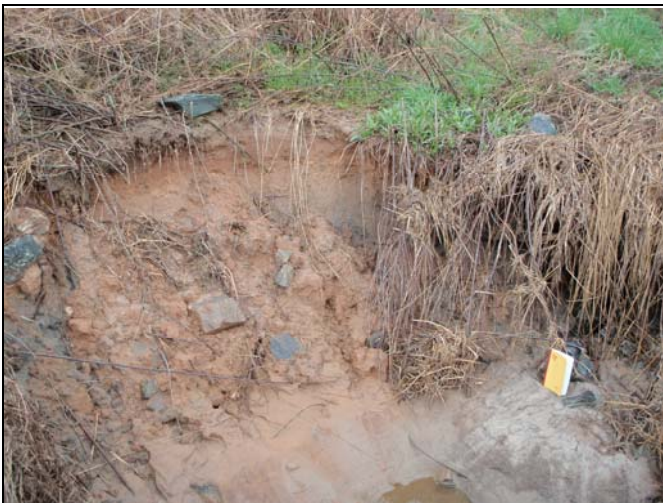
During Year 5 stream repairs were completed on the Site. The first repair is located at the road side swale along Concord Church Road. Storm flows in the swale had created a large headcut above the right top of bank. This repair was completed by adding class B stone to the affected area, thus, creating a riprap swale above and below the headcut to stabilize the area. The second repair was located at the upstream area of the project between stations 13+00 and 14+00. The repairs in this area included bank stabilization and installation of transplants. A toe log held in place with boulders provided bank stabilization. Transplants were used to provide extra reinforcement within the repair. Before and after photos of the repaired swale are included in Appendix A.

Headcut at Concord Church Road roadside swale – before repair

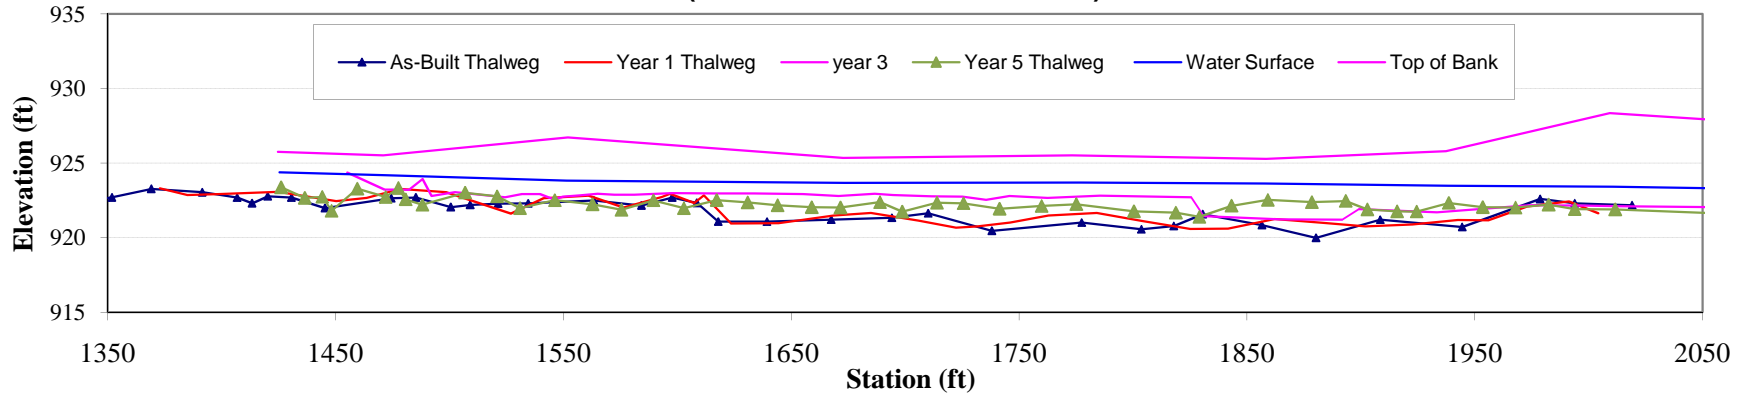
**Elk Shoals Profile Chart, Years 1 - 5, Stations 13+73 to 20+05
(Data Collected November 2009)**

The Year 5 monitoring data for the Elk Shoals Creek profile show that the riffles and pools are stable upstream of the cross vane at station 16+20. According to the survey data, the thalweg downstream of the cross vane at station 16+20 has aggraded since as-built conditions. This aggradation has occurred in the section of remnant channel that was restored, upstream of the

connection with the new section of restored channel that was constructed across the floodplain. This remnant channel section was lower in elevation than the design, but the design approach was to allow this section to aggrade over time to reach equilibrium. The in-stream structures in this section were placed to center the thalweg flows while this process was occurring; therefore, aggradation around the structures was planned. The thalweg stabilizes back to the as-built elevation at approximate station 19+75. From stations 45+25 to station 50+93 it was observed that the channel deepened in some locations due to scour downstream of structures; however, the channel bed elevation has changed little since the Year 3 data were collected and it appears that the channel has equilibrated.

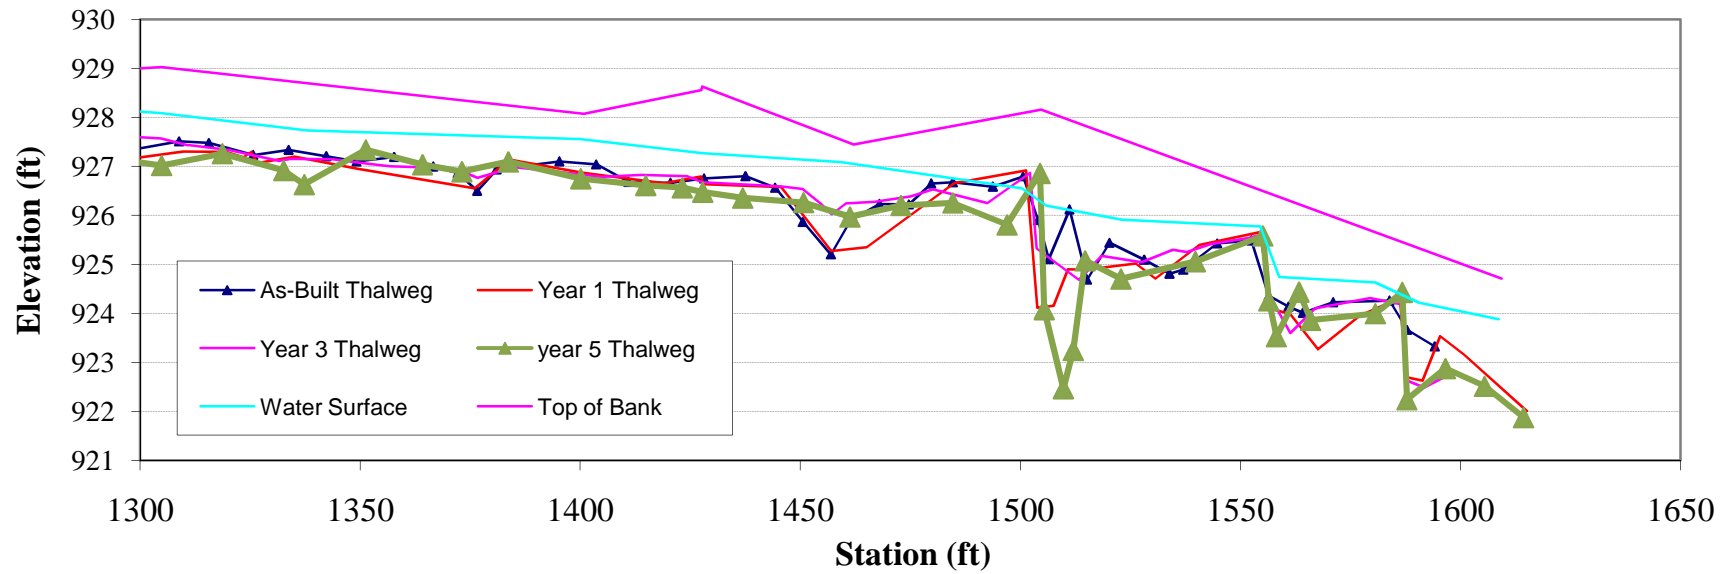
**Elk Shoals UT1 Profile Chart , Years 1 - 5, Stations 13+09 to 16+13
(Data Collected - November 2009)**

The profile for UT1 shows that meander bend pools have decreased in depth while the pools at cross vanes have deepened. According to the survey data, the riffles on UT1 have remained relatively stable. The UT2 Year 5 longitudinal profile demonstrates that the pools within the meander bends have fluctuated slightly throughout the monitoring period. The pools at the two cross-vanes on UT2 have also changed overtime, showing a tendency to fill during low rainfall periods and to scour back out during higher rainfall periods. . The riffles on UT2 have remained relatively stable and are within the quantitative parameters defined for the restored stream type.

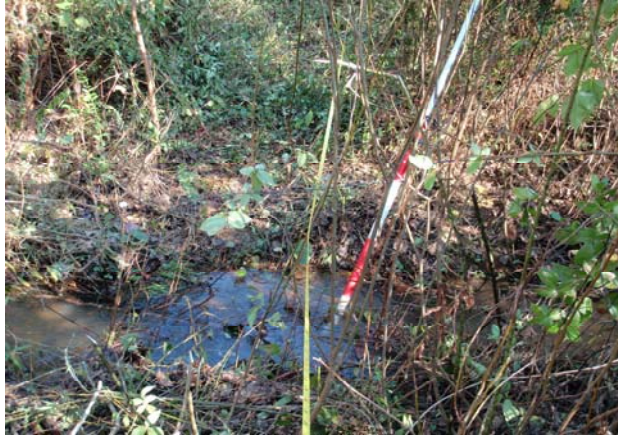
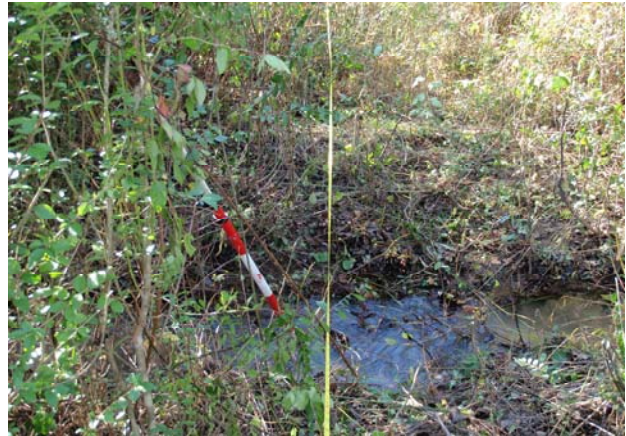
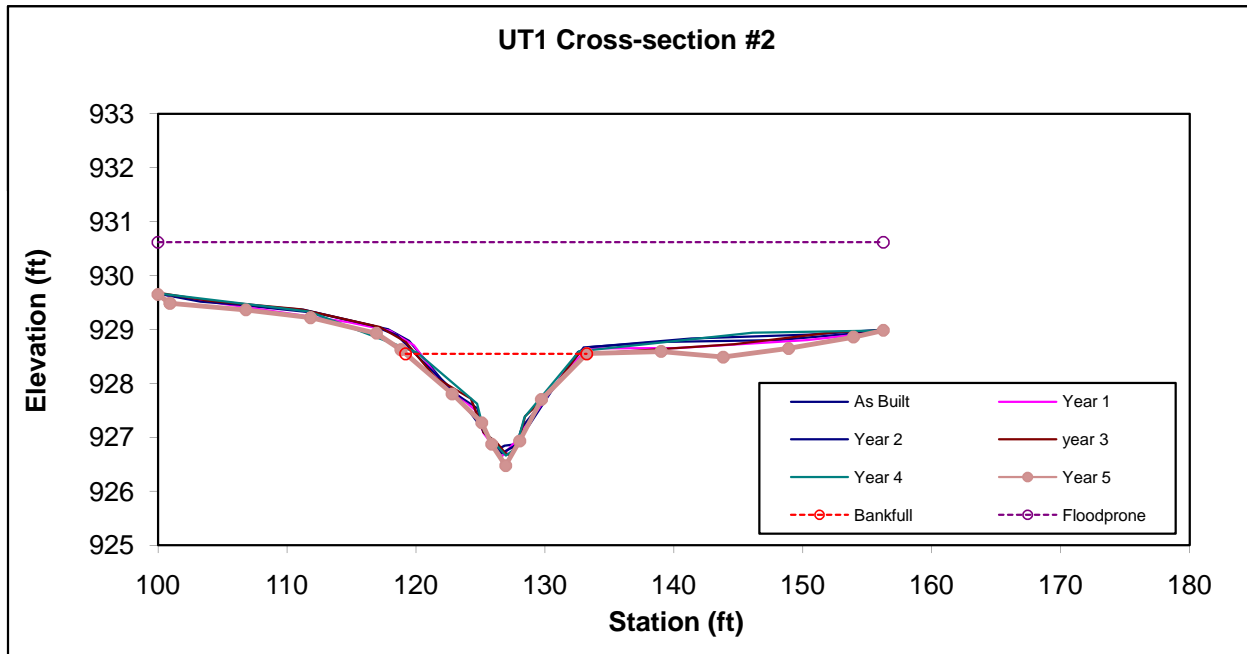
UT1 Permanent Cross-section #2

Cross-sections 1 and 2 are located on UT1 between stations 12+00 and 15+00. The dimensions of pool cross-section 1 have changed significantly throughout the monitoring period. Cross-section 1 was originally constructed with a bankfull area of 13.4 feet. During Year 5 the cross-sectional area of the channel has decreased to approximately 2.4 square feet and is now functioning as a riffle. Riffle cross-section 2 on UT1 after Year 5 has remained very stable since as-built conditions. Given that the pool cross-sectional area has decreased and the riffle cross-section has remained stable, it appears that after Year 5 of monitoring UT1 is reaching a state of equilibrium.

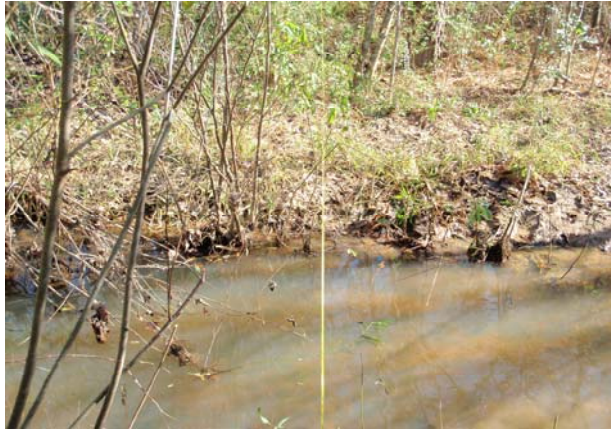
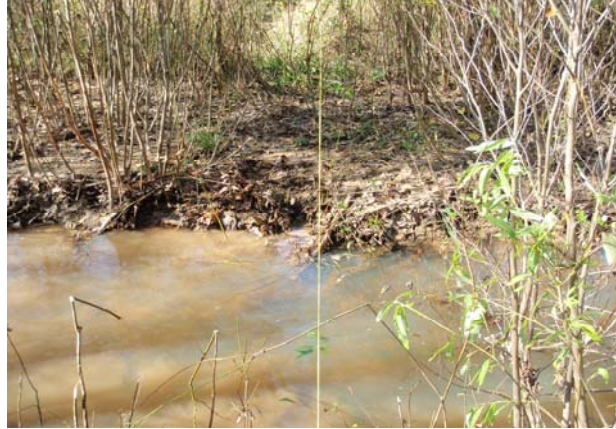
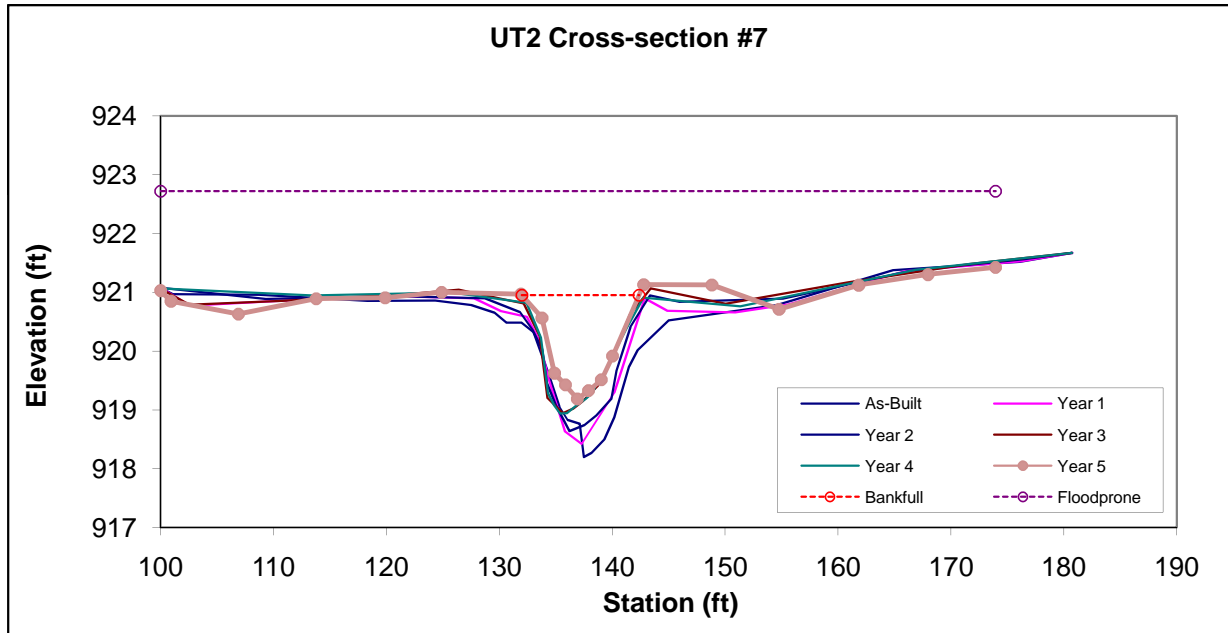
UT2 Permanent Cross-section #7

UT2 pool and riffle cross sections 7 and 8 respectively, were also compared to the earlier monitoring survey data. The dimension of pool cross-section 7 changed throughout the monitoring period to decrease the cross-sectional area. During as-built conditions cross-section 7 showed a bankfull area of 13.7 feet, after Year 5 it was determined to have a channel area of 6.9 feet. Riffle cross-section 8 remained relatively stable throughout the monitoring period; the apparent shift in the cross-section seen in the Year 5 data was caused by the survey crew needing to shift around growing woody vegetation along the bank. Since the pool bankfull area has decreased and the riffle bankfull has remained stable, it appears that after Year 5 of monitoring, UT2 is also reaching a natural equilibrium. The cross-section data show that UT1 and UT2 are experiencing similar year-to-year variability.
