# ELLERBE CREEK STREAM RESTORATION SITE

## MONITORING REPORT - YEAR 1

OCTOBER 2005

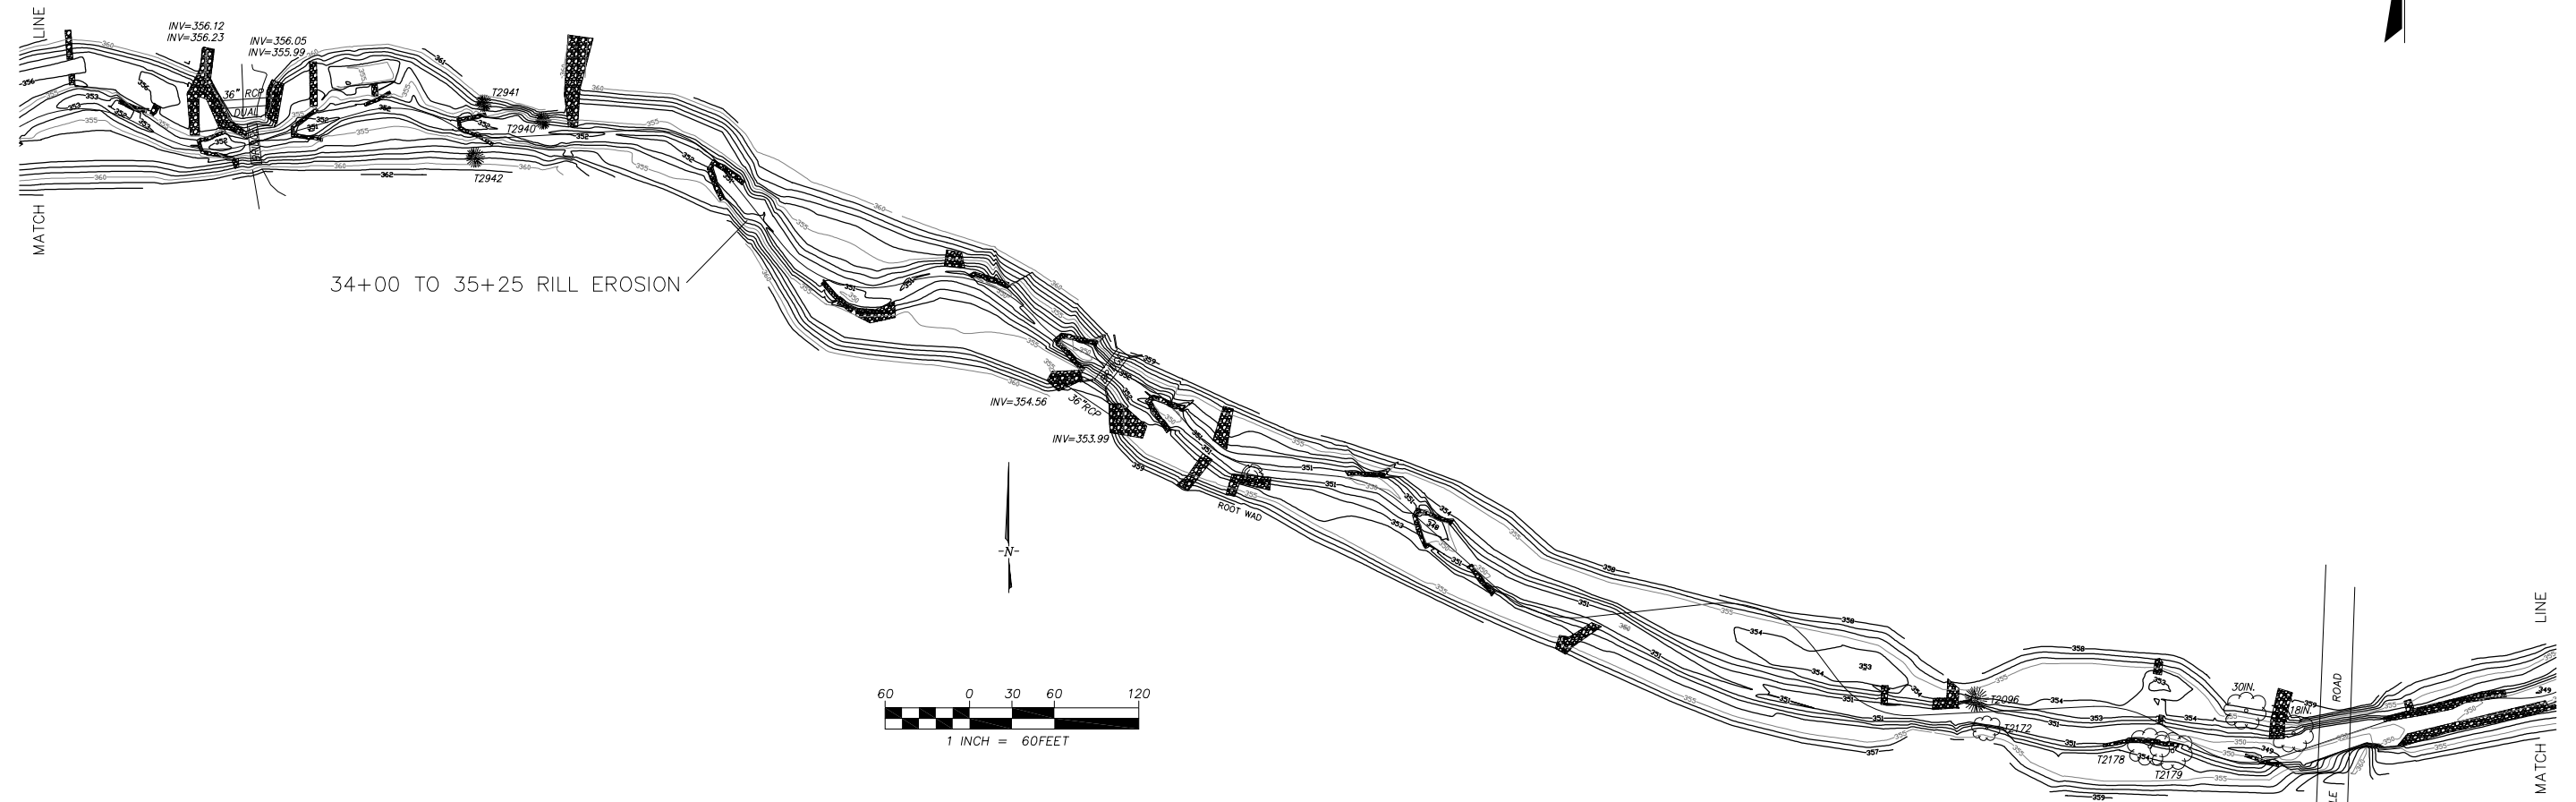
Ellerbe Creek  
 STREAM PROBLEM AREAS  
 Plan View  
 Durham County, North Carolina  
 FIGURE 6B

34+00 TO 35+25 RILL EROSION

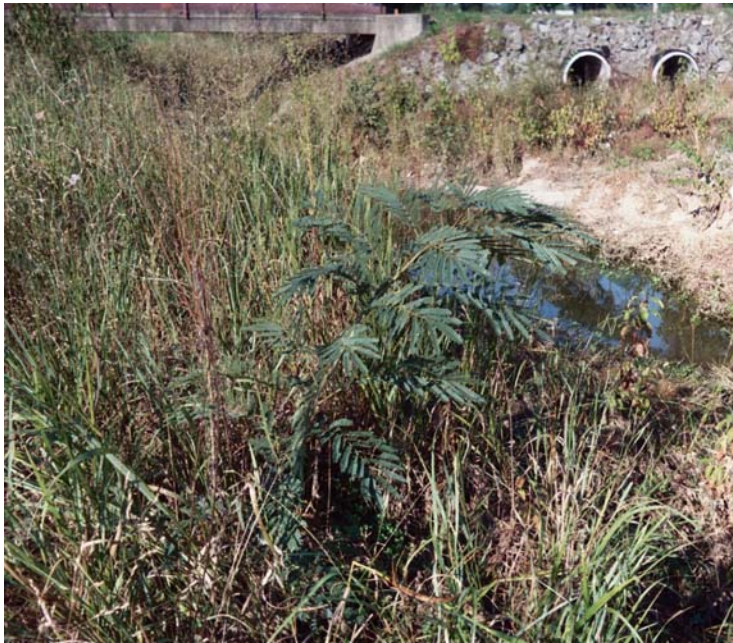
<b>Exhibit Table VIII. Vegetative Problem Areas Project Number 010551001 (Ellerbe Creek Stream Restoration)</b>			
<b>Feature/Issue</b>	<b>Station # / Range</b>	<b>Probable Cause</b>	<b>Photo #</b>
<b>Rill Erosion</b>	34+00 to 34+25	Steep terrace slope.	VP-1
<b>Invasive Plant Species</b>	29+88	Mimosa	VP-2

VP-1: Invasive Species - Mimosa Tree  
(STA 29+88)

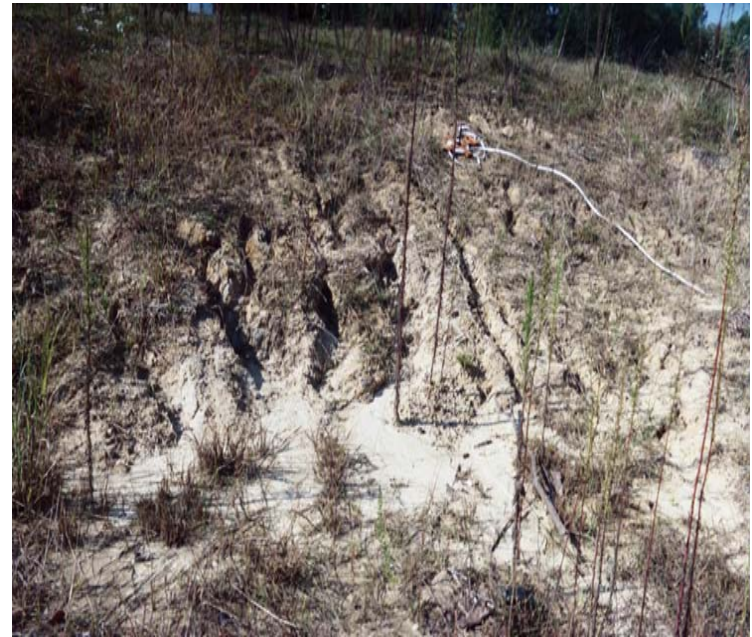
VP-2: Rill Erosion (STA34+00 to 34+25)

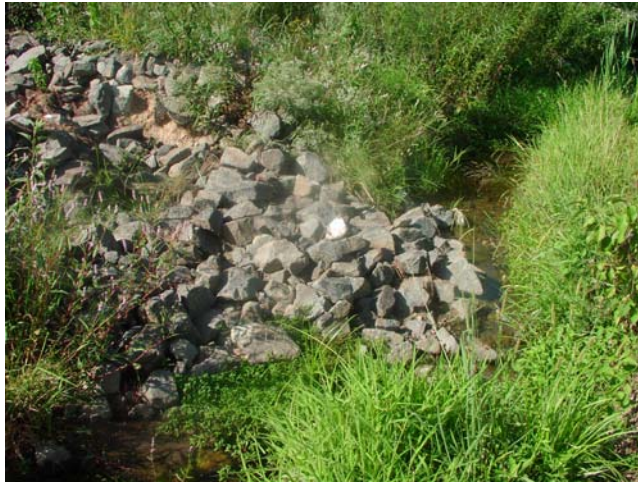
<b>Exhibit Table X. Stream Problem Areas Project Number 010551001 (Ellerbe Creek Stream Restoration)</b>			
<b>Feature Issue</b>	<b>Station numbers</b>	<b>Suspected Cause</b>	<b>Photo number</b>
Rock washed into stream from junction box.	20+30	Undersized rock at junction box outlet.	SP1
Coir fiber matting detached from bank.	52+00	Matting in need of additional tacking.	SP2
Leak in storm water wetland weir	Upper wetland	Unknown	SP3

SP1 – Rock in channel

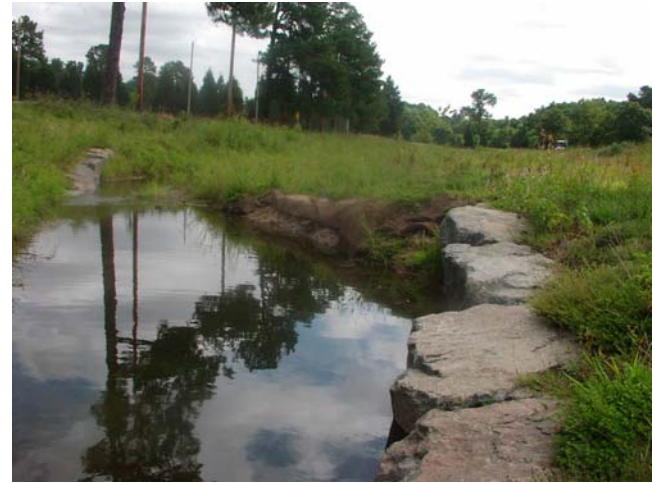
SP2 – Coir fiber matting.

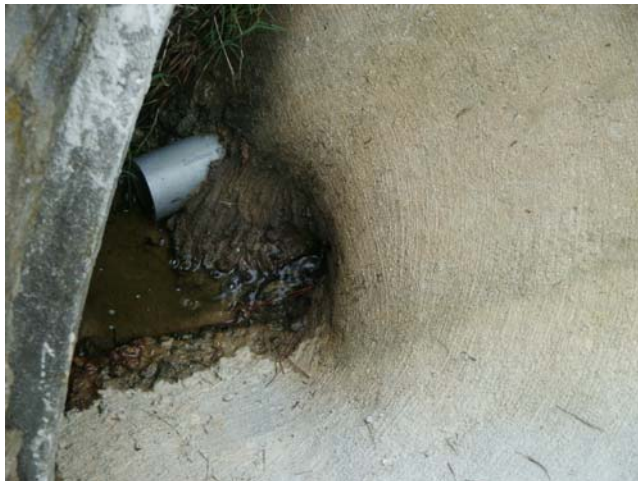
SP3 – Weir leak.
