**ELLERBE CREEK STREAM RESTORATION – Project #127
Second Annual Monitoring Report - February 2007 - Final**

Designed by:
Stantec Consulting Services, Inc.
Suite 300, 801 Jones Franklin Road
Raleigh, North Carolina 27606

North Carolina Department of Environment and
Natural Resources
Ecosystem Enhancement Program
1652 Mail Service Center
Raleigh, NC 27699-1652

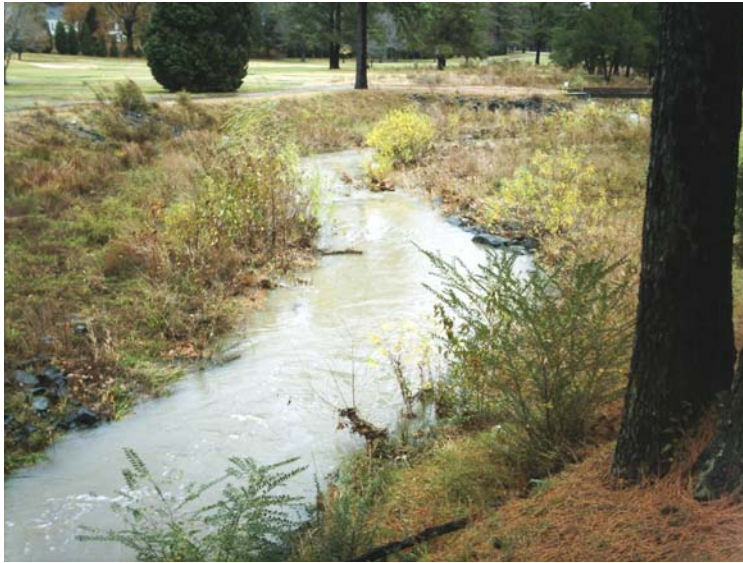
Qualitative evaluation (rack and drift lines, downed herbaceous and woody vegetation on the floodplain) indicated at least three high flow events during 2006 (April, June, and September (left photo)).

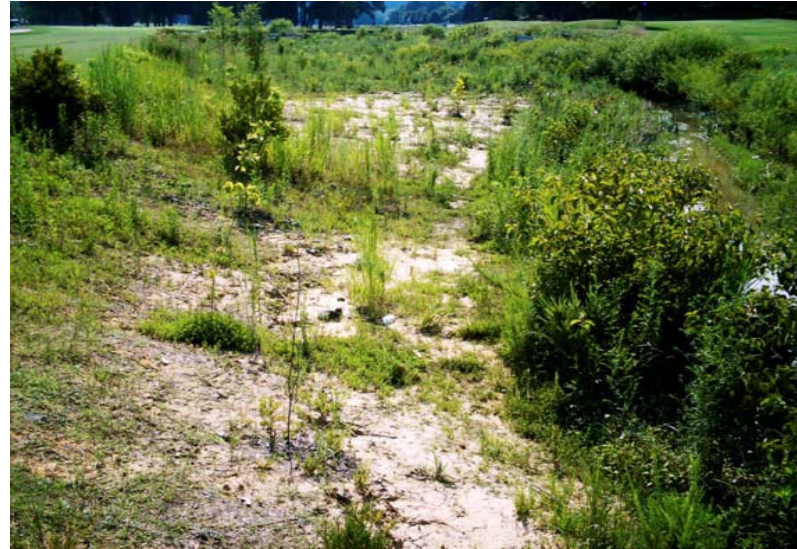
Feature/Issue	Station/Range	Probable Cause	Photo #
Bare soil/eroded slopes	1110-1260	Compated soil/high runoff from golf course	VP1, VP2
Bare soil/eroded slopes	1800-1975	Compated soil/high runoff from golf course	VP1, VP2
Bare soil/eroded slopes	1850-2020	Compated soil/high runoff from golf course	VP1, VP2
Beaver browsing	2880-2910	Beaver dams in area	VP3
Bare soil/eroded slopes	3490-3560	Compated soil/high runoff from golf course	VP1, VP2
Bare soil/eroded slopes	6235-6470	Compated soil/high runoff from golf course	VP1, VP2
Beaver browsing	6355-6490	Beaver dams in area	VP3

Three vegetation problem areas were observed in the Hillsborough reach during the second growing season. Two of them are on the slopes between the terrace and the golf course. They are likely to have resulted from rill and gully erosion in compacted subsoil. The third, and largest, vegetation problem area is the result of beaver damage to planted woody stems in the floodplain and lower terrace, immediately adjacent to the beaver ponds.

VP2. Bare / eroded soil

Replanting, mulching, and installation of erosion control devices (e.g. coir matting) in the rill and gully areas is recommended. During the June qualitative evaluation, a beaver dam was observed. Several more dams were observed during the September evaluation and vegetation monitoring and planted woody stems appeared have been harvested. The beaver on the site was reported to have been killed by an automobile during late November 2006 (Roy Clark, Greenskeeper, Hillandale Golf Course, personal communication). The dams were subsequently removed by an EEP subcontractor. Because the impacted planted woody stems adjacent to the ponds were unlikely to have been killed and may recover during the 2007 growing season, no remedial action is recommended at this time. In addition to beaver harvest in this floodplain area, planted woody stem vigor in this floodplain area was relatively low. Because of the low slope in this floodplain area, the cause appears to be lack of and adequate growth medium (i.e. too compact/not enough organic material/nutrients).

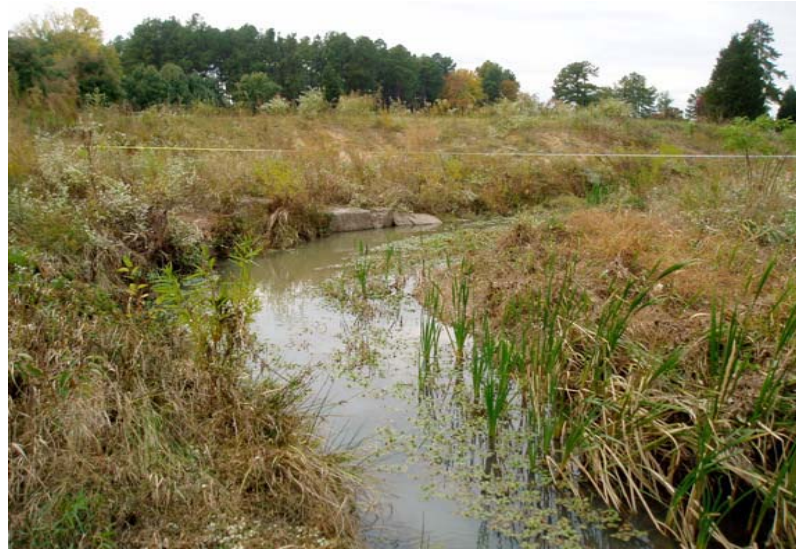
Exhibit Table X. Stream Problem Areas – Ellerbe Stream Restoration – Project #127			
Feature/Issue	Station	Probable Cause	Photo #
Bank undercut	1010.5	Rootwad needed	SP6
Aggradation (bar)	1234	Unknown	SP1
Rill and gully	1291	Insufficient growth medium	SP5
Aggradation (pool)	1369.2	Beaverdam	SP2
Rill and gully	1496.2	Insufficient growth medium	SP5
Rill and gully	1596	Insufficient growth medium	SP5
Beaver dam	1682	Colonization from downstream	SP3,4
Rill and gully	1767	Insufficient growth medium	SP3,4
Aggradation (pool)	1791	Beaverdam	SP2
Rootwad undercut	1824	Unknown	SP7
Beaverdam	1985	Colonization from downstream	SP4

SP2. Aggradation (pool)

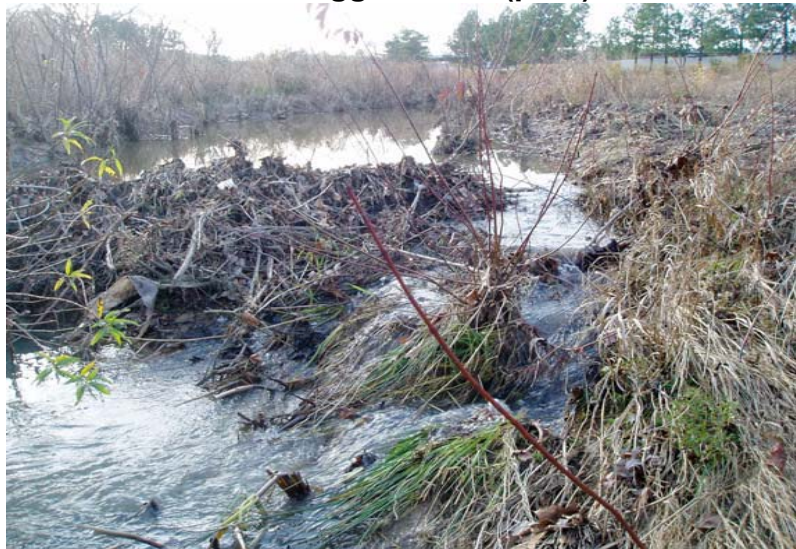
Most structural problems observed were caused by the occupation of the site by one or more beavers. The constructed dams caused flooding throughout the restoration site. This eliminated a normal sediment transport regime and caused impacts to vegetation through flooded conditions and beaver harvest of planted woody stems. Other instream problems observed were flooding/burying of cross-vanes, which was presumably worsened by the presence of beaver dams causing excessive sediment collection in some areas and low flows and minimal deposition in others. In one area where the dam had failed, the stream was developing a new pattern by downcutting through the deposited sediment.

SP4. Beaverdam

As noted above, the beaver and its dams have since been removed from the restoration site and therefore, immediate remedial action is not recommended.

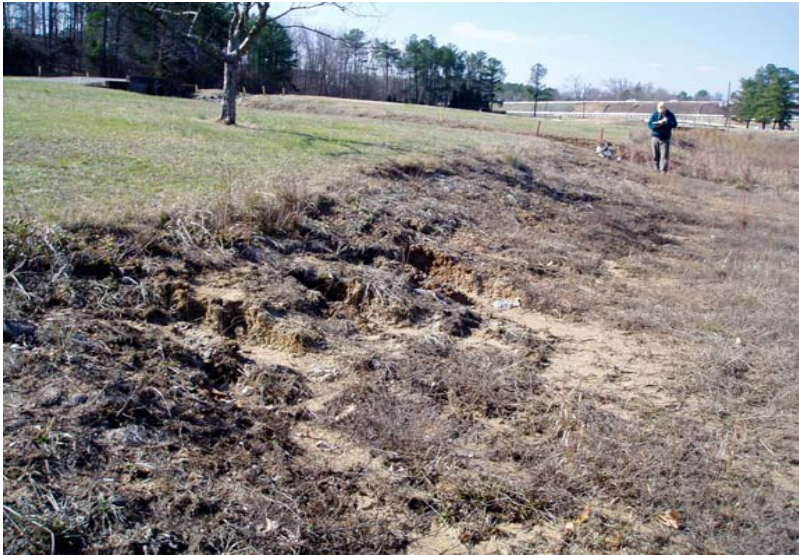
SP5. Rill and gully

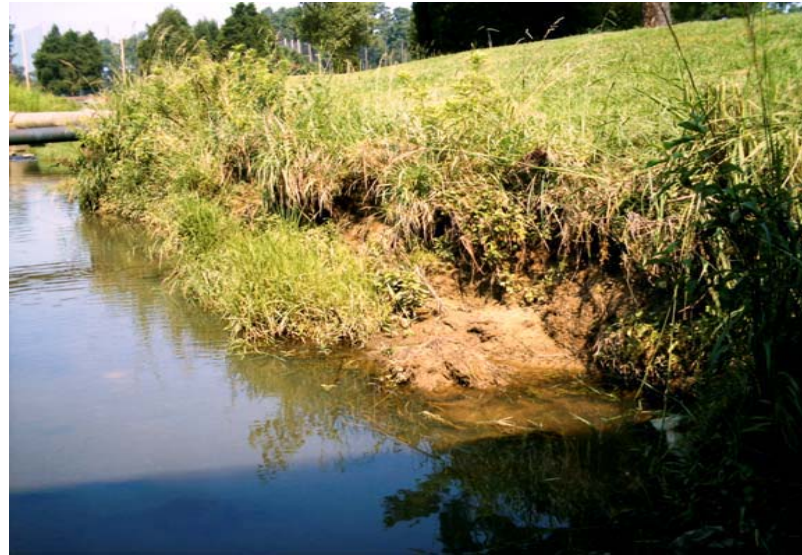
SP6. Bank undercut/scour

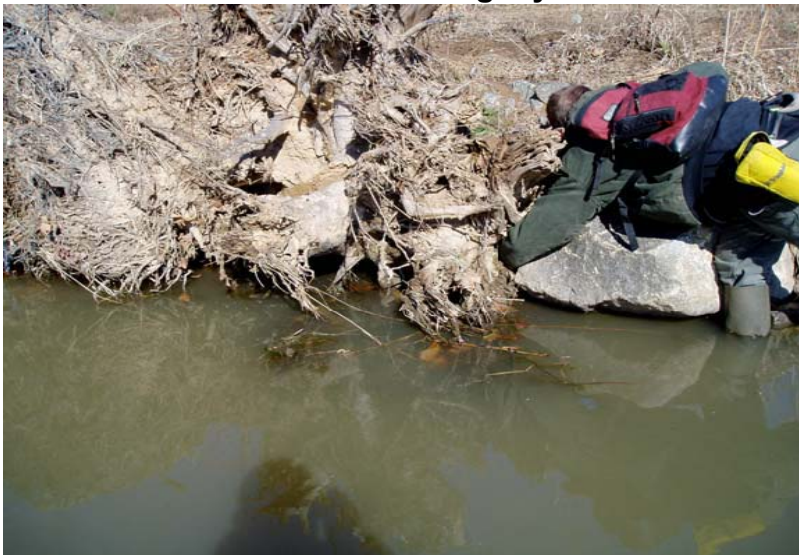
SP7. Root wad undercut

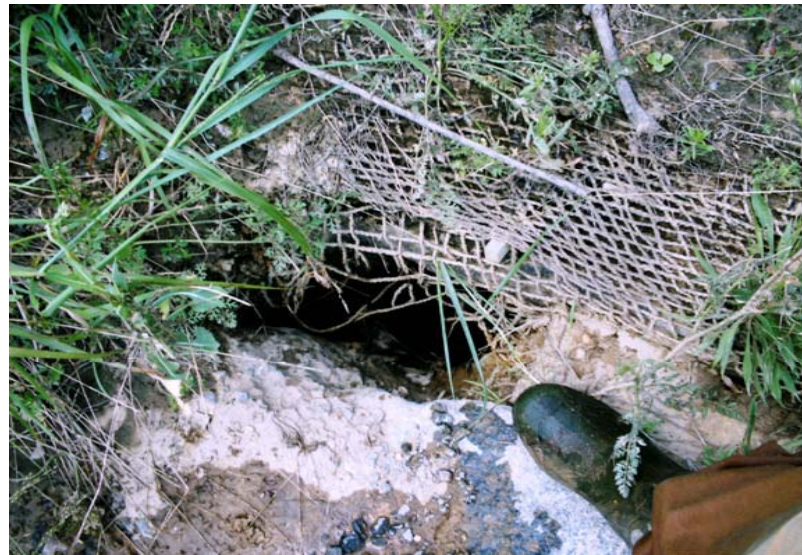
SP8. Vane backcut/scour
