**ELLERBE CREEK STREAM RESTORATION – Project #127
Third Annual Monitoring Report - February 2008 - FINAL**

Designed by:
Stantec Consulting Services, Inc.
Suite 300, 801 Jones Franklin Road
Raleigh, North Carolina 27606

North Carolina Department of Environment and
Natural Resources
Ecosystem Enhancement Program
1652 Mail Service Center
Raleigh, NC 27699-1652

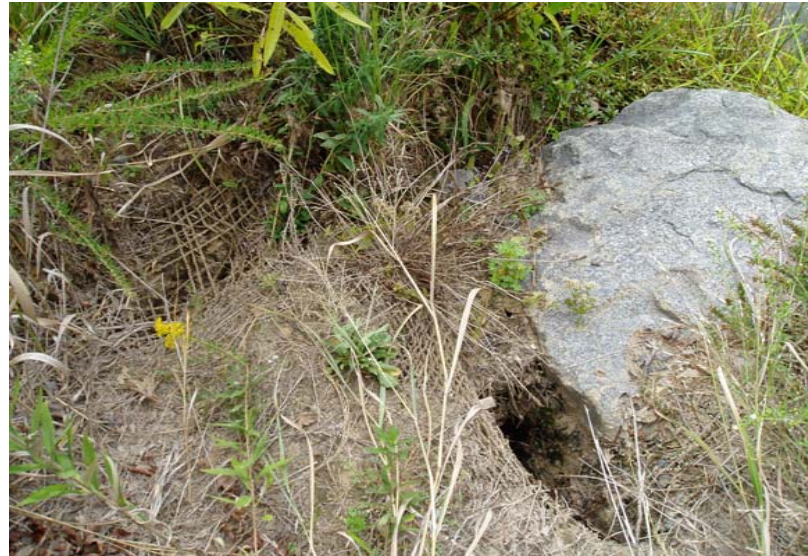
SP6. Boulder undercut

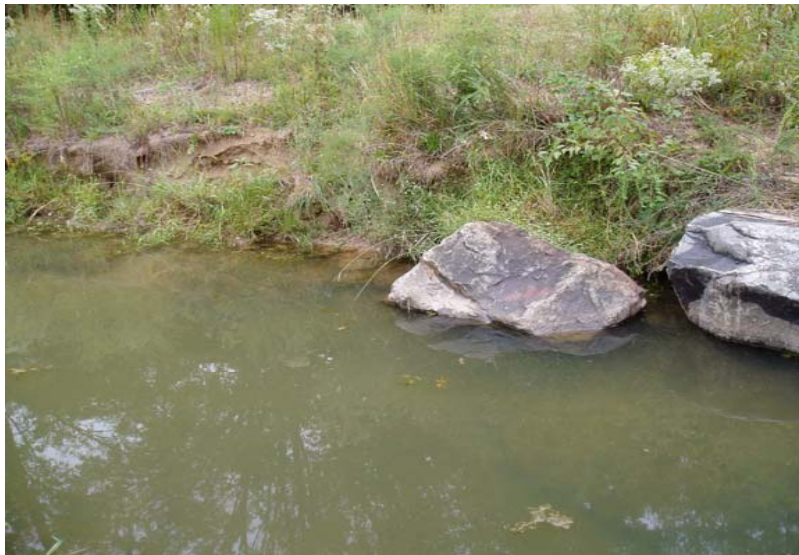
One high priority structural failure was observed at a cross vane on Ellerbe Creek's right bank at station 6330 (Appendix B1.3). The vane's downstream-most header rock has become entirely dislodged from the underlying footer and is in the channel below. From the header's former location, the downstream bank is eroding severely and slumping into the creek for approximately 30 more feet. Several low priority areas of scour, aggradation, and structure undermining were observed at other locations (Exhibit Table X, Appendix B1).

SP7. Boulder failure

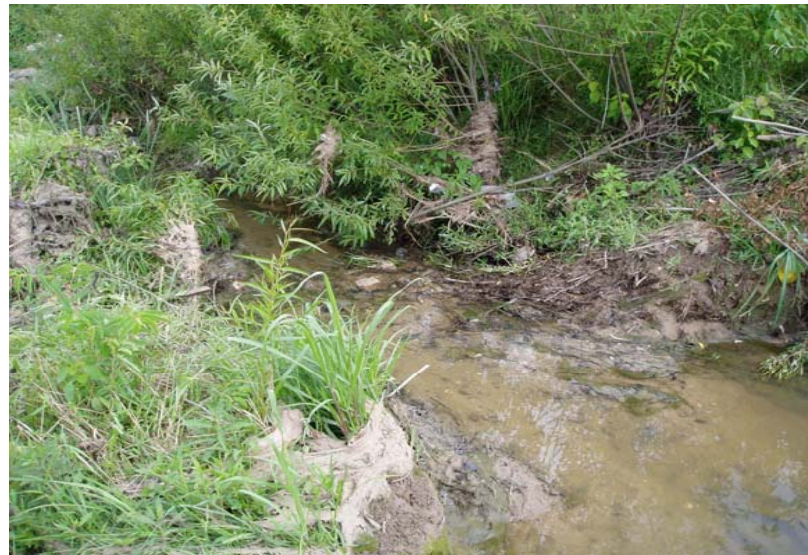
One beaverdam was found in the Hillsborough reach and removed by a subcontractor during data collection. The removal occurred on 2 July 2007 and the results of which can be seen in the longitudinal profile data (Appendix B.6). Beaver were subsequently removed from the site.

SP8. Stream after beaverdam removal
