**ELLERBE CREEK STREAM RESTORATION – Project #127
Fourth Annual Monitoring Report - 2008 - FINAL**

Submitted on January 30, 2009 to:

North Carolina Department of
Environment and Natural Resources
Ecosystem Enhancement Program
1652 Mail Service Center
Raleigh, NC 27699-1652

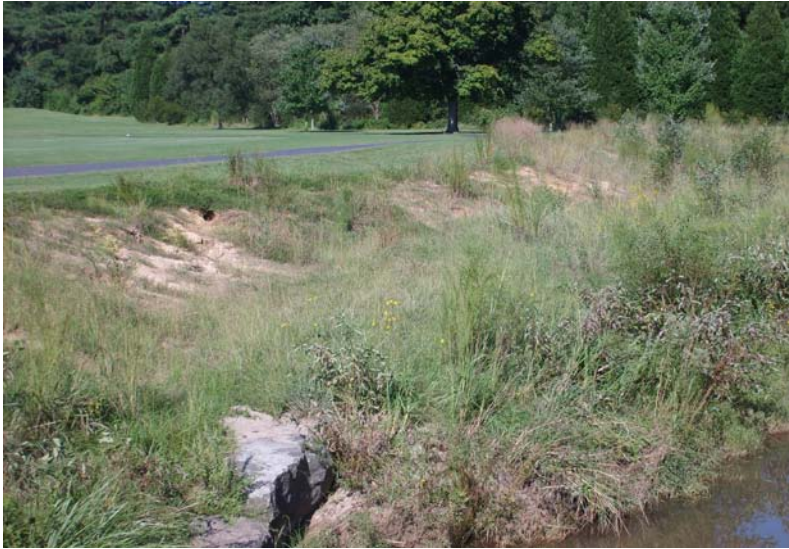
Three vegetation problem areas were observed in the Hillsborough reach during the fourth growing season. All occur on the slopes between the terrace and the golf course and are likely to have resulted from rill and gully erosion in compacted subsoil. All three areas were identified as problem areas in 2006 and 2007, but have decreased in size and move off of the floodplain areas. In addition to these three larger vegetation problem areas, small, isolated rill and gully areas exist throughout the project that have poor vegetative cover, as well (Appendix A.1 and A.2).

Table 6. Vegetation Problem Areas Ellerbe Creek Stream Restoration – Project #127			
Feature/Issue	Station # / Range	Probable Cause	Photo #
Bare soil/eroded slopes	1140-1280	Compacted soil/high runoff from golf course	VP1
Bare soil/eroded slopes	1840-1945	Compacted soil/high runoff from golf course	VP1
Bare soil/eroded slopes	1865-1990	Compacted soil/high runoff from golf course	VP1
Bare soil/eroded slopes	3540-3630	Compacted soil/high runoff from golf course	VP1
Bare soil/eroded slopes	3880-3960	Compacted soil/high runoff from golf course	VP1
Bare soil on floodplain	4450-4470	Compacted soil	VP2
Bare soil/eroded slopes, including floodplain	5555-5840	Compacted soil/high runoff from golf course	VP1, VP2
Bare soil/eroded slopes	6315-6570	Compacted soil/high runoff from golf course	VP1

VP1. Bare soil/eroded slopes (9/18/08)

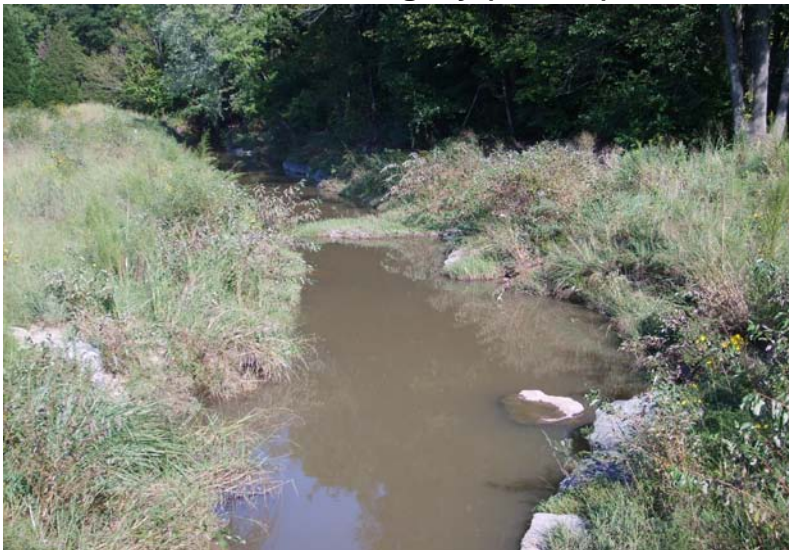
Aggradation (bar)	5265-5275	SP7	Sediment from stormwater/scour areas
Aggradation (bar)	5285	SP7	Sediment from stormwater/scour areas
Mid-channel bar	6075	SP8	Sediment from stormwater/scour areas
Mid-channel bar	6110	SP8	Sediment from stormwater/scour areas
Mid-channel bar	6160	SP8	Sediment from stormwater/scour areas
Bank slump/scour	6180-6270	SP7	Insufficient rootwad/armoring
Boulder failure	6330	SP7	Insufficient coarse backfill
Rill and gully	6350	SP5	Insufficient growth medium
Bank undercut/scour	6340-6360	SP7	Insufficient rootwad/armoring
Aggradation (bar)	6390	SP7	Sediment from stormwater/scour areas
Rill and gully	6425	SP5	Insufficient growth medium

SP7. Boulder failure, banks scour, bar (9/18/08)

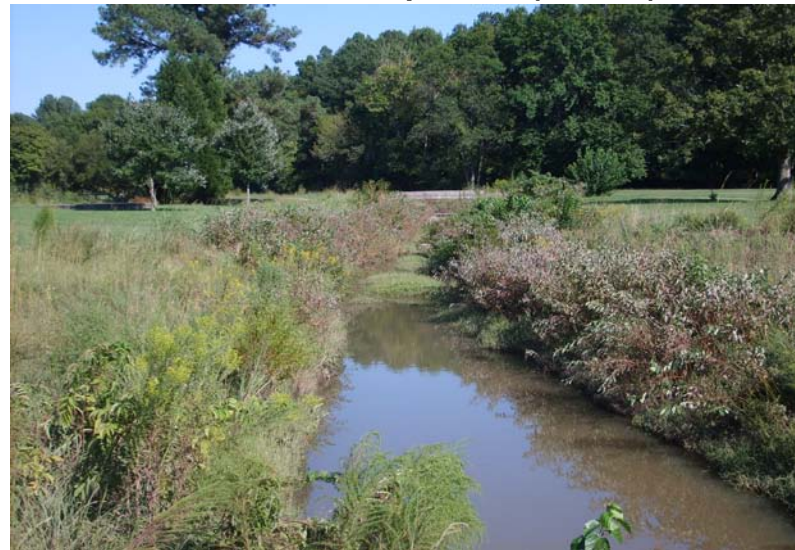
SP8. Mid-channel bars (9/18/08)
