**ELLERBE CREEK STREAM RESTORATION – Project #127
Fifth Annual Monitoring Report - 2009 - FINAL**

Submitted on January 11, 2010 to:

North Carolina Department of
Environment and Natural Resources
Ecosystem Enhancement Program
1652 Mail Service Center
Raleigh, NC 27699-1652

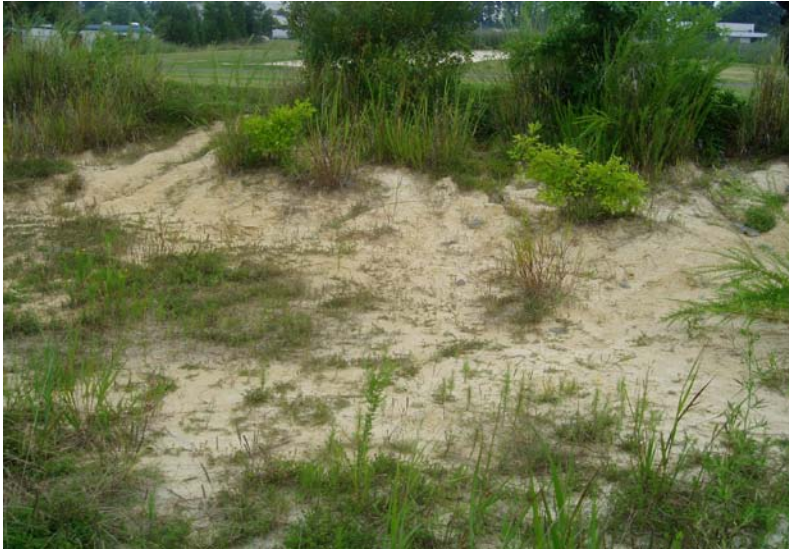
Table 6. Vegetation Problem Areas – Ellerbe Creek Stream Restoration – Project #127			
Feature/Issue	Station/Range	Probable Cause	Photo #
Bare soil/eroded slopes	1890-1975	Compacted soil/high runoff from golf course	VP1

VP1. Bare soil/eroded slopes (7/16/09)

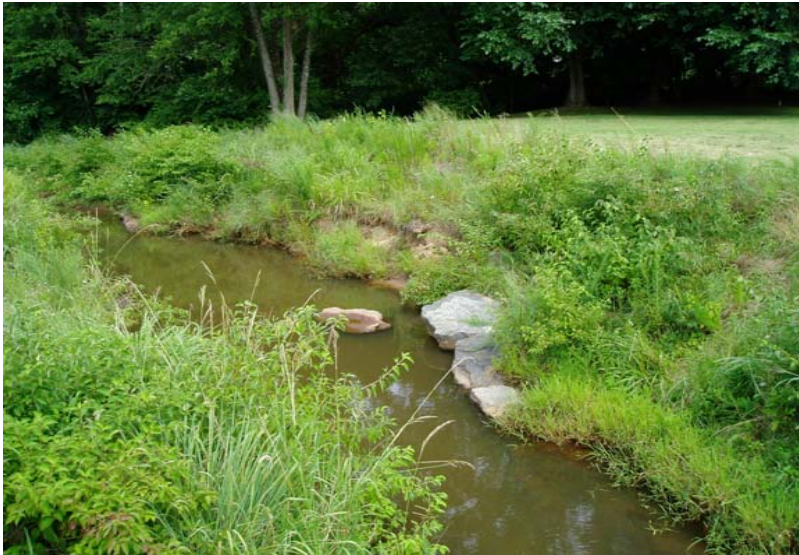
Since 2006, a structural failure has been monitored at a cross vane on Ellerbe Creek's right bank at station 6330 in the Albany Reach (Appendix B1.3). The vane's downstream-most header rock has become entirely dislodged from the underlying footer and is in the channel below. From the header's former location, the downstream bank is eroding and slumping into the creek for approximately 20 more feet. As indicated in Exhibit Table VII, Stream Feature Visual Stability Assessment, this bank erosion problem has a minimal affect on the overall success and stability of the stream banks in this reach. Areas of scour, aggradation, and structure undermining were also observed at other locations, but again with minimal affect on the stability of the overall stream channel. Stability scores by feature can be found in Exhibit VII and Table B5 in Appendix B. Locations for specific problem areas are identified in Table B1 in Appendix B.

SP5. Scour at cross vane arm (7/16/09)

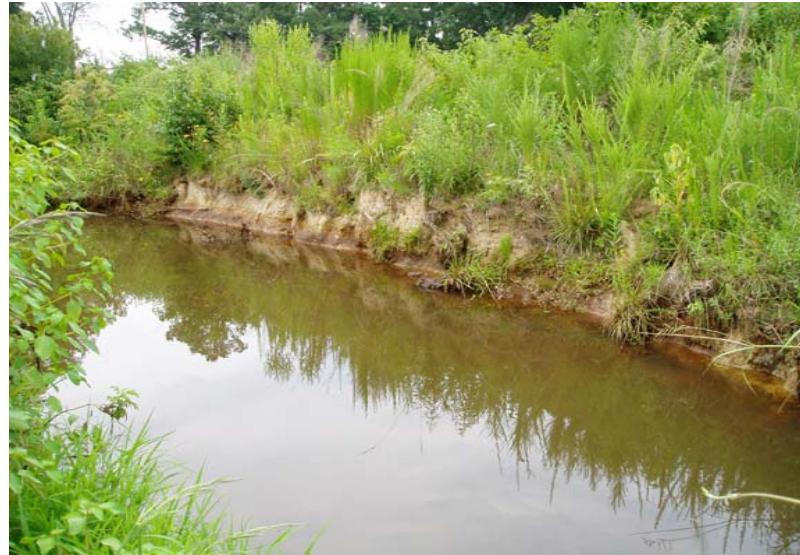
SP6. Bank slump/scour (7/16/09)

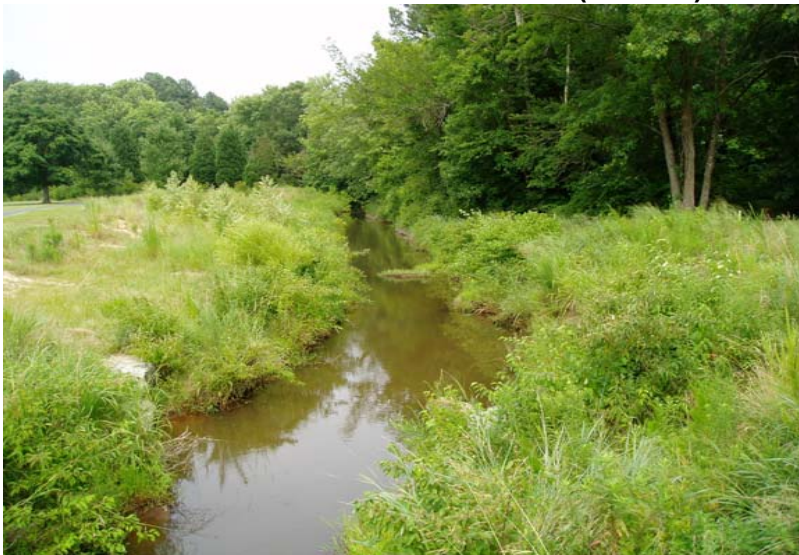
SP7. Aggradation (bar) (7/16/09)
