**ELLINGTON BRANCH STREAM RESTORATION SITE
FULL DELIVERY PROJECT
WARREN COUNTY, NORTH CAROLINA**

EEP Project No. 16-D06045

FINAL Monitoring Report #1 (Year 2008)

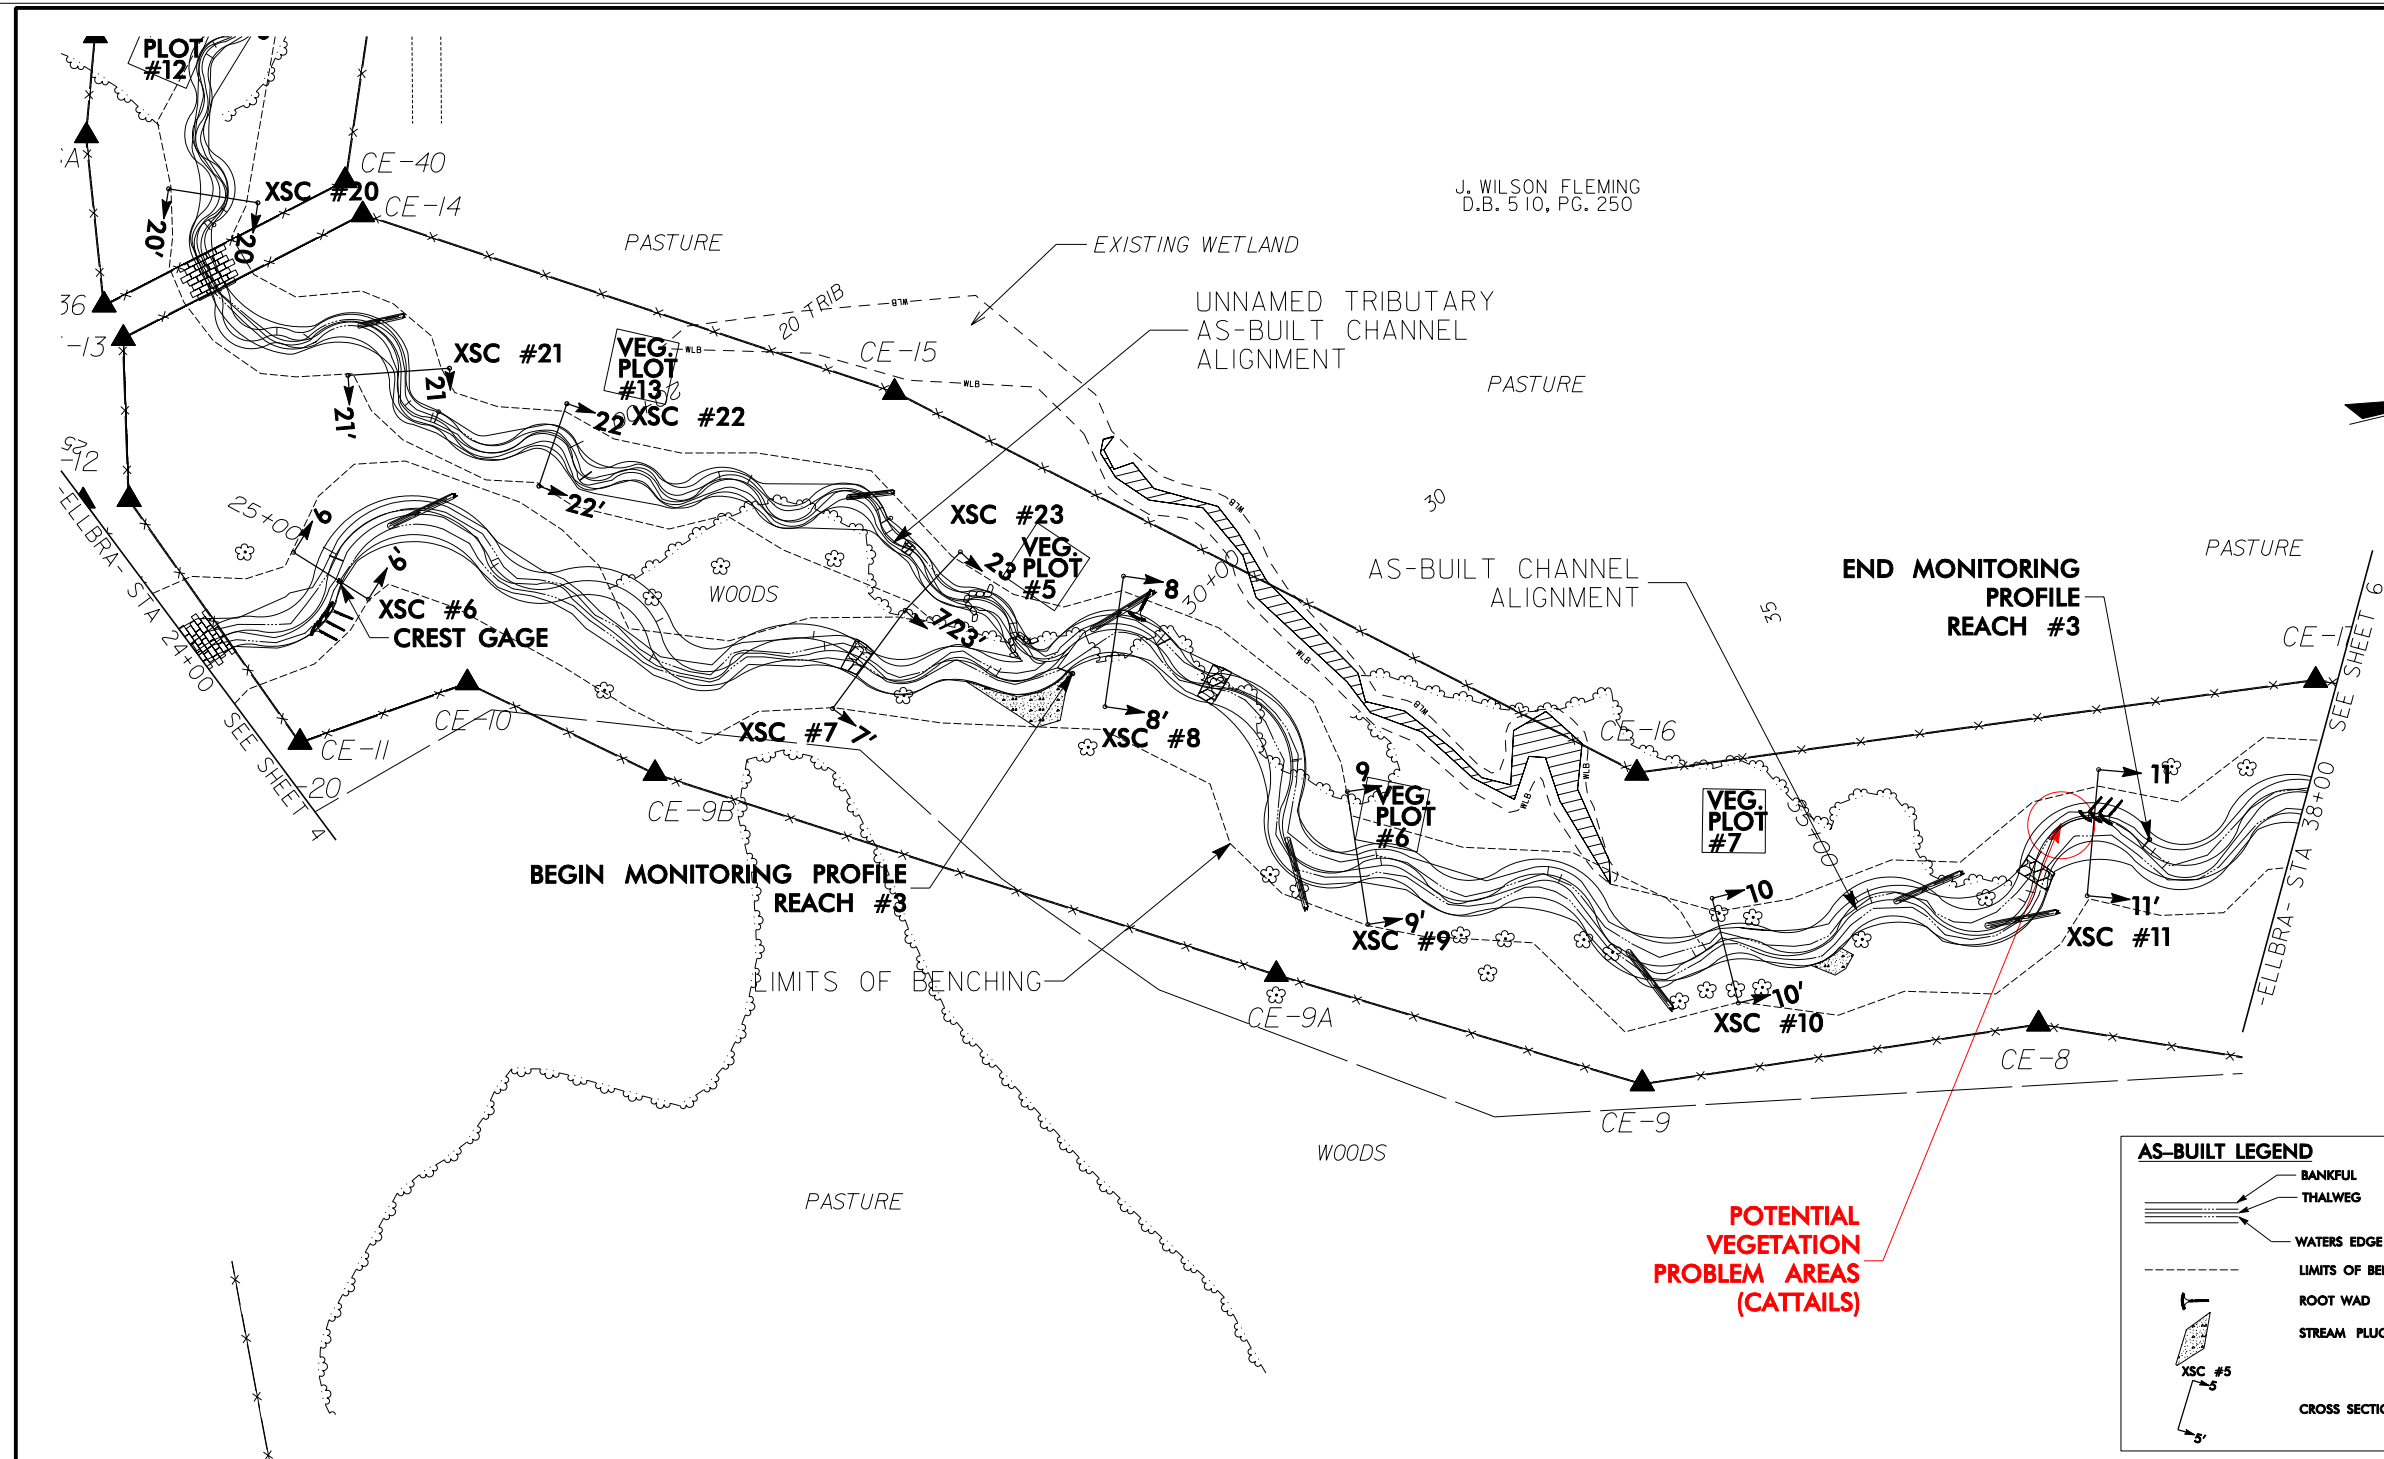
128 Raleigh Street Holly Springs, NC 27540	
SHEET NAME	
PROBLEM AREAS PLAN VIEW

Cattails were observed in seven separate locales within the Project Site, specifically Station Numbers 14+50, 16+25, 36+50, 43+25, 44+25 and 46+50 along Ellington Branch. It was also observed at Station Number 16+00 along the UT. The occurrences were all scattered and individual counts were minimal. It is apparent that the establishment of cattails is a result of wind and/or bird dispersal. No other cattails were observed on the property. Low water levels and limited floodflows have allowed this species to become established. These areas will continue to be closely monitored throughout the spring and summer of next year. Spot treatments with an aquatic herbicide will be performed, as necessary.

POTENTIAL VEGETATION PROBLEM AREAS (CATTAILS)
