**ELLINGTON BRANCH STREAM RESTORATION SITE
FULL DELIVERY PROJECT
WARREN COUNTY, NORTH CAROLINA**

EEP Project No. 16-D06045

Final Monitoring Report Year #2 (2009)

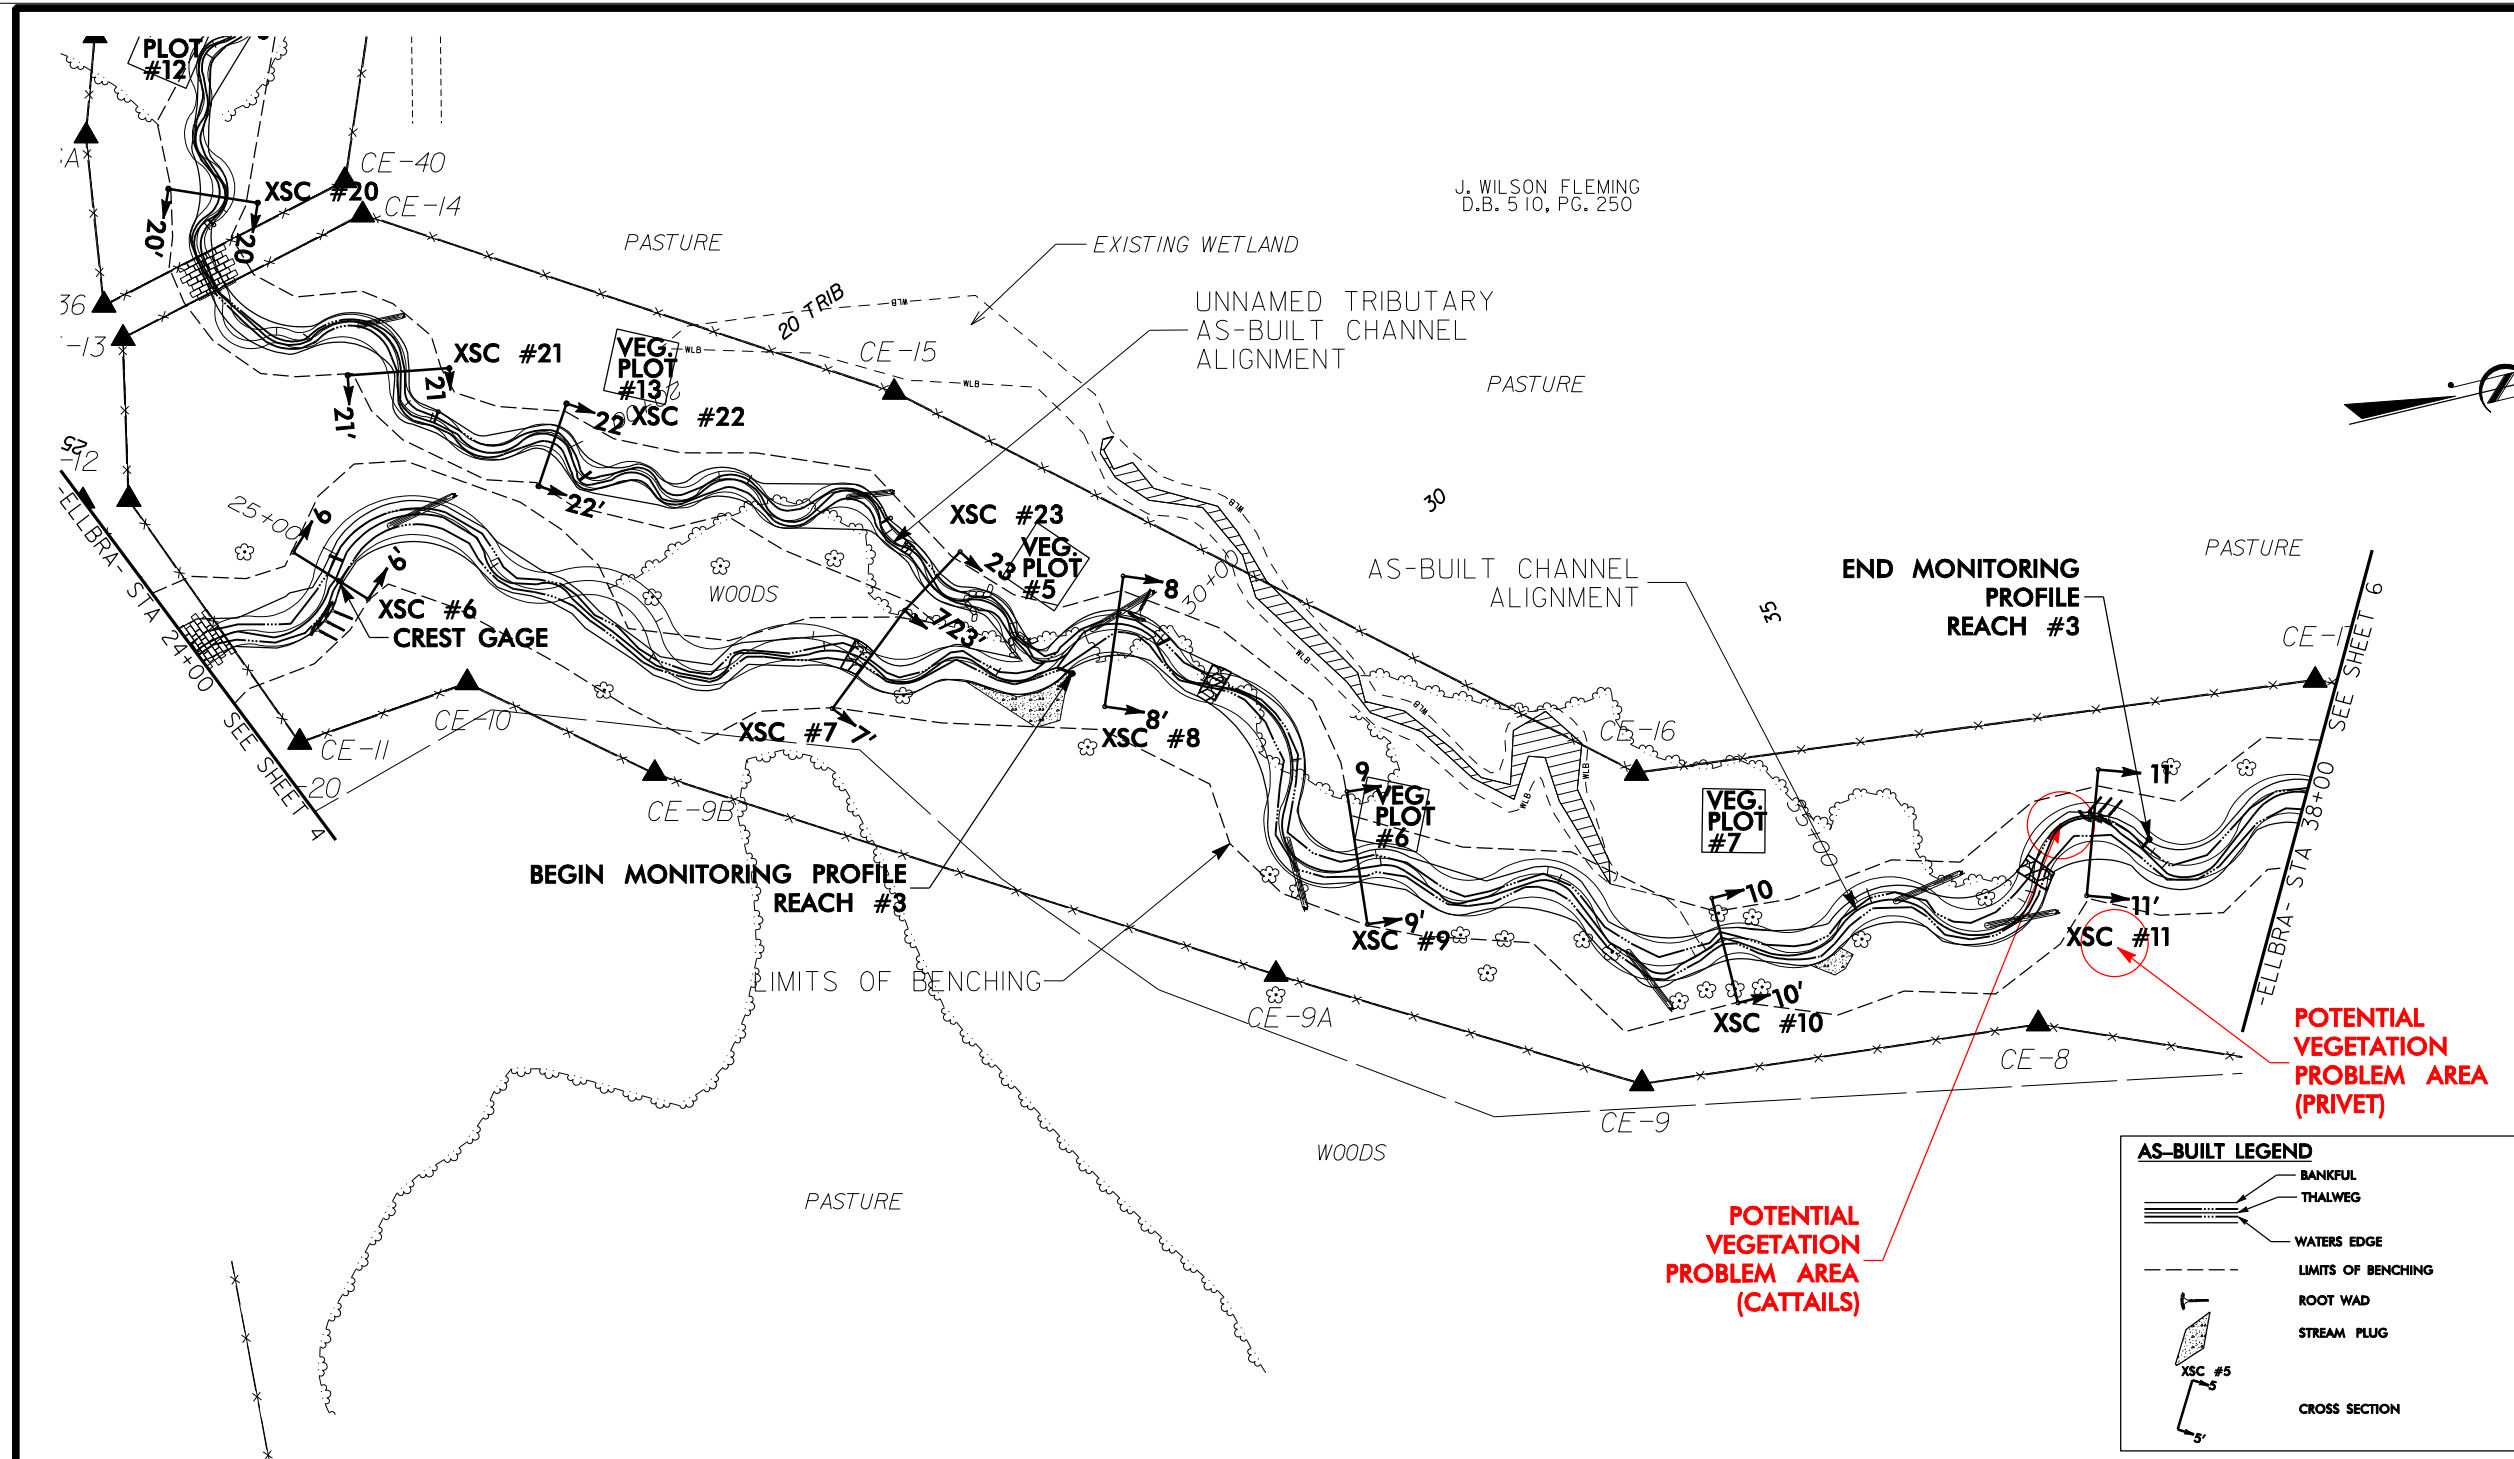
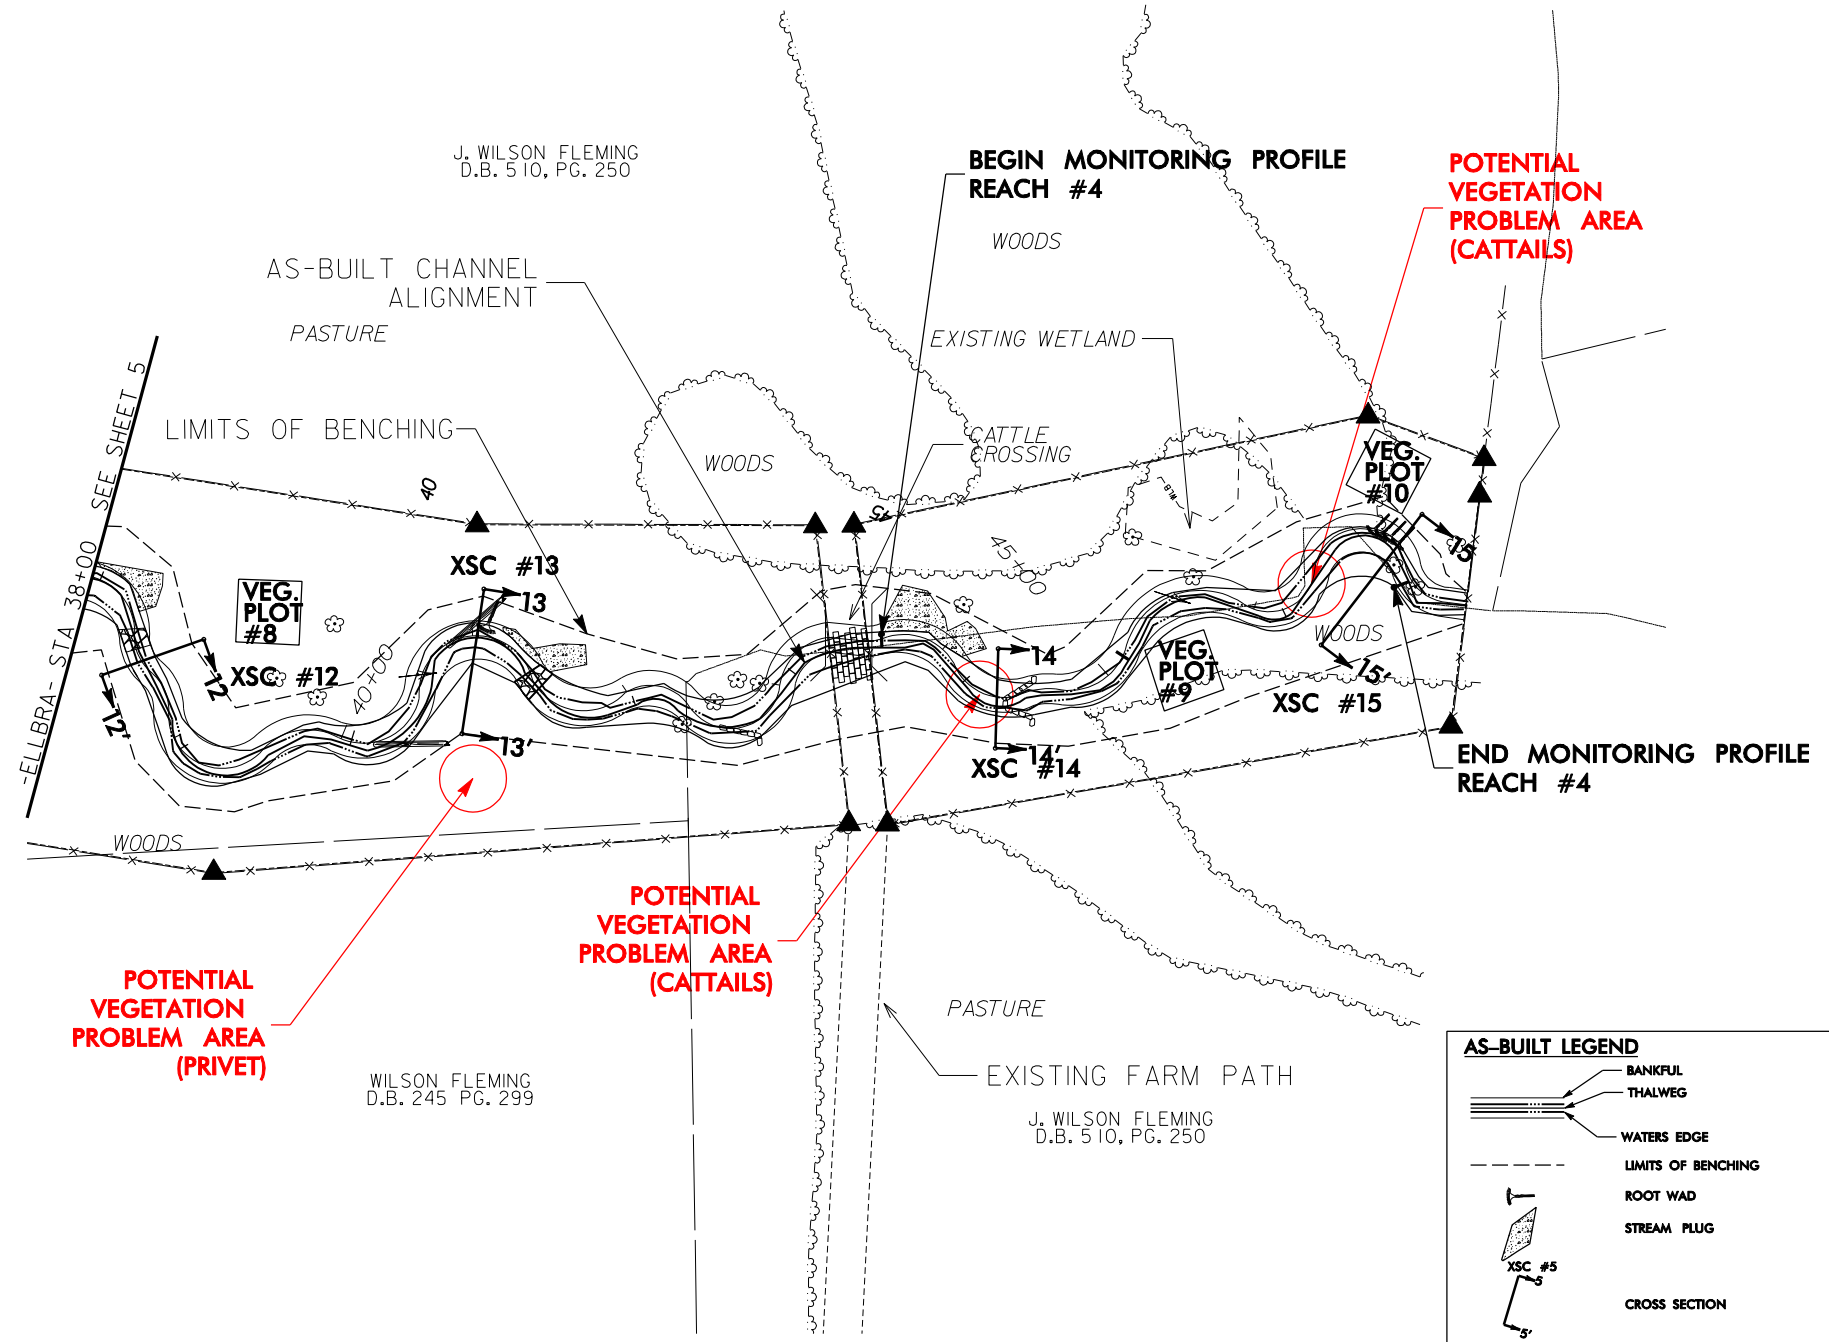
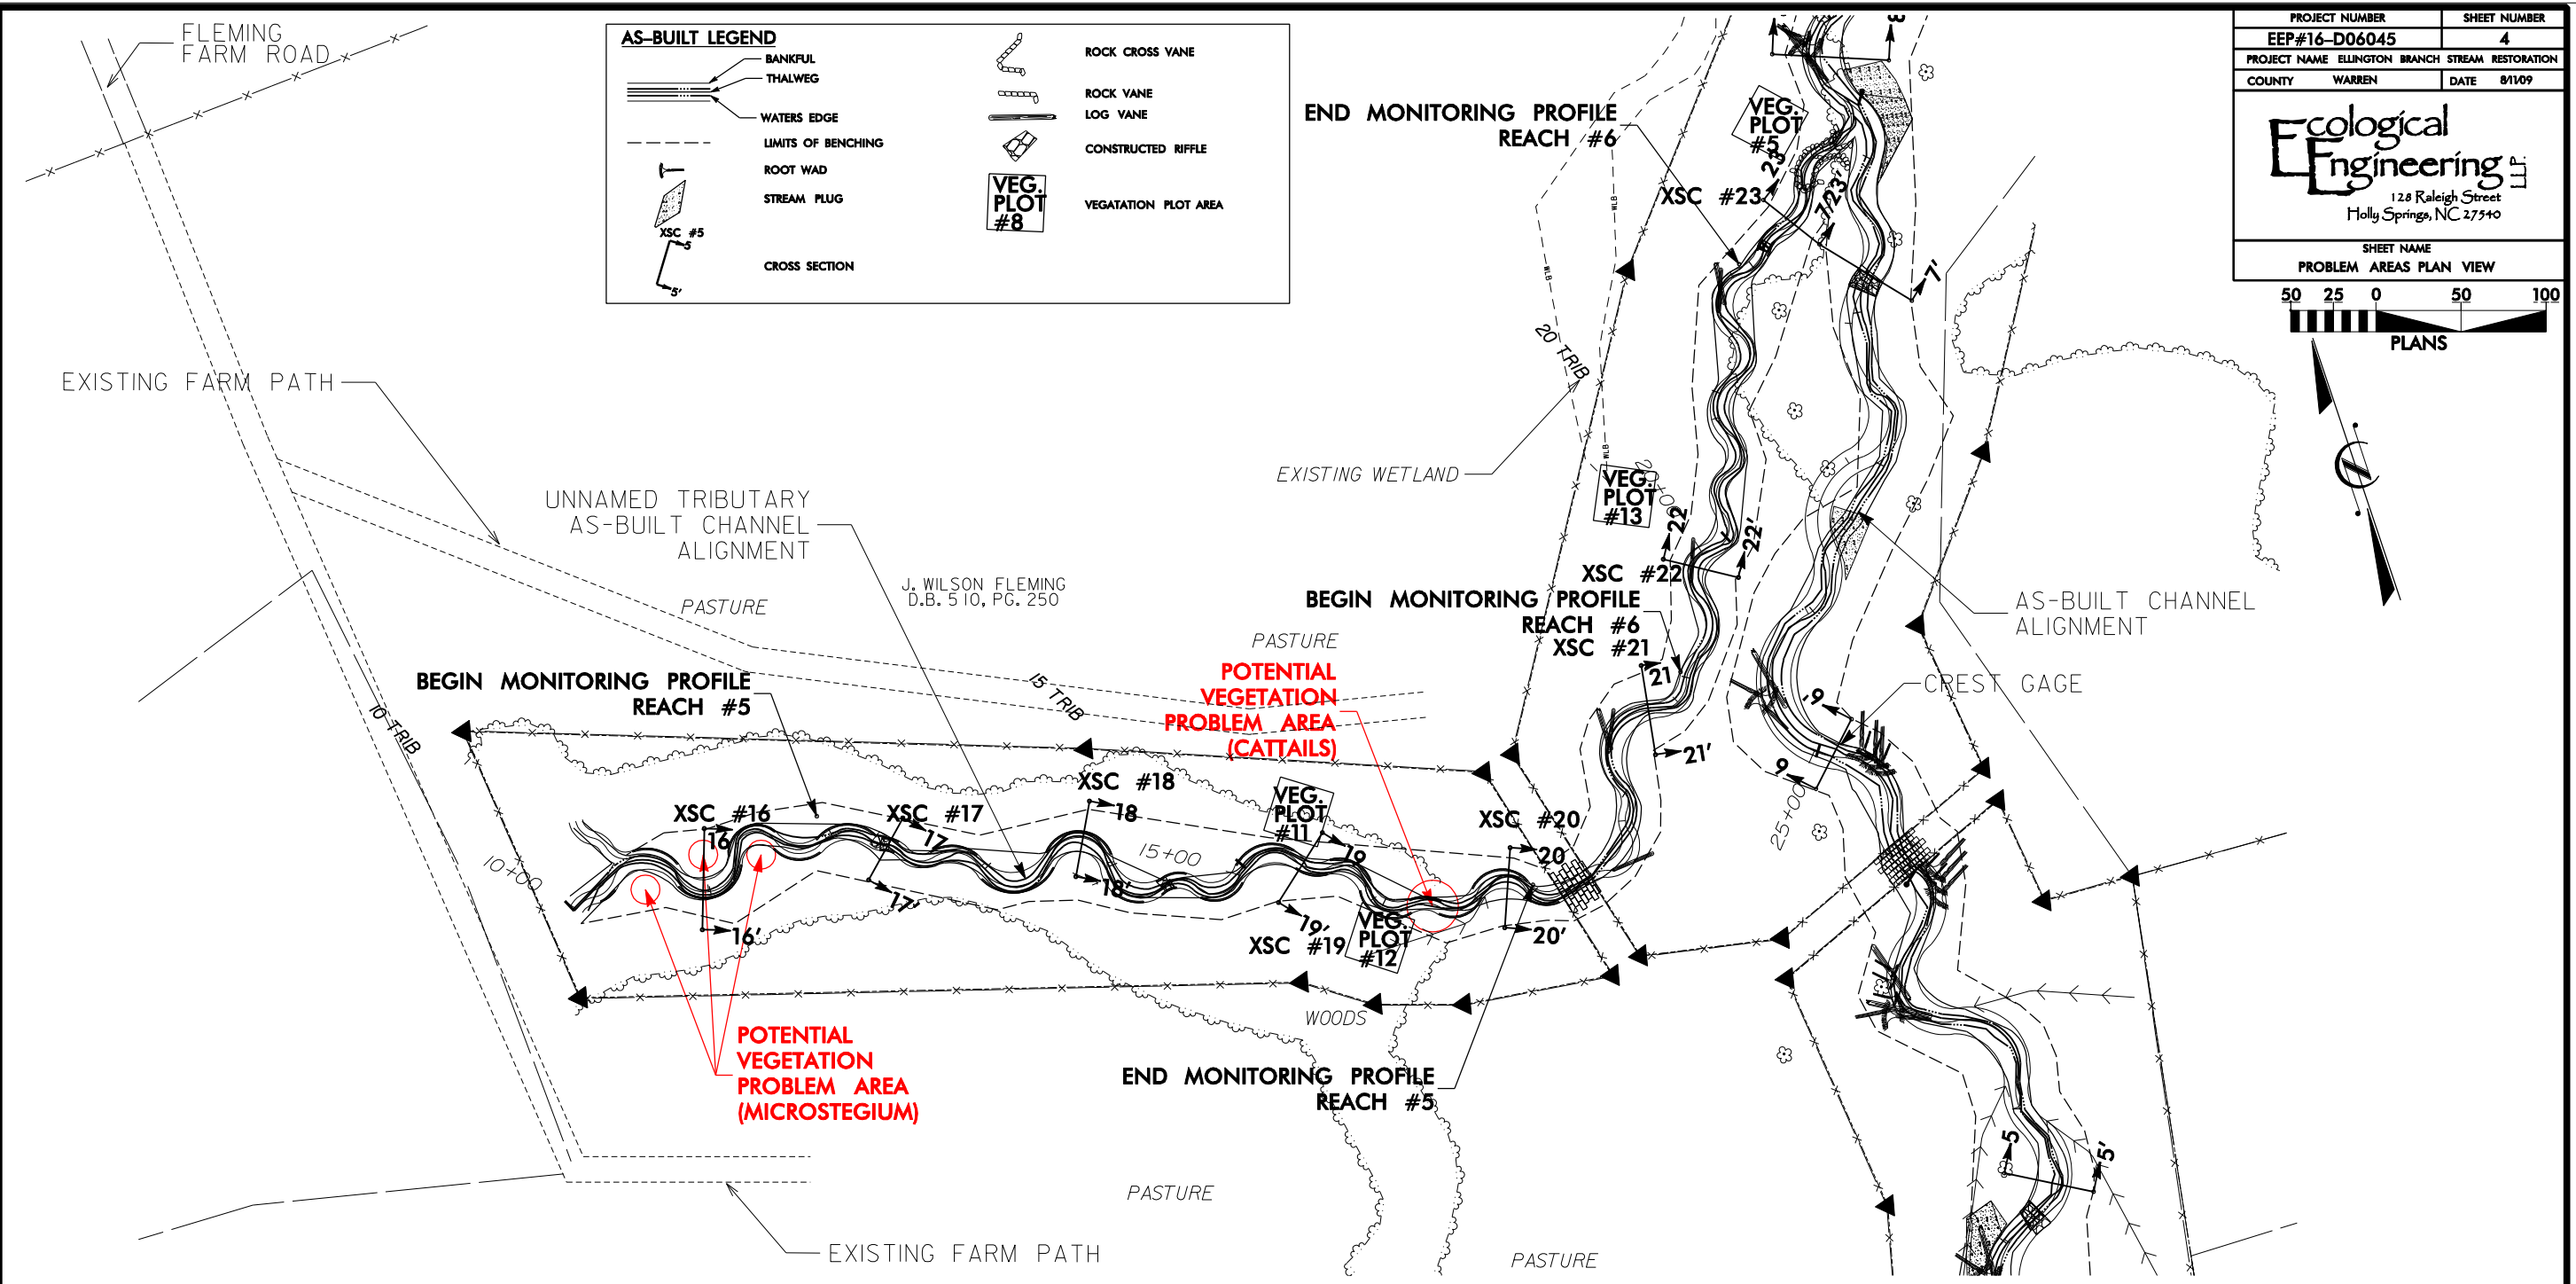
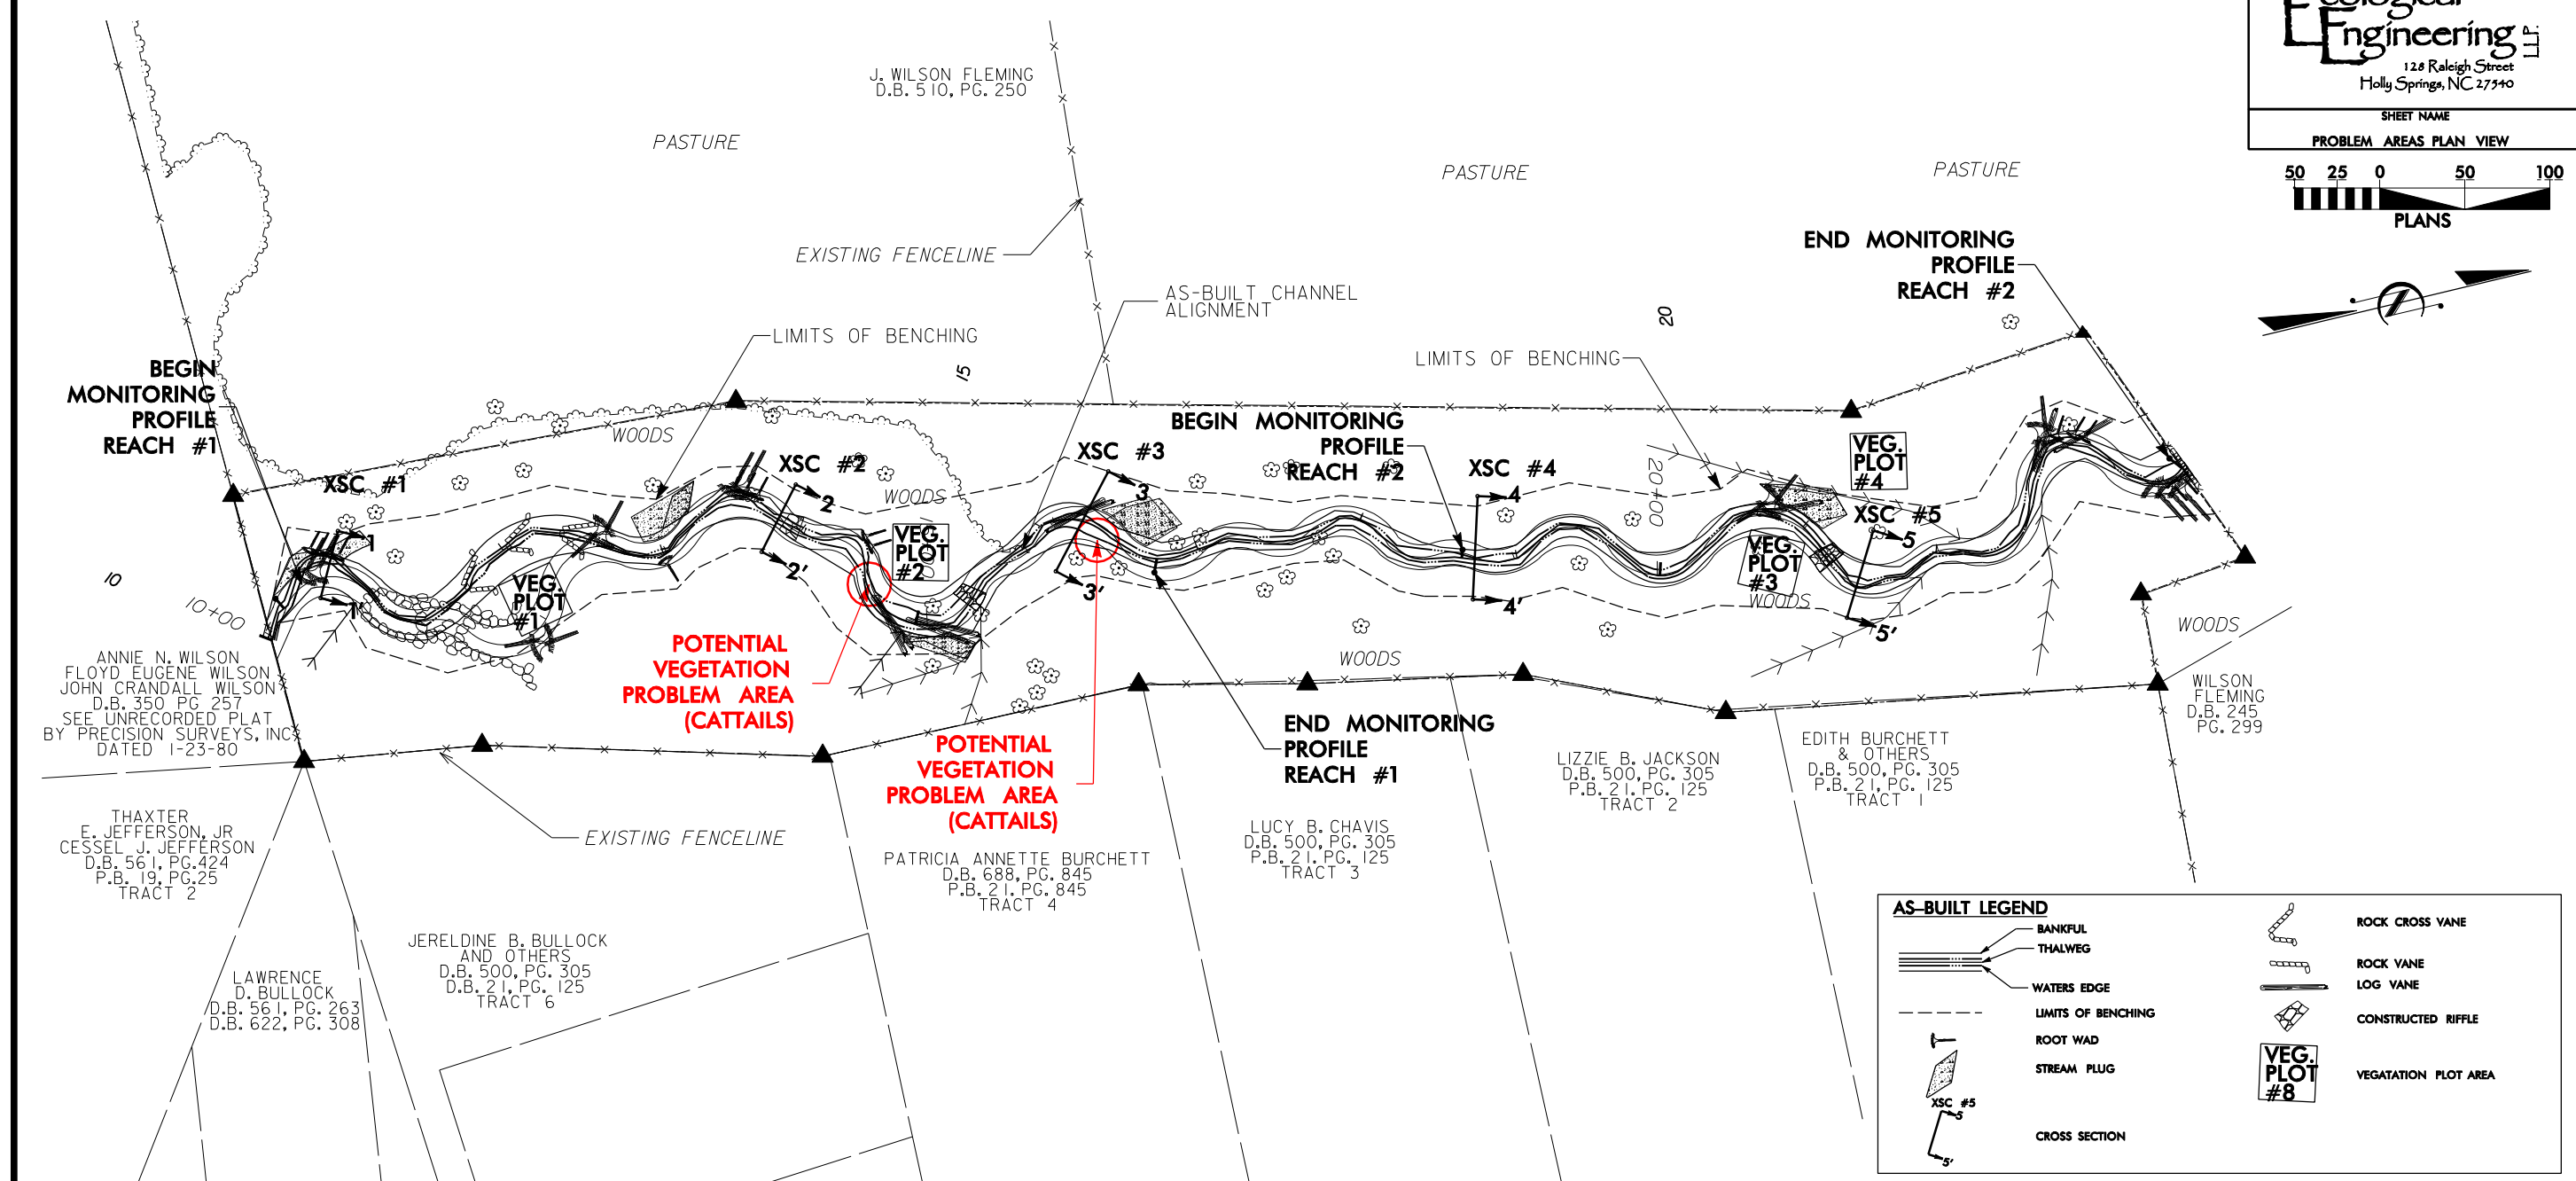
SHEET NAME
PROBLEM AREAS PLAN VIEW

Cattails were observed in seven separate locales within the Project Site, specifically Station Numbers 14+50, 16+25, 36+50, 43+25, 44+25 and 46+50 along Ellington Branch. It was also observed at Station Number 16+00 along the UT. The occurrences were all scattered and individual counts were minimal. It is apparent that the establishment of cattails is a result of wind and/or bird dispersal. No other cattails were observed on the property. Low water levels and limited floodflows have allowed this species to become established. These areas will continue to be closely monitored throughout the 2009 growing season. Spot treatments with an aquatic herbicide will be performed during 2010, as necessary.

Chinese privet was observed in limited numbers throughout the project area. A notable increase in individuals was noted between the 2008 and 2009 growing seasons. The majority of the individuals were spot treated during late April 2009. This treatment including lopping each stem and painting it with a concentrated systemic herbicide. Ecological Engineering will continue to monitor this species and will continue to perform spot treatments with herbicide as necessary.

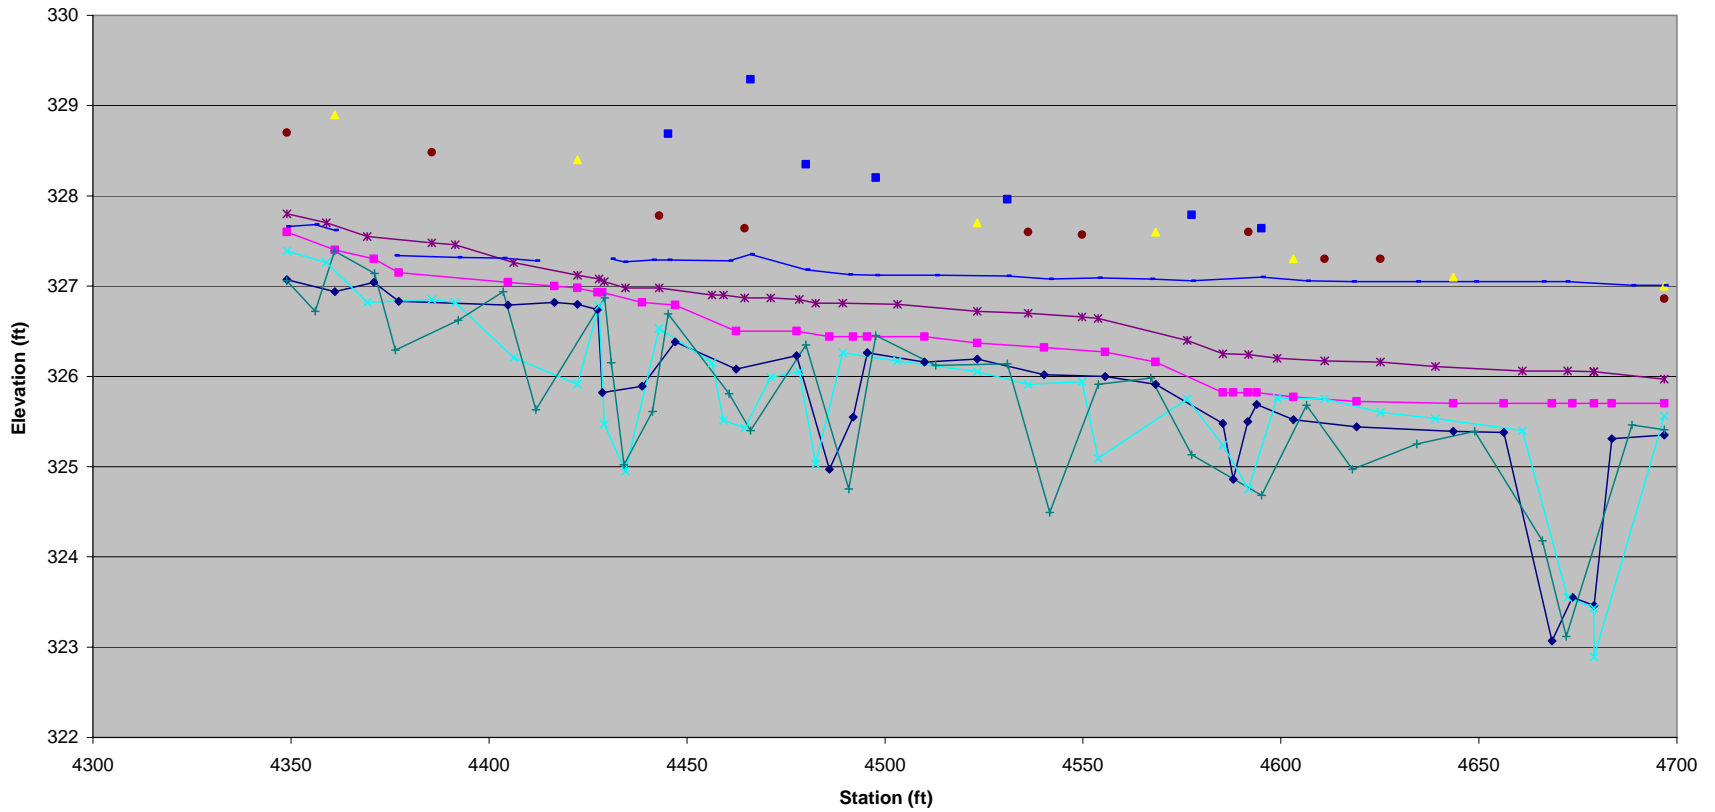
**Profile Reach 4
(EB Sta. 43+49 to 46+96.8)**

Evidence of beaver (*Castor canadensis*) was observed during June and July along the extreme lower portion of Ellington Branch. This evidence included a small dam in the vicinity of Station 47+20. Ecological Engineering and Sungate coordinated with Mr. Anthony Steed, US Department of Agriculture Wildlife Services, to remove the beavers from the project area. Mr. Steed was able to successfully remove the beavers in their entirety in early August. A letter denoting his efforts is provided within Appendix D. No visual damage, other than the ponding of water was noted as a result of the dam. The location was immediately downstream of Reach Profile #4.
