**ELLINGTON BRANCH STREAM RESTORATION SITE
FULL DELIVERY PROJECT
WARREN COUNTY, NORTH CAROLINA**

EEP Project No. 16-D06045

FINAL Monitoring Report #3 (Year 2010)

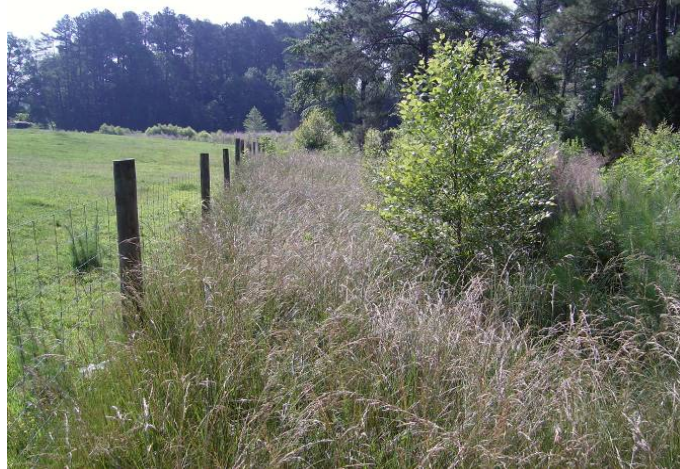
Fescue was initially observed during the winter months of 2009 and early spring months of 2010 along several fence lines separating the Project Site from the adjacent pasture areas. Its establishment is the likely result of wind and down-slope dispersal from the adjacent pastures. Ecological Engineering conducted spot-treatments with herbicide during March 2010. Although the treatments were successful at the time, site investigations using July revealed that fescue was still present in those areas. Spot treatments will again be conducted during the dormancy season to reduce the spread of fescue. It is anticipated that the overall growth and establishment of fescue will be diminished once there is ample shade within the easement area.

Photo #47. Facing east
(downstream) along the
northern edge of the
Unnamed Tributary at
fescue from the adjacent
pasture.

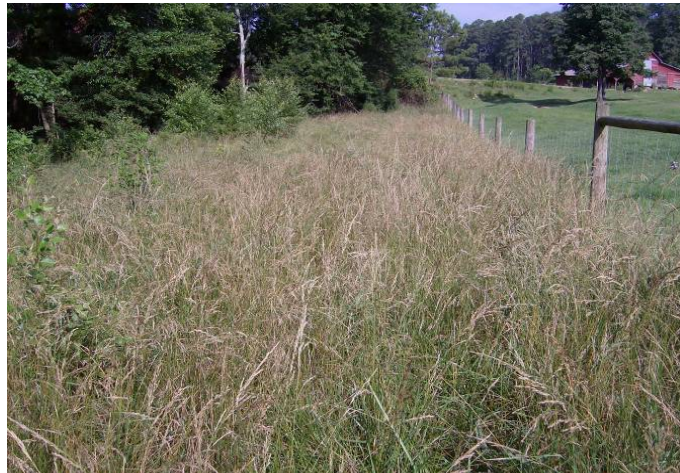
Photo #48. Facing west
(upstream) along the
Unnamed Tributary at
fescue from the adjacent
pasture.

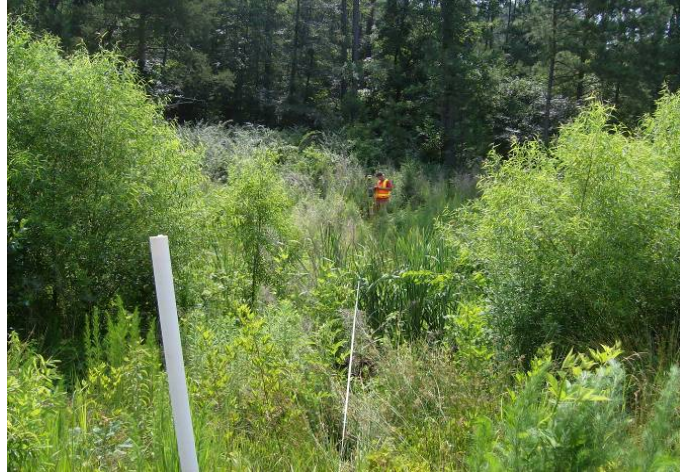
Cattails were observed in eight separate locales within the Project Site, specifically Station Numbers 16+25, 30+00, 31+75, 36+50, 44+25 and 46+25 along Ellington Branch and Station Numbers 16+00 and 20+00 along the UT. The occurrences were all scattered and individual counts were minimal. It is apparent that the establishment of cattails is a result of wind and/or bird dispersal. No other cattails were observed on the property. Low water levels and limited floodflows during 2008 and 2009 have allowed this species to become established. These areas will continue to be closely monitored throughout the 2010 growing season. Spot treatments with an aquatic herbicide will be performed during late 2010, as necessary.

Chinese privet was observed in limited numbers throughout the project area. A notable increase in individuals was noted between the 2008 and 2009 growing seasons. The majority of the individuals were spot treated during late April 2009. This treatment including lopping each stem and painting it with a concentrated systemic herbicide. Ecological Engineering will continue to monitor this species and will continue to perform spot treatments with herbicide as necessary.

Photo #50. Facing east
across Cross Section 11 at
cattails within the
streambed and privet
adjacent (north)
of the instrument.

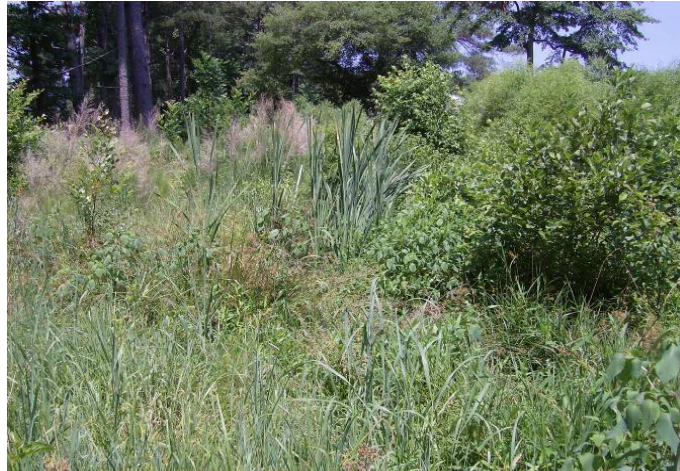
Photo #51. Facing west
(upstream) along the
Unnamed Tributary at
cattails adjacent to
Vegetation Plot #12 along
the Unnamed Tributary.

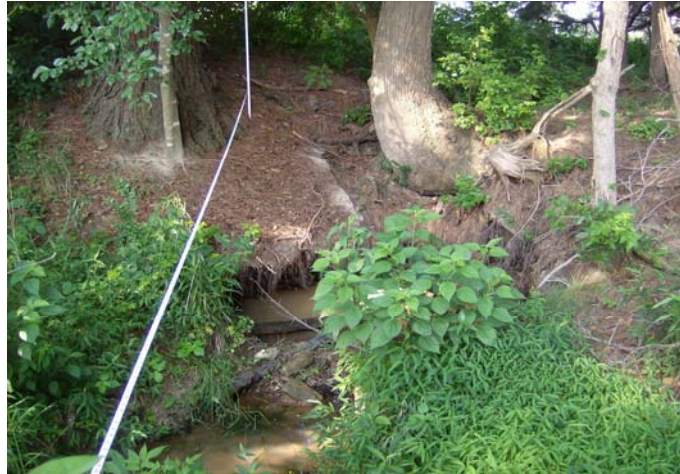
Photo #53. Facing south
across Cross Section #16
along the Unnamed
Tributary at the springhead
and enlarged scour area.

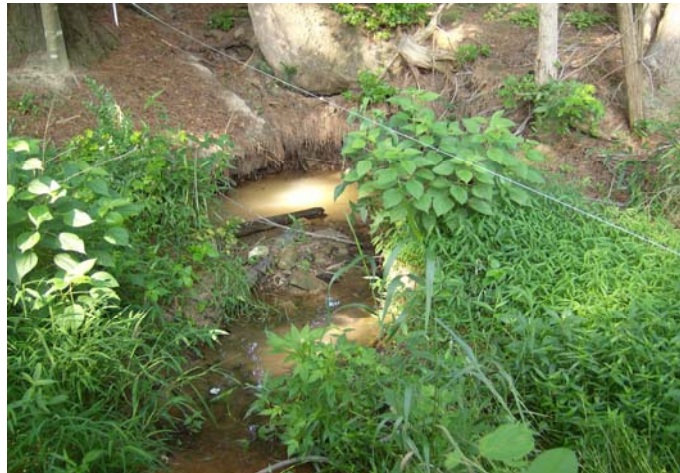
Photo #54. Facing southwest
at Cross Section #16 and the
subsequent springhead and
enlarged scour area.

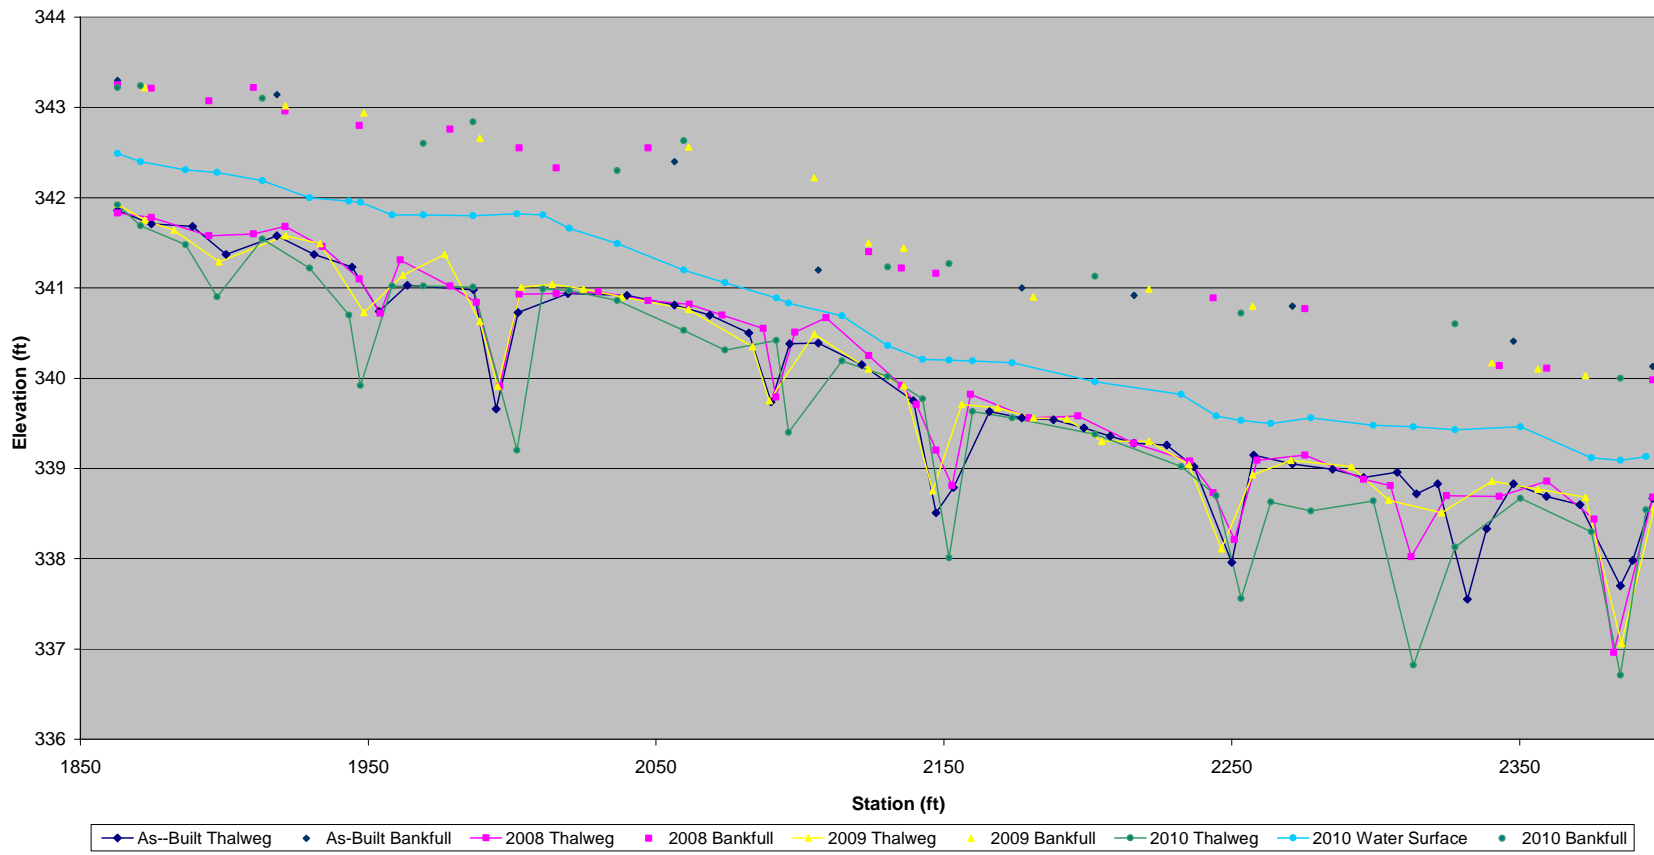
Profile Reach 2
(EB Sta. 18+62.9 to 23+96.3)

In addition, differences in the longitudinal profiles were also noted along the monitored reaches. The most obvious was an approximately six-inch drop in elevation along Profile Reach 2 between Stations 22+50 and 23+60. The down cutting likely occurred during the bankfull events recorded between the Year 2 and Year 3 surveys and resulted from the removal of excess vegetation within active channel. The area has been under drought conditions since project implementation in 2008. Herbaceous and aquatic vegetation had become established throughout the active channel. Rain events during the winter of 2009 and spring of 2010 have been responsible for “flushing” some of this vegetation from within the active channel. It is likely under normal conditions that vegetation is restricted primarily to the adjacent banks and areas of slow moving water. The channel was stable along Reach 2 and based on the visual assessment, in-stream vegetation was limited which confirms this assumption. Ecological Engineering will continue to monitor this profile to ensure that it does not become unstable.
