**ELLINGTON BRANCH STREAM RESTORATION SITE  
FULL DELIVERY PROJECT  
WARREN COUNTY, NORTH CAROLINA**

**EEP Project No. 16-D06045**

**Final Monitoring Report #4 (Year 2011)**

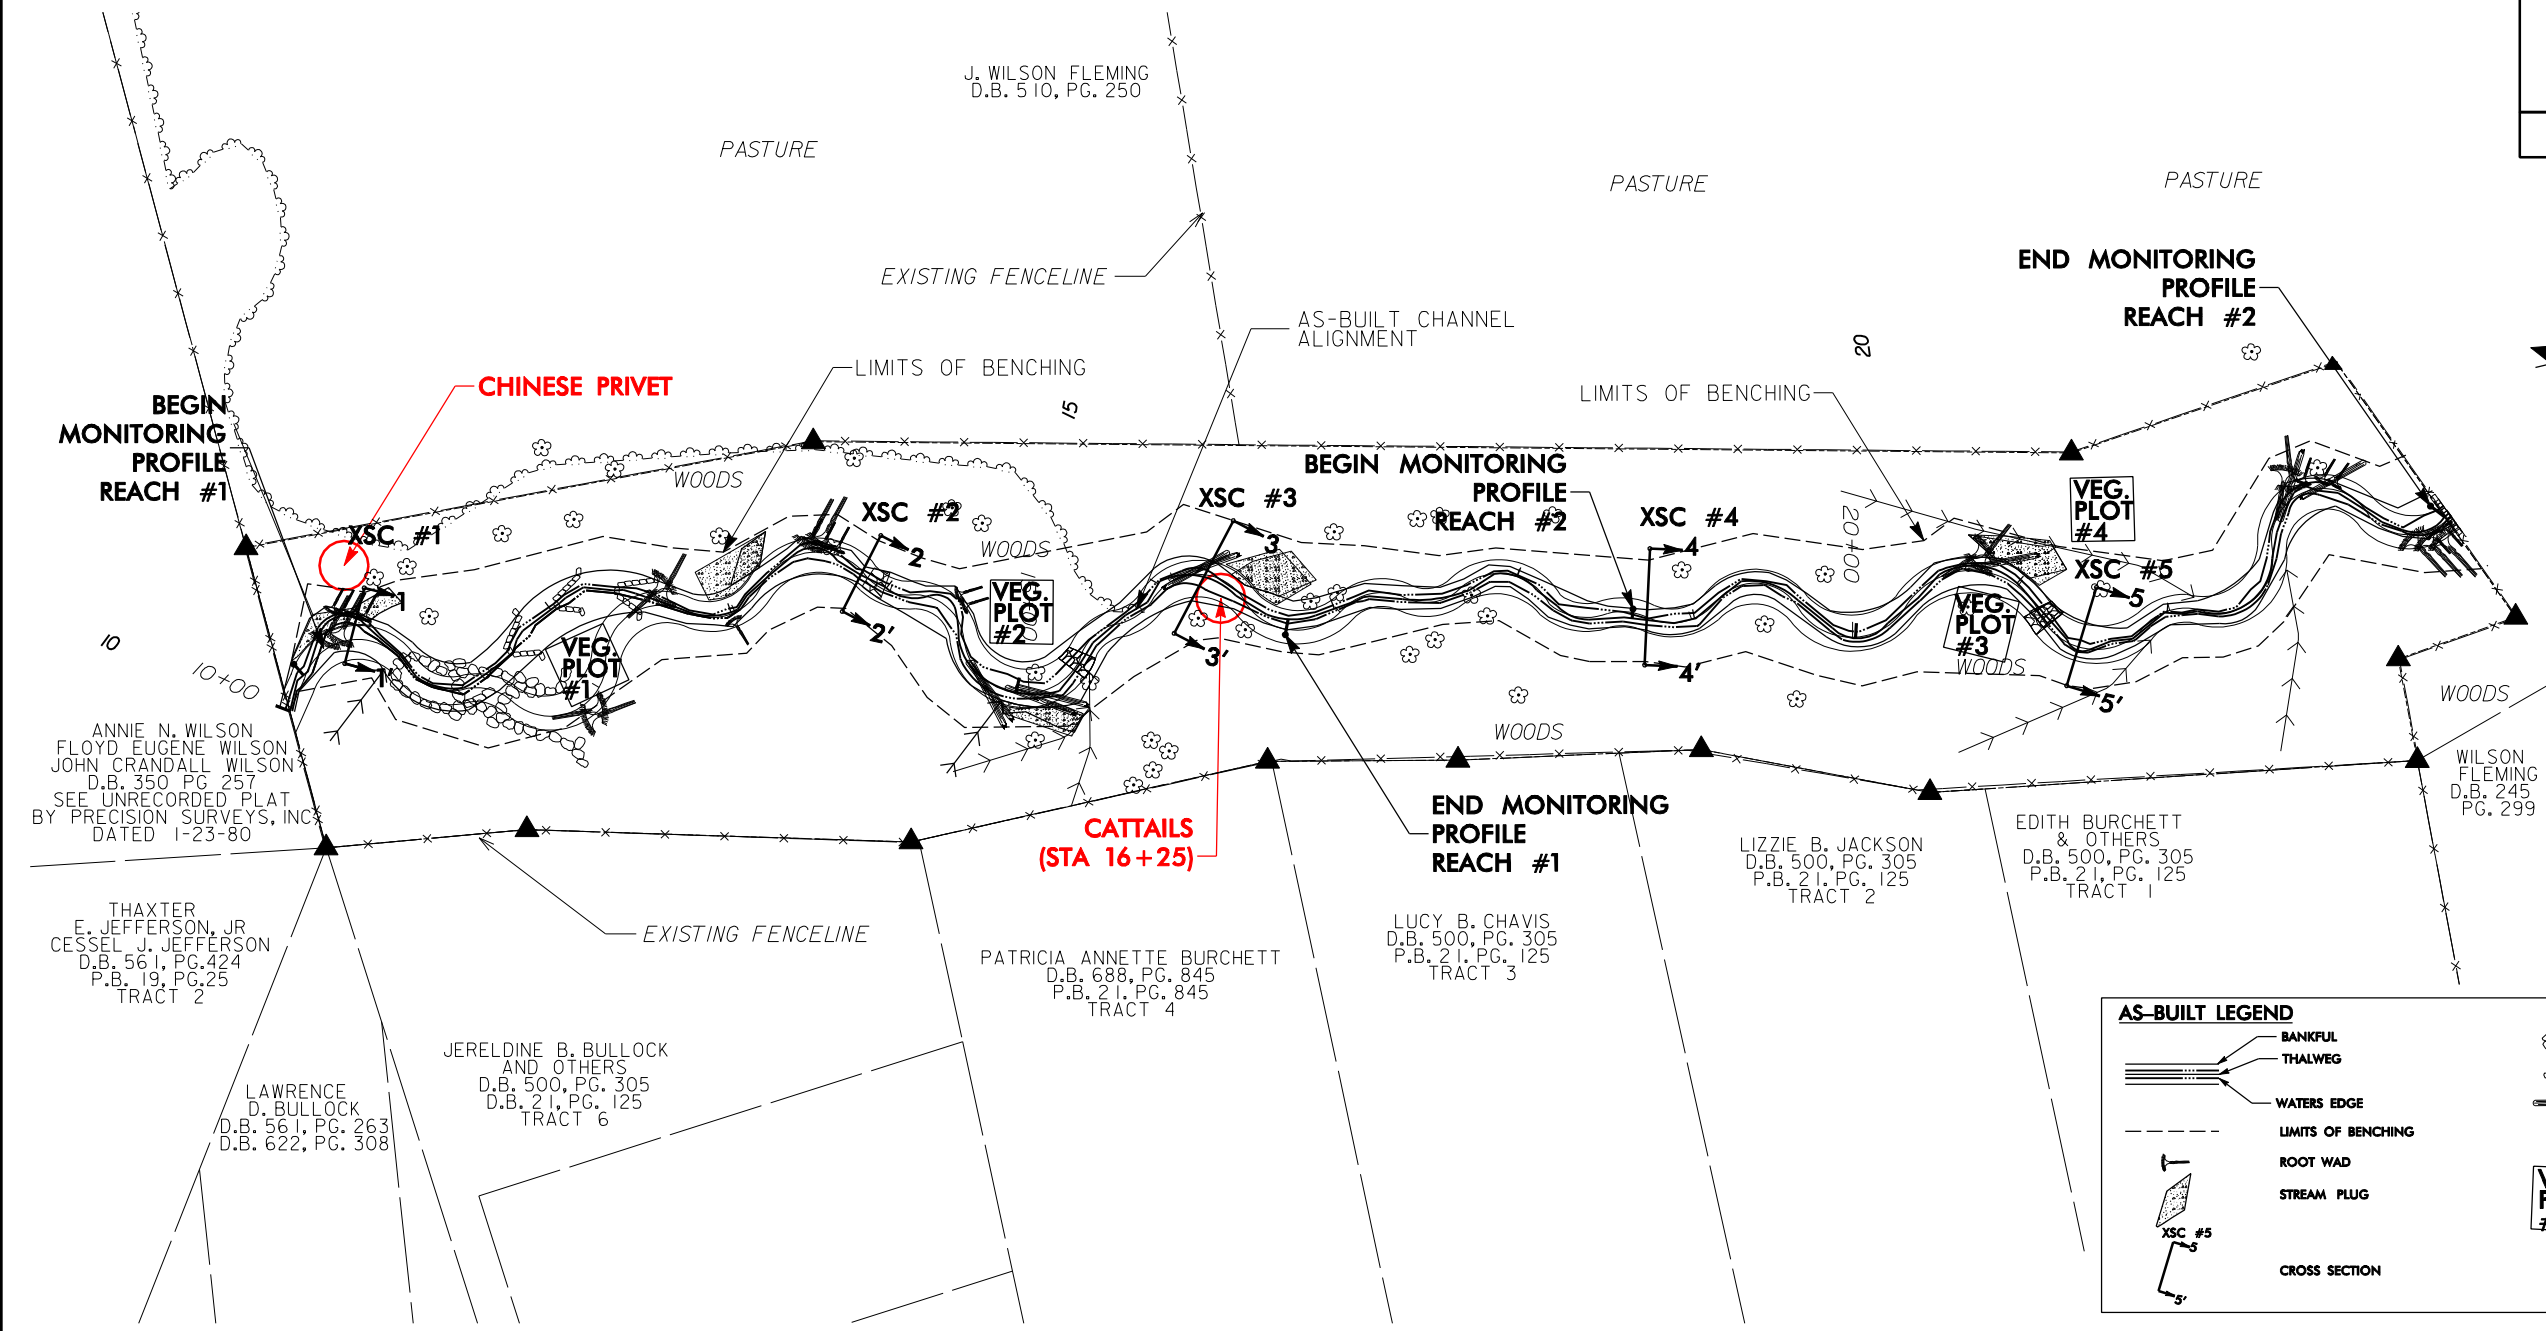
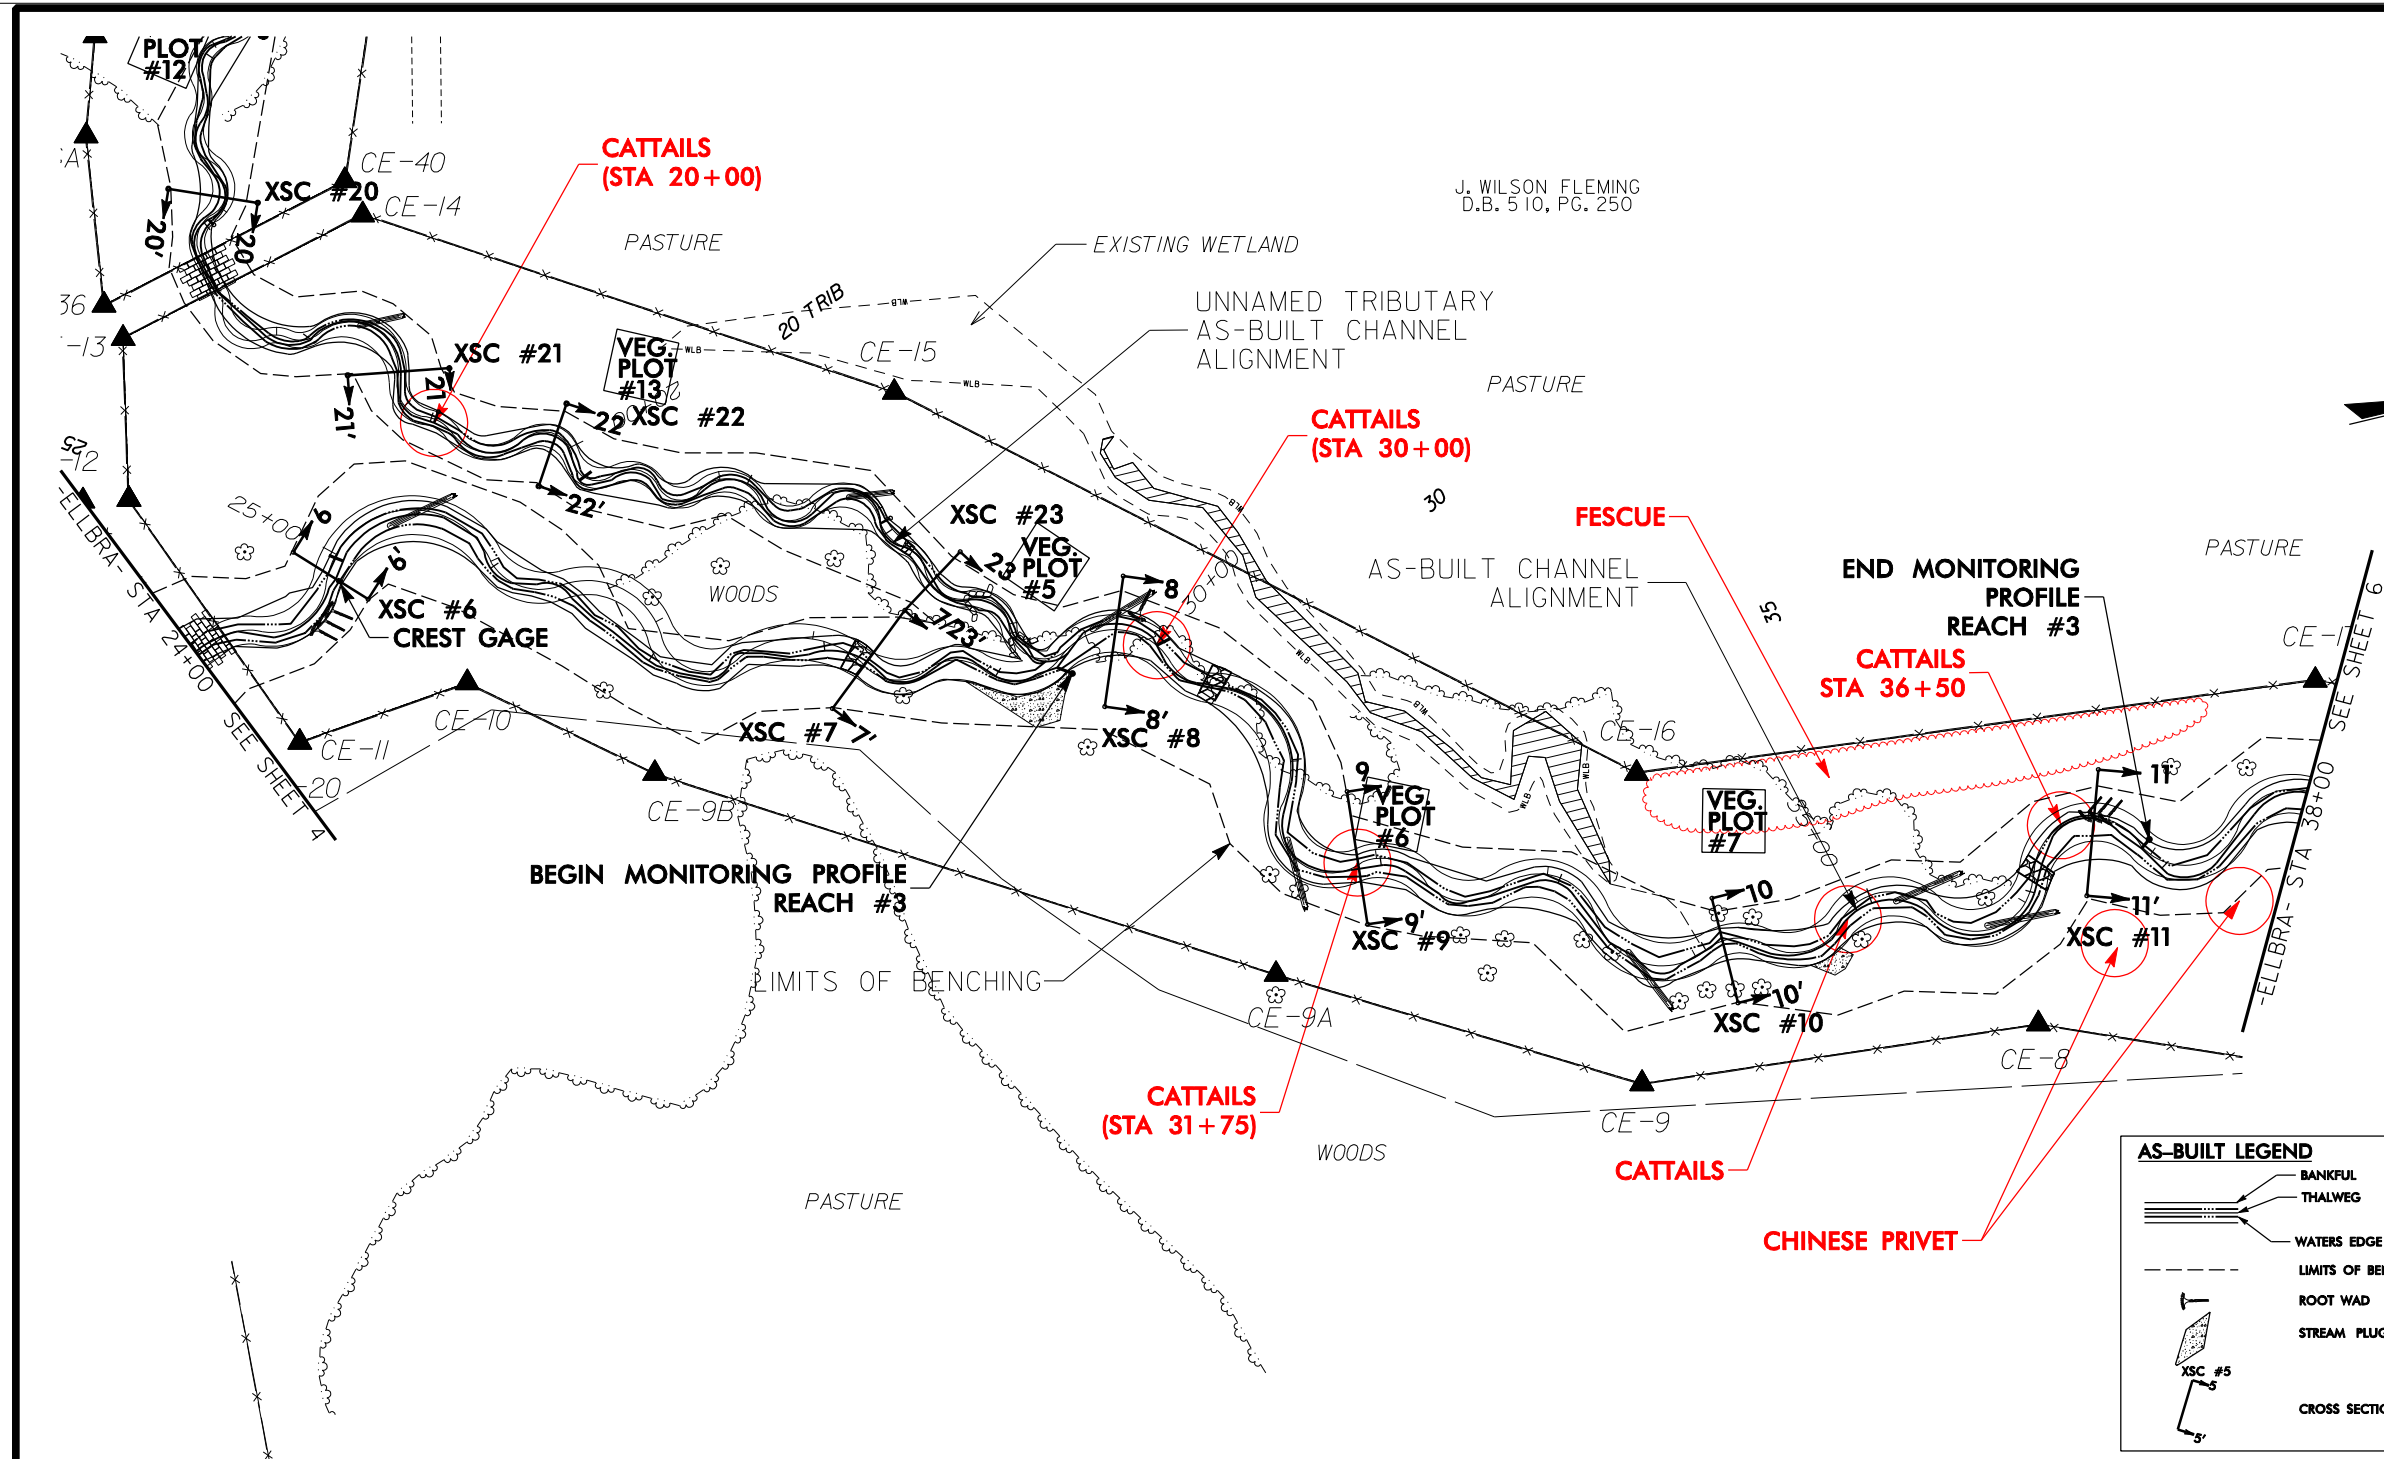
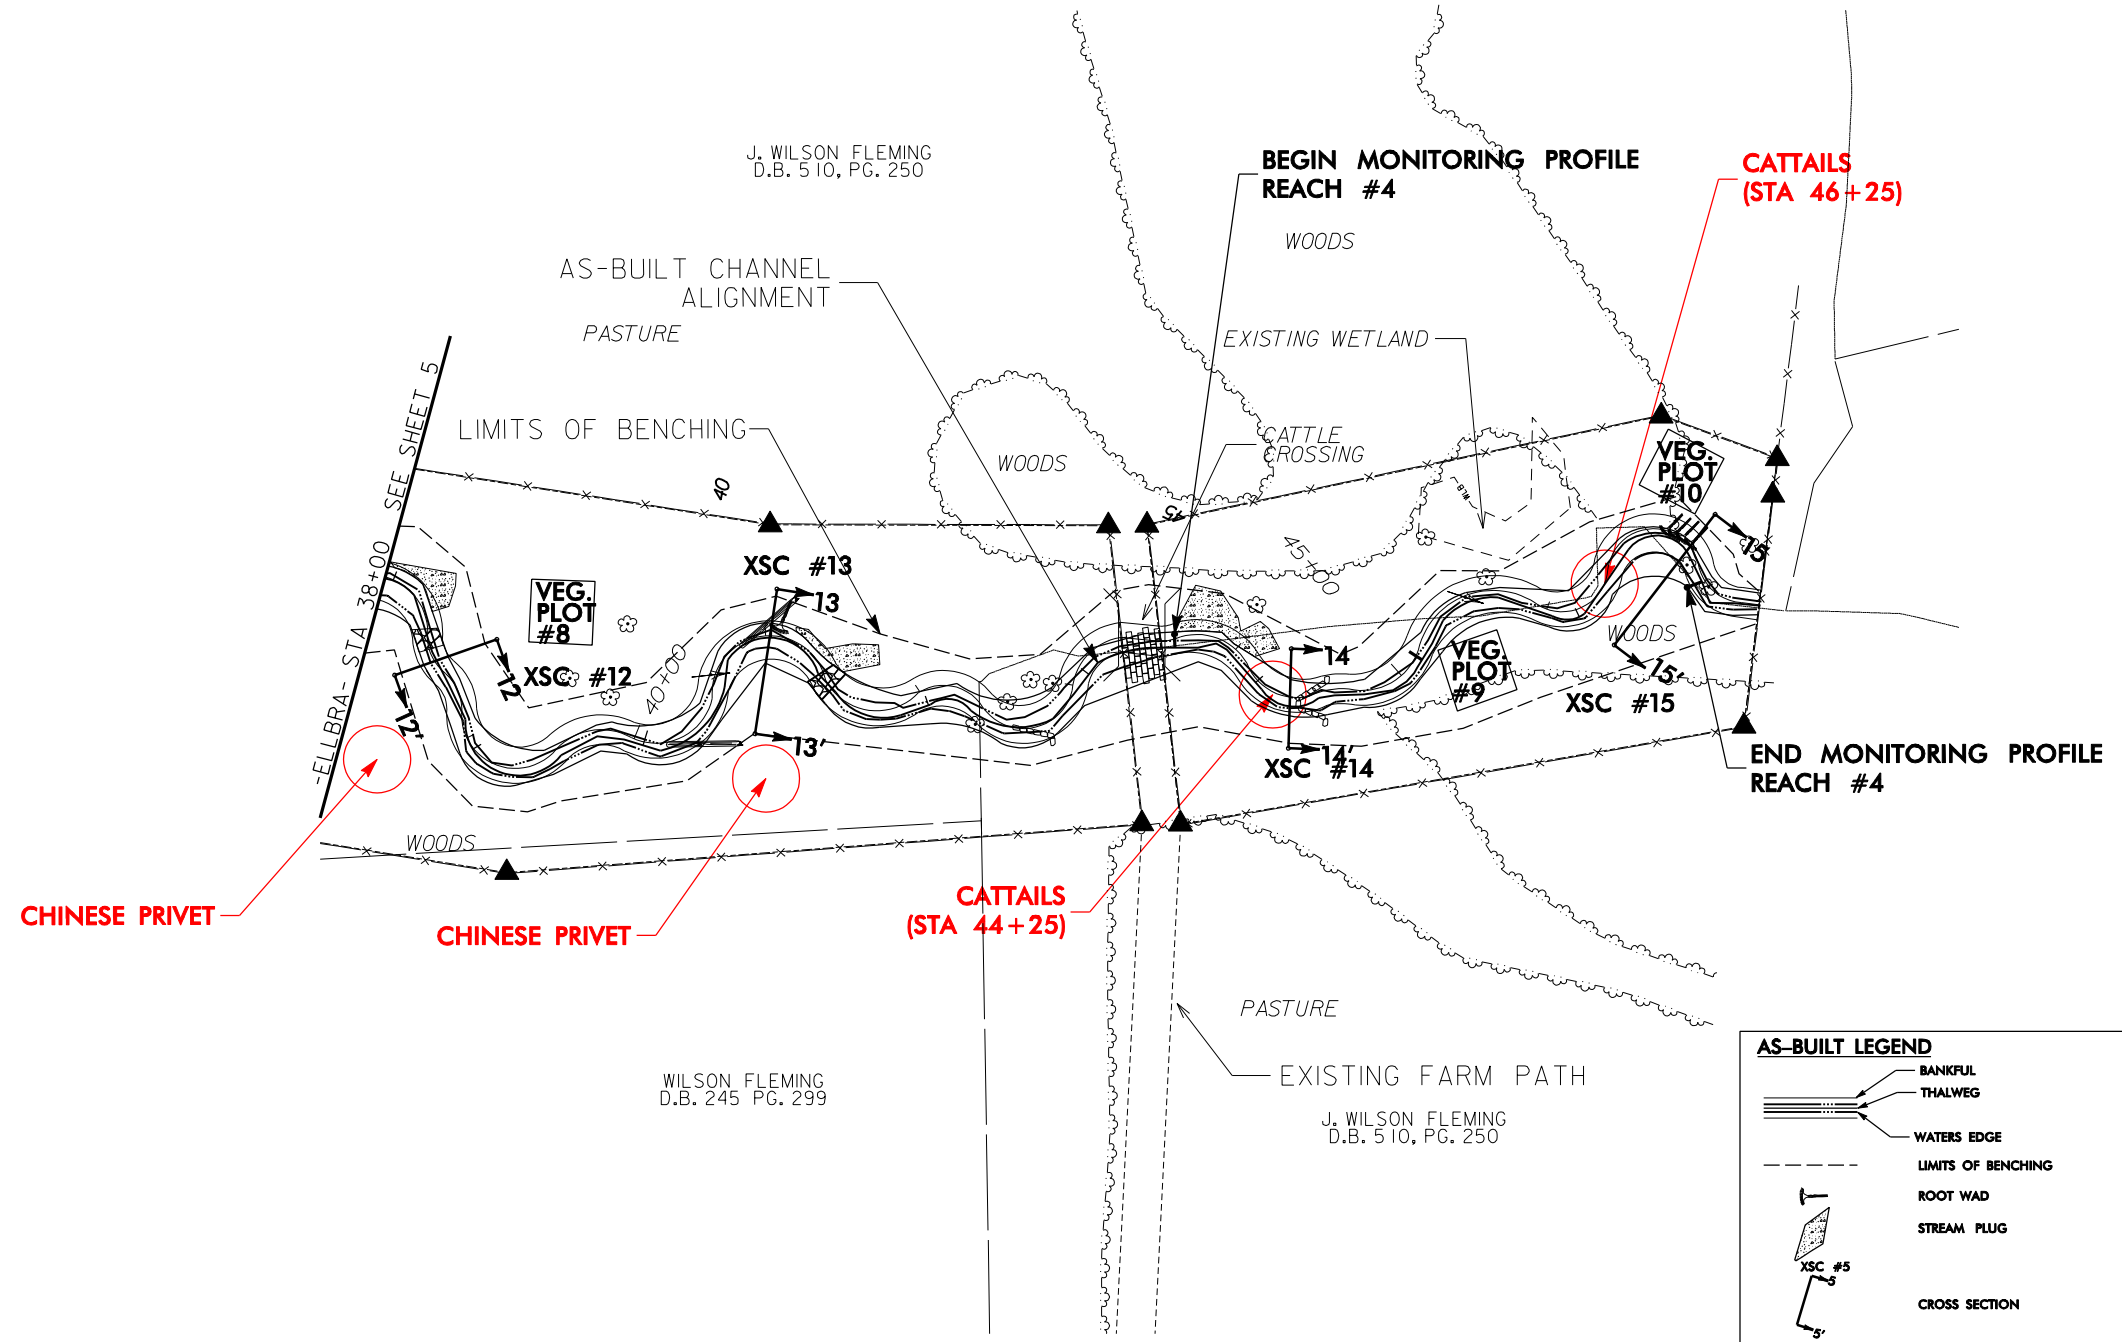
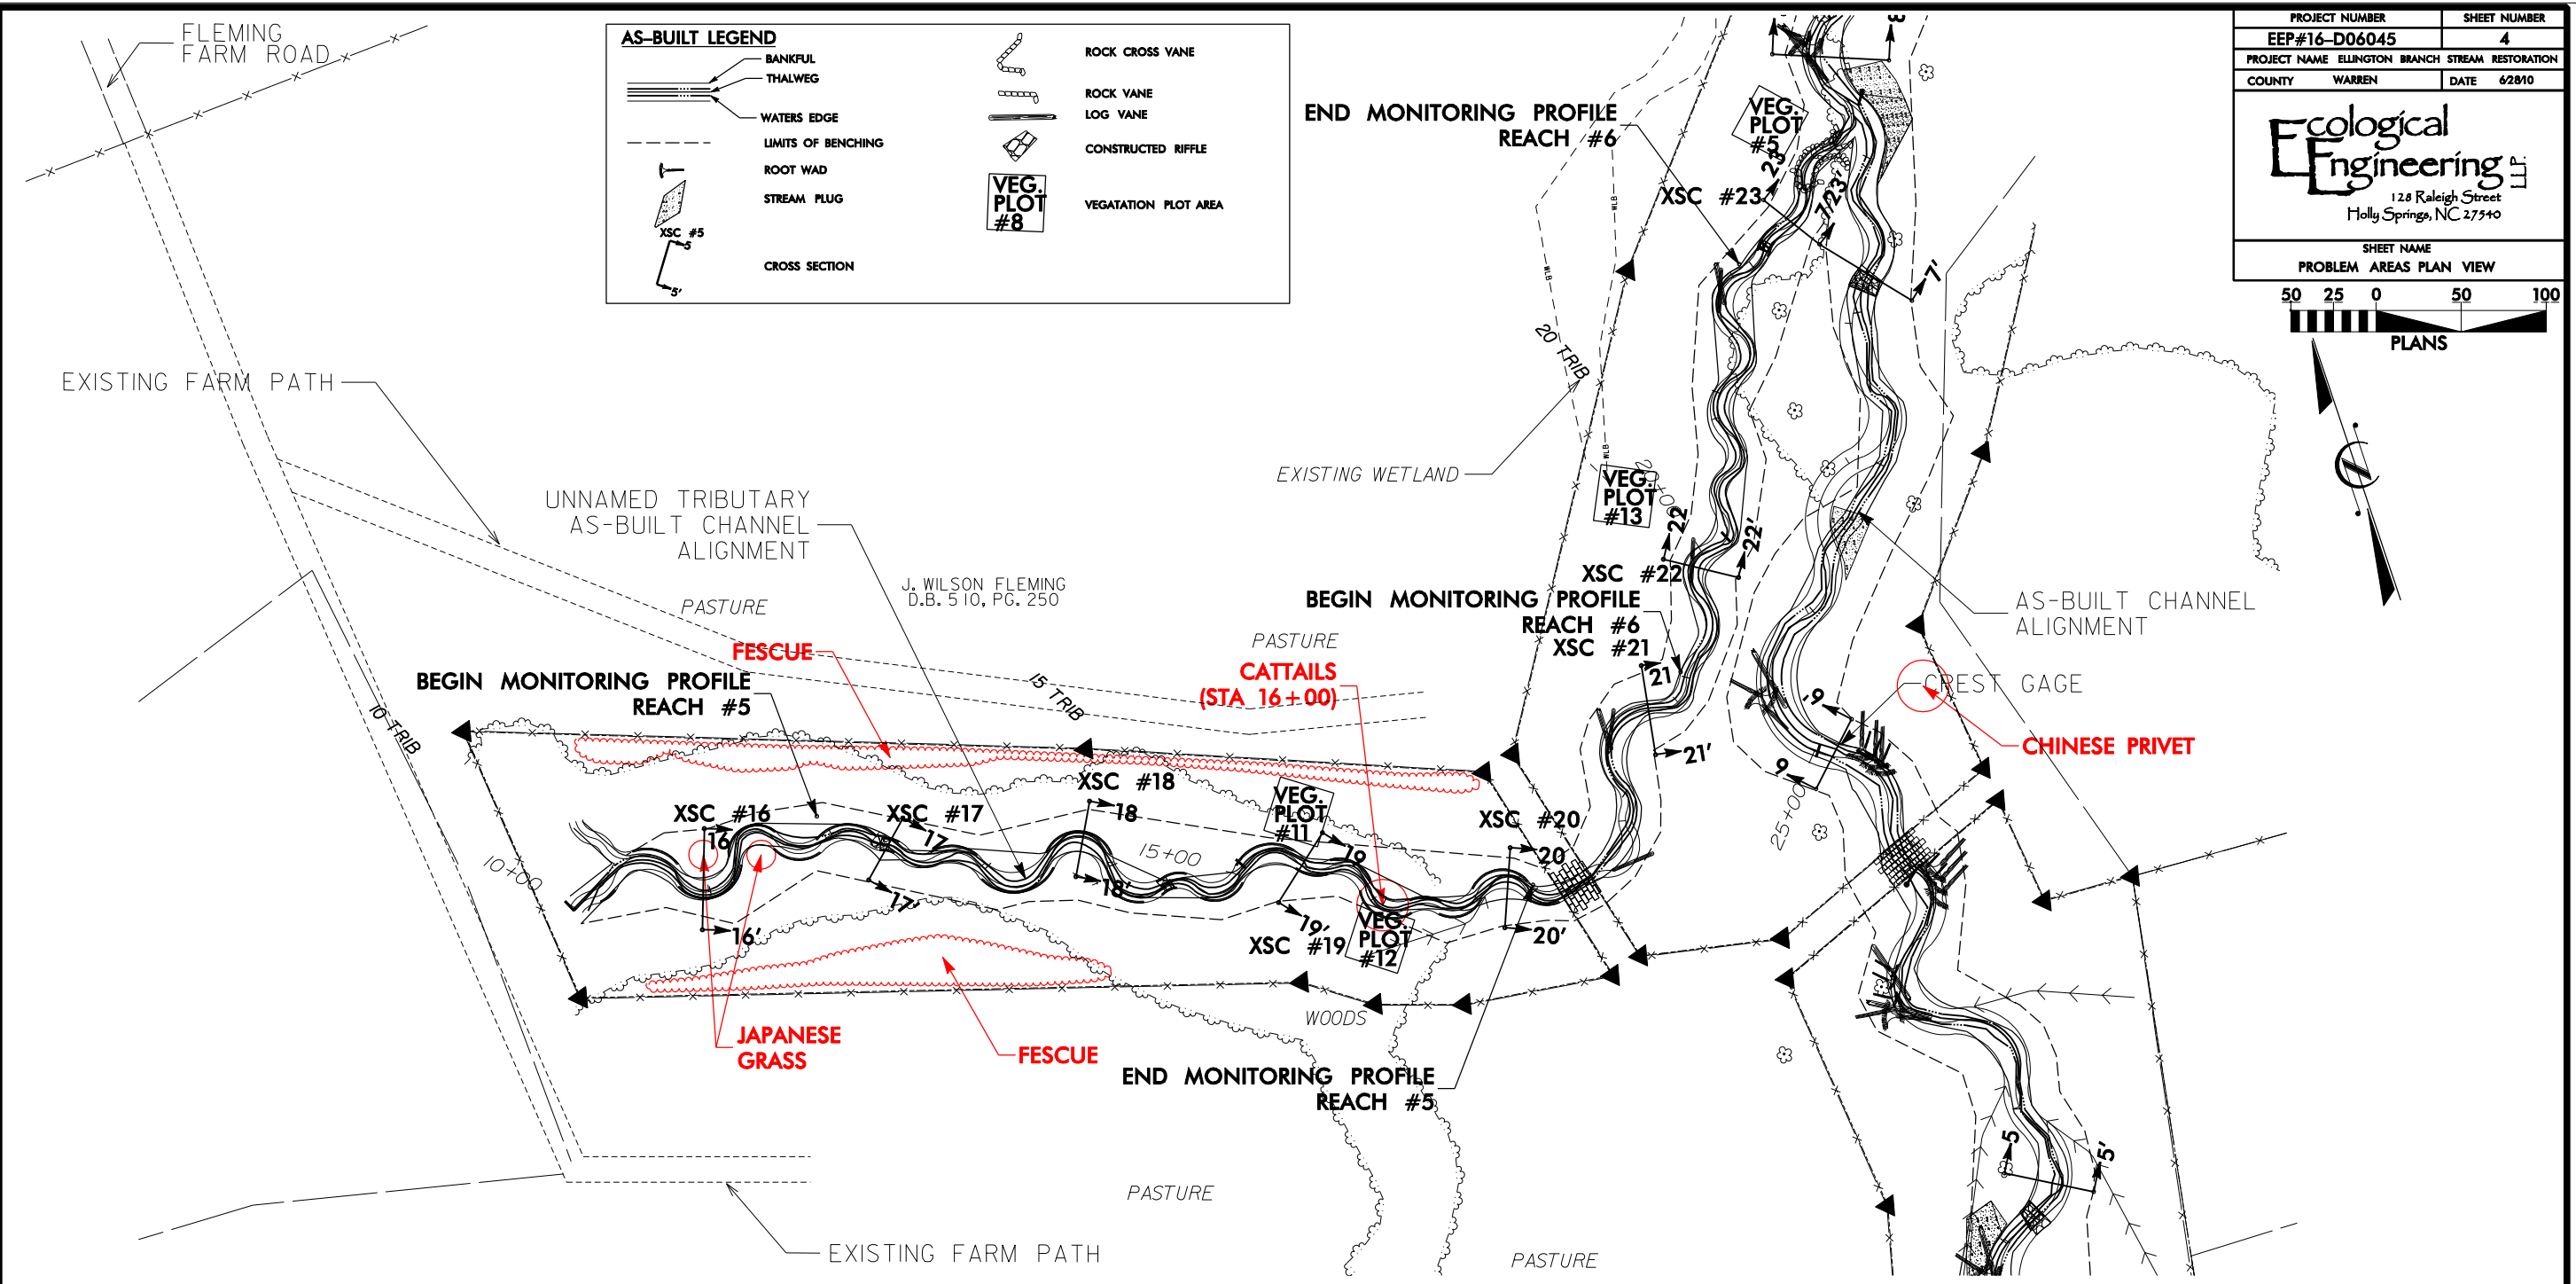
### 3. Vegetative Problem Areas Plan View

Fescue was initially observed during the winter months of 2009 and early spring months of 2010 along several fence lines separating the Project Site from the adjacent pasture areas. Its establishment is the likely result of wind and down-slope dispersal from the adjacent pastures. Ecological Engineering conducted spot-treatments with herbicide during March 2010. Although the treatments were successful at the time, recent site investigations denote that fescue is still present in those areas. It is anticipated that the overall growth and establishment of fescue will be diminished once there is ample shade within the easement area.

Japanese grass or Nepalese browntop is present along the upstream portion of the UT, specifically in the vicinity of Cross Section #16 (Station Number 11+00). It has become established within the area either as a result from wind dispersal, bird dispersal or via soil disturbance. Additional shading is minimizing the spread of this species. This area has not increased in size and will continue to be monitored throughout the remainder of the monitoring period.

Cattails continue to exist in eight separate locales within the Project Site, specifically Station Numbers 16+25, 30+00, 31+75, 36+50, 44+25 and 46+25 along Ellington Branch and Station Numbers 16+00 and 20+00 along the UT. The occurrences were all scattered and individual counts were minimal. It is apparent that the establishment of cattails is a result of wind and/or bird dispersal. No other cattails were observed. Low water levels and limited floodflows during 2008, 2009 and 2011 have allowed this species to become established. These areas will continue to be closely monitored throughout the 2012 growing season.

Chinese privet was observed in limited numbers throughout the project area. A notable increase in individuals was noted between the 2008 and 2009 growing seasons. The majority of the stems were spot treated during late April 2009. This treatment including lopping each stem and painting it with a concentrated systemic herbicide. This species was observed again in 2011. It will continue to be spot treated until closeout.
