**ELLINGTON BRANCH STREAM RESTORATION SITE
FULL DELIVERY PROJECT
WARREN COUNTY, NORTH CAROLINA**

EEP Project No. 16-D06045

Final Monitoring Report MY5 (Year 2012)

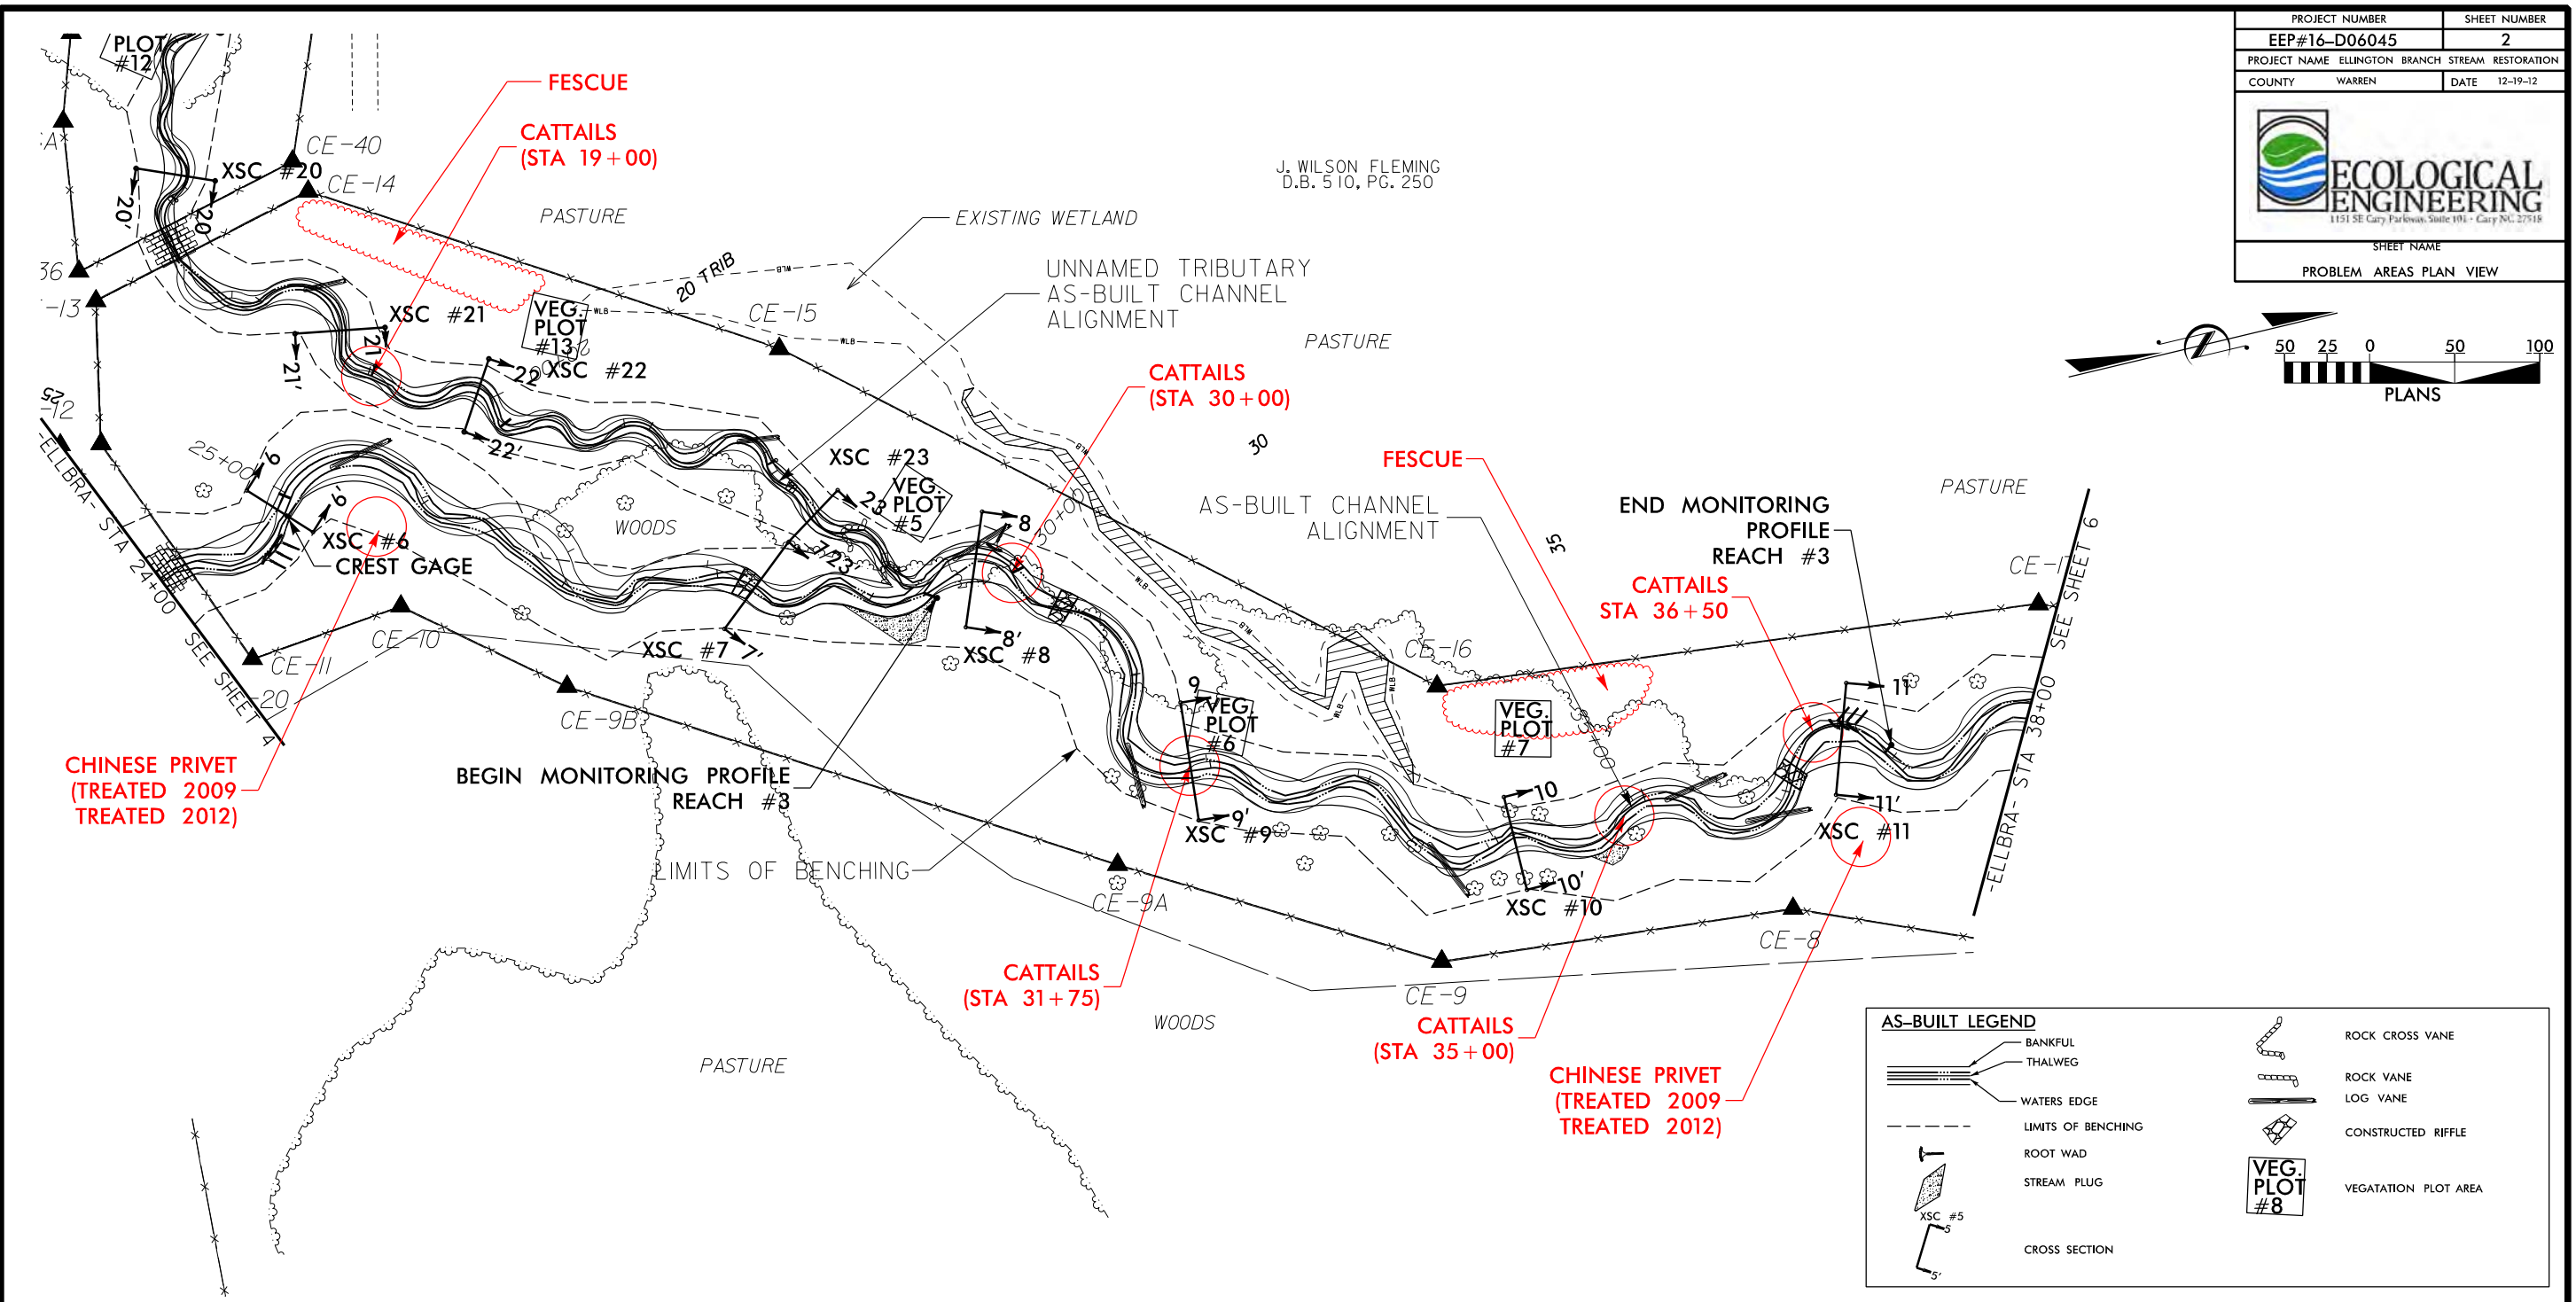
Chinese privet was observed in limited numbers throughout the project area. A notable increase in individuals was noted between the 2008 and 2009 growing seasons. The majority of the stems were spot treated during late April 2009. This treatment including lopping each stem and painting it with a concentrated systemic herbicide. This species was observed again in 2012. It will be spot treated prior to closeout.

CHINESE PRIVET
(TREATED 2009
TREATED 2012)

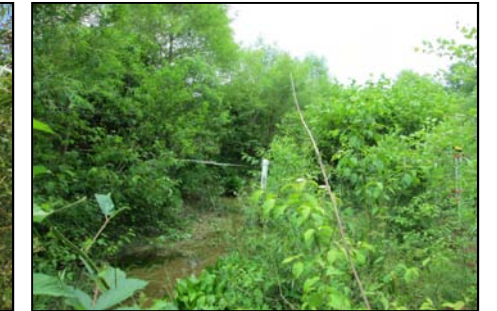
Photo #11
Facing north
(downstream) at
Cross Section #6
along Ellington
Branch

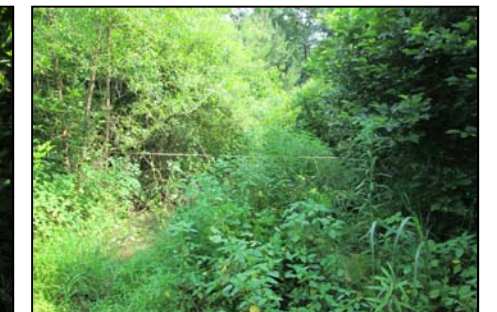
Photo #15
Facing north
(downstream) at
Cross Section #8
along Ellington
Branch

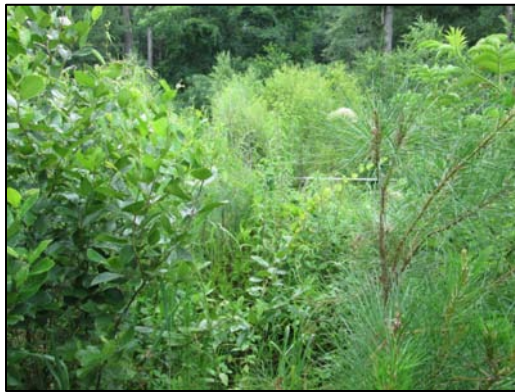
**XSC #12 - Ellington Branch Sta. 38+49.7
(riffle)**

Evidence of beaver (*Castor canadensis*) was observed from January through March 2012 along Ellington Branch immediately upstream of Cross Section 12. A dam was located in the vicinity of Station 38+30, which impounded water approximately 300 feet upstream. Ecological Engineering and Sungate began coordination efforts in January 2012 with Mr. Anthony Steed, US Department of Agriculture Wildlife Services, to remove the beavers from the project area. Mr. Steed completed the task in March 2012. Recent assessments of this area indicate that channel functions have been restored since the breach of the dam.

Facing east (downstream) at Cross Section #12 (2012)

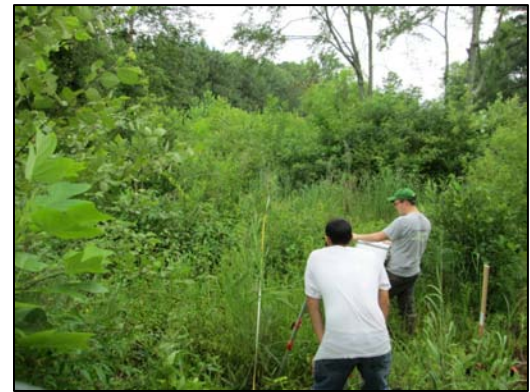
Facing west along Cross Section #12 (2012)
