**Farrar Dairy Stream and Wetland Restoration Site
Monitoring Report – MY01
Harnett County, NC**

December 2009

**Project Manager: Tim Morris
Email: tim.morris@kci.com
KCI Project No: 12065438**

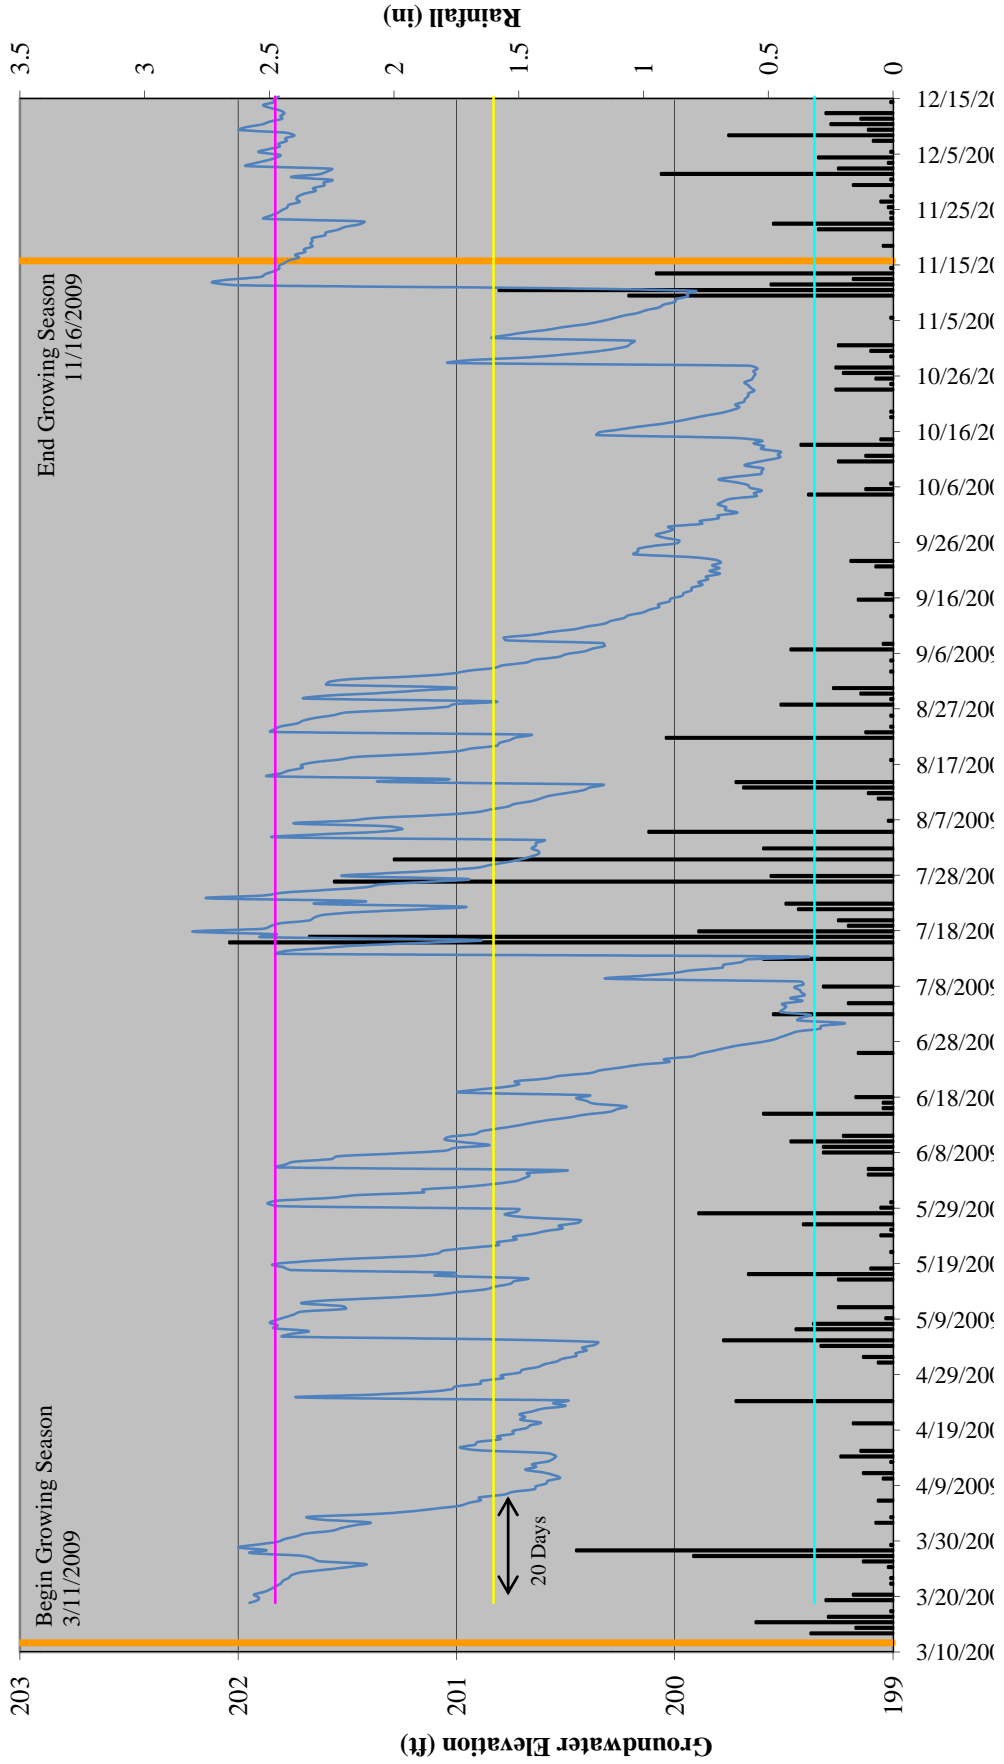
**Farrar Dairy Restoration Site
Hydrograph
Wetland Gauge 6**

Gauge 6 shows wetland hydrology for only 5%-8% of the growing season. It should be noted that both Gauges 6 and 7 were installed seven days into the growing season. If they had been installed prior to the beginning of the growing season it is likely that they would have demonstrated wetland hydrology for an additional seven days, which would mean that Gauge 6 would have wetland hydrology for 8%-12.5% of the growing season.

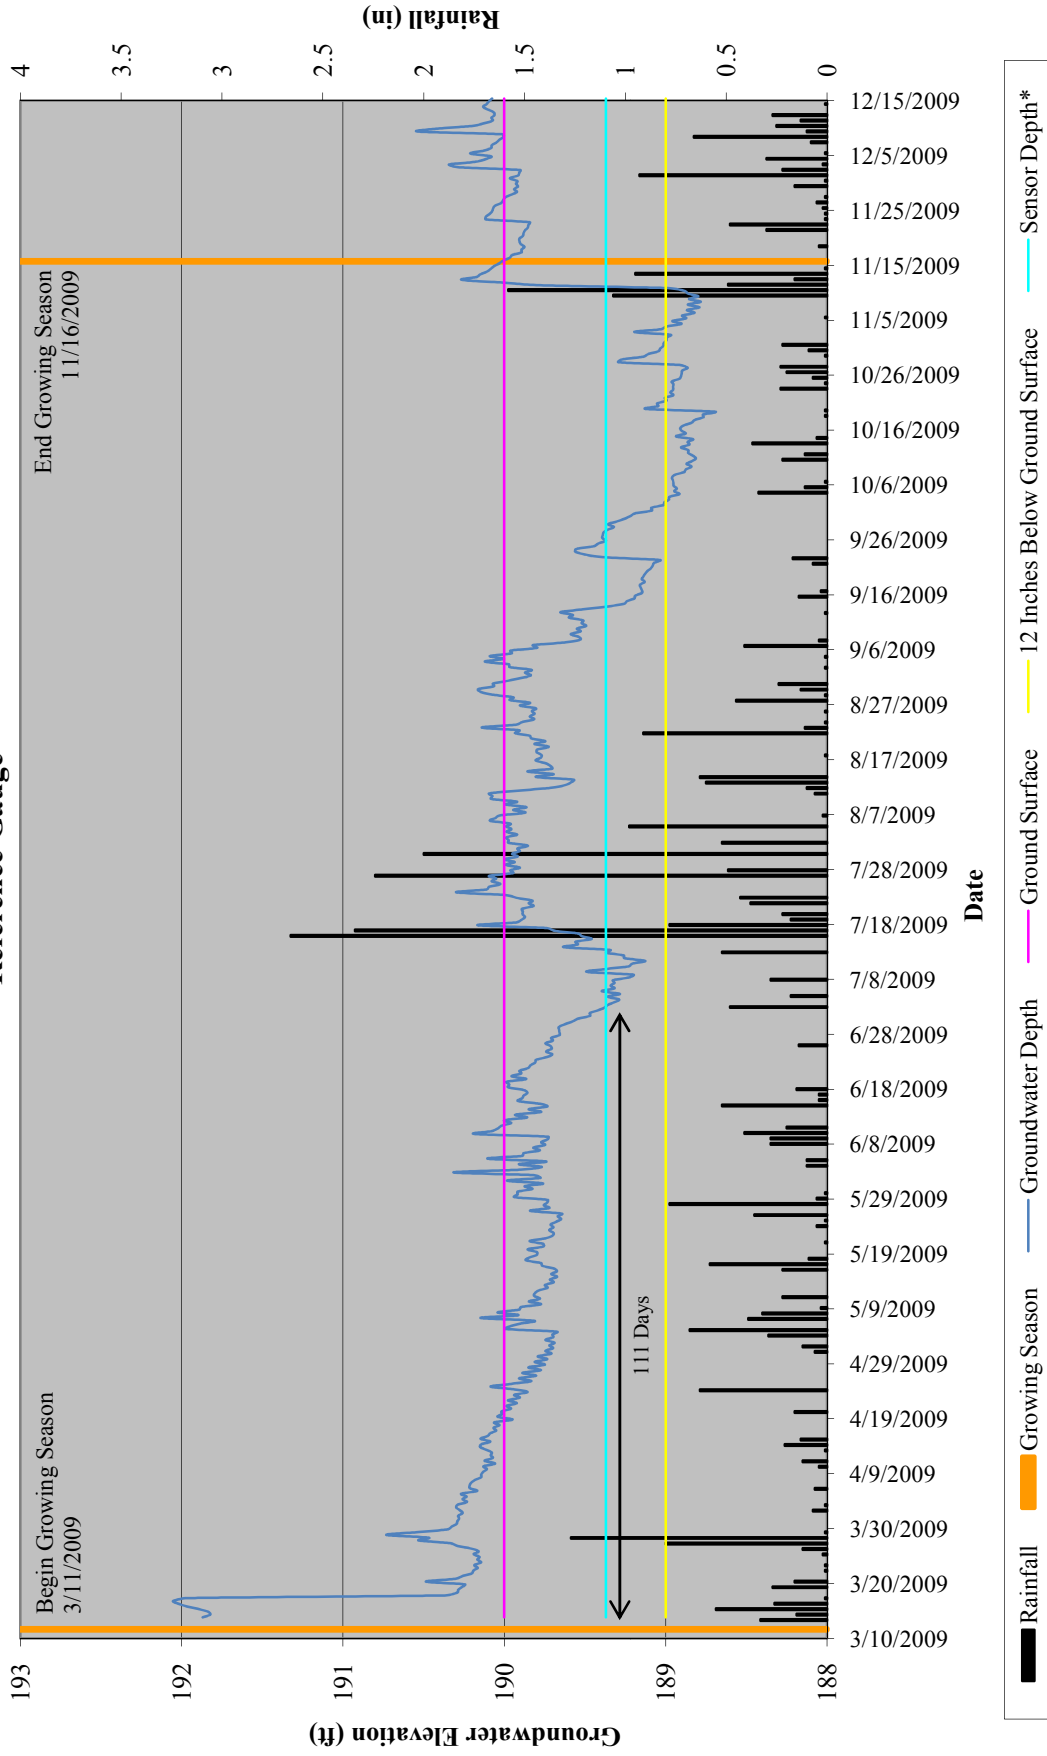
Farrar Dairy Restoration Site Hydrograph Reference Gauge

*Sensor elevation higher than jurisdictional elevation. Sensor depth will be lowered for Monitoring Year 2.
