**Farrar Dairy Stream and Wetland Restoration Site
Monitoring Report – MY02
Harnett County, NC**

January 2011

**Project Manager: Tim Morris
Email: tim.morris@kci.com
KCI Project No: 12065438**

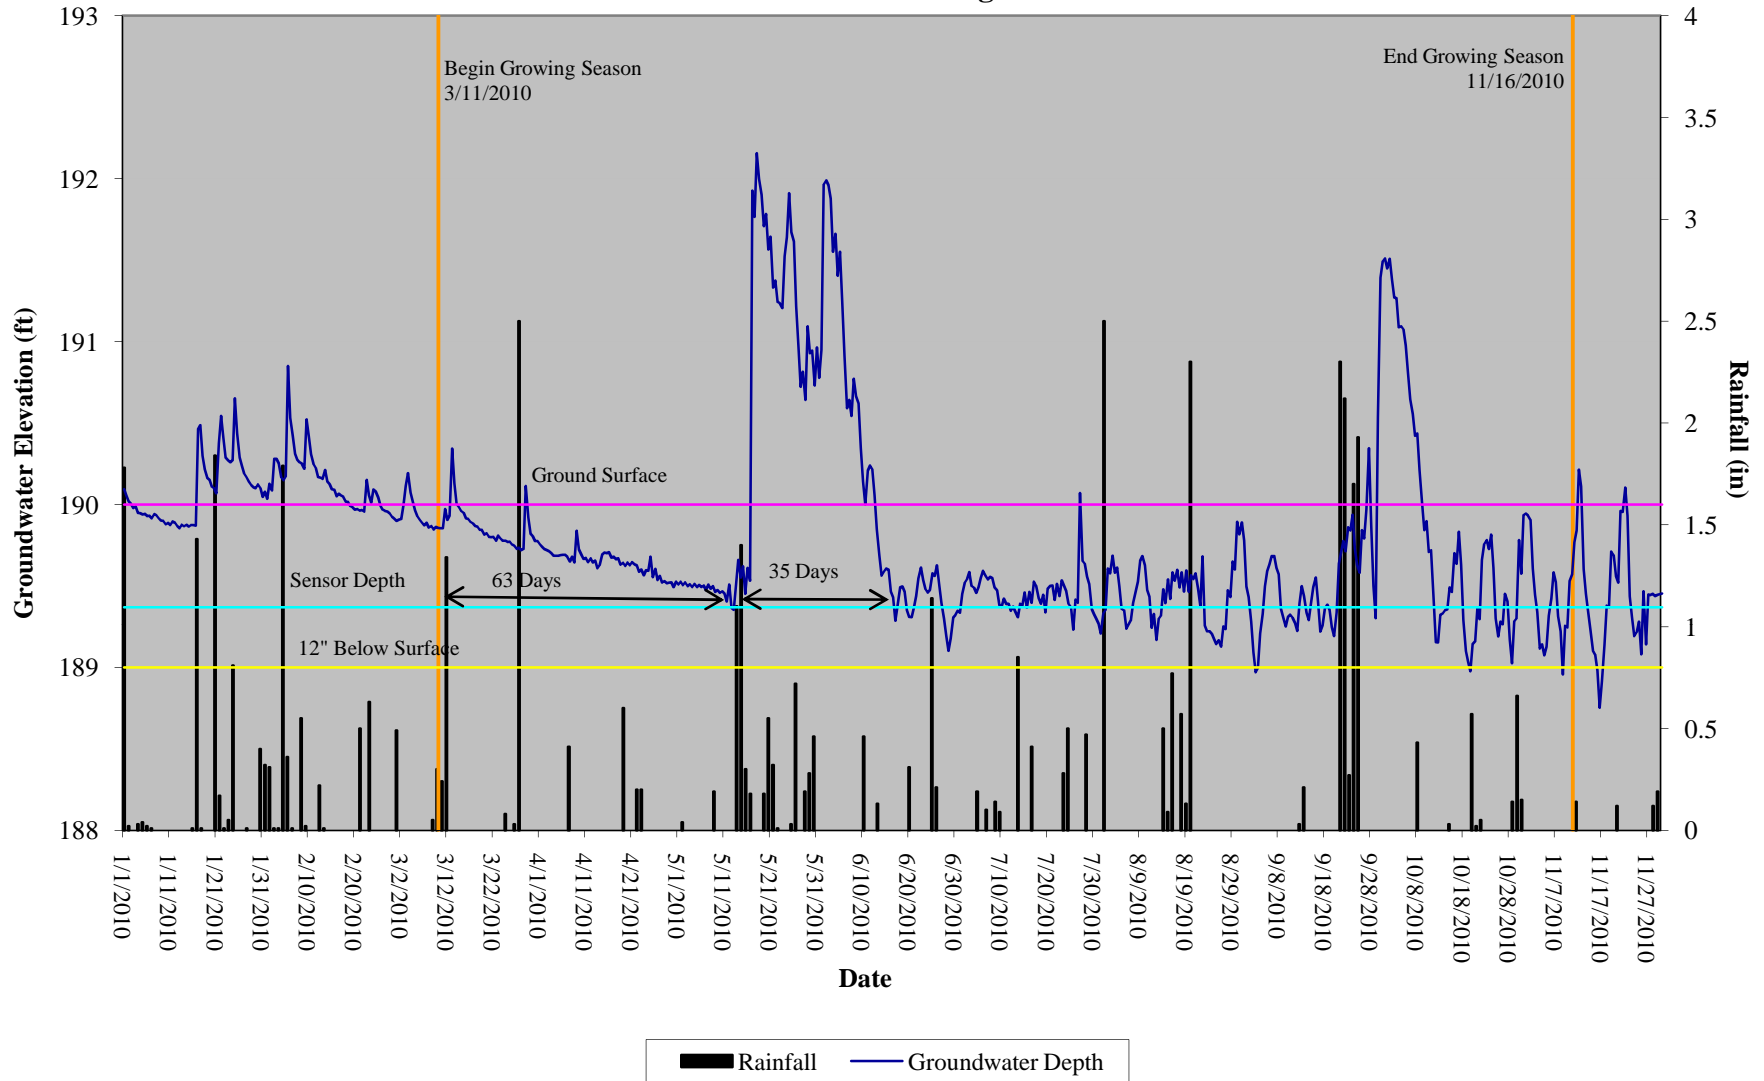
Farrar Dairy Restoration Site Hydrograph Reference Gauge

*Sensor elevation higher than jurisdictional elevation. Sensor depth will be lowered for Monitoring Year 3.
