## **Year 1 of 5 Monitoring Report**

**Five-Mile Branch Stream and Wetland  
Restoration, Iredell County**

**NCEEP IMS ID# 92185**

Our Ref.:  
NC604017.0000  
Project Manager:  
Robert Lepsic  
Date:  
January 2014

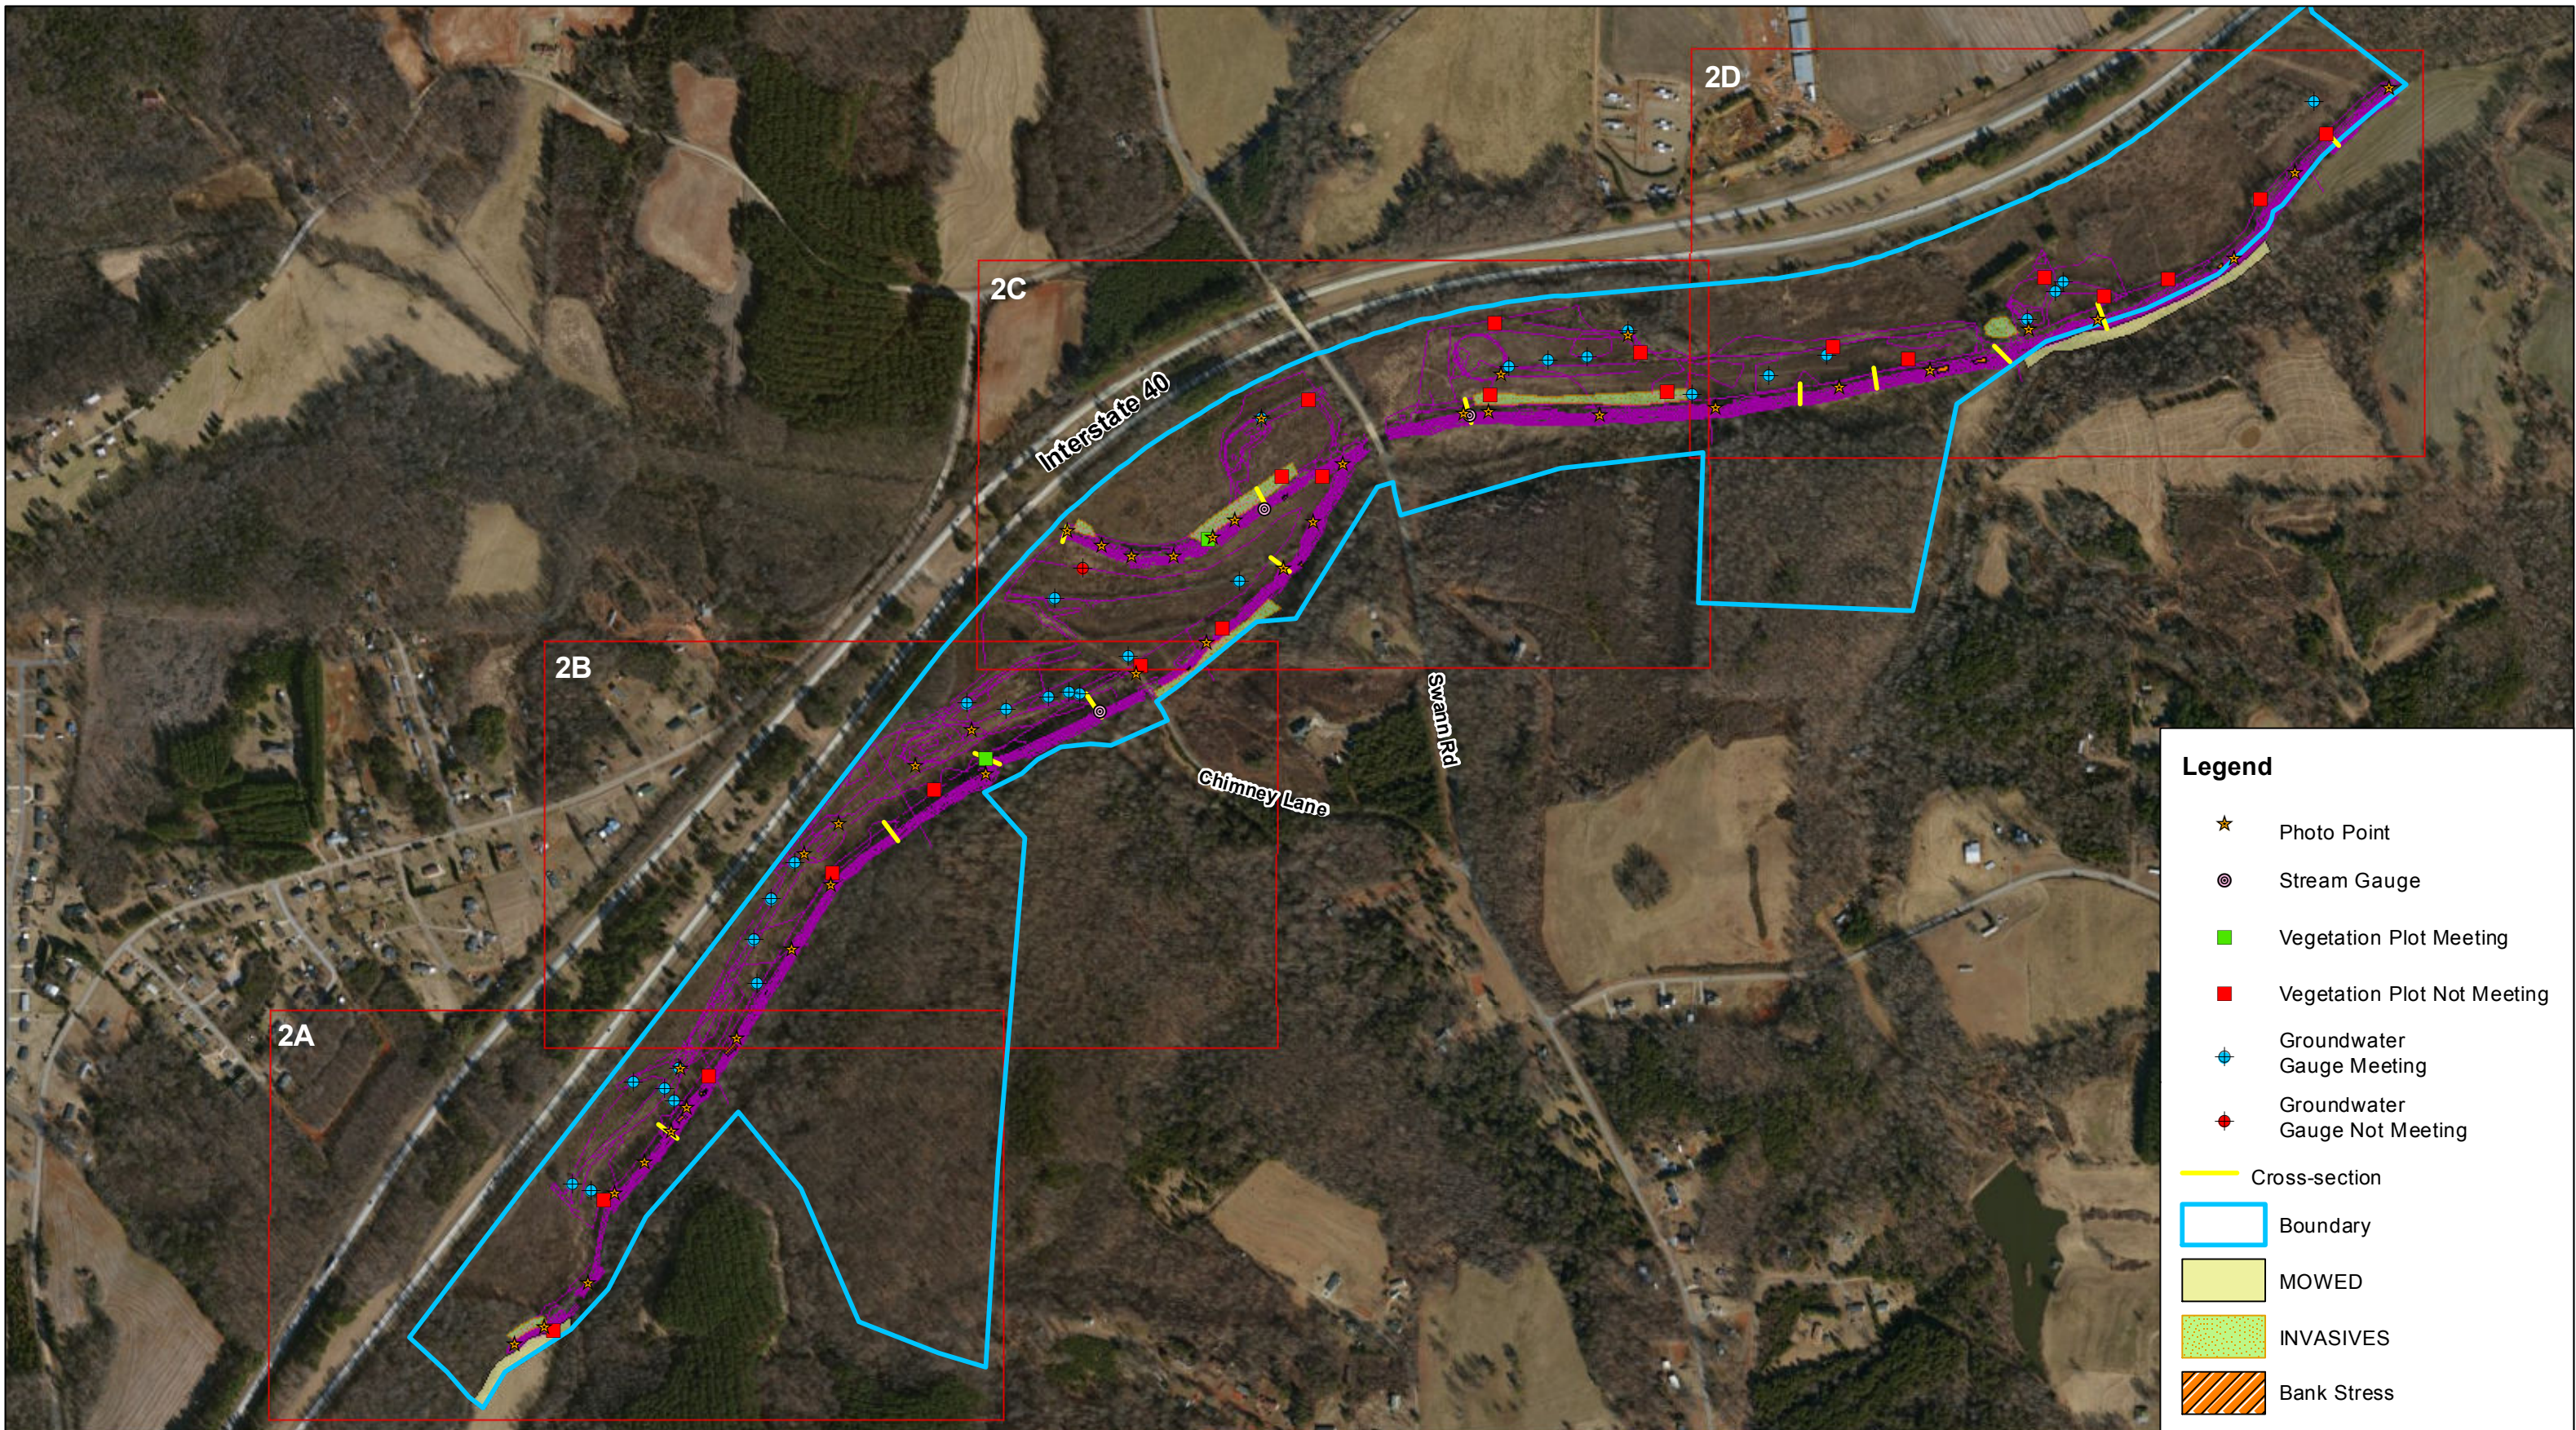
**2**

In April 2013, it was observed that two adjacent property owners mowed a portion of the buffer area, one parcel at the western end and one parcel on the eastern end. See Figure 2 CCPV. This resulted in 100% mortality of planted stems and a significant reduction in stem count totals given that plot 1 was located in the eastern parcel. Plot 1 stem counts were reduced from 10 planted stems at baseline to zero stems during year one. No vegetation monitoring plots are located in the eastern mowed parcel. NCEEP and NCDOT have made contact with the landowners. The landowners have been notified of the property violation and have been asked to stop mowing this area. NCDOT owns the western parcel fee simple and purchased an easement on the central parcel. The areas will be replanted in the 2014/2015 dormant season once the encroachments have been rectified.

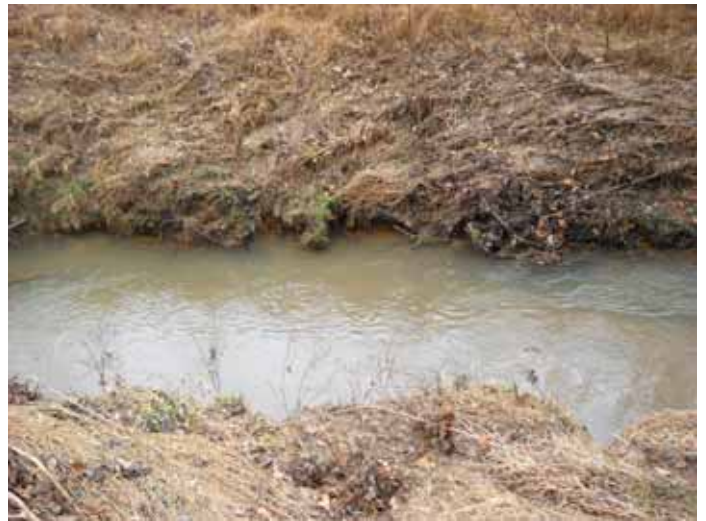
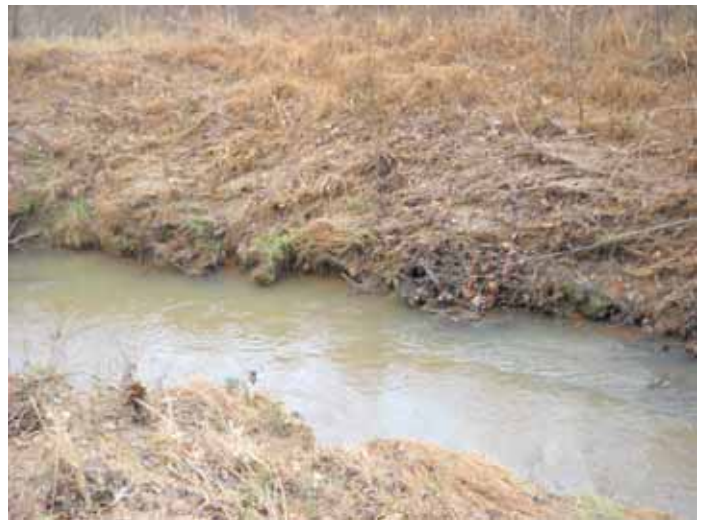
Cross Section 5 12/5/13

When looking at the plotted cross sections, several of the year one cross sections do not align with the as-built condition and several appear to have significantly changed from the as-built condition, most notable cross section 5. These apparent changes may be the result of the lack of detail in the as-built channel survey. The as-built cross sections were generated from the surface contours created from the as-built field survey, which was not surveyed by ARCADIS staff. The year one cross sections were surveyed in the field by ARCADIS staff and are likely more accurate. These discrepancies were not noticed until the year one cross sectional survey was overlaid on the as-built drawing. Several of the cross sections do align well (3, 9, 10, 11 and 13).

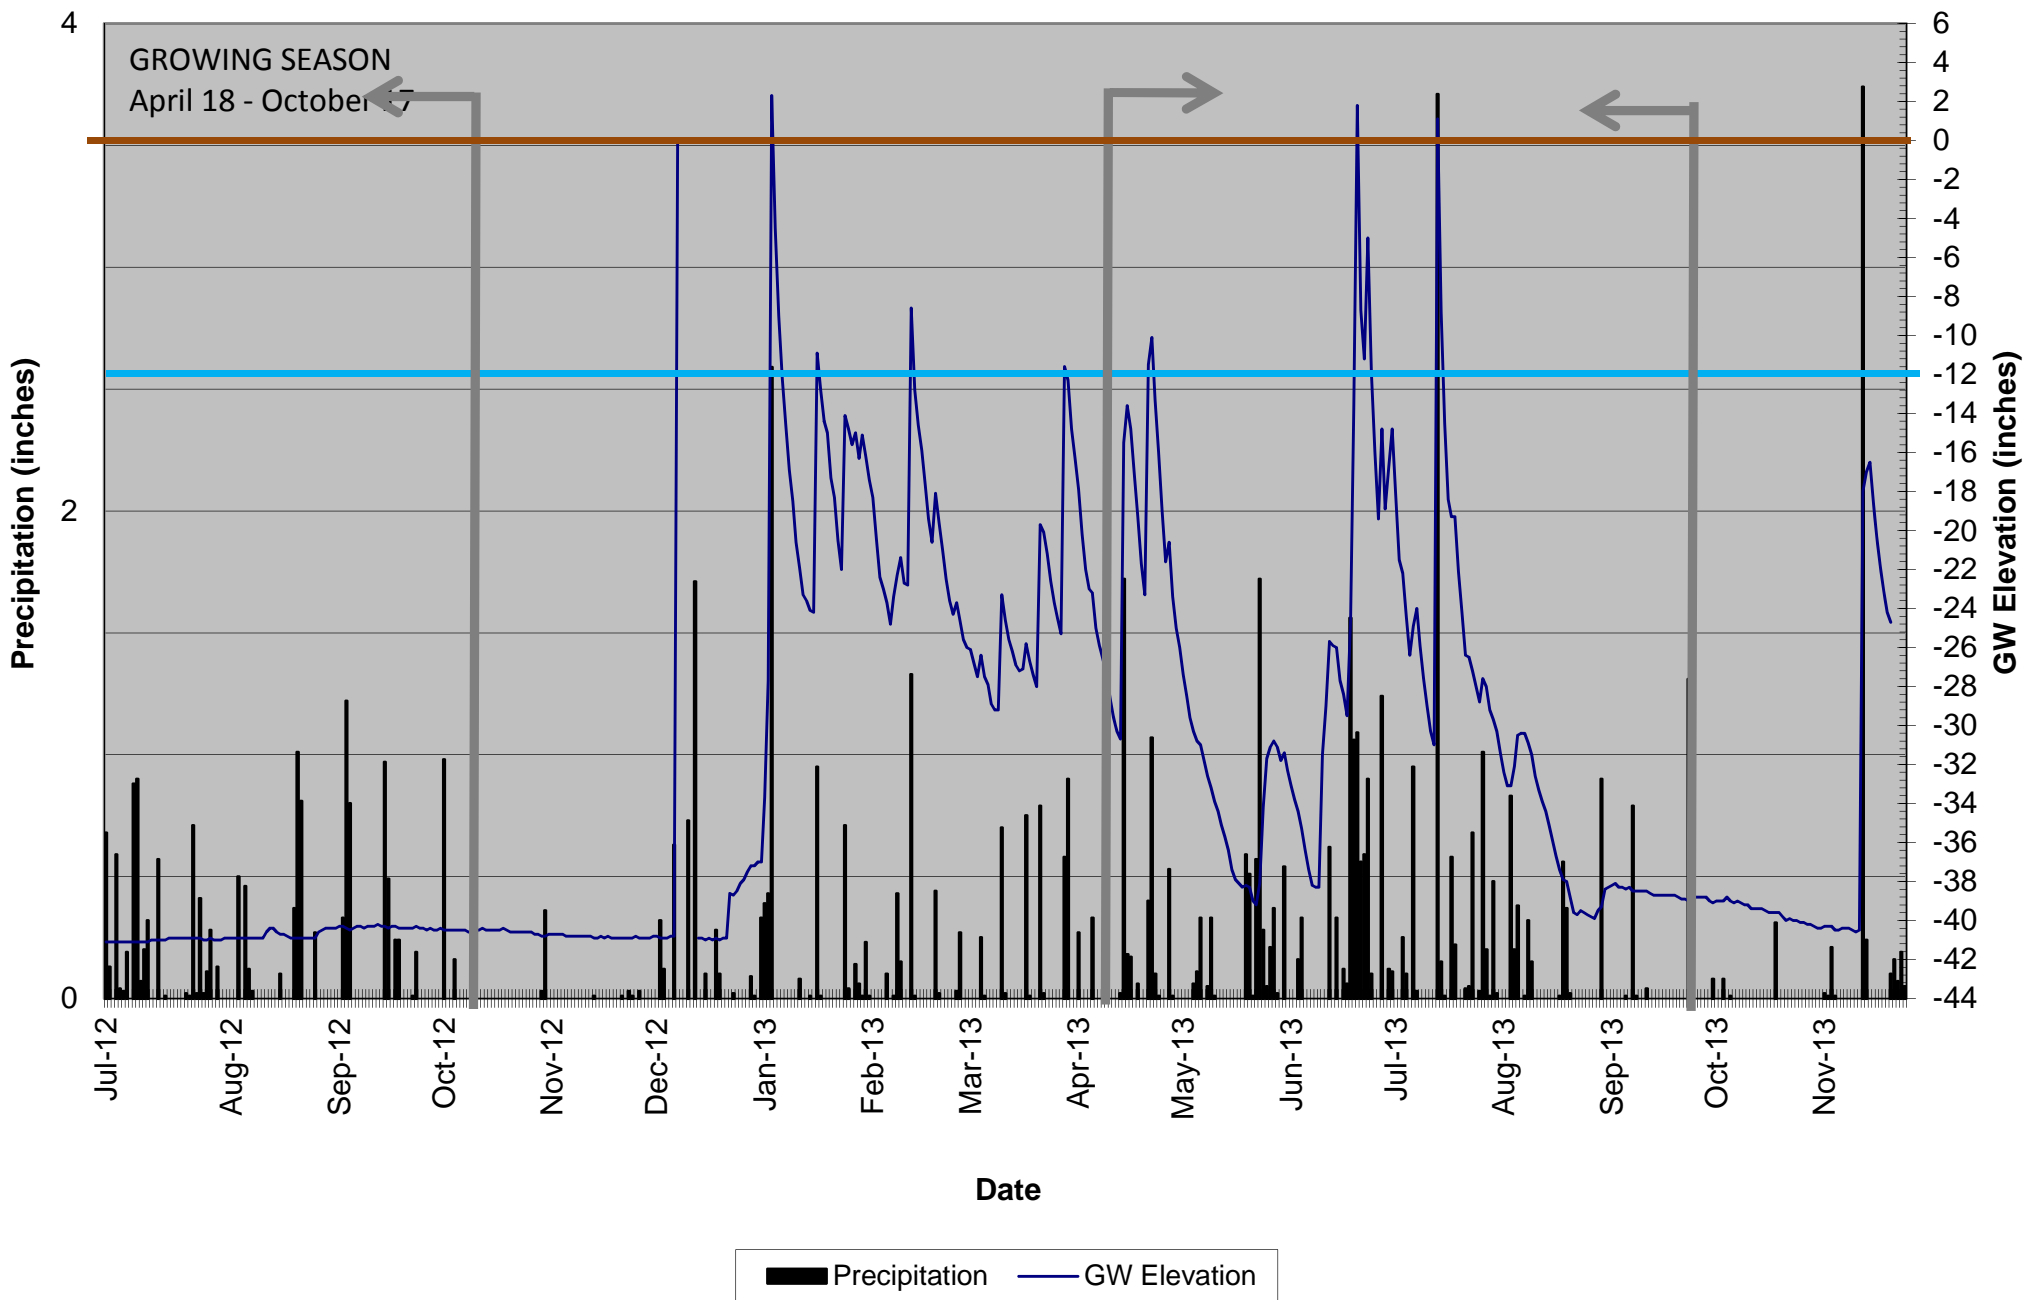
# Five Mile Branch Gauge #17 14E16DE5

Wetland hydrology was monitored for the entire growing season (April 18 – October 17) in the year 1 monitoring term. Of the 30 gauges on site, all but one (gauge 17) are meeting the established groundwater success criteria of ground water within 12 inches of the ground surface for 9 consecutive days in the growing season (5% of 183 days). Gauge 17 recorded groundwater within 12 inches of the surface for a maximum of 4 consecutive days (2.2 percent) during the growing season. Wetland hydrology at gauges meeting success criteria ranged from 100 percent (183 days) of the growing season at gauges 8, 10, 21, 22 and 23 to 7.7 percent (14 days) of the growing season at gauge 28.
