## **Year 2 of 5 Monitoring Report**

**Five-Mile Branch Stream and Wetland  
Restoration, Iredell County**

**NCEEP IMS ID# 92185**

March 2015

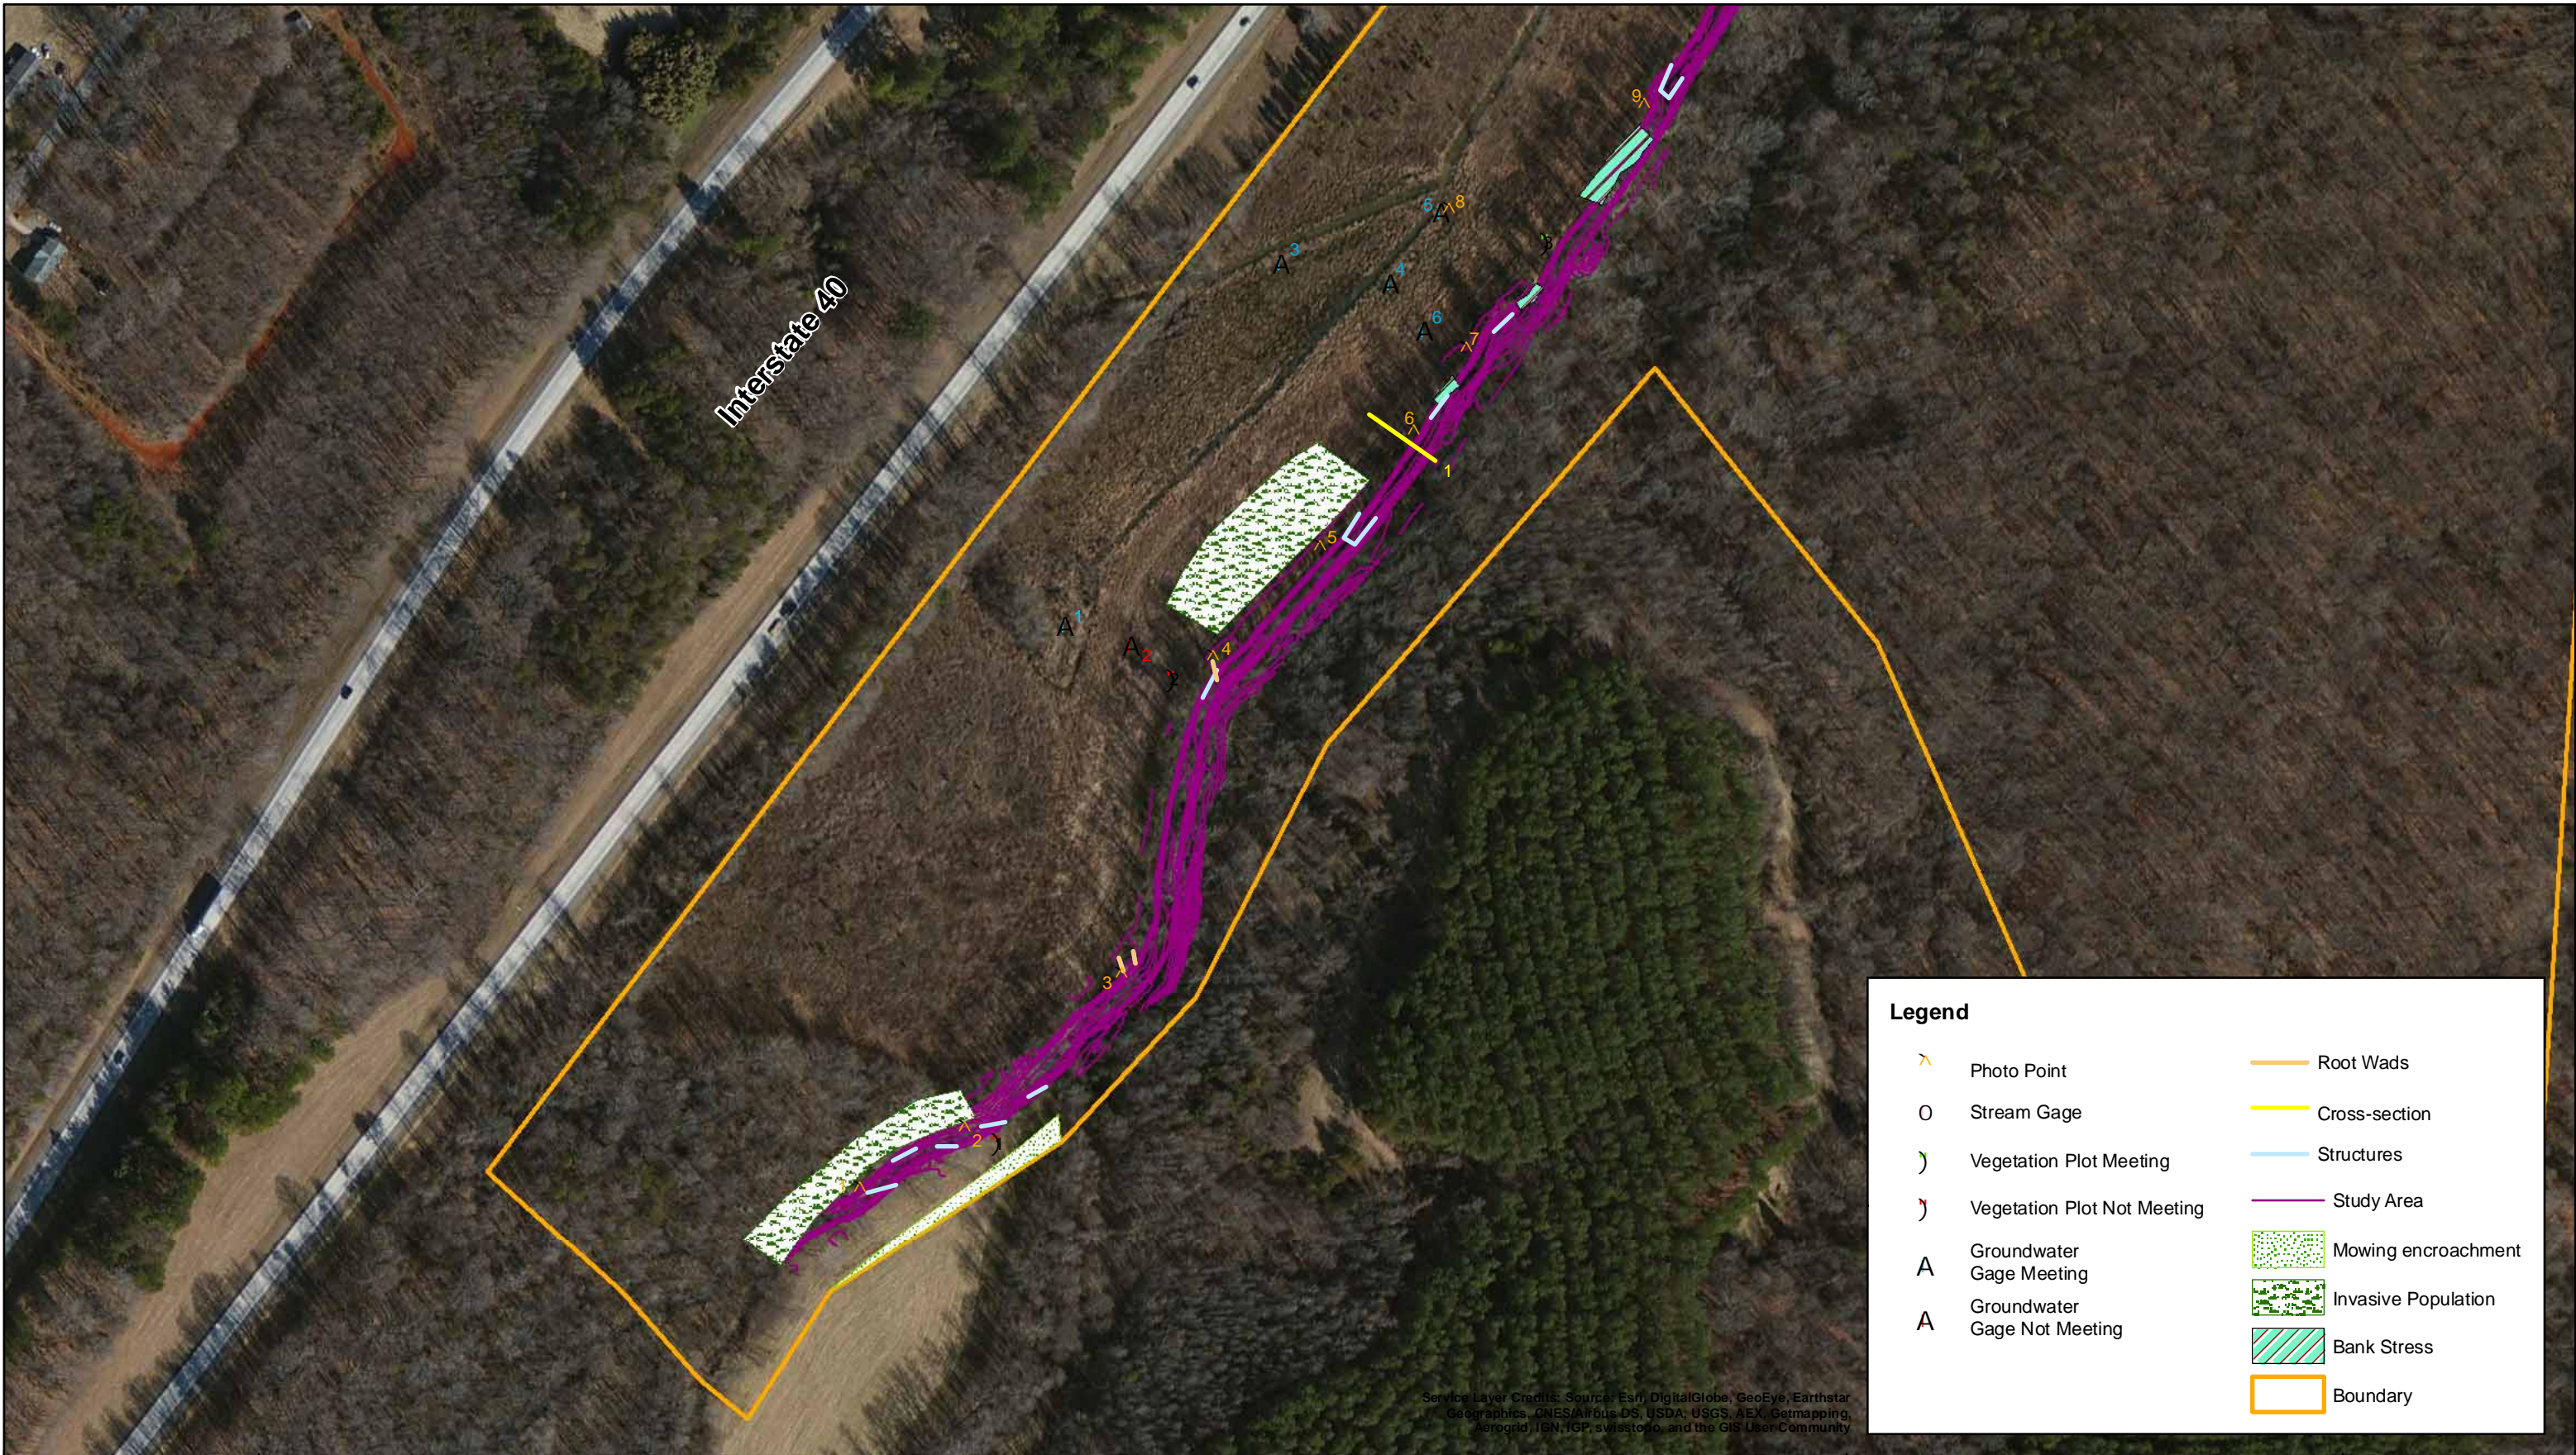
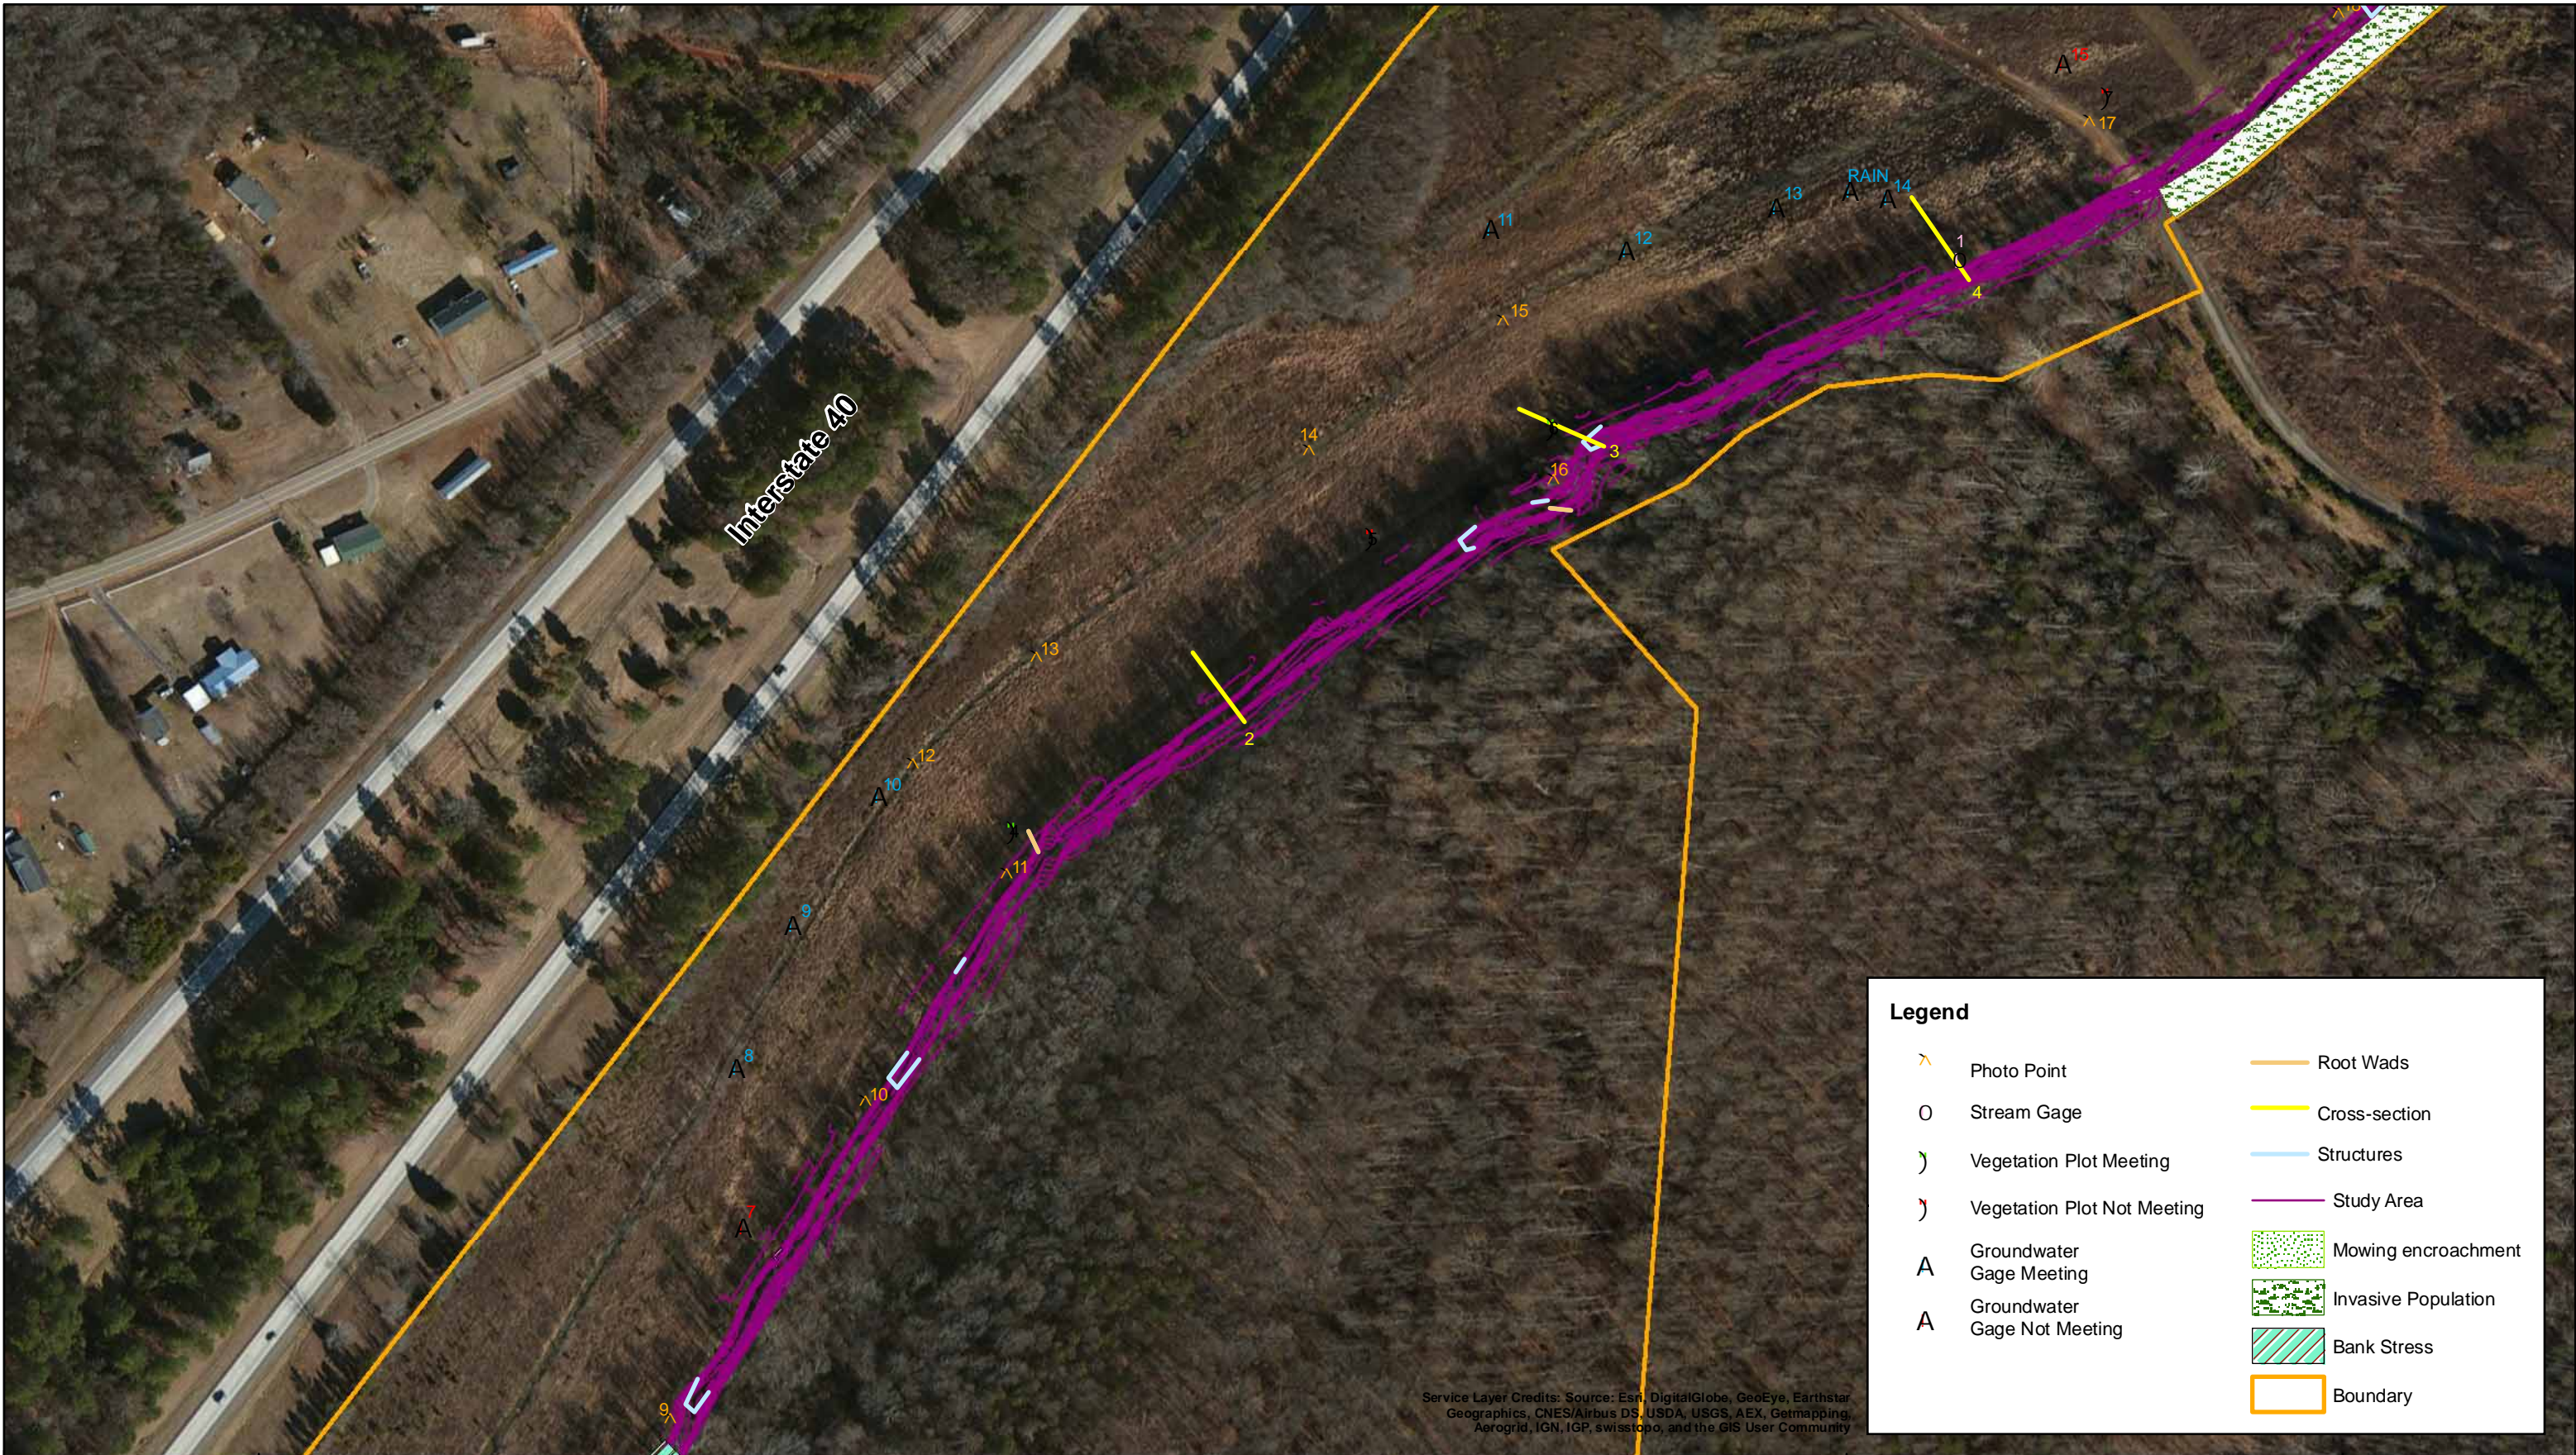
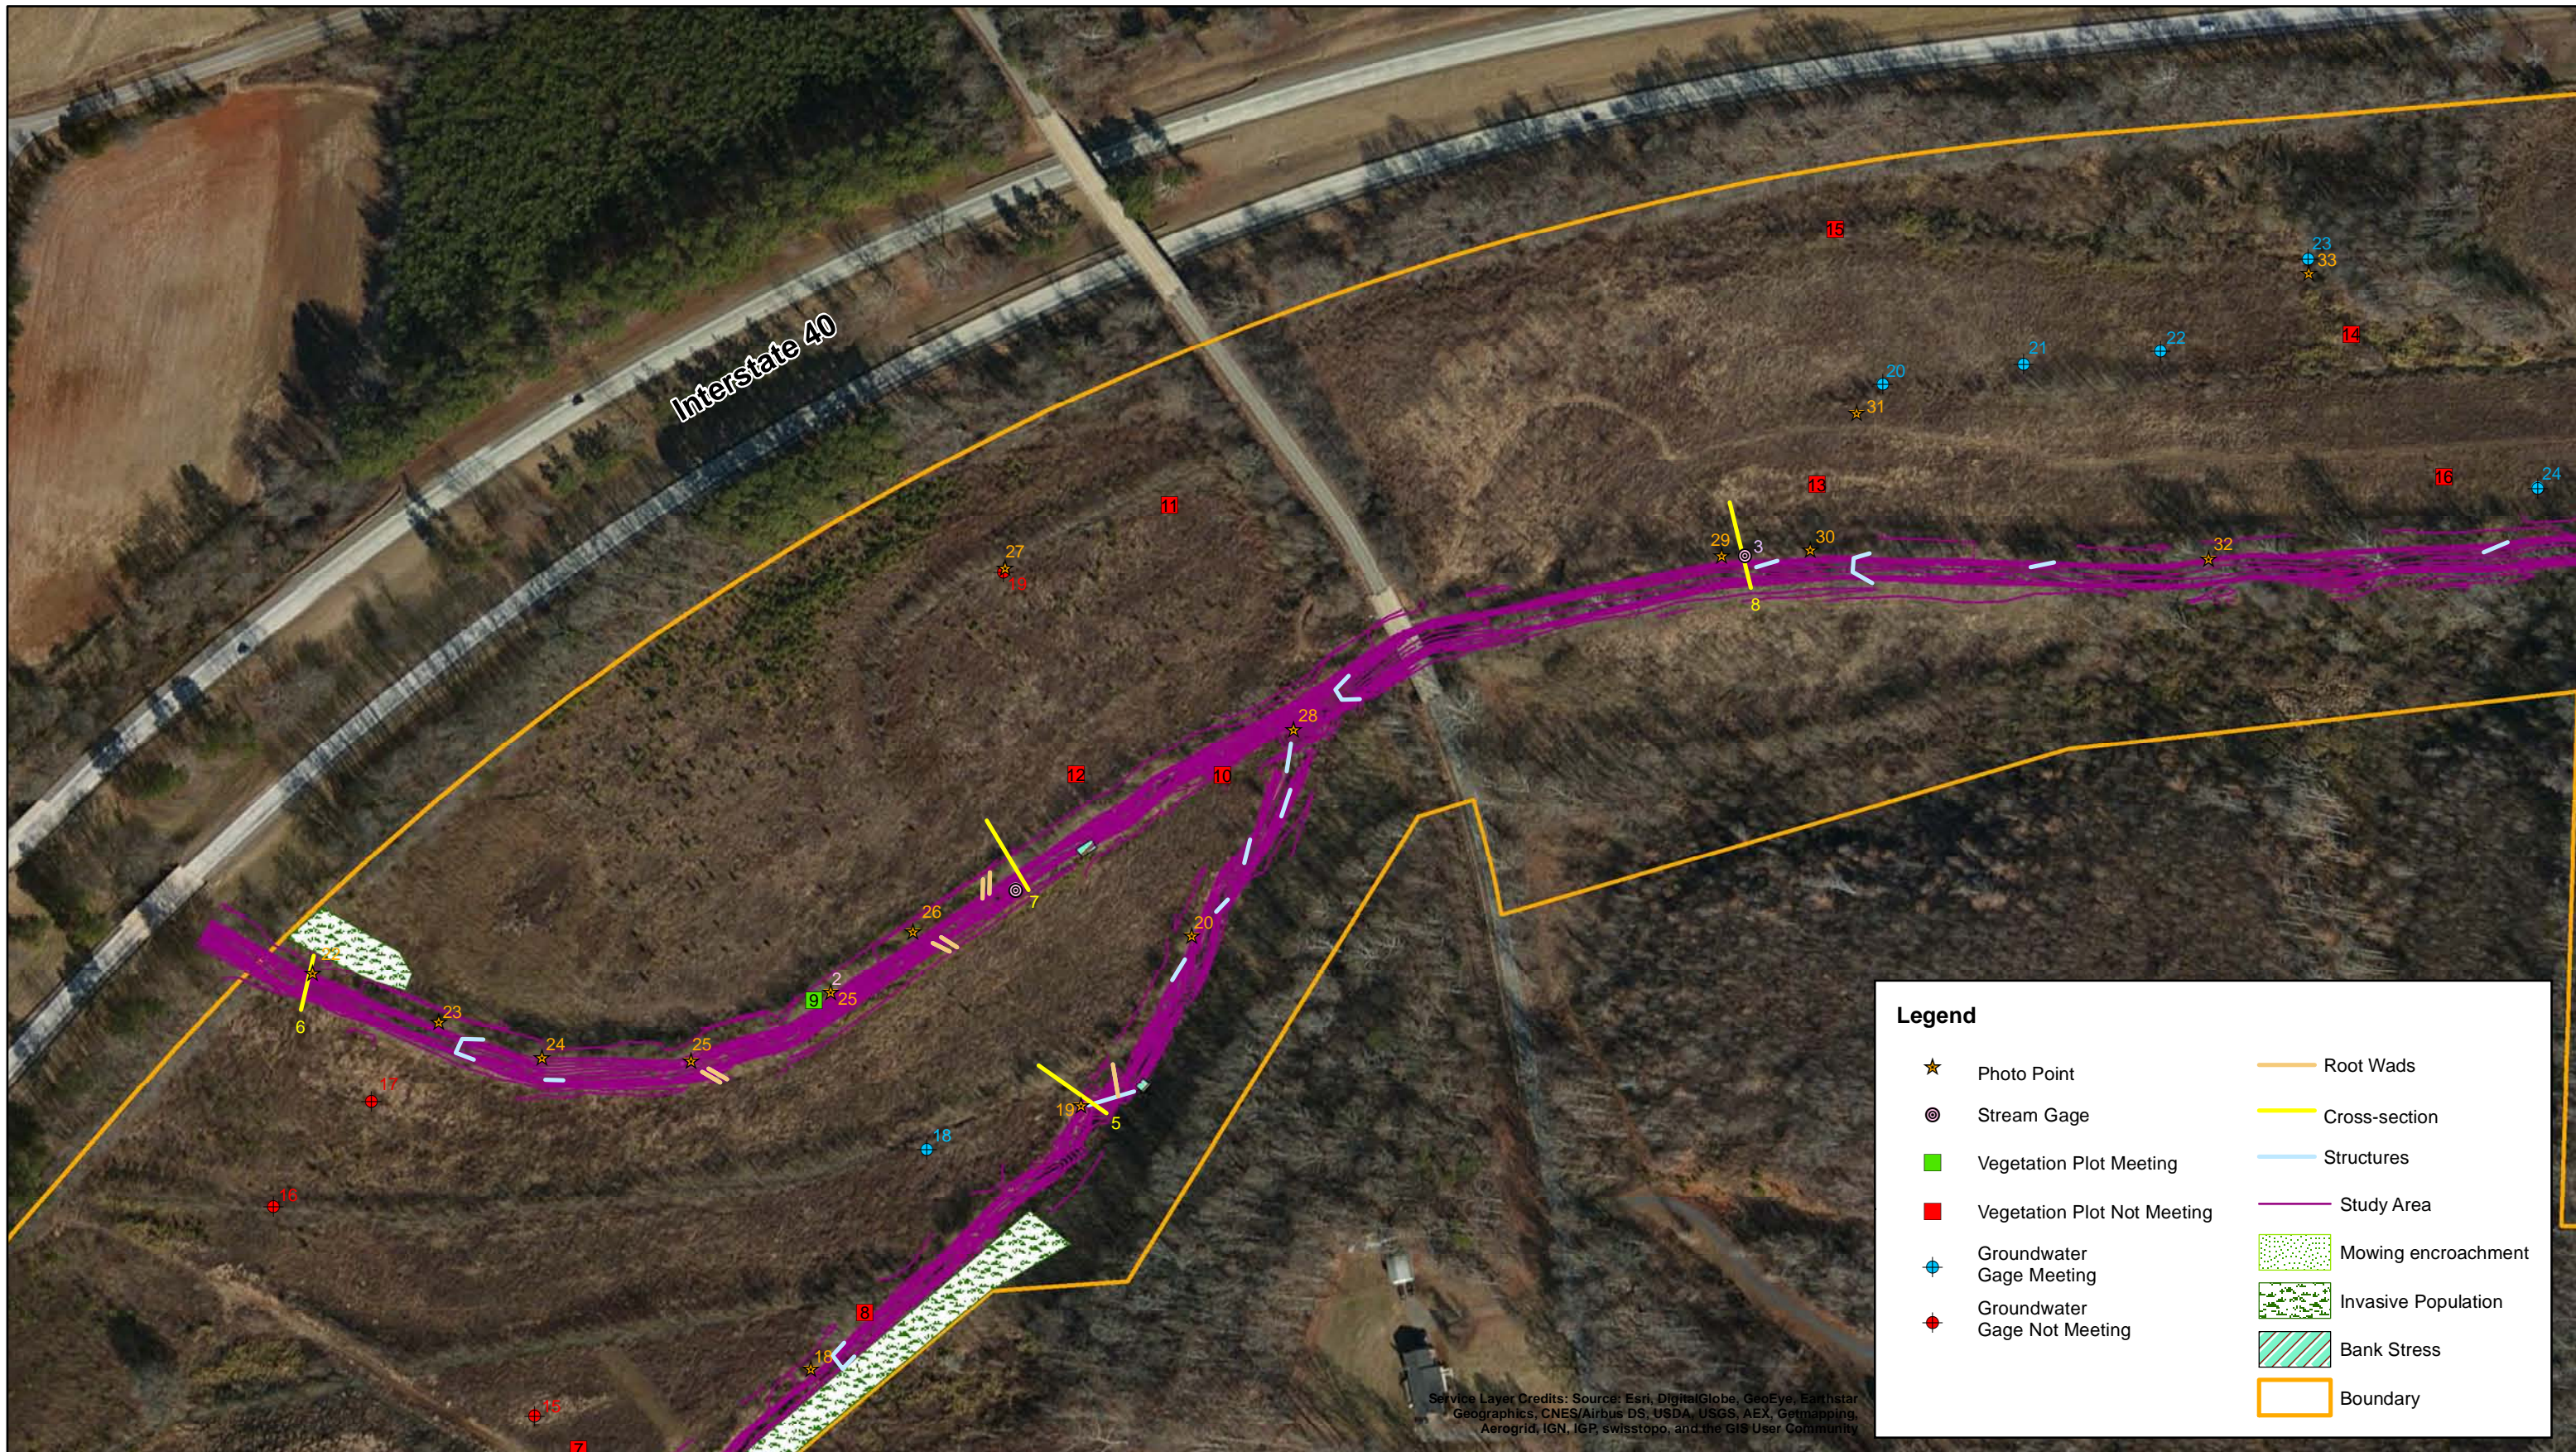
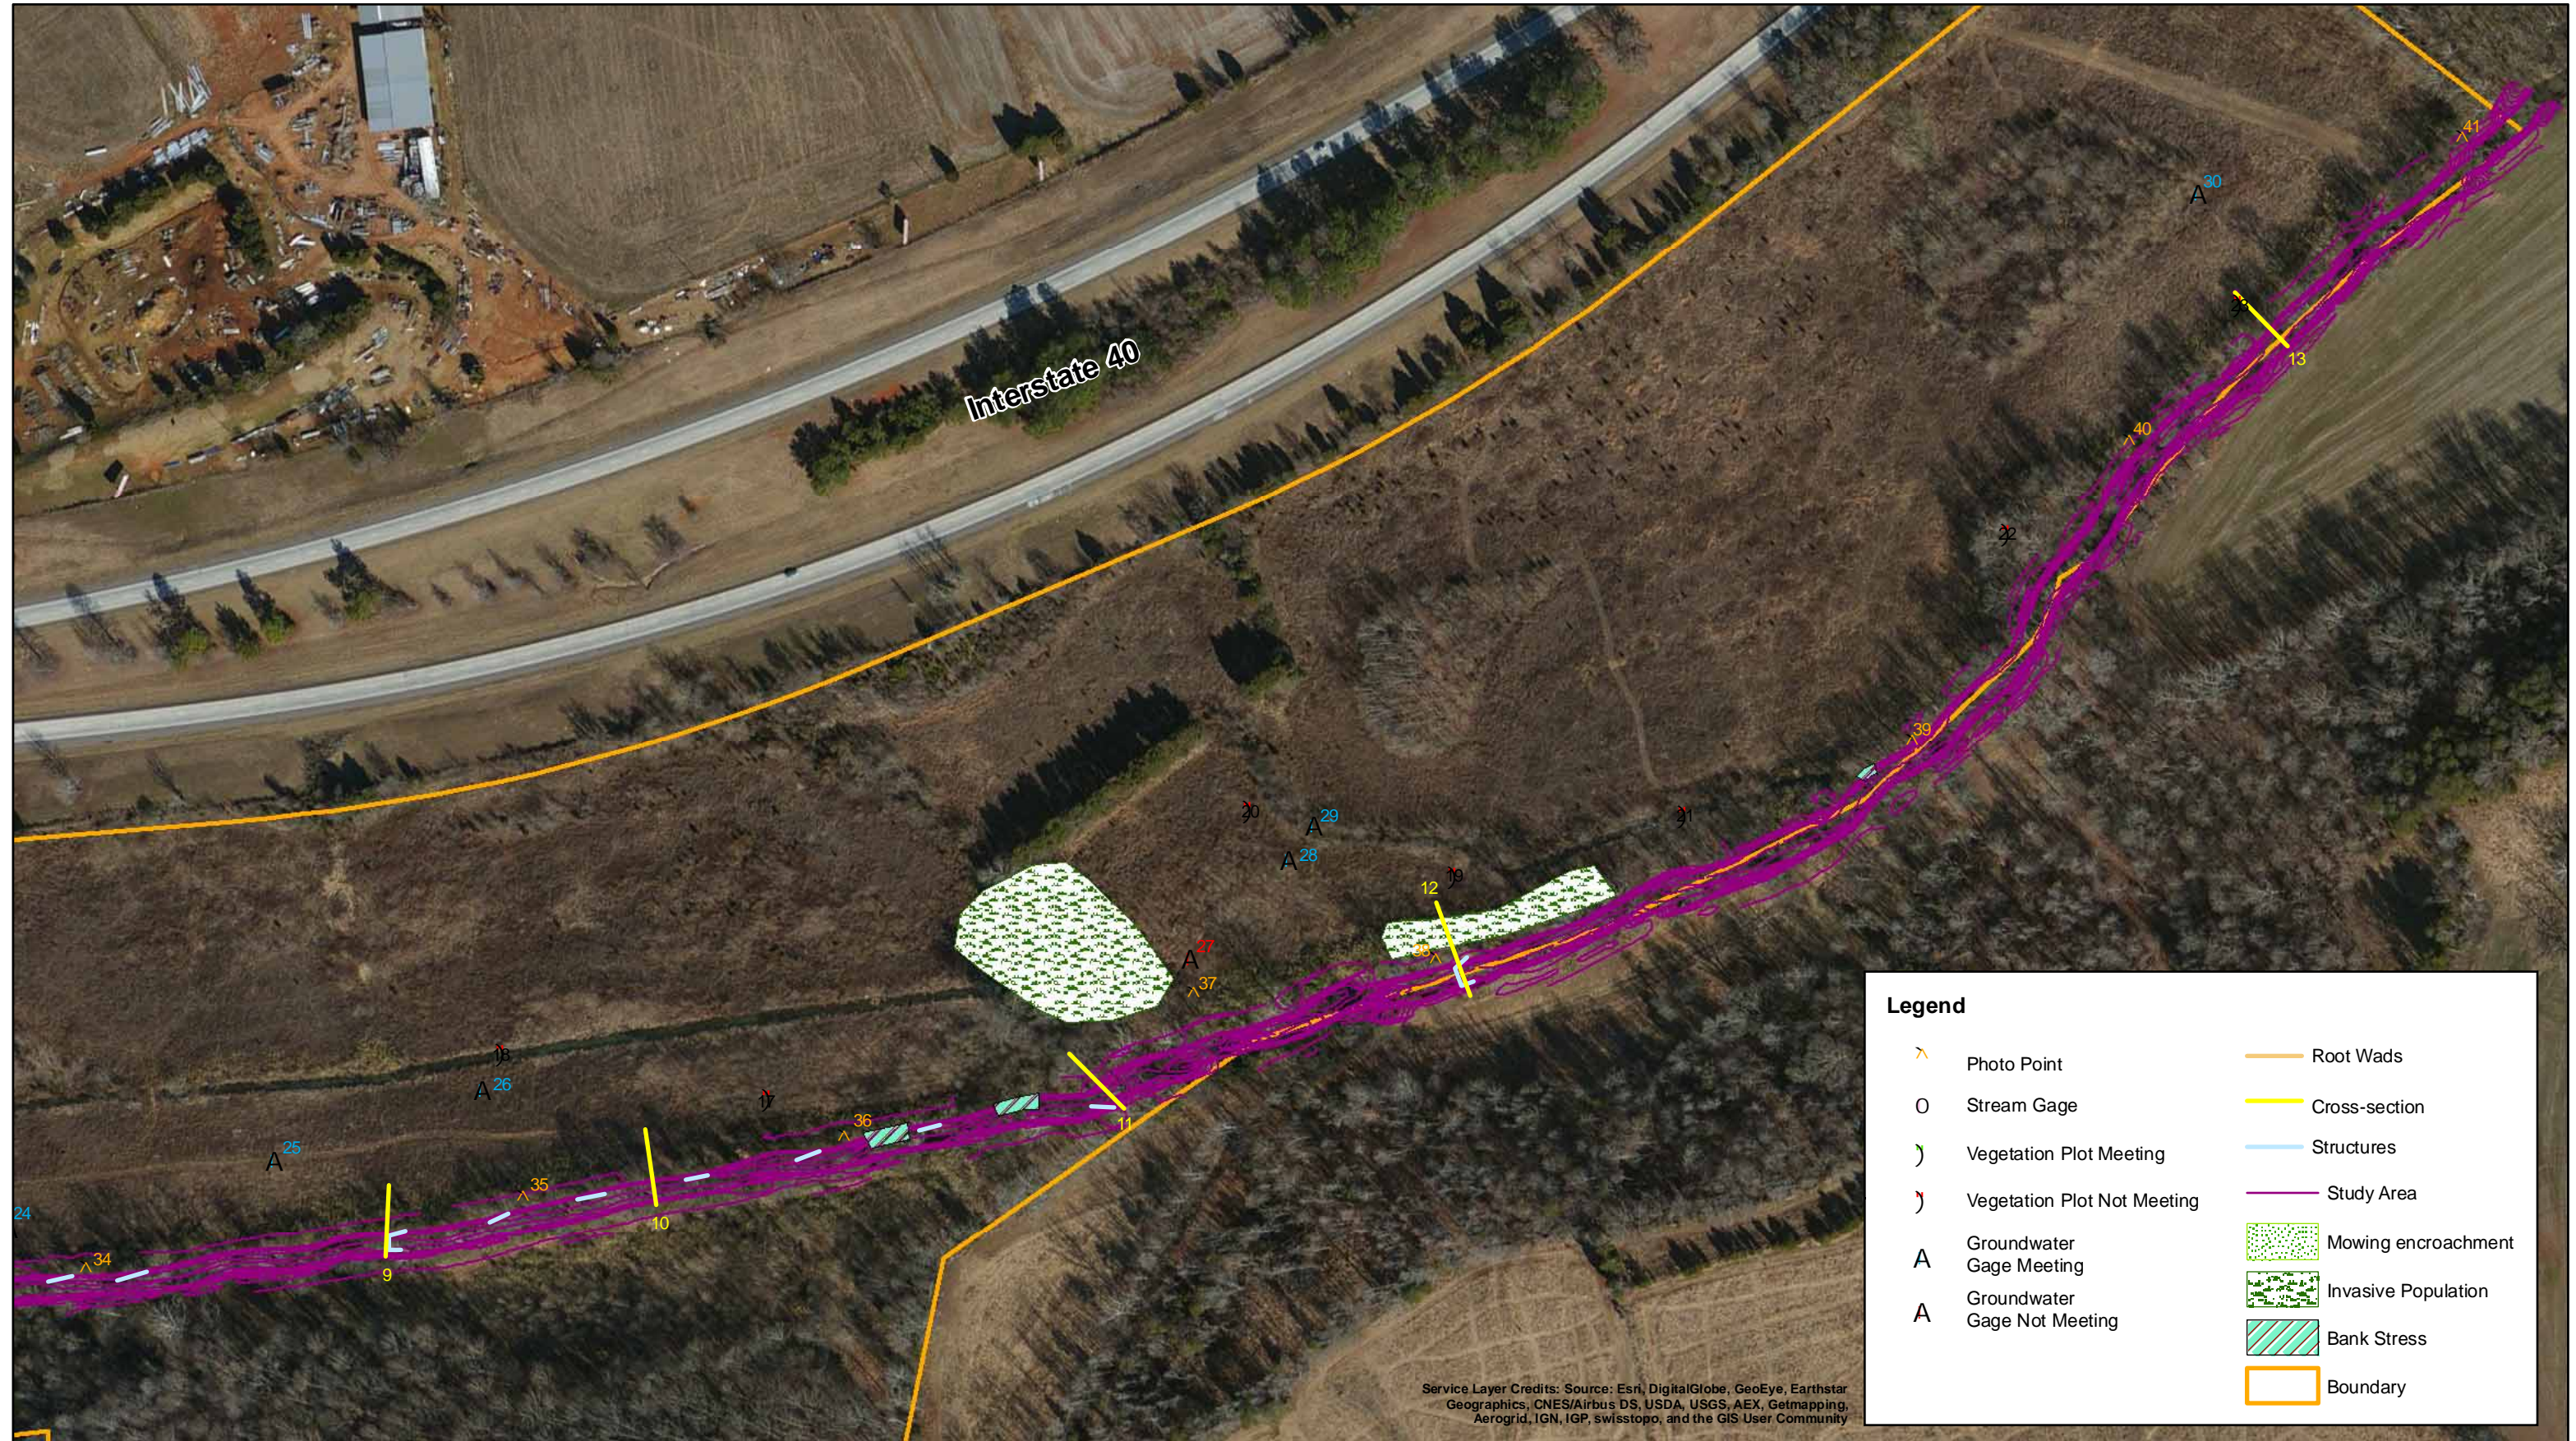
No bare areas were observed within the floodplain. A few bare areas on stream banks associated with bank erosion were noted. Refer to CCPV map.

Several bank stress areas were again identified in year 2. They are located in the same areas as year 1. There did not seem to be a significant increase in the length of stream bank affected.
