## **Year 3 of 5 Monitoring Report**

**Five-Mile Branch Stream and Wetland  
Restoration, Iredell County**

**NCDMS IMS ID# 92185  
DEQ Contract # 6036**

ARCADIS G&M of North Carolina, Inc.

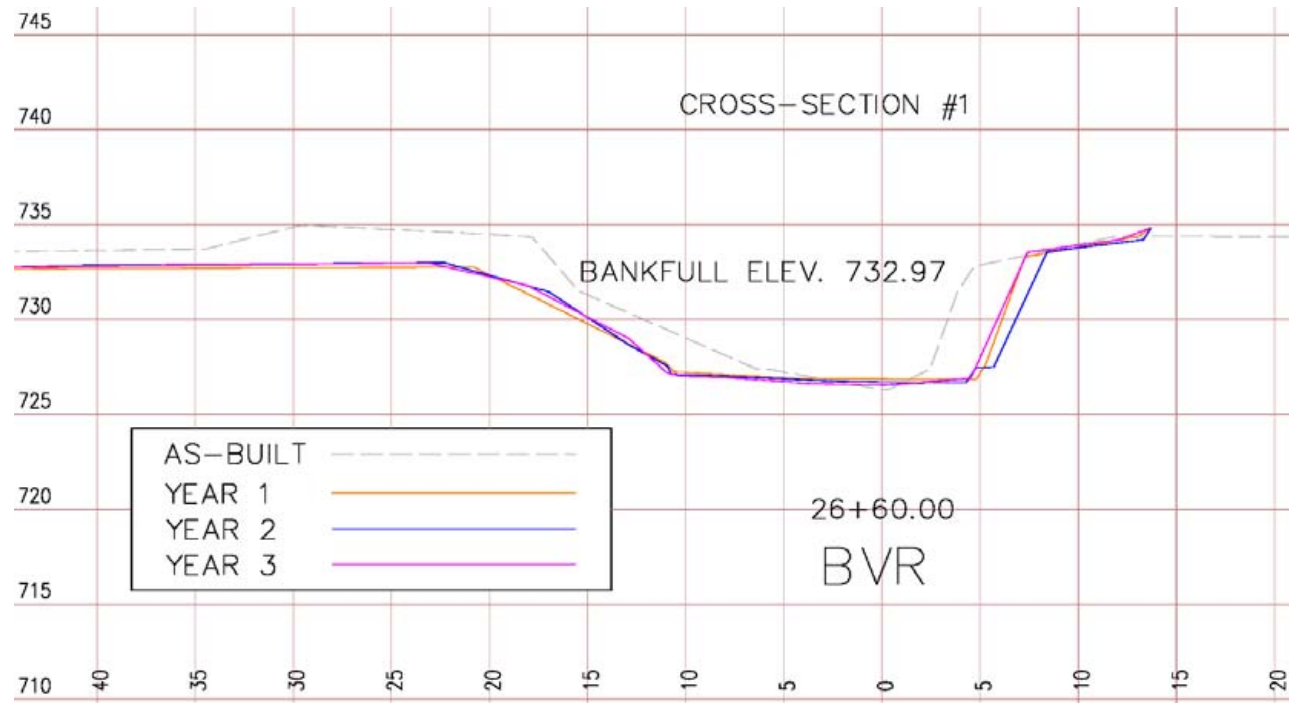
SUMMARY DATA	
Bankfull Elevation:	732.97
Bankfull Cross-Sectional Area:	130.1
Bankfull Width:	30.3
Floodprone Area Elevation:	739.37
Floodprone Width:	200
Max Depth at Bankfull	6.4
Mean Depth at Bankfull	4.3
W/D Ratio	7.0
Entrenchment Ratio:	6.6
Bank Height Ratio:	1.0

Stream Type: E5

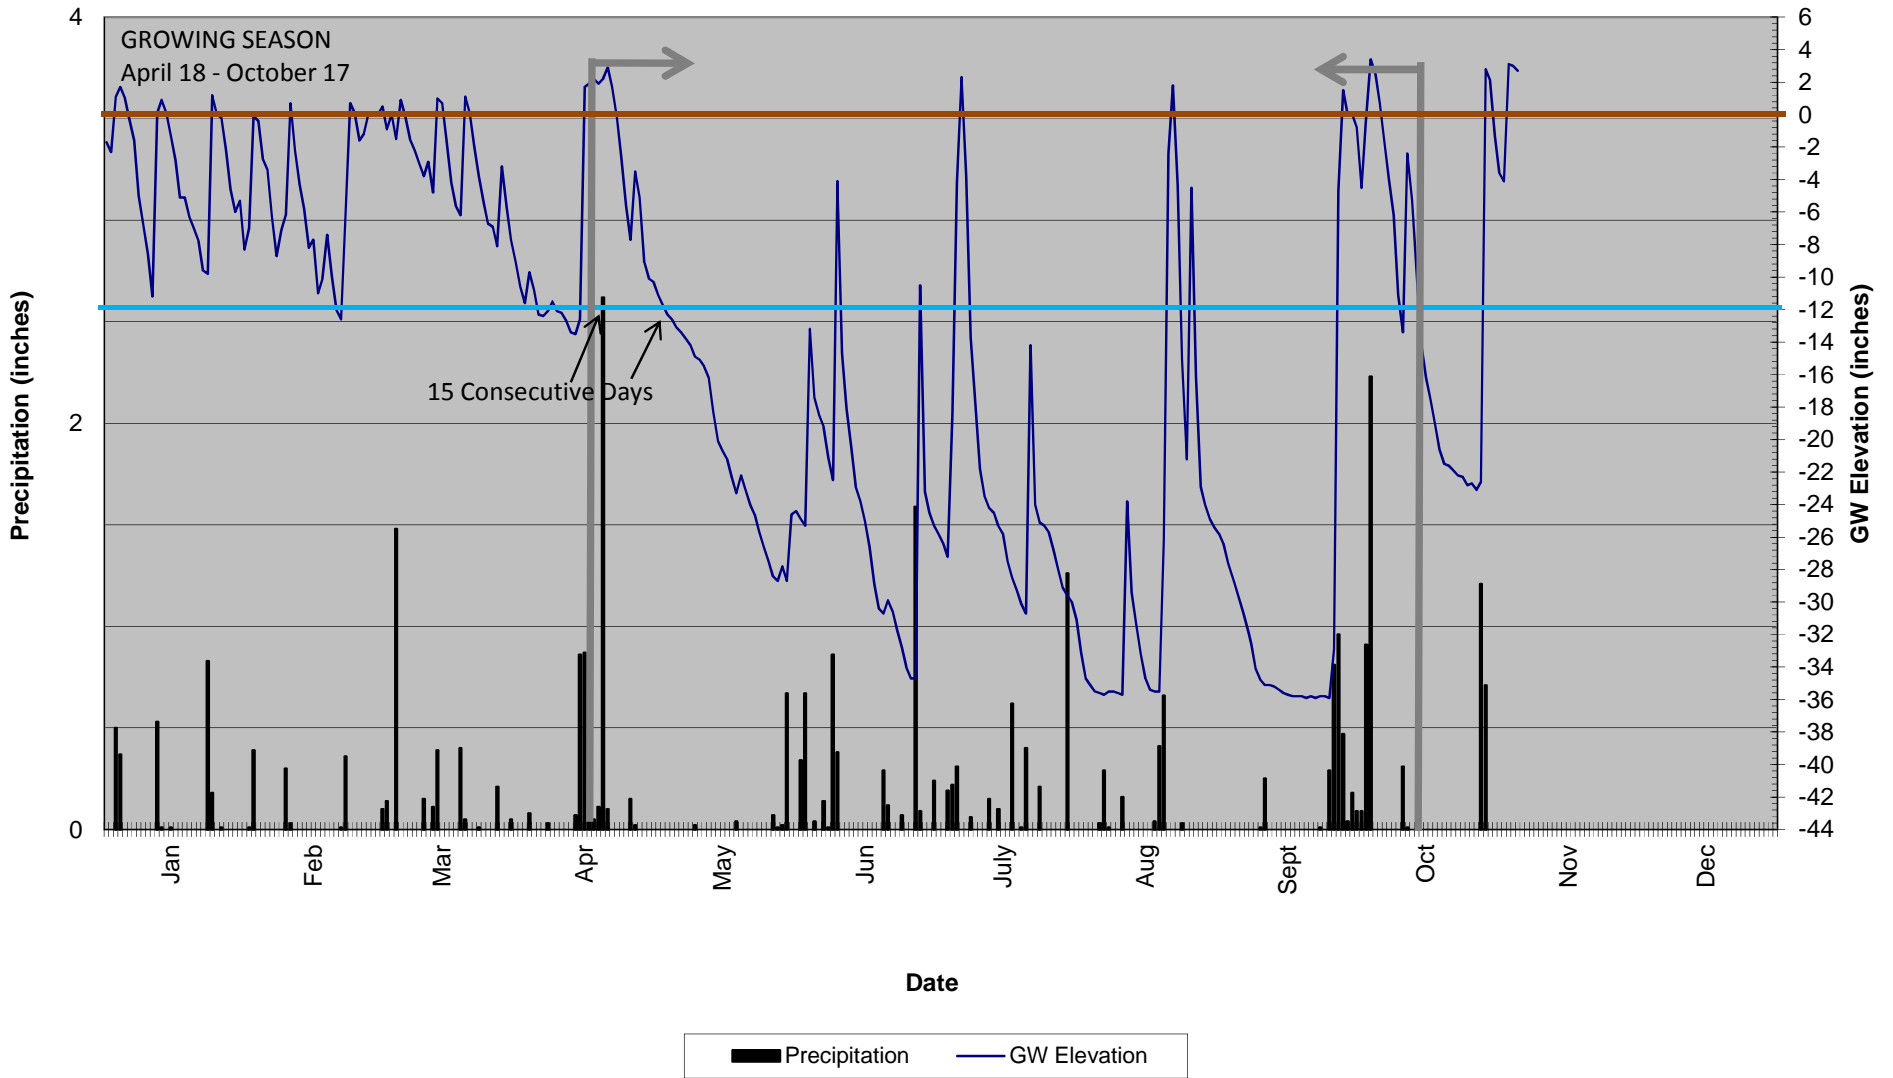
### Five Mile Branch Guage #6 14E1A3C5

6	14E1A3C5	Reprogrammed due to not downloading.	ok	ok	No attempt.	Failed	ok	No attempt.	Ok. Replaced battery. Deleted old data.	ok	OK. Deleted old data.	No attempt due to weather.	ok
7	13D4CA32	ok	ok	ok	No attempt.	ok	ok	No attempt.	Replaced with 1314FC9A	Partial data	OK. Deleted old data.	No attempt due to weather.	ok
8	13D49BC4	ok	ok	ok	No attempt.	ok	ok	No attempt.	OK. Deleted old data.	ok	OK. Deleted old data.	No attempt due to weather.	ok
9	136B6377	ok	ok	ok	No attempt.	Failed	Replaced with EBD20B9.	No attempt.	OK. Deleted old data.	ok	OK. Deleted old data.	No attempt due to weather.	ok
10	13D4B632	ok	ok	ok	No attempt.	ok	ok	No attempt.	OK. Deleted old data.	ok	OK. Deleted old data.	No attempt due to weather.	ok
11	14E178FC	ok	ok	ok	No attempt.	Failed	Replaced with EBD074F.	No attempt.	OK. Deleted old data.	ok	OK. Deleted old data. Replaced battery.	No attempt due to weather.	ok
12	14E13DAE	ok	ok	ok	No attempt.	ok	ok	No attempt.	OK. Deleted old data.	ok	OK. Deleted old data.	No attempt due to weather.	OK. Missing 6/5 - 6/11 data.

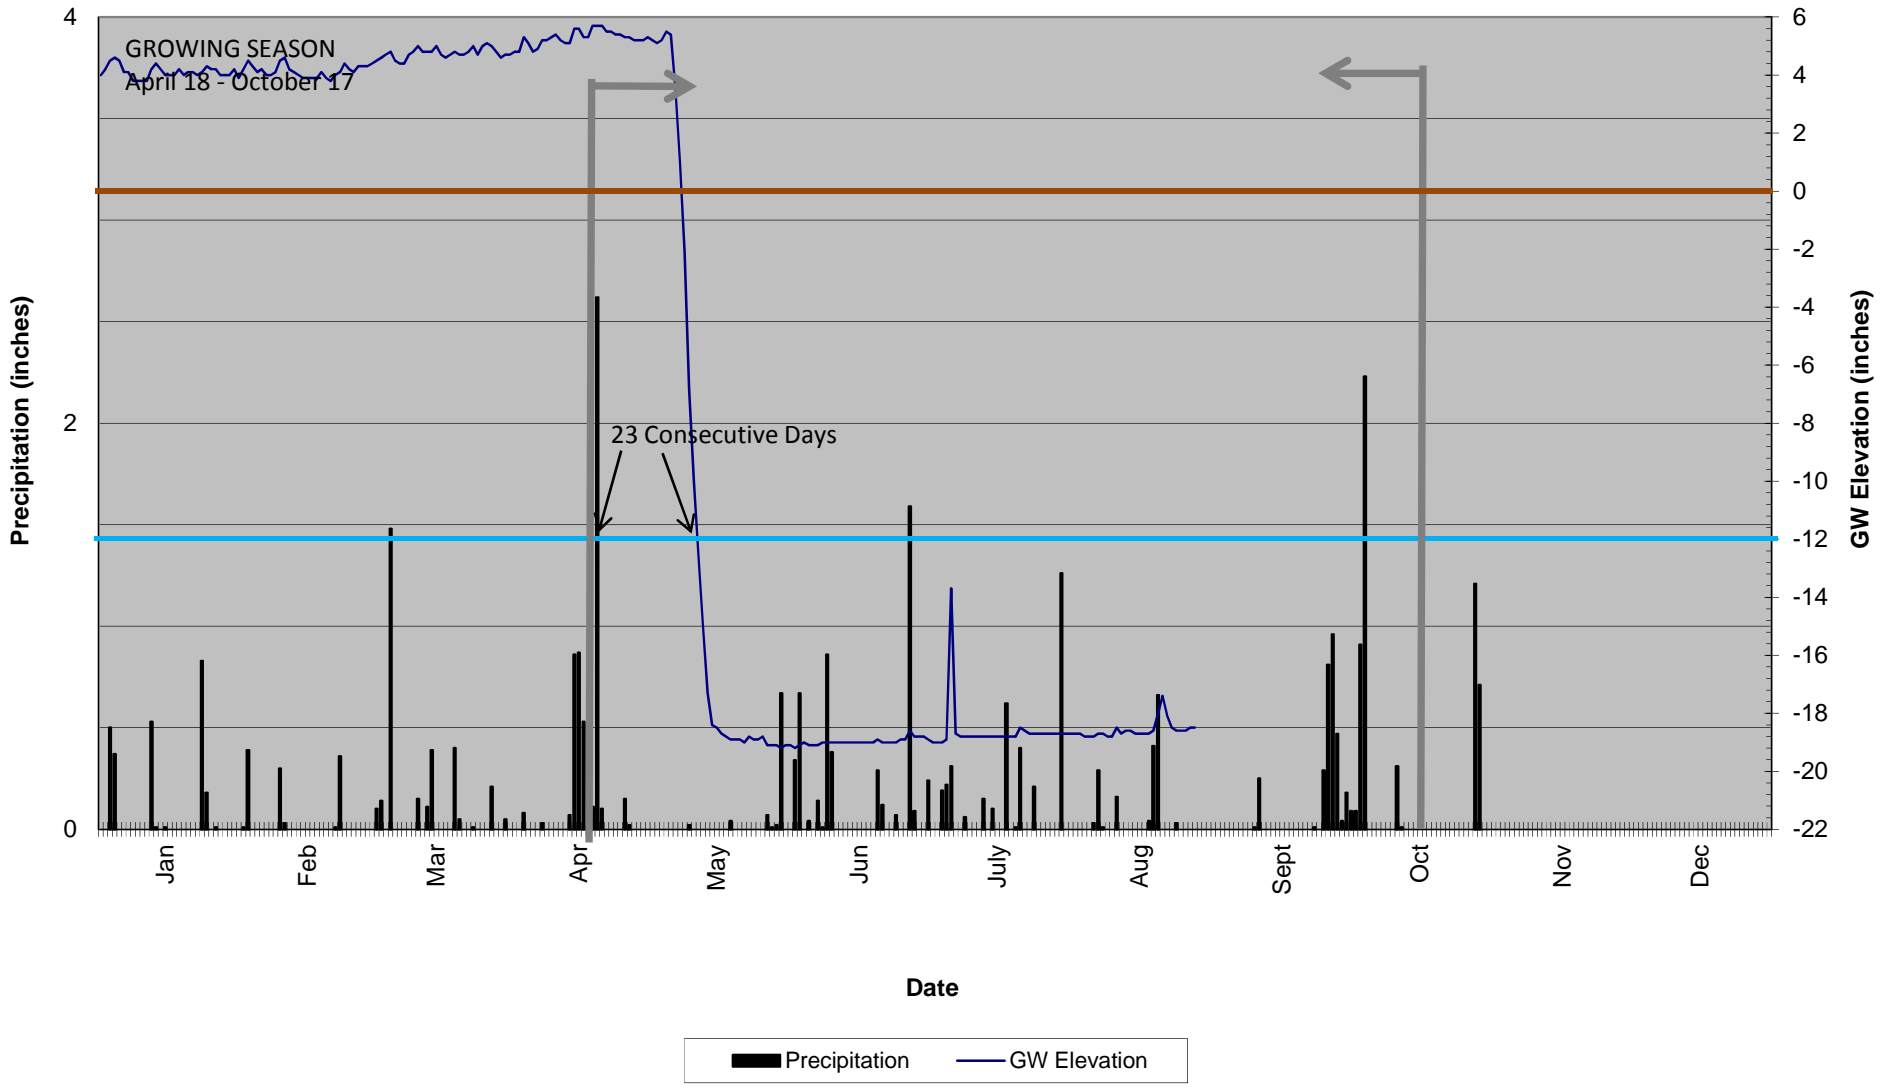
### Five Mile Branch Gauge #13 13D4A9D9

13	13D4A9D9	ok	ok	ok	No attempt.	ok	ok	No attempt.	Ok. Reprogrammed. Deleted old data.	ok	OK. Deleted old data. Replaced battery.	ok	Wrong logging dates. Reprogrammed.
14	13D4C9C5	ok	ok	ok	No attempt.	Failed	ok	No attempt.	OK. Deleted old data.	ok	OK. Deleted old data. Replaced battery.	ok	ok
15	A28B85B	ok	ok	ok	No attempt.	No attempt due to malfunctioning handheld.	No attempt.	No attempt.	Ok. Replaced battery. Deleted old data.	failed	OK. Deleted old data.	ok	ok
16	11312B9E	ok	Failed	ok	No attempt.	No attempt due to malfunctioning handheld.	No attempt. Submerged	No attempt.	Replaced with EBCFF2F	Partial data	OK. Deleted old data.	No attempt due to weather.	ok
17	14E16DE5	ok	ok	ok	No attempt.	No attempt due to malfunctioning handheld.	ok	No attempt.	Ok. Replaced battery. Deleted old data.	Partial data	OK. Deleted old data. Replaced battery.	No attempt due to weather.	OK. No data after 6/27. Reprogrammed.

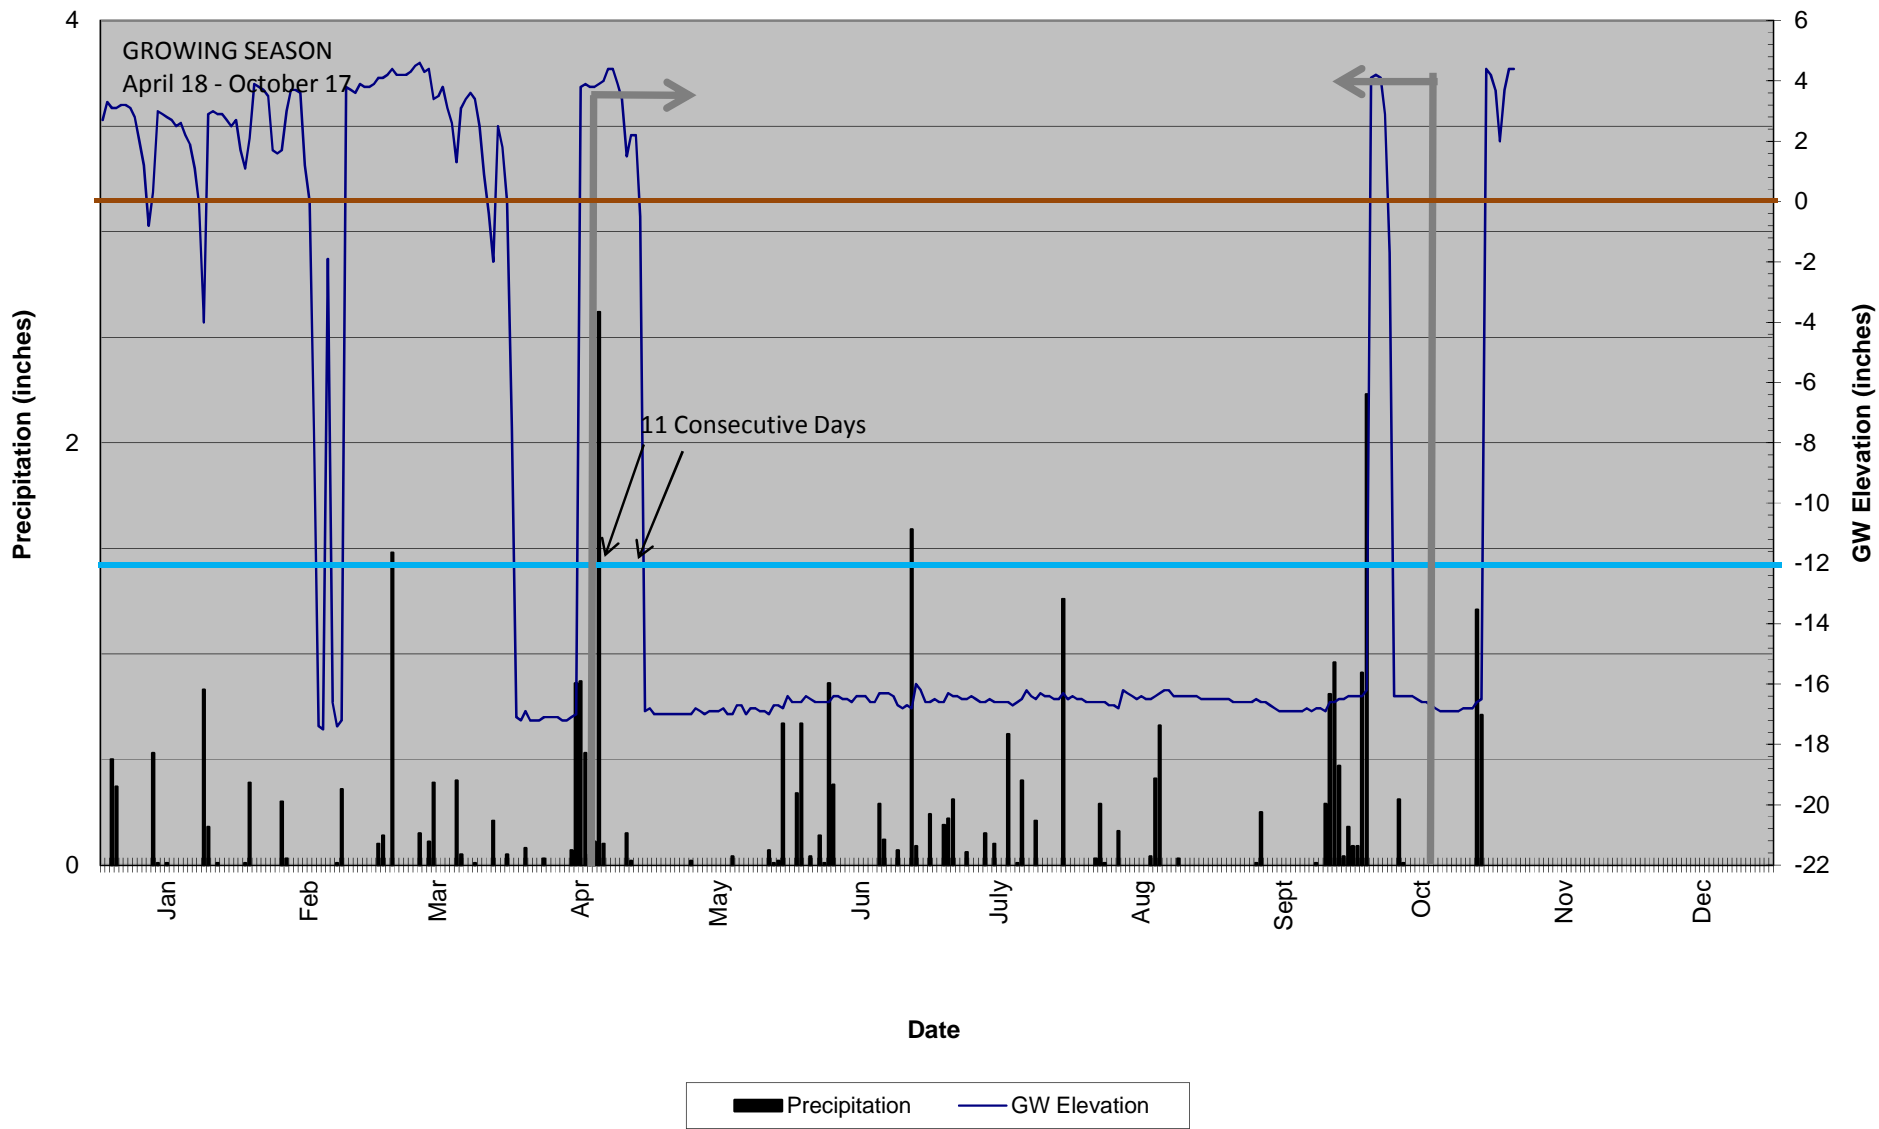
### Five Mile Branch Gauge #18 13D493A9

18	13153397	Failed	Replaced with 13D493A9.	No attempt due to accident.	No attempt. Could not locate.	No attempt due to malfunctioning handheld.	ok	No attempt.	OK. Deleted old data.	ok	OK. Deleted old data.	No attempt due to weather.	ok
19	14E15453	ok	ok	No attempt due to accident.	ok	No attempt due to malfunctioning handheld.	No attempt.	ok	Replaced with 13D4B648	Partial data	OK. Deleted old data.	ok	OK. Missing 10/29 - 11/7 data.
20	9DE6C32	ok	ok	No attempt due to accident.	ok	No attempt due to malfunctioning handheld.	No attempt.	ok	OK. Deleted old data.	ok	OK. Deleted old data.	ok	ok
21	9DE6D1F	ok	ok	No attempt due to accident.	ok	No attempt due to malfunctioning handheld.	No attempt.	ok	Failed	ok	OK. Deleted old data.	ok	ok
22	EBD1038	ok	ok	No attempt due to accident.	ok	No attempt due to malfunctioning handheld.	No attempt.	ok	OK. Deleted old data.	ok	OK. Deleted old data.	ok	ok
23	13D4B61D	ok	ok	No attempt due to accident.	ok	No attempt due to malfunctioning handheld.	No attempt.	ok	OK. Deleted old data.	ok	OK. Deleted old data.	ok	ok

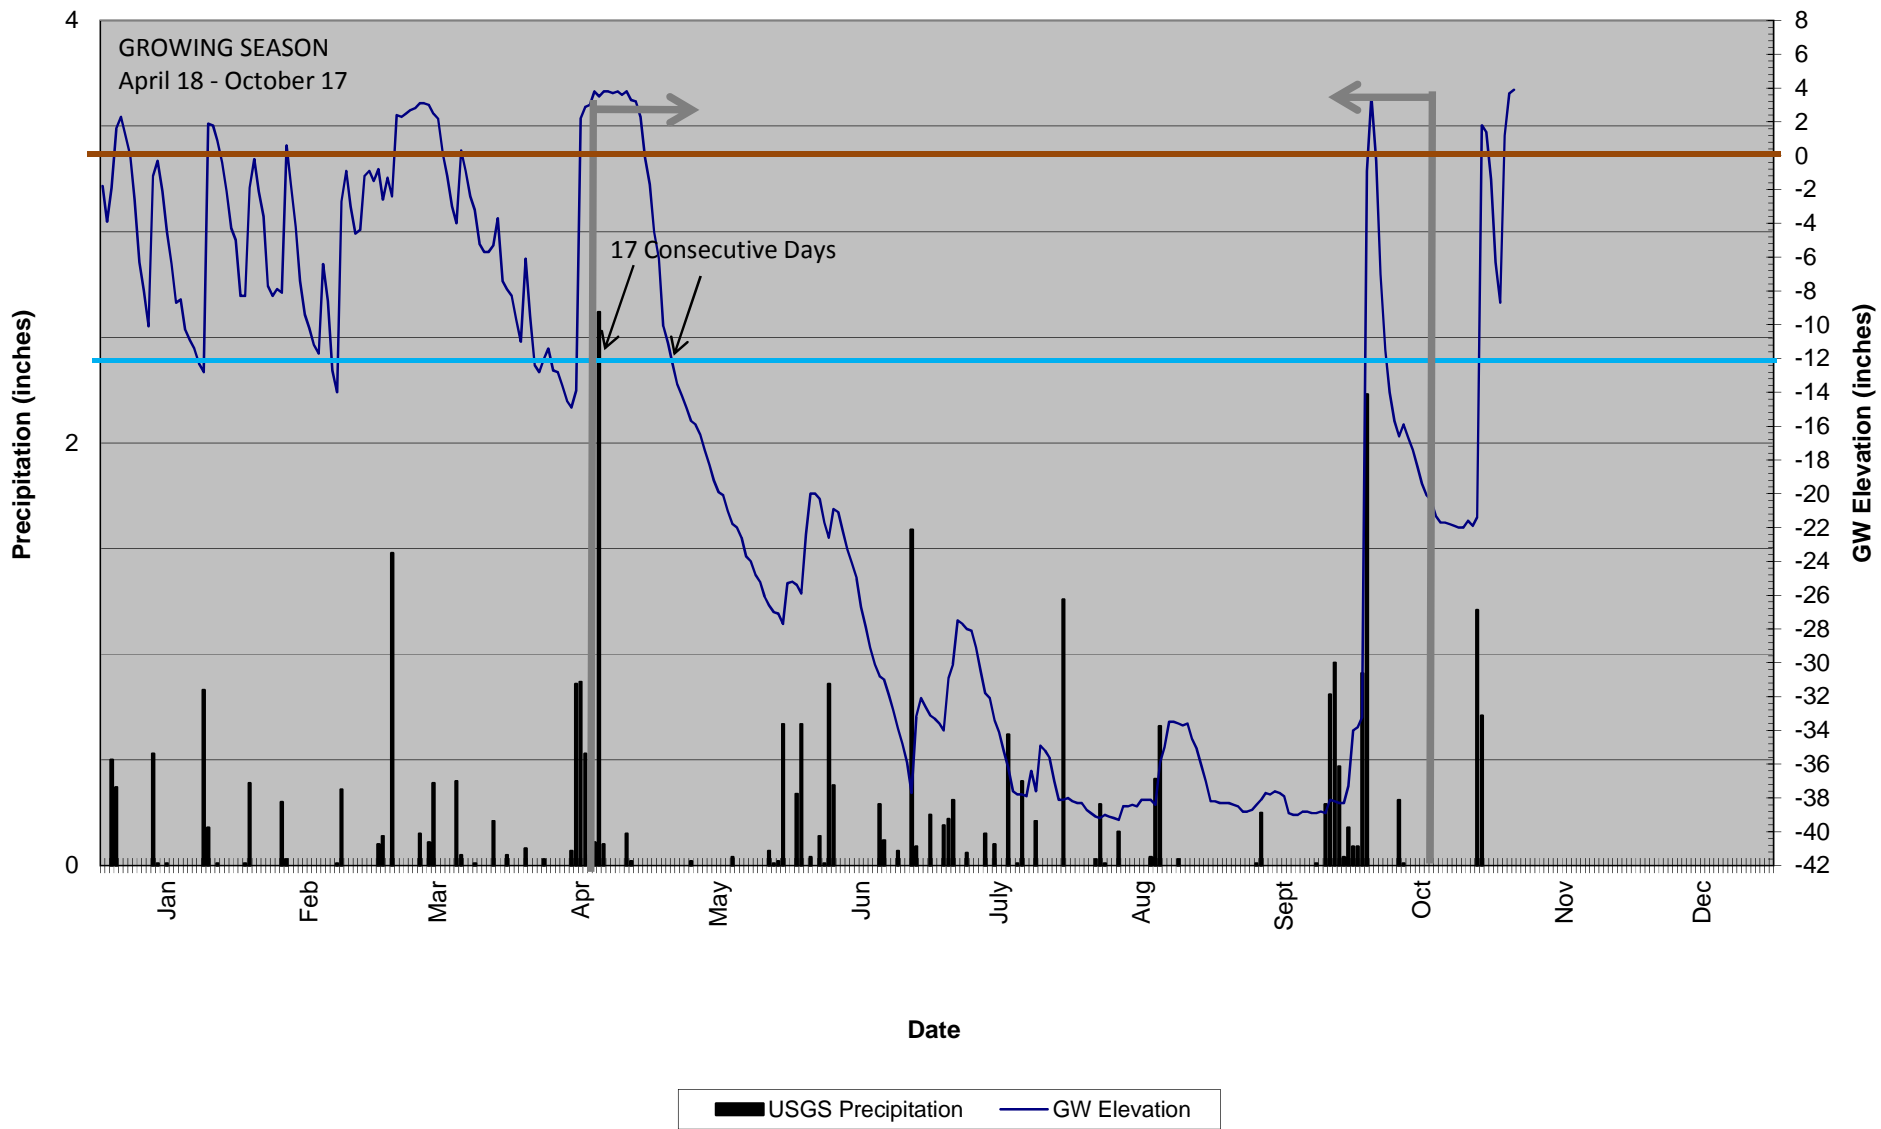
### Five Mile Branch Gauge #30 13D4CA00

30	13D4CA00	ok	ok	No attempt due to accident.	No attempt.	No attempt due to malfunctioning handheld.	No attempt.	ok	OK. Deleted old data.	ok	OK. Deleted old data.	ok	ok
RAIN	13D4BAF9	ok	ok	ok full of ants	No attempt.	Failed. Silt in gauge from flooding.	Failed	Failed	No attempt. Wasp nest on gauge.	No attempt	No attempt	No attempt	No attempt
