YEAR 4 OF 5 MONITORING REPORT - FINAL

**Five-Mile Branch Stream and Wetland Restoration, Iredell County
NCDMS IMS ID# 92185**

**North Carolina Department of Environmental Quality,
Division of Mitigation Services Raleigh North Carolina**

April 25, 2017

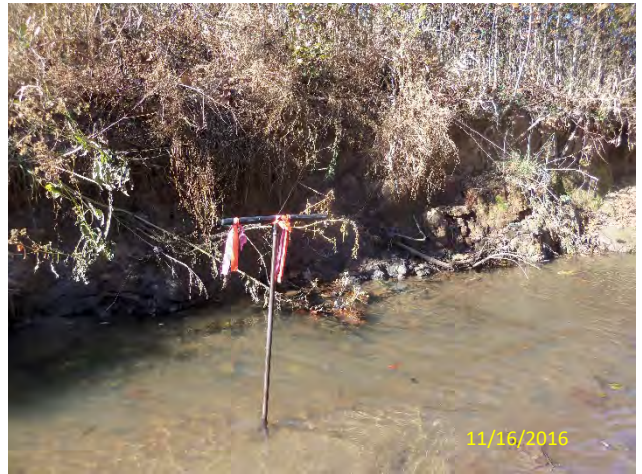
Bank Erosion 29+00 BVR

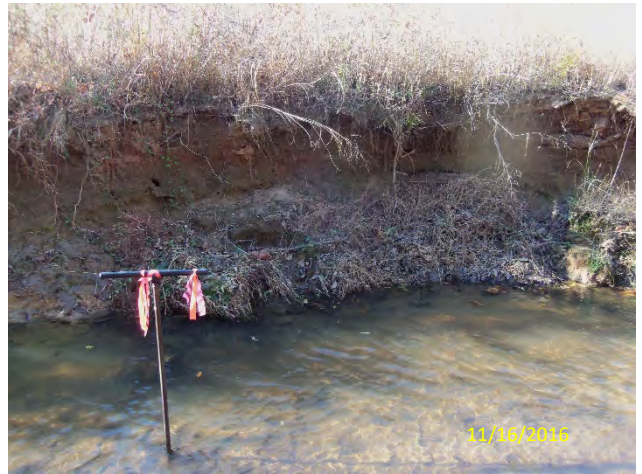
Bank Erosion 34+25 BVR

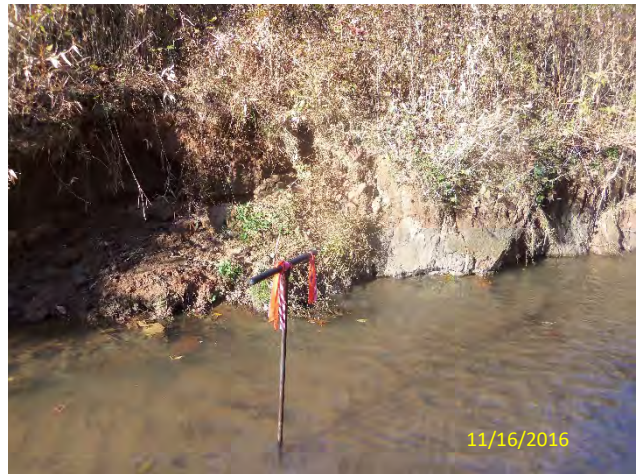
Bank Erosion 41+00 BVR

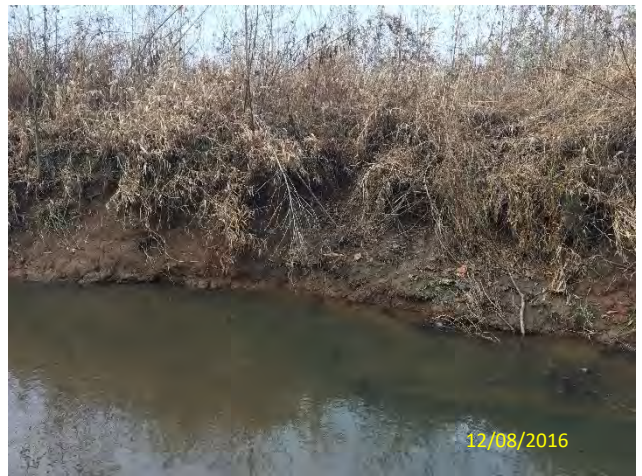
Bank Erosion 67+00 FTH

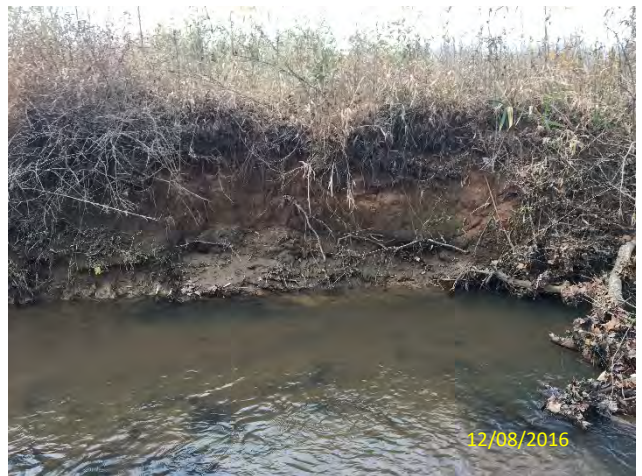
Bank Erosion 73+25 FTH
