Fletcher Stream and Wetland Mitigation Site

Annual Monitoring Report

Monitoring Year 3 of 7

Henderson County, North Carolina

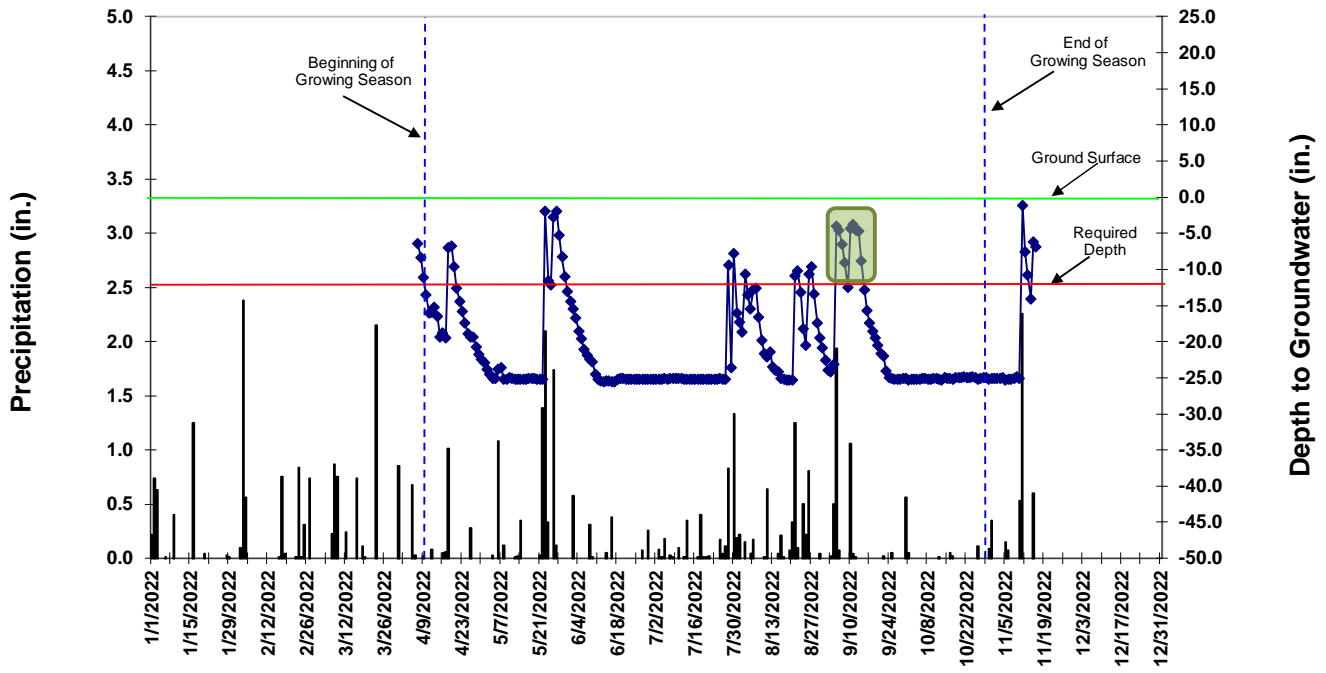
Gauge ID: **MW3**
Total Number of Consecutive Days Water Table within 12 inches of Soil Surface: **23**
Percentage of Growing Season Water Table within 12 inches of Soil Surface: **11%**

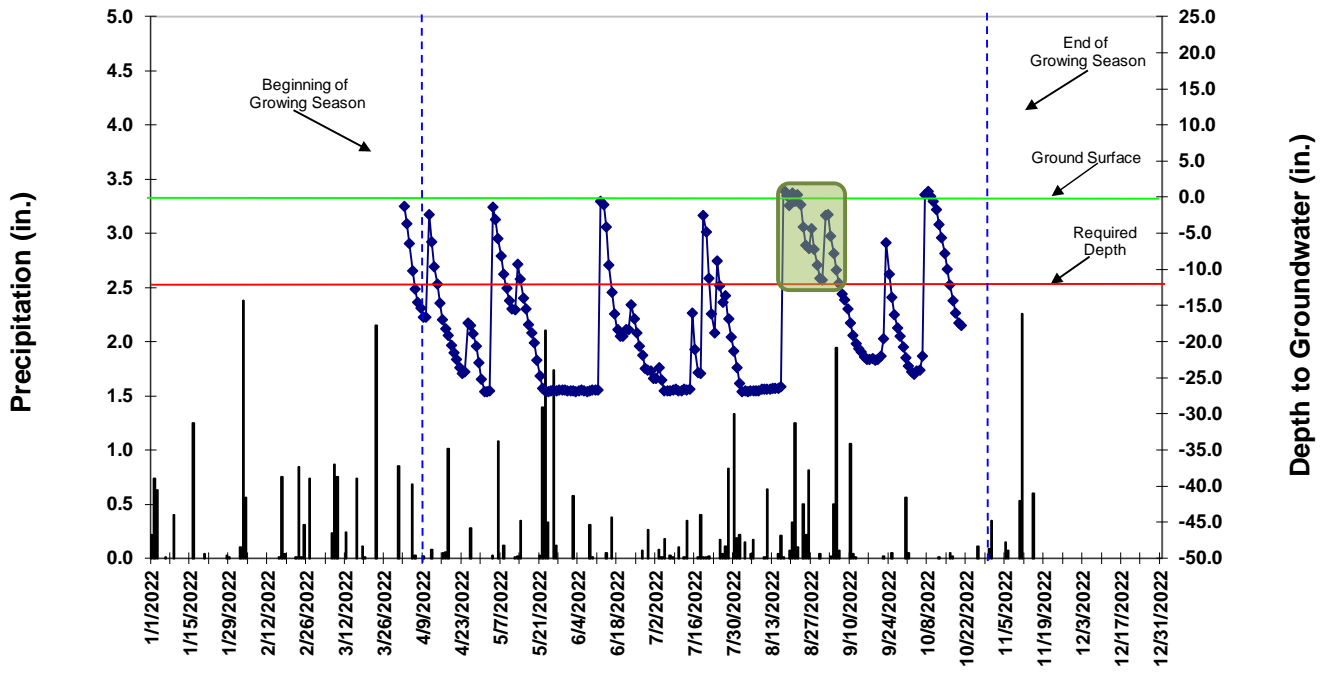
Gauge ID: **MW8**
Total Number of Consecutive Days Water Table within 12 inches of Soil Surface: **21**
Percentage of Growing Season Water Table within 12 inches of Soil Surface: **10%**

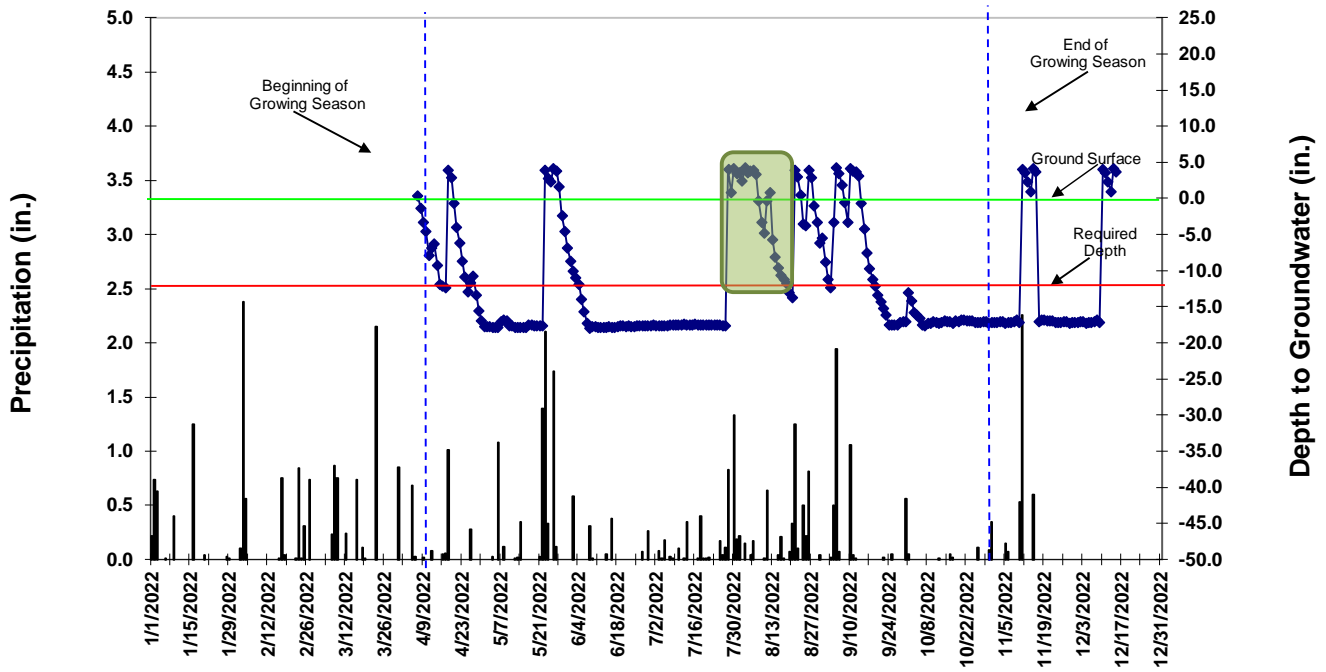
Gauge ID: **MW9**
Total Number of Consecutive Days Water Table within 12 inches of Soil Surface: **22**
Percentage of Growing Season Water Table within 12 inches of Soil Surface: **11%**
