# **Fletcher Stream and Wetland Mitigation Site**

## **Annual Monitoring Report**

Monitoring Year 4 of 7

Fletcher Stream and Wetland Mitigation Site

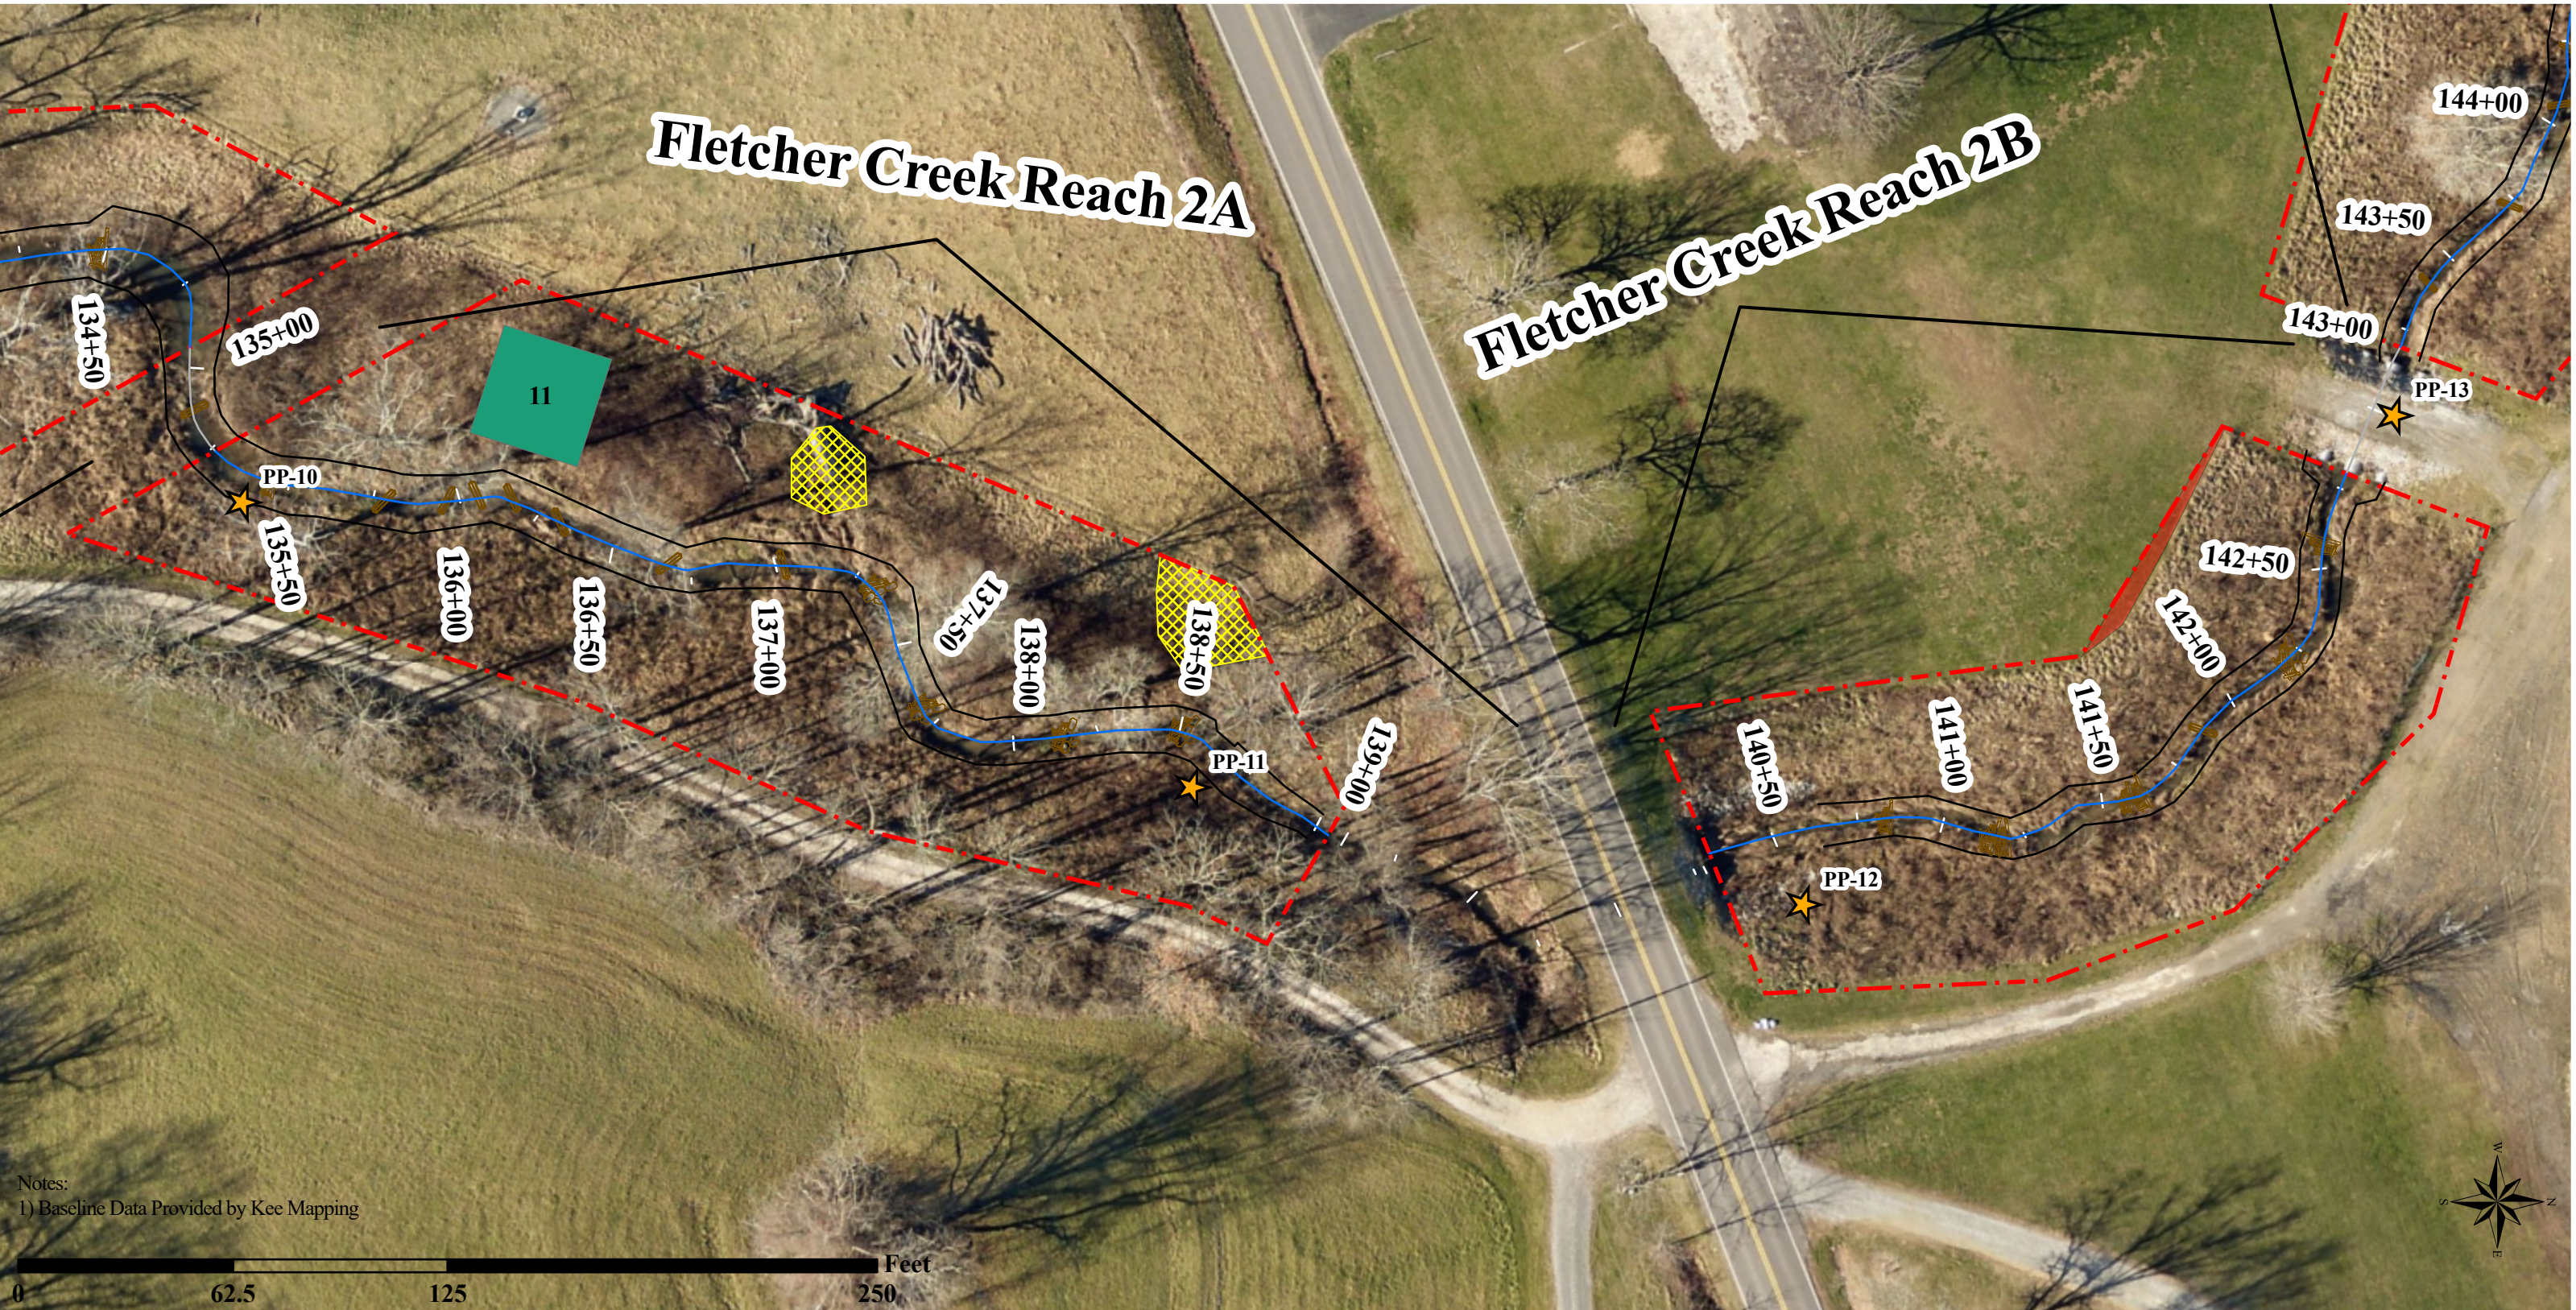
Current Condition Plan View  
Fletcher Mitigation Site  
Monitoring Year 4  
Henderson County, NC  
NCDMS Contract No.: 006997  
NCDMS Project No.: 100004  
December 2023  
Sheet 4 of 12

- Bank erosion was noted in the prior year’s monitoring report (MY3) near Fletcher Creek STA 142+50; however this area is not noted on the CCPV (Sheet #4) or included in the photo section in the MY4 report. Was this area repaired or has it healed over? If not please provide an update on its condition, along with any applicable supportive data/photos. **The area has healed over.**

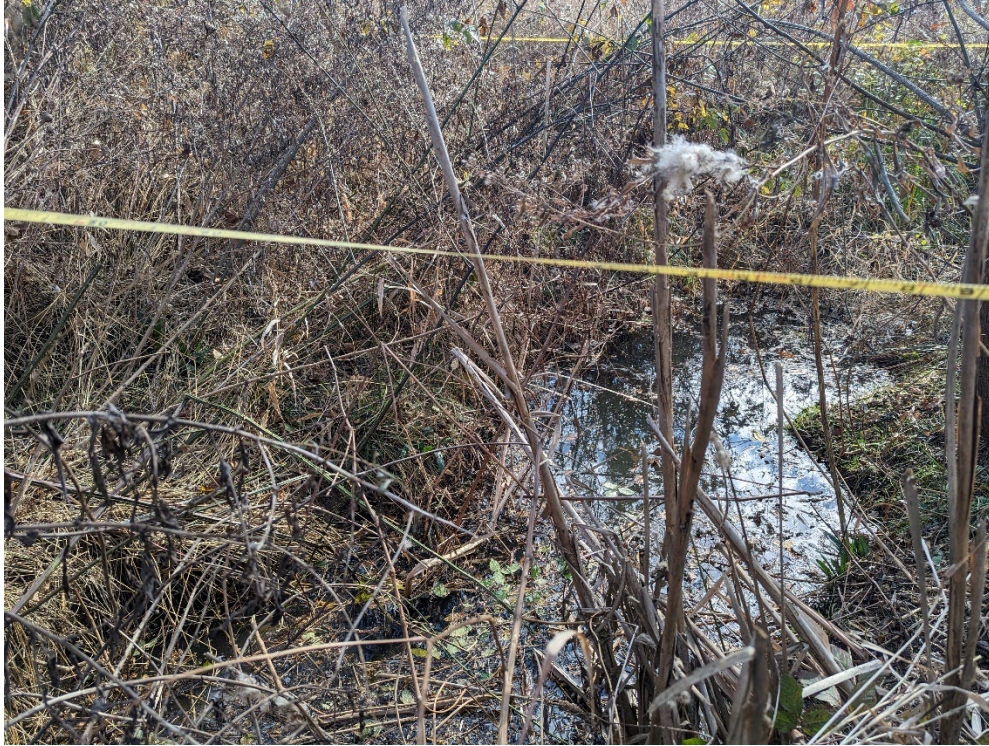
- Please include the project stream basin and HUC on the report cover. **Added**
- At the 2023 Credit Release Meeting, the IRT requested an update of the failing structure in the XS 10 area along Fletcher Creek Reach 2A, and photos (beyond the graph photo) in the MY4 report. Please provide this. **The photographs presented with the cross-section provide the best representation of the area. A problem area photo for this location was added to the report and electronic files.**

3. Cross Section 10, failed structure and extended pool, Station 133+50
