**Fletcher-Meritor Site
(UT to Cane Creek) Stream and Wetland Restoration
Project No: 138**

Monitoring Report Year 2 of 5

Henderson County, North Carolina

Construction Complete: May 2012
Data Collected: May 2014
Report Submission: December 2014

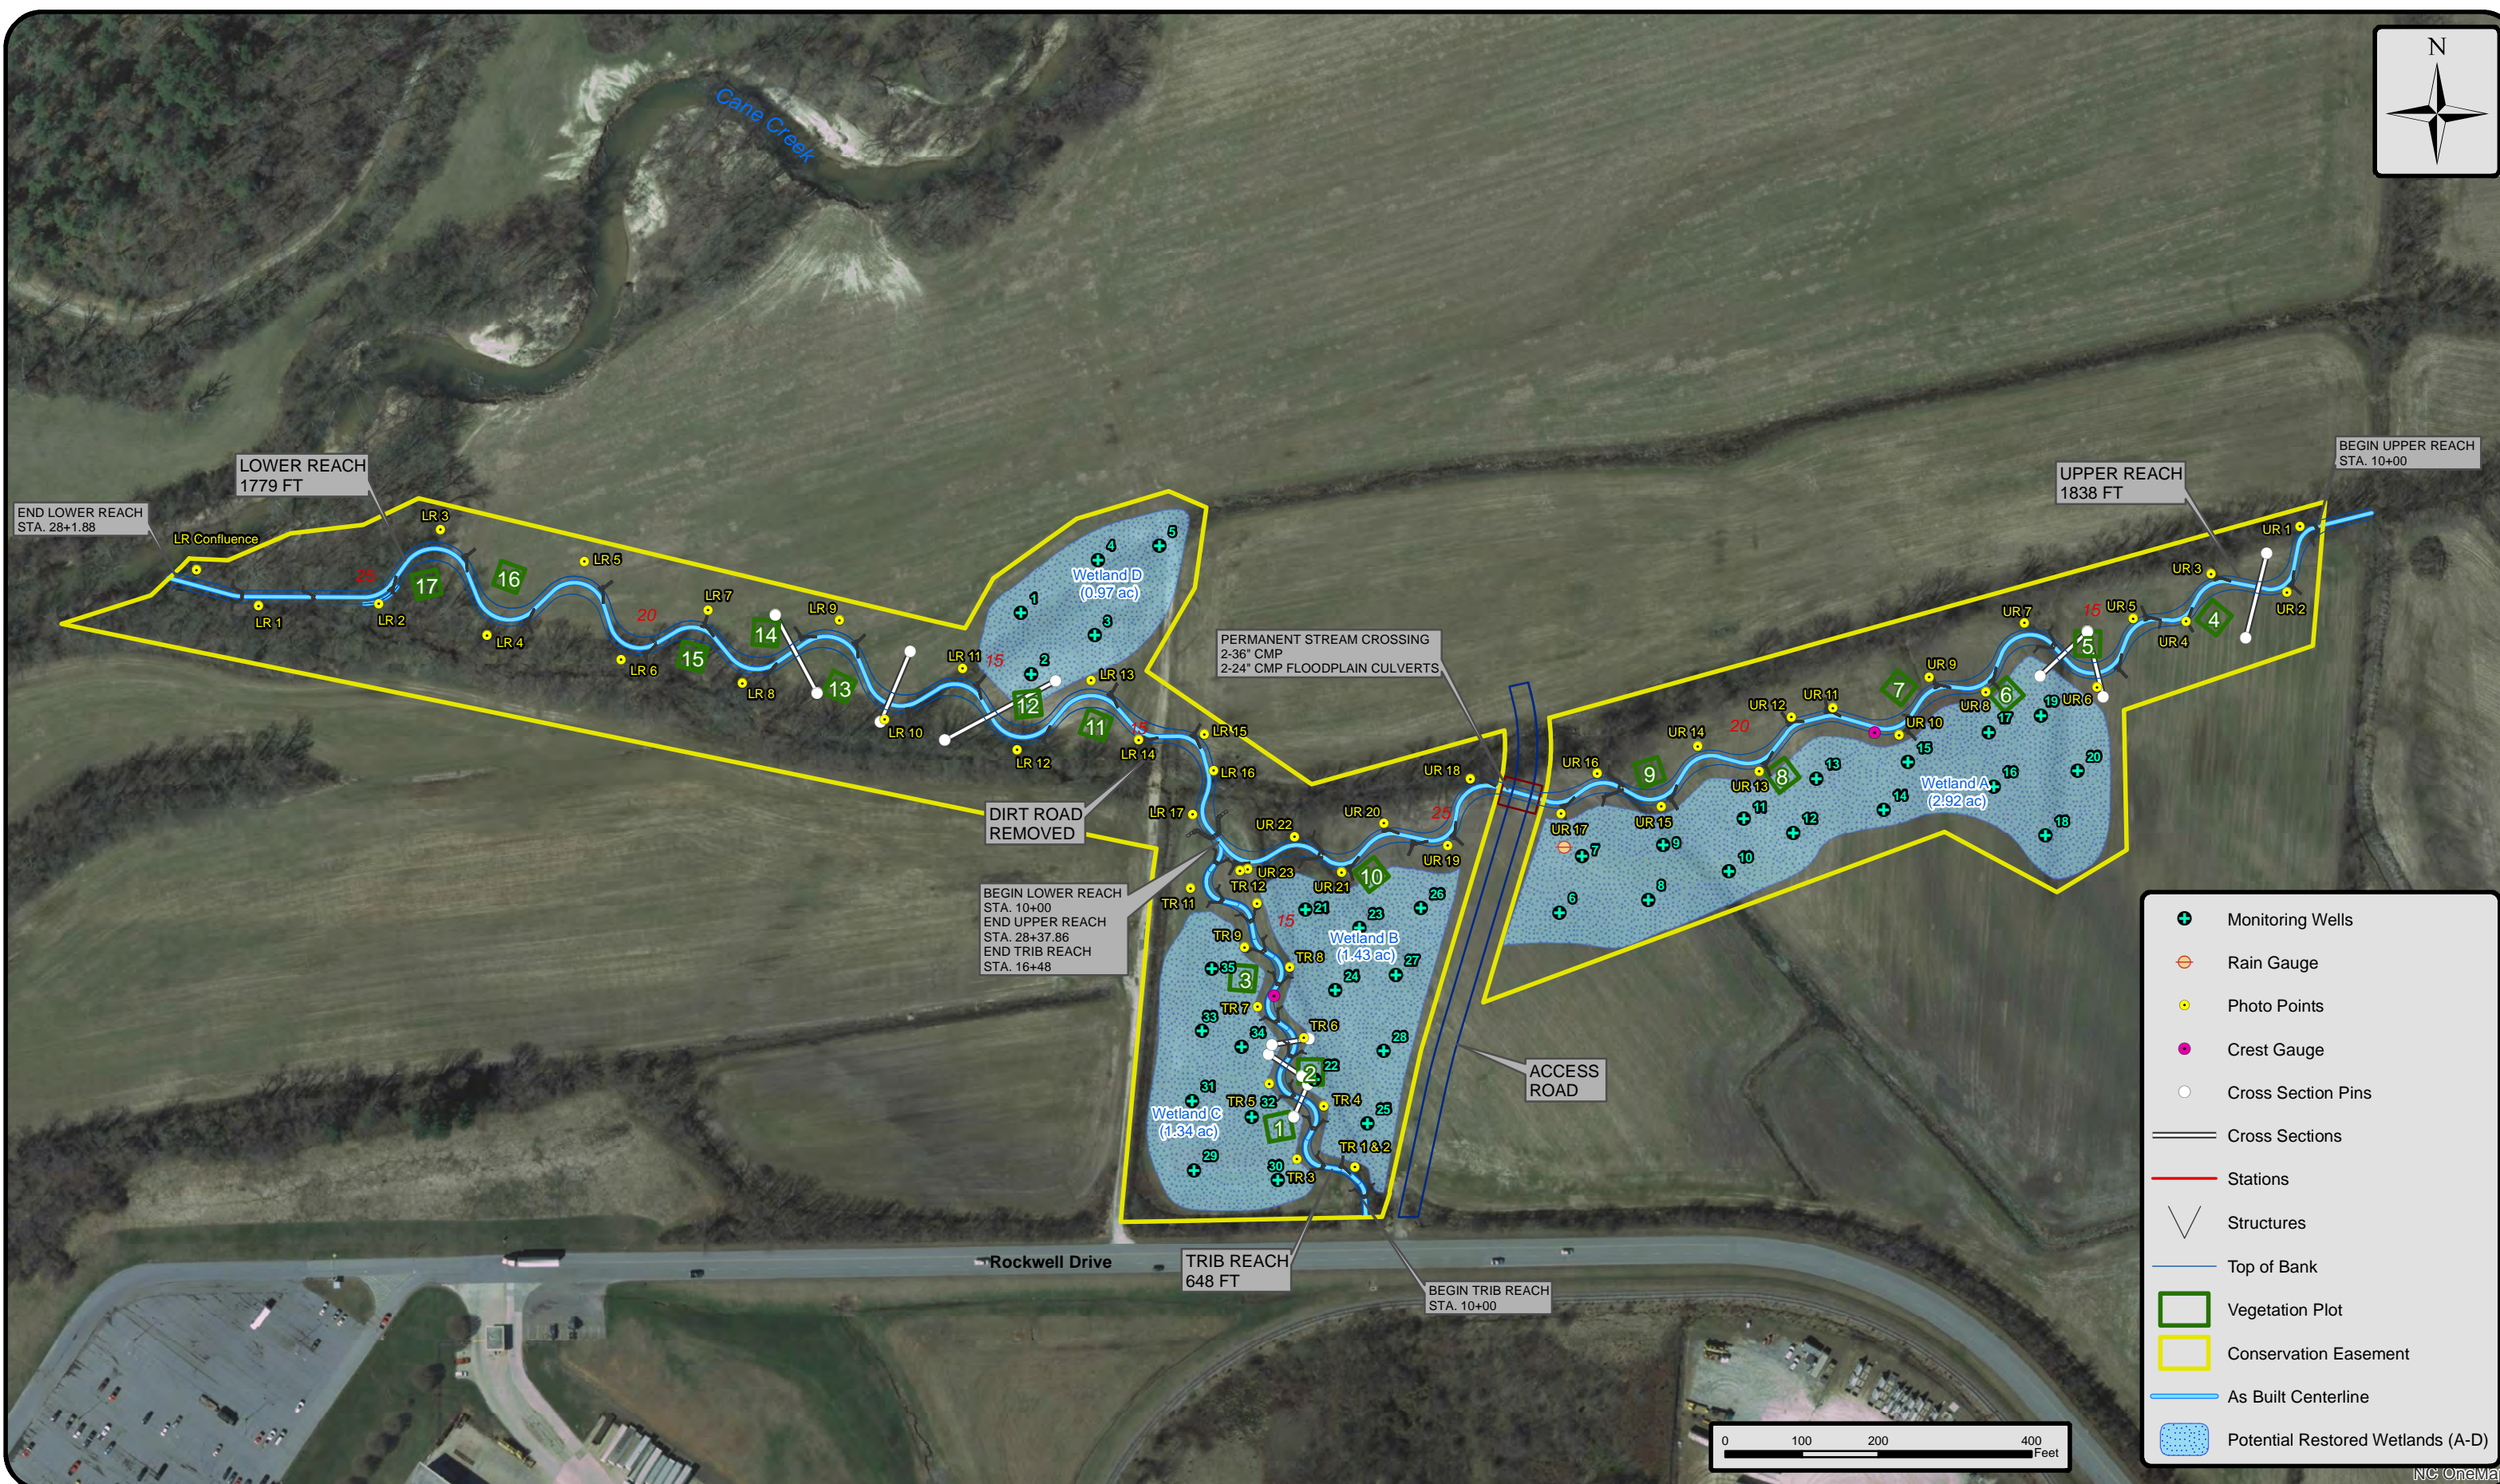
Current Conditions Plan View
Figure 3a

Numerous locations were noted along the reaches as having sparse vegetation during the monitoring event. This could be due to climatic reasons as well as backwater effects and deposition on the floodplain. These areas are illustrated on the Current Condition Plan View (CCPV) in Appendix B. In addition to these locations, there is a large area of cattails (*Typha latifolia*) growing within the upper wetland area. The cattails are not posing problems to the reaches currently; however, this location provides a seed source and should be watched. Cattails have created issues when stands grow within streams by out-competing other riparian herbaceous species and creating potential areas for aggradation. No easement encroachments were noted on the project site although farming activities continue to occur in close proximity. Also, a nearby area has been grassed and maintained for a local group of model airplane enthusiasts.

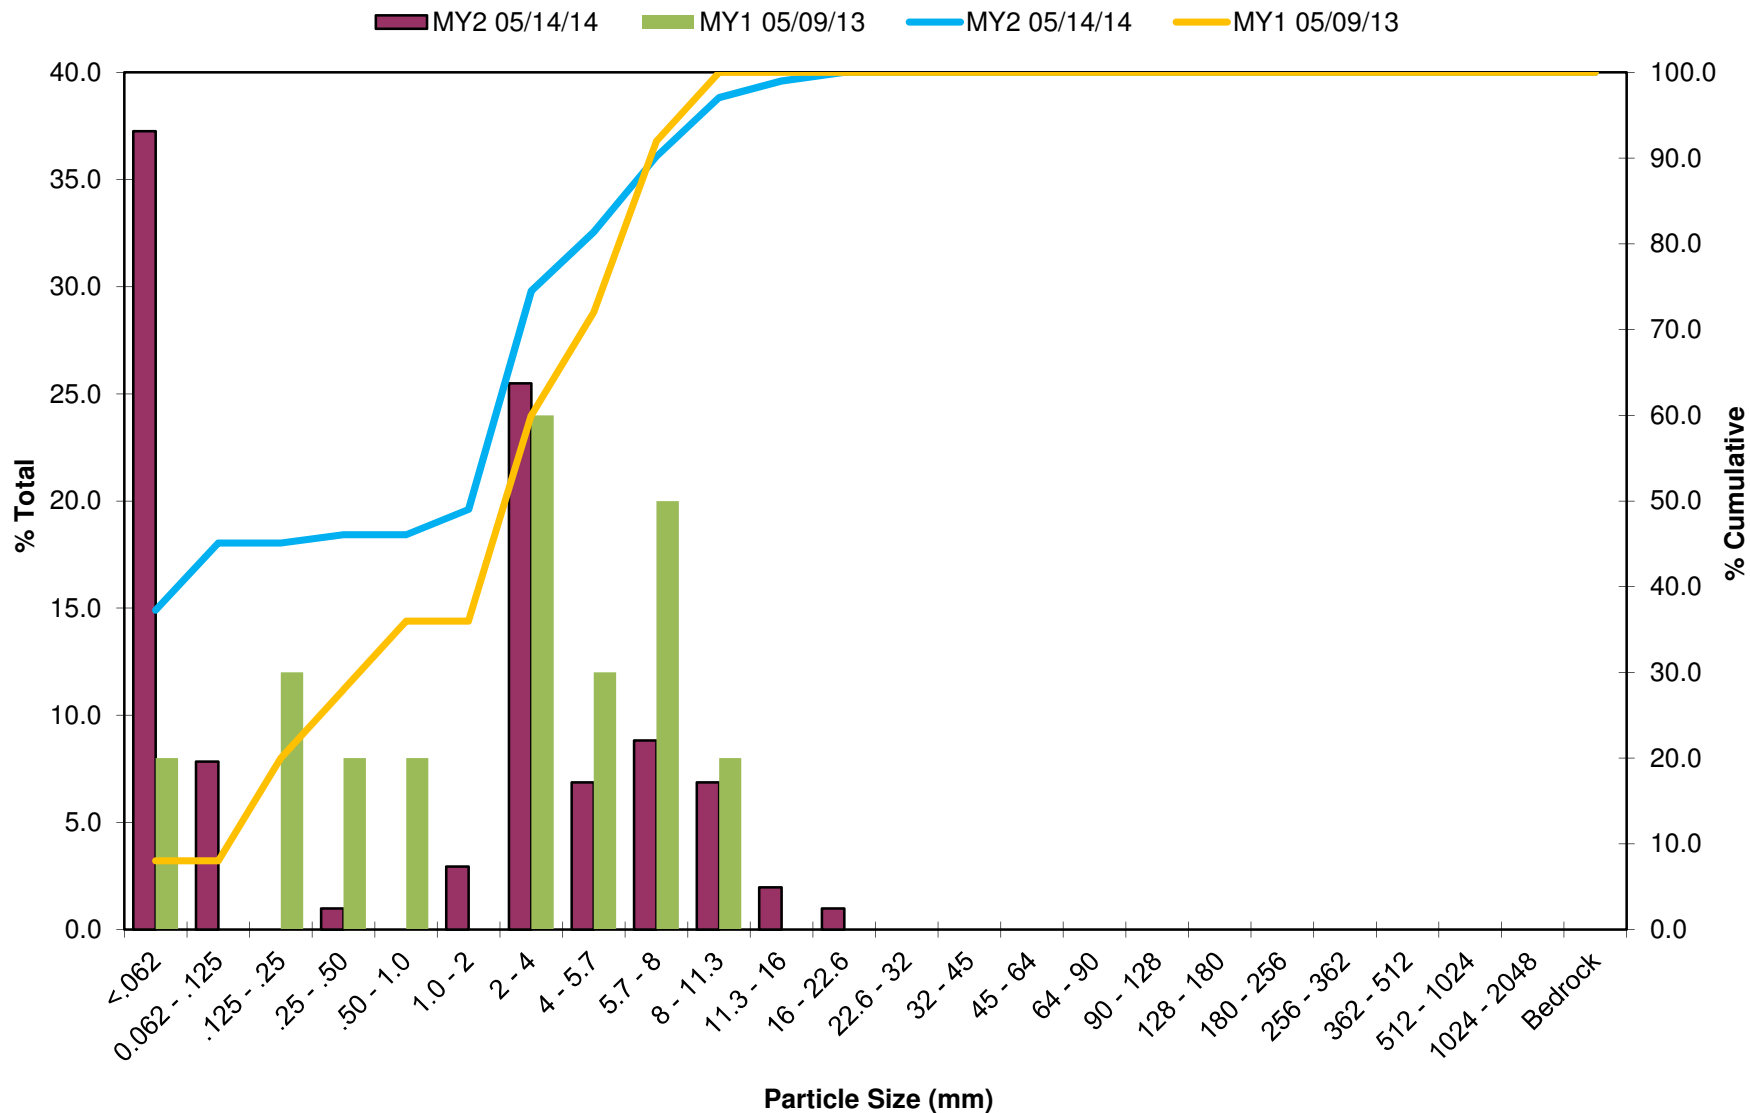
Pebble count at XSC-1-Riffle

Small changes to D50 were observed in the two upper reach riffle sections. For XSC1, significantly more silt/clays were counted in year 2. However, there is still a good presence of fine and small gravels such

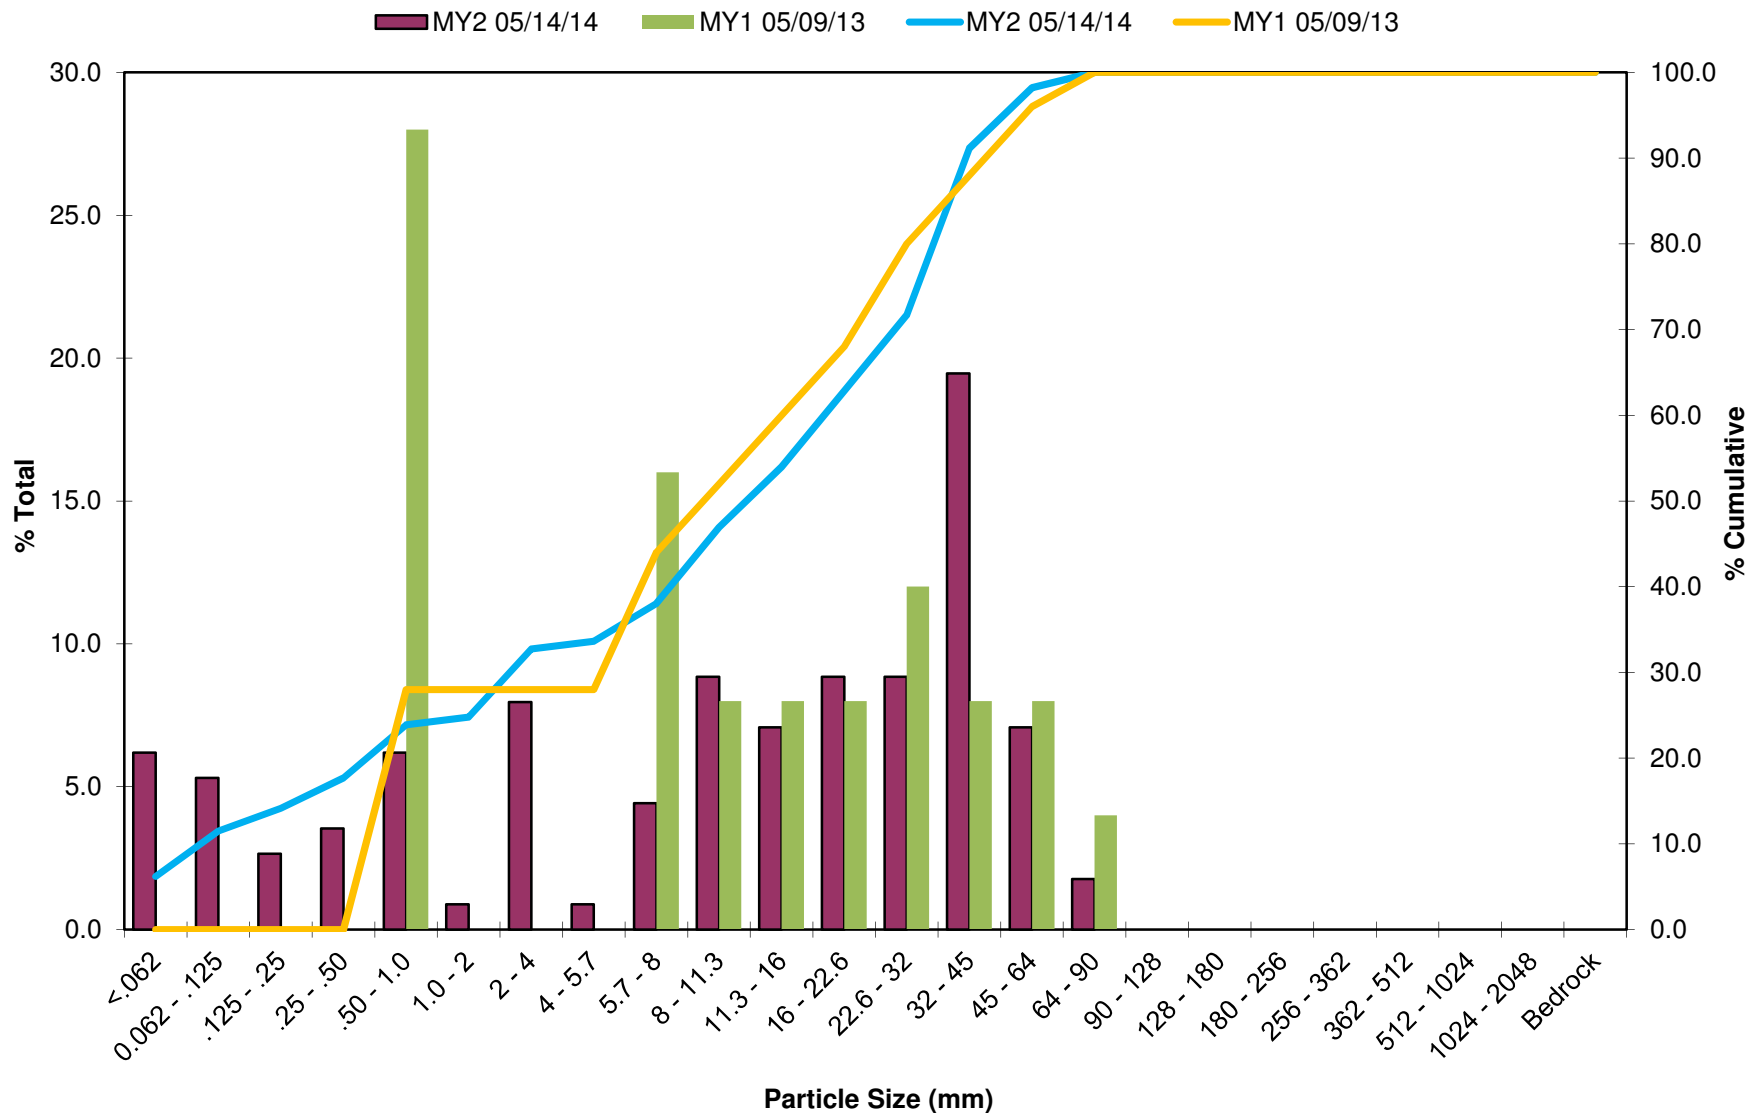
Pebble count at XSC-4-Riffle

Lower Reach values for predicted movable particle size versus D50 from pebble counts are very similar indicating stable conditions. For XSC4, the predicted movable particle size is 14mm compared to the observed D50 of 13mm. Riffle XSC6 has a predicted movable particle size of 12mm compared to an observed D50 of 17mm.
