**Fletcher-Meritor Site
(UT to Cane Creek) Stream and Wetland Restoration
Project No: 138**

Monitoring Report Year 3 of 5

Henderson County, North Carolina

HDR Engineering
555 Fayetteville Street, Suite 900
Raleigh, NC 27601

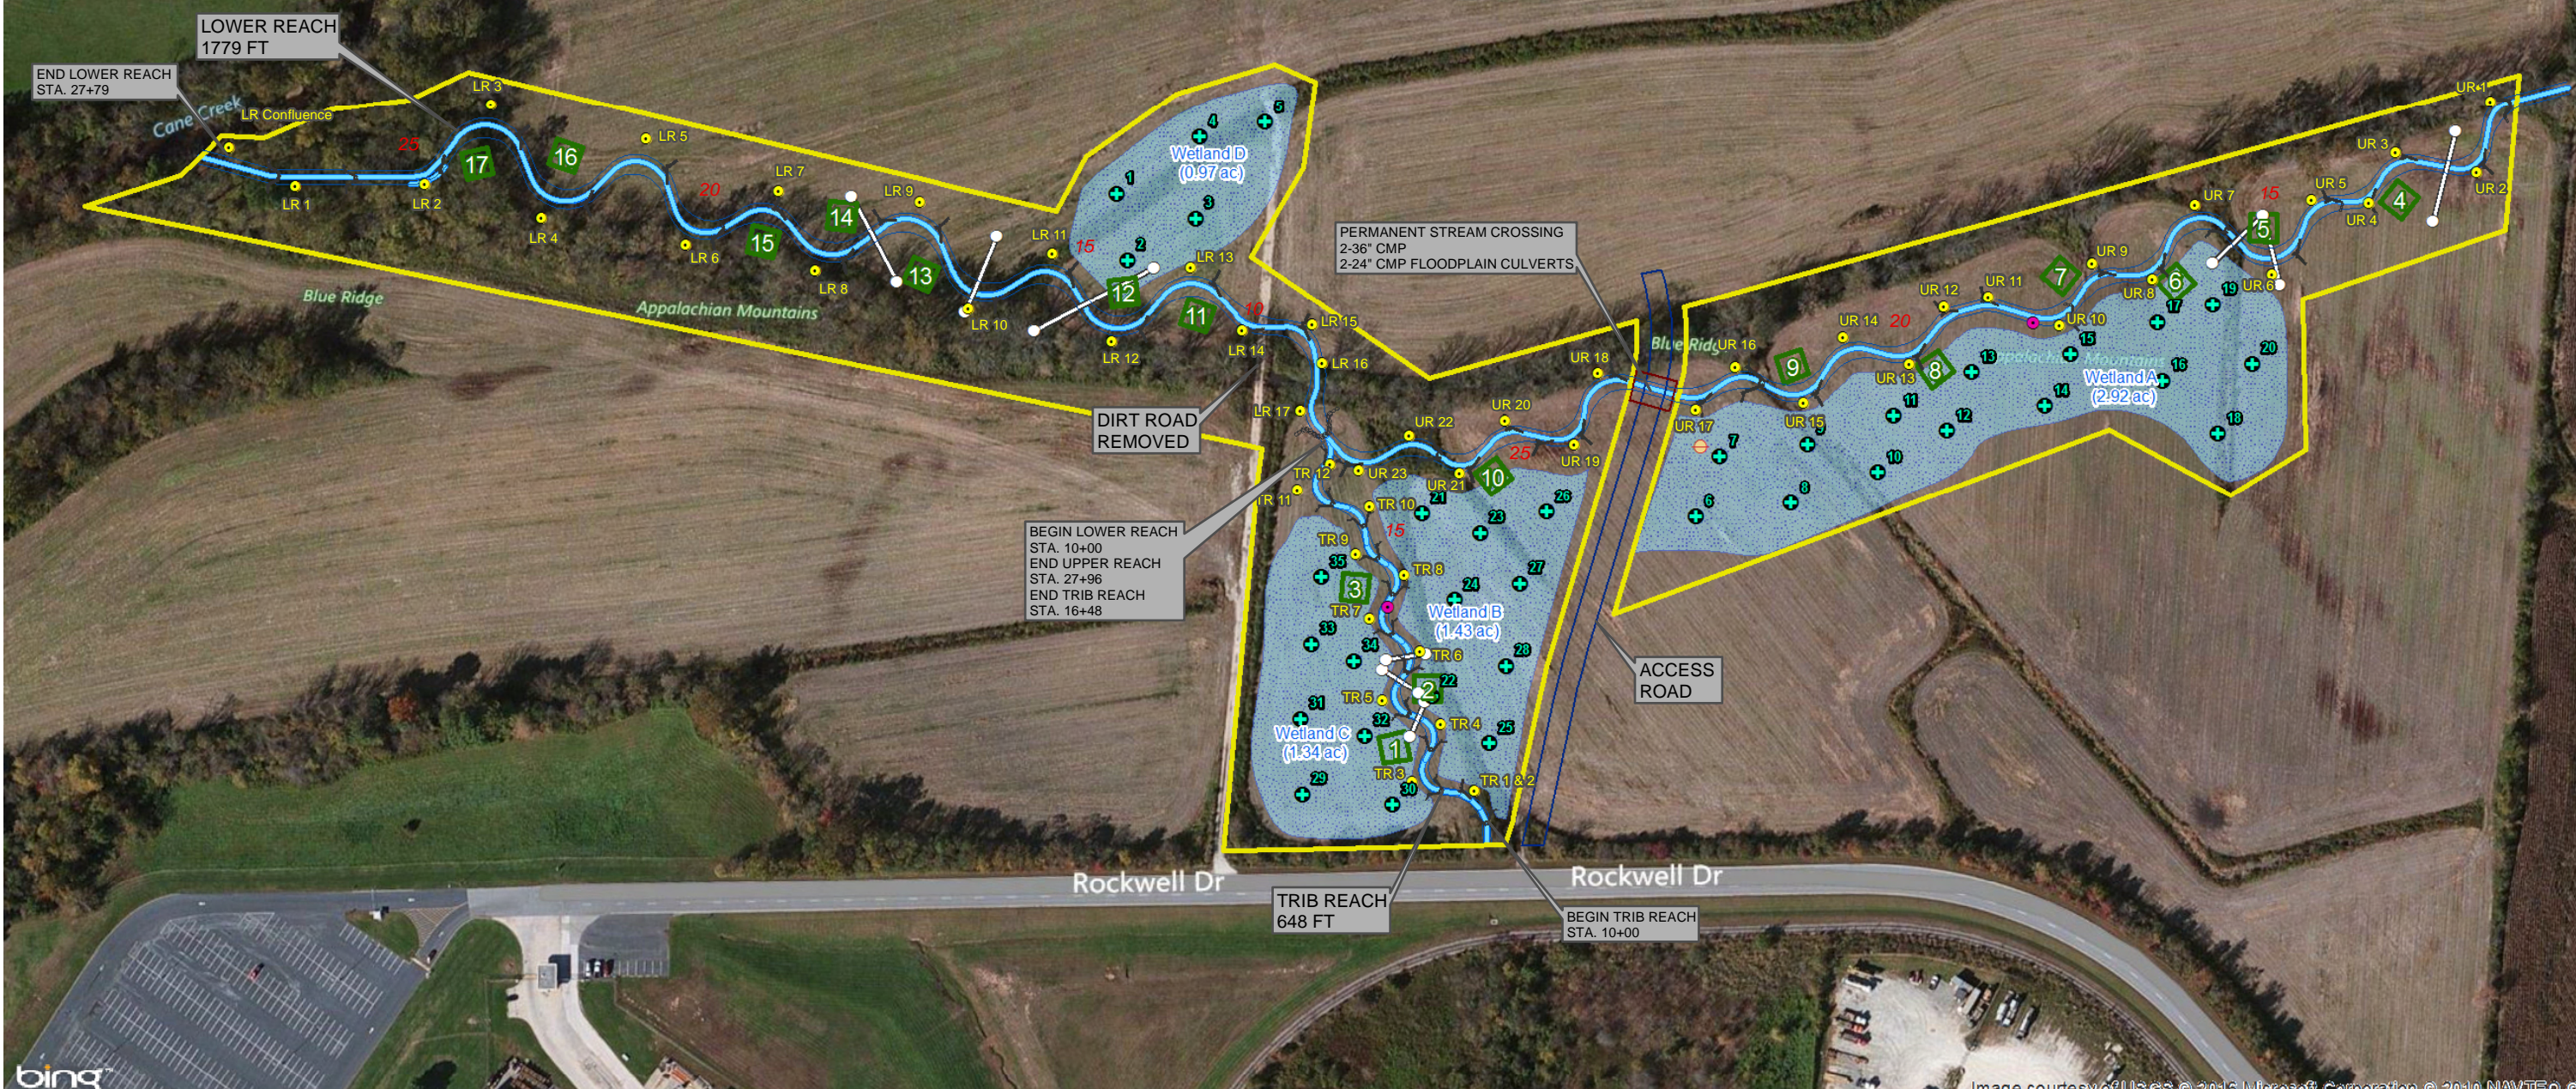
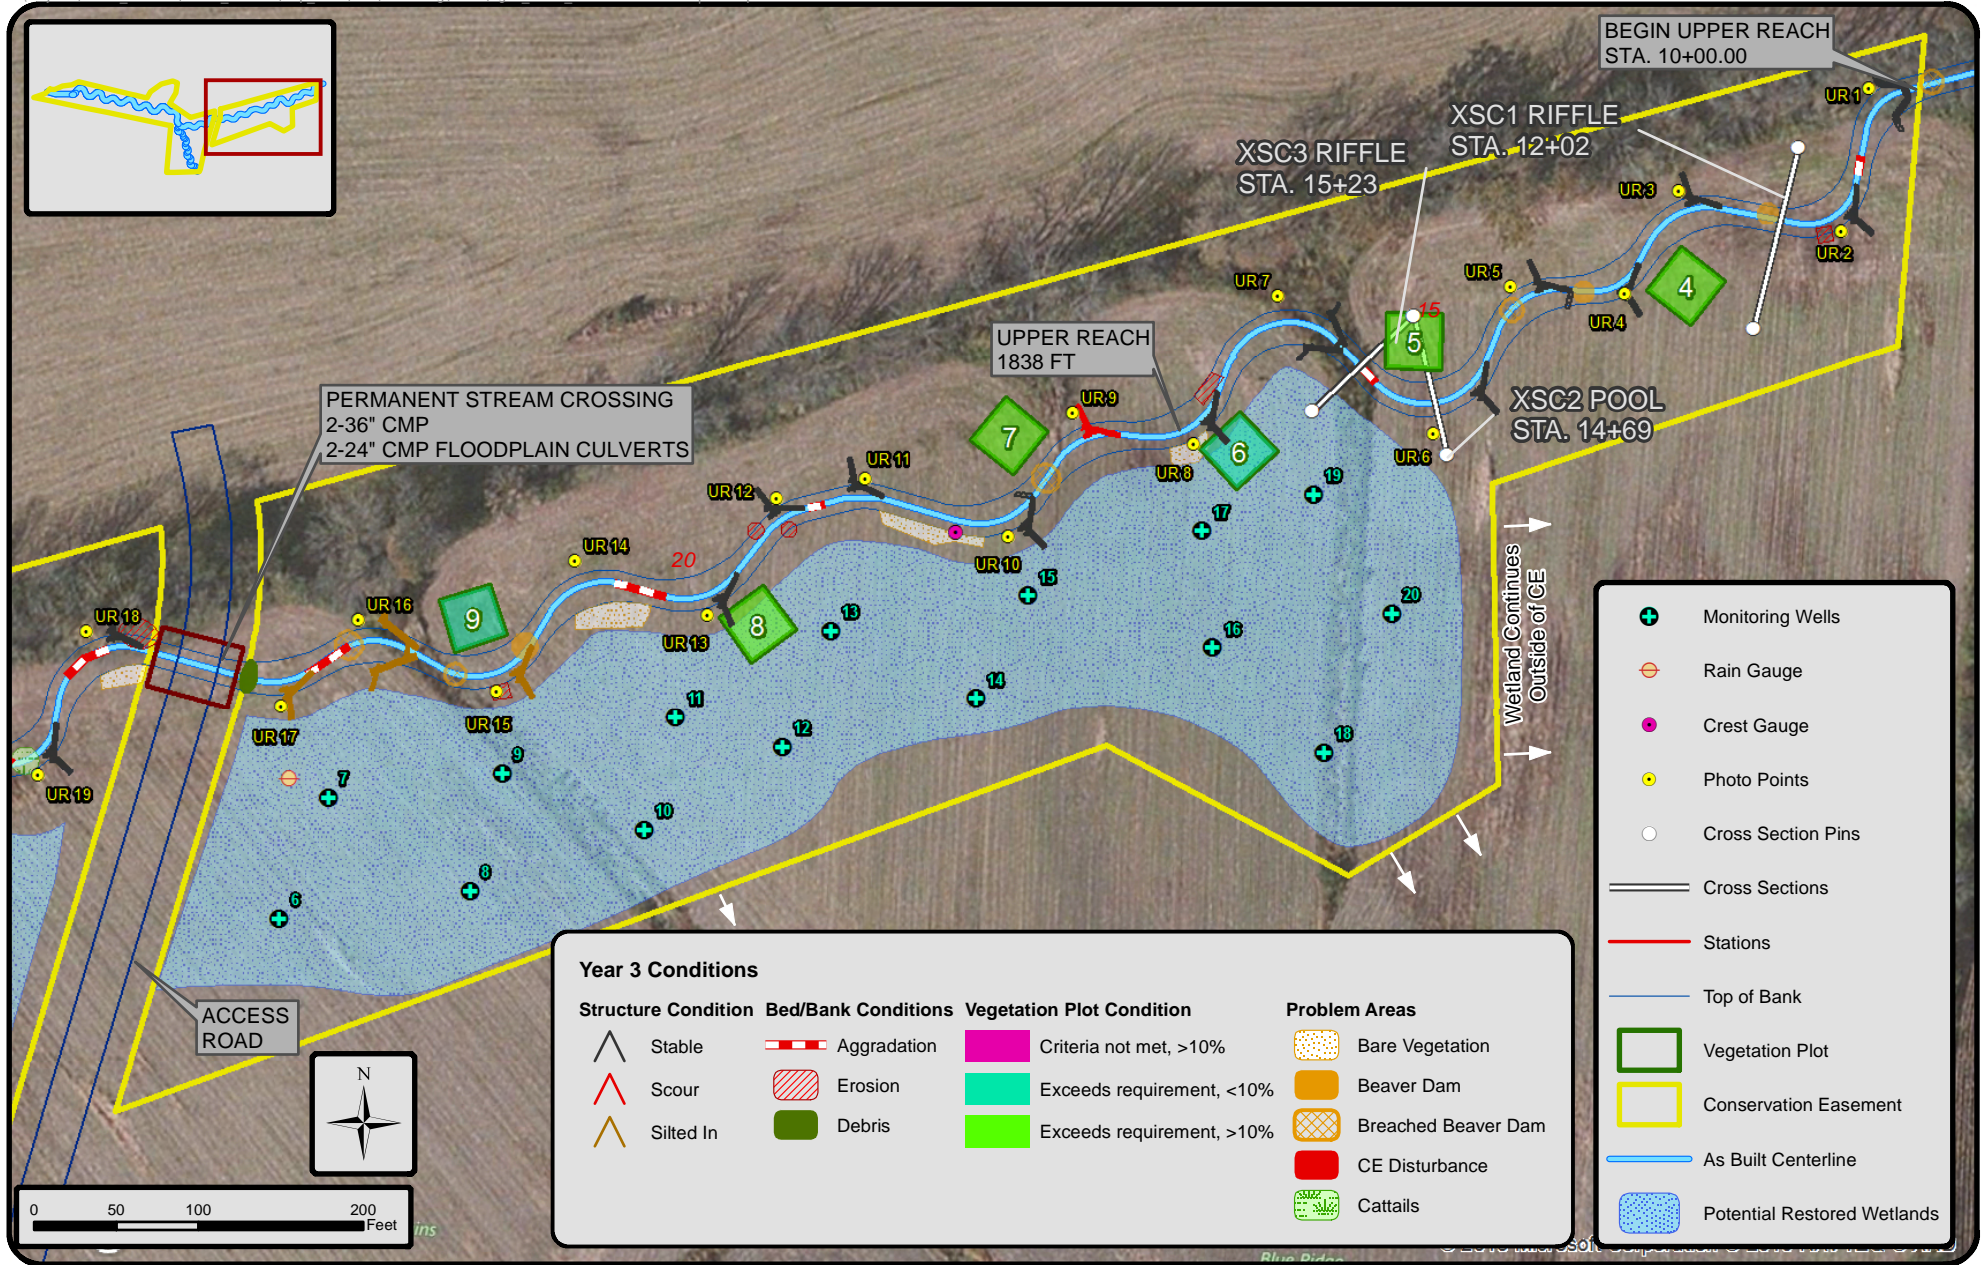
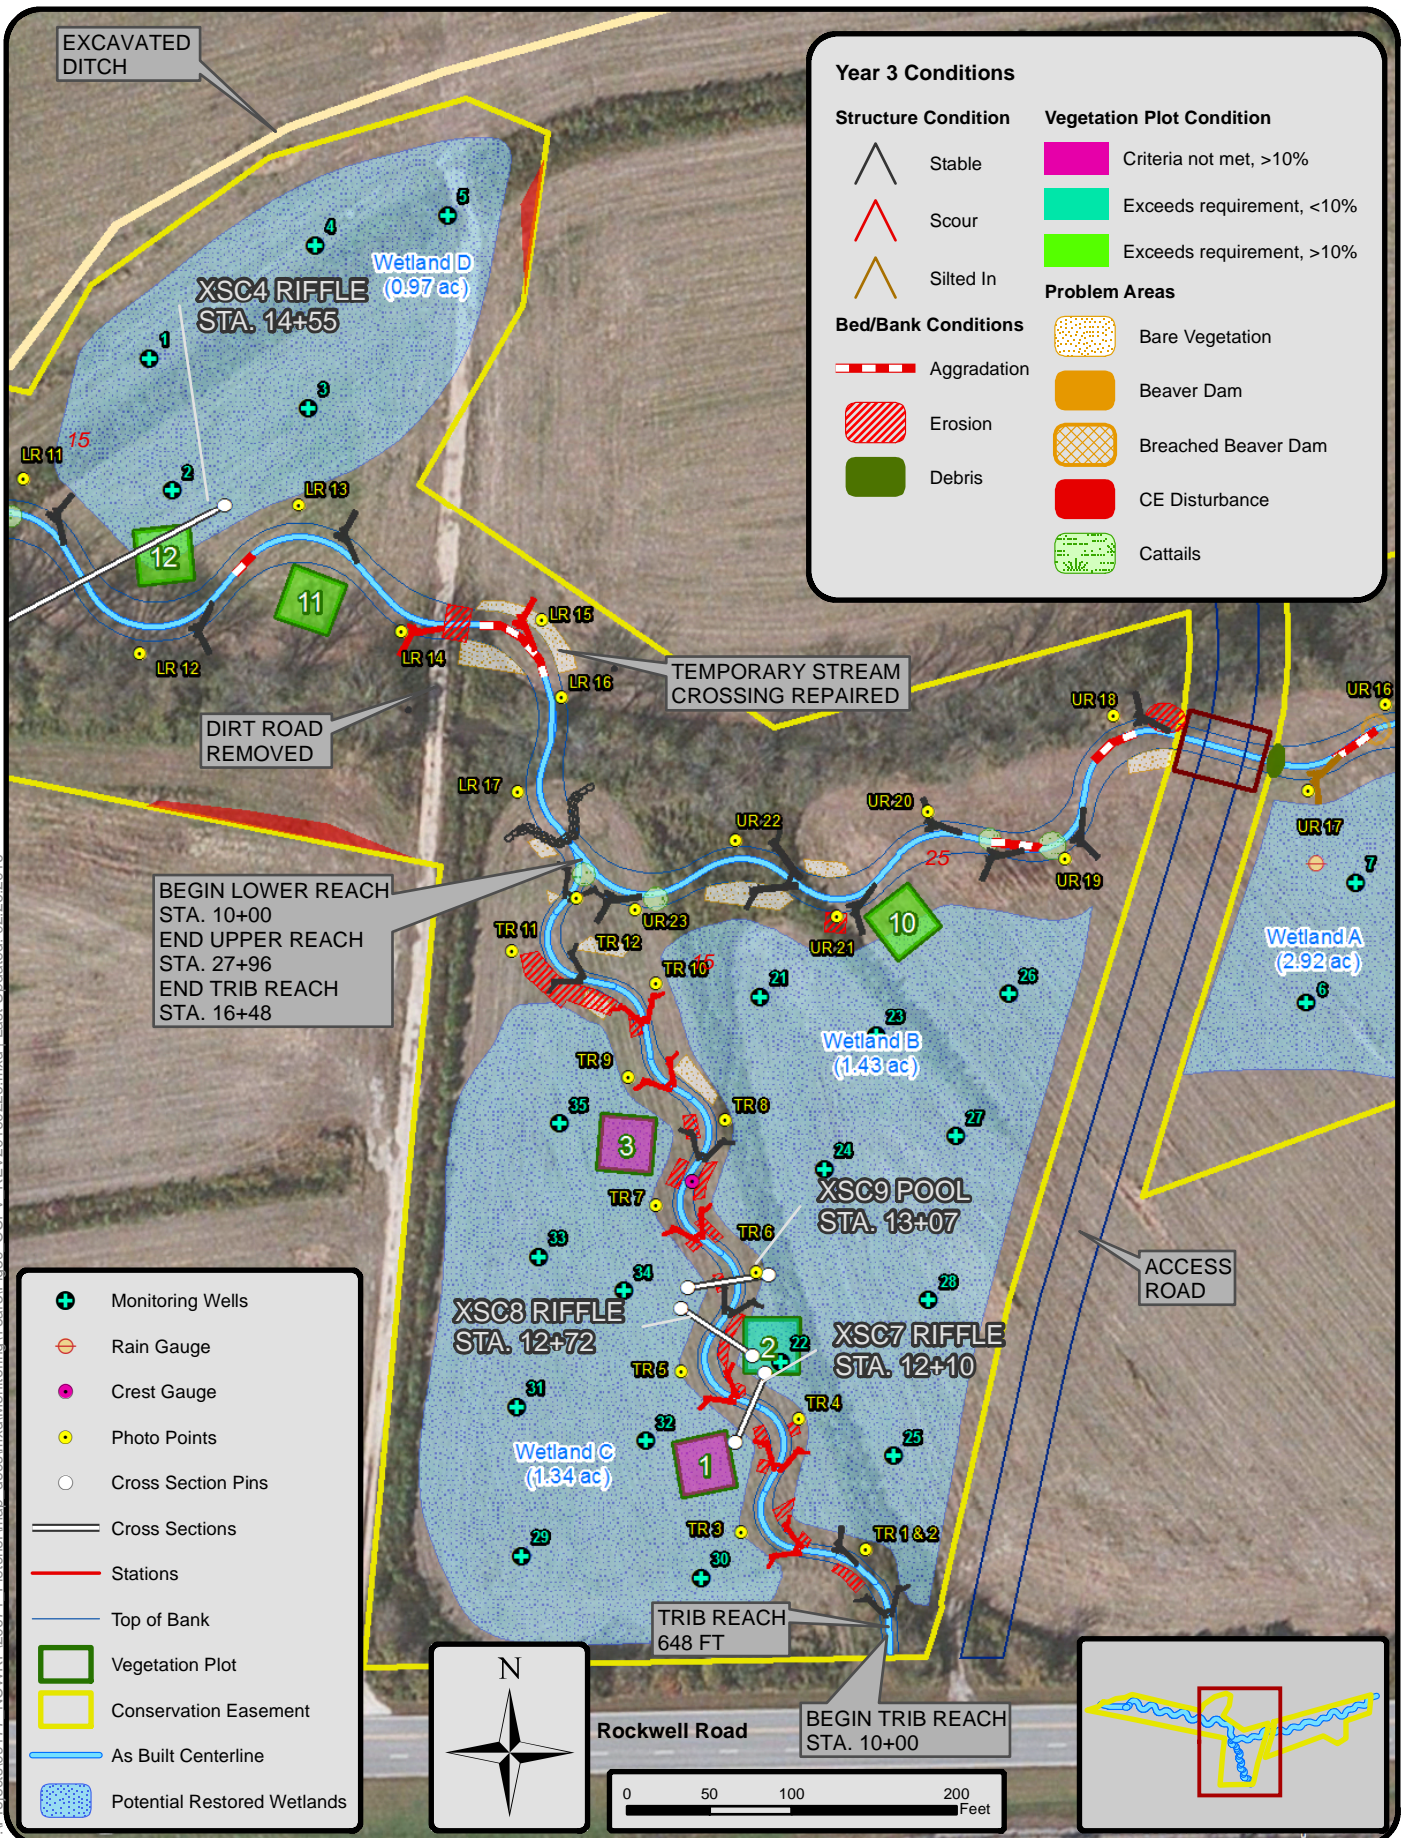
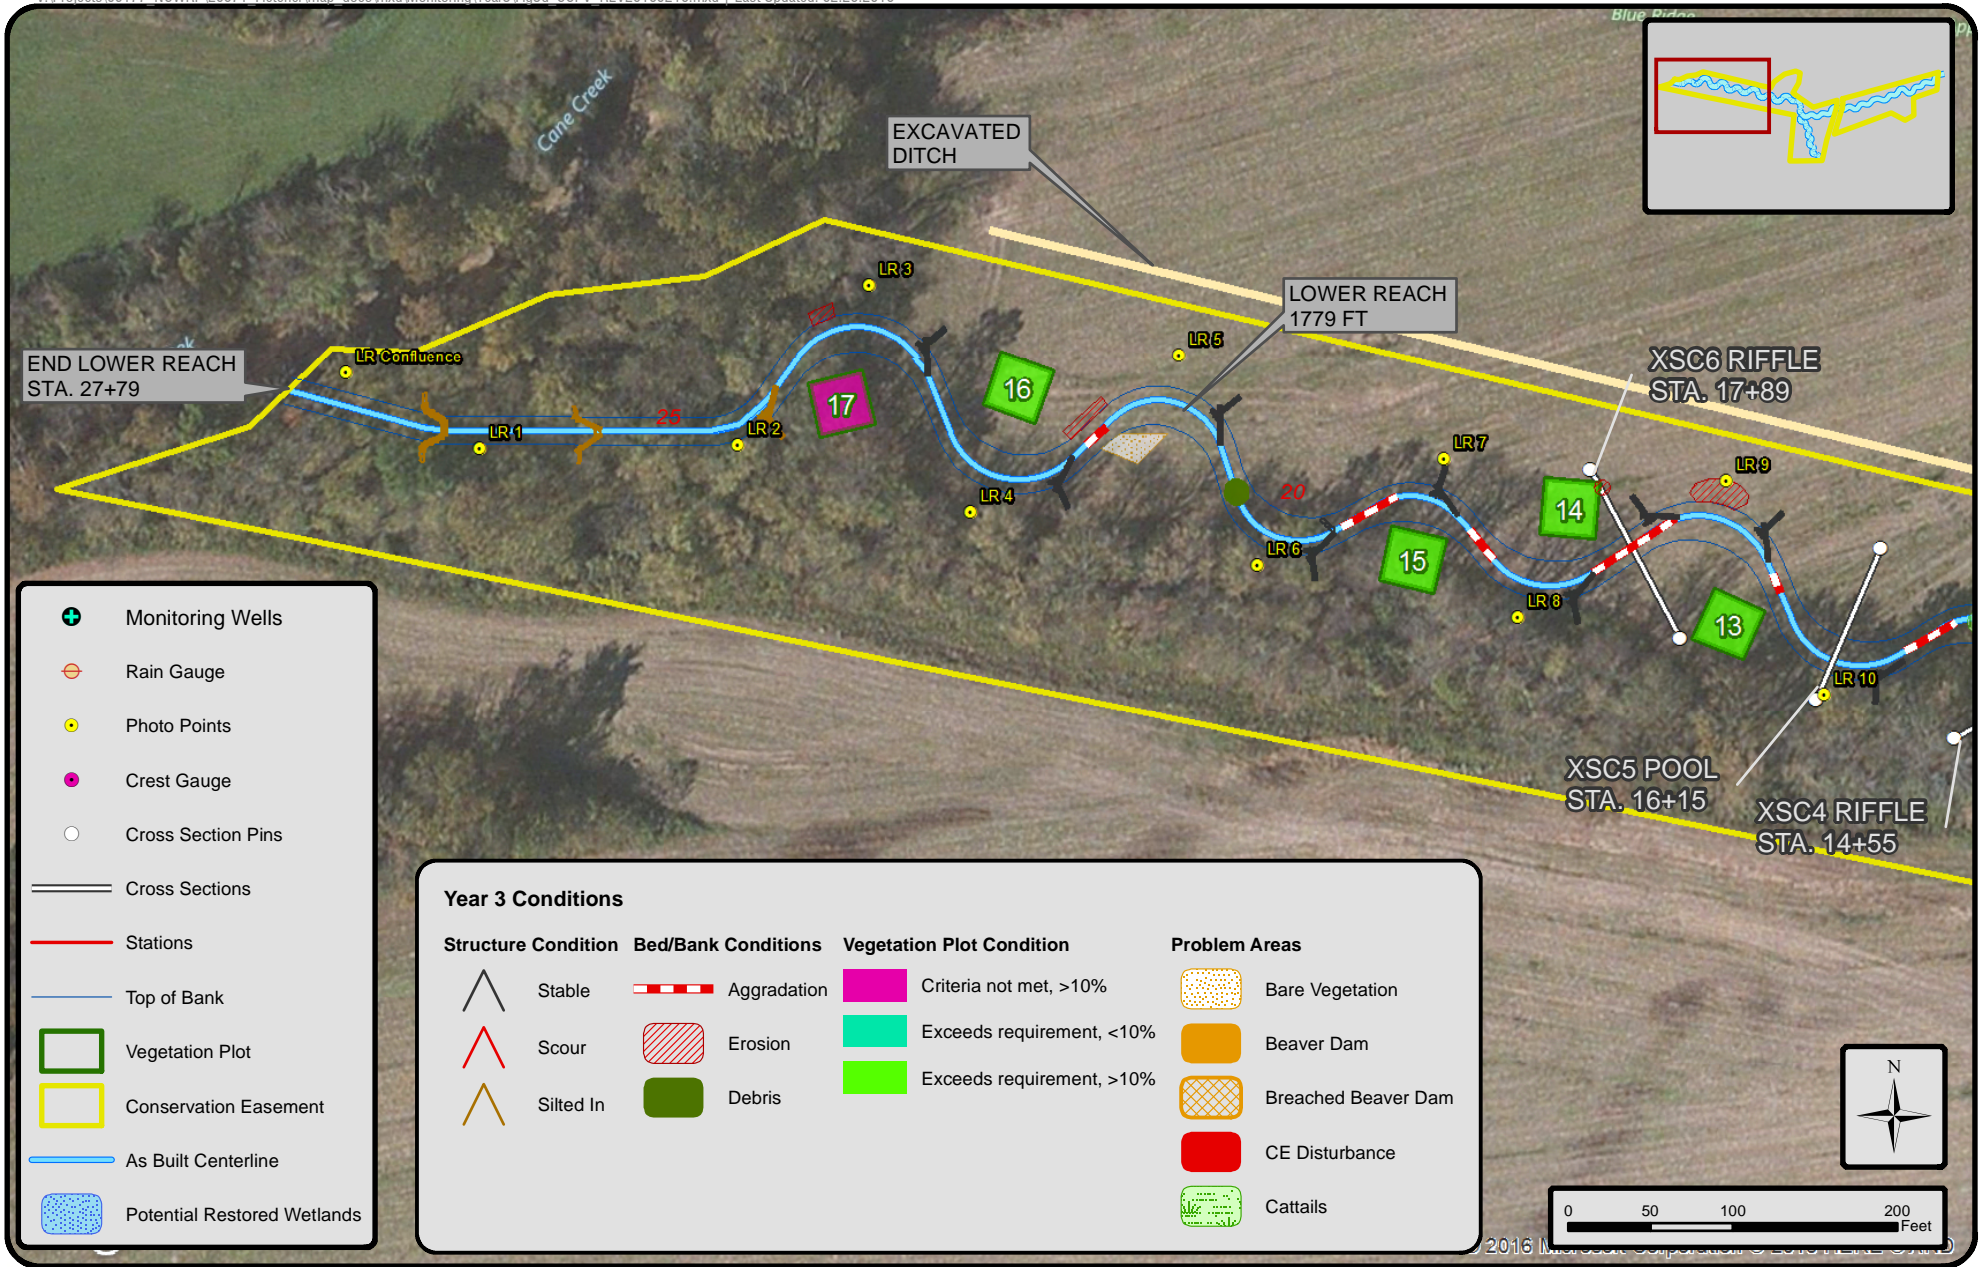
Numerous locations along the reaches have been noted as having sparse vegetation during previous monitoring events; however, these areas are much smaller than in previous years. These areas are illustrated on the Current Condition Plan View (CCPV) in Appendix B. In addition to these locations, a large area of cattails (*Typha latifolia*) is growing within the upper wetland area. The cattails are not posing problems to the reaches currently; however, this location provides a seed source and should be watched. Cattails have created issues when stands grow within streams by out-competing other riparian herbaceous species and creating potential areas for aggradation. One location of multiflora rose (*Rosa multiflora*) was noted near vegetation plot 9. No other invasive species were noted. This will be monitored in subsequent years due to the potential for invasives to develop.

Other areas of minor aggradation, erosion, or areas of sparse vegetation are noted in the tables, shown in the photos, and illustrated on the attached mapping. These areas do not appear to be negatively impacting the channel morphology at this time. Water clarity was slightly turbid to clear and water levels appeared to be slightly higher than the previous assessment. Some trash/debris was noted on the site including balls, cans, papers, etc. No construction equipment or materials were noted along the access roads during the assessment.

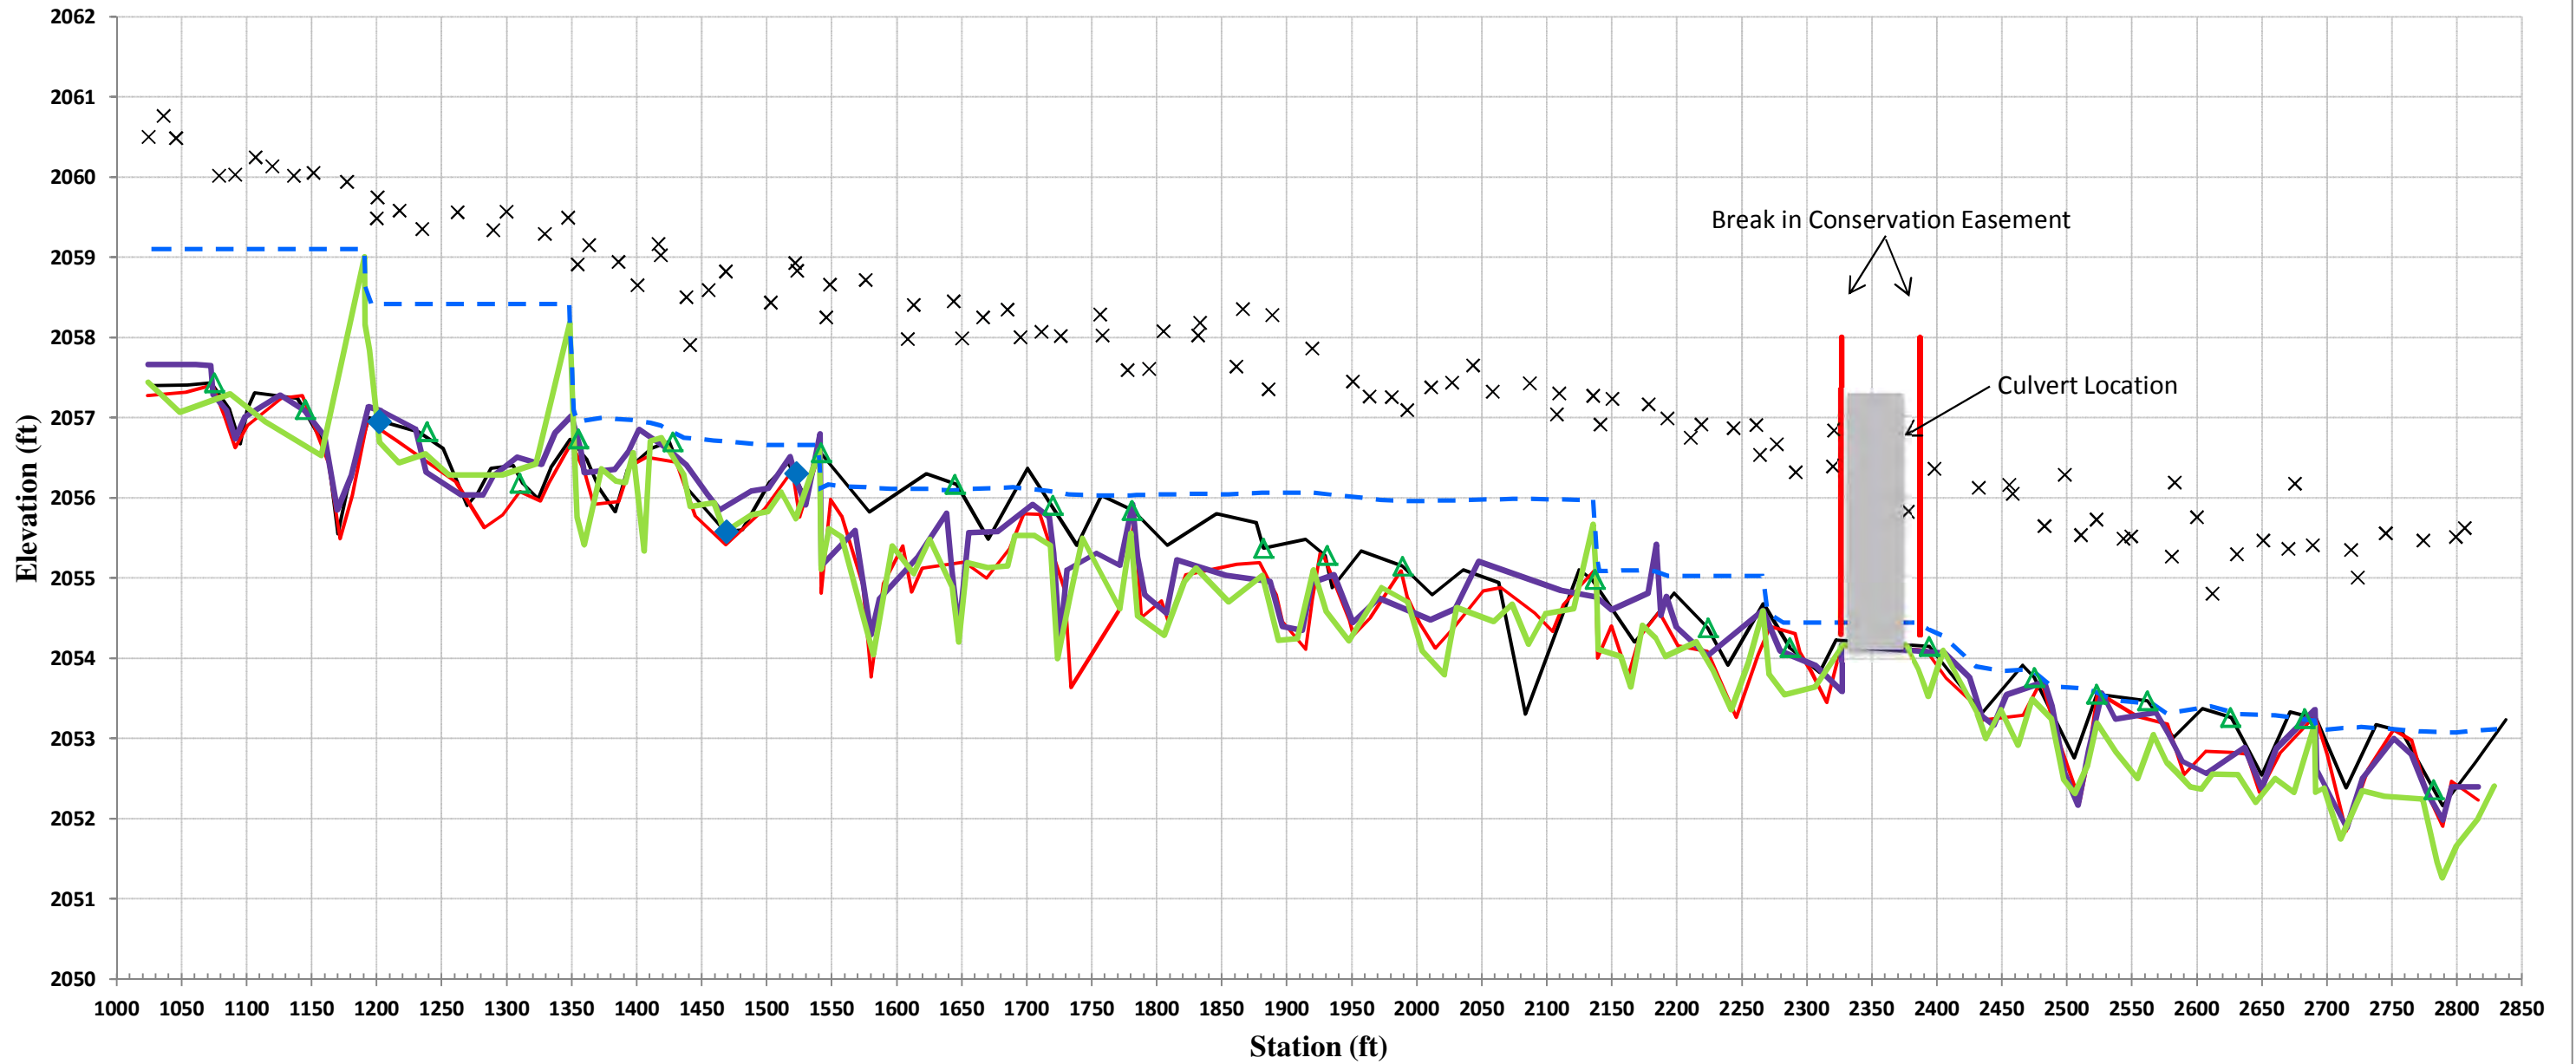
**Longitudinal Profile
Fletcher - Upper Reach
Project Number - 138
Station 10+25.00 - 28+37.86**

The entire length of the reach was monitored by HDR using the VRS System. Multiple parameters were located including top of bank, thalweg, and water surface. In year 3, the upper reach was greatly impacted by beaver activity. New dams were observed at the very top of the reach and near the riffle cross section at 12+02. Breached dams and debris also contributed to water backing up in the reach. As a result, there is a significant absence of riffle features until downstream of the culverts at Sta. 23+50. The riffles observed however, matched well with values from previous years.

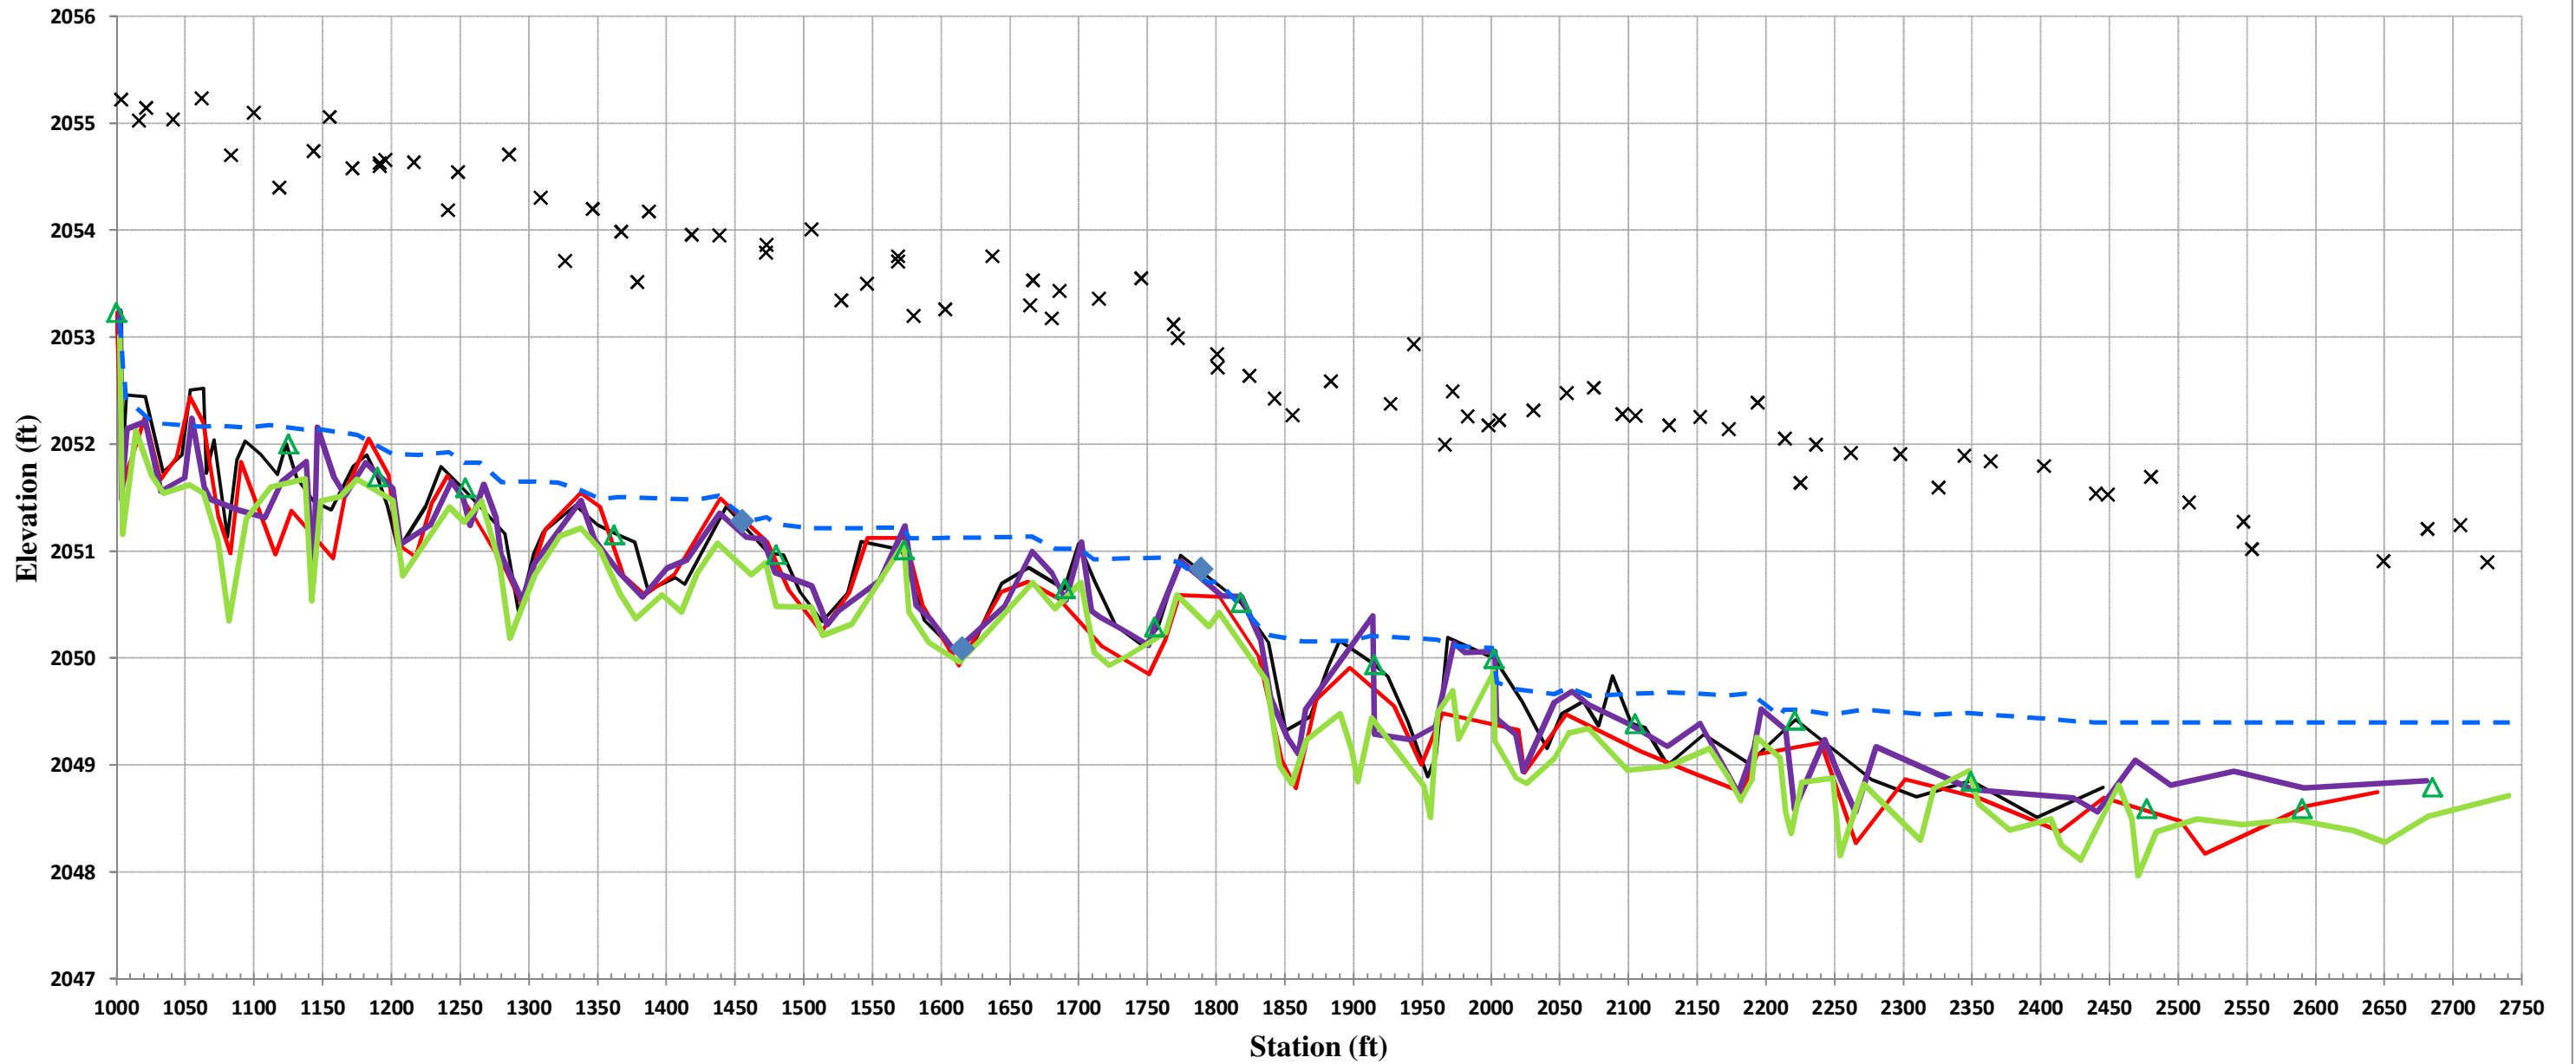
**Longitudinal Profile
Fletcher - Lower Reach
Project Number - 138
Station 10+00.00 - 26+45.00**

In the lower reach segment, similar measurements for riffles and pools were observed as compared to the previous year. Some aggradation was observed, as reported in the CCPV, but overall profile facets are remaining stable. Also of note is the removal of the aerial sewer crossing. Work on the sewer was complete prior to longitudinal profile monitoring.

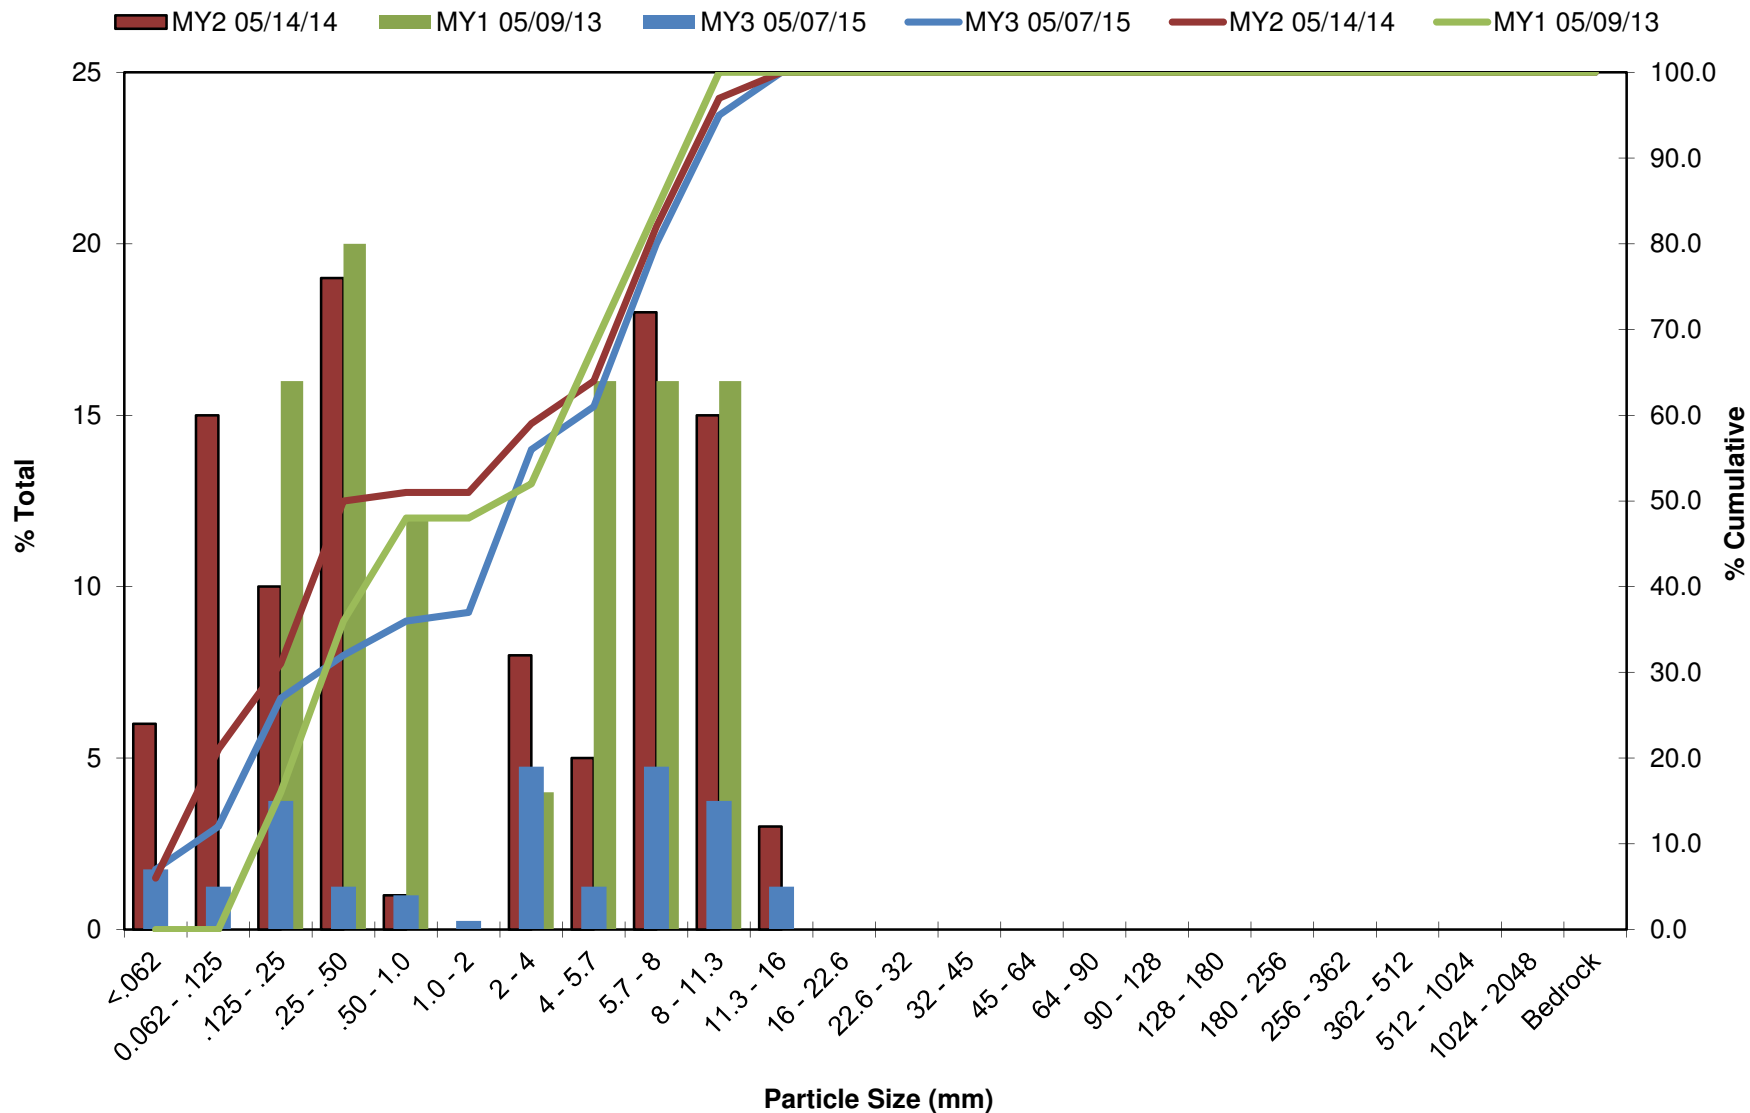
Fletcher -Lower Reach - XSC-4 Riffle Pebble Count

Lower Reach values for predicted movable particle size versus D50 from pebble counts are similar indicating stable conditions. For XSC4, the predicted movable particle size is 13mm compared to the observed D50 of 20mm. Riffle XSC6 has a predicted movable particle size of 12mm compared to an observed D50 of 19mm.
