**Fletcher-Meritor Site  
(UT to Cane Creek) Stream and Wetland Restoration  
Project No: 138**

**Monitoring Report Year 4 of 5**

**Henderson County, North Carolina**

**Construction Complete: May 2012  
Data Collected: March, May, & December 2016  
Report Submission: January 2017**

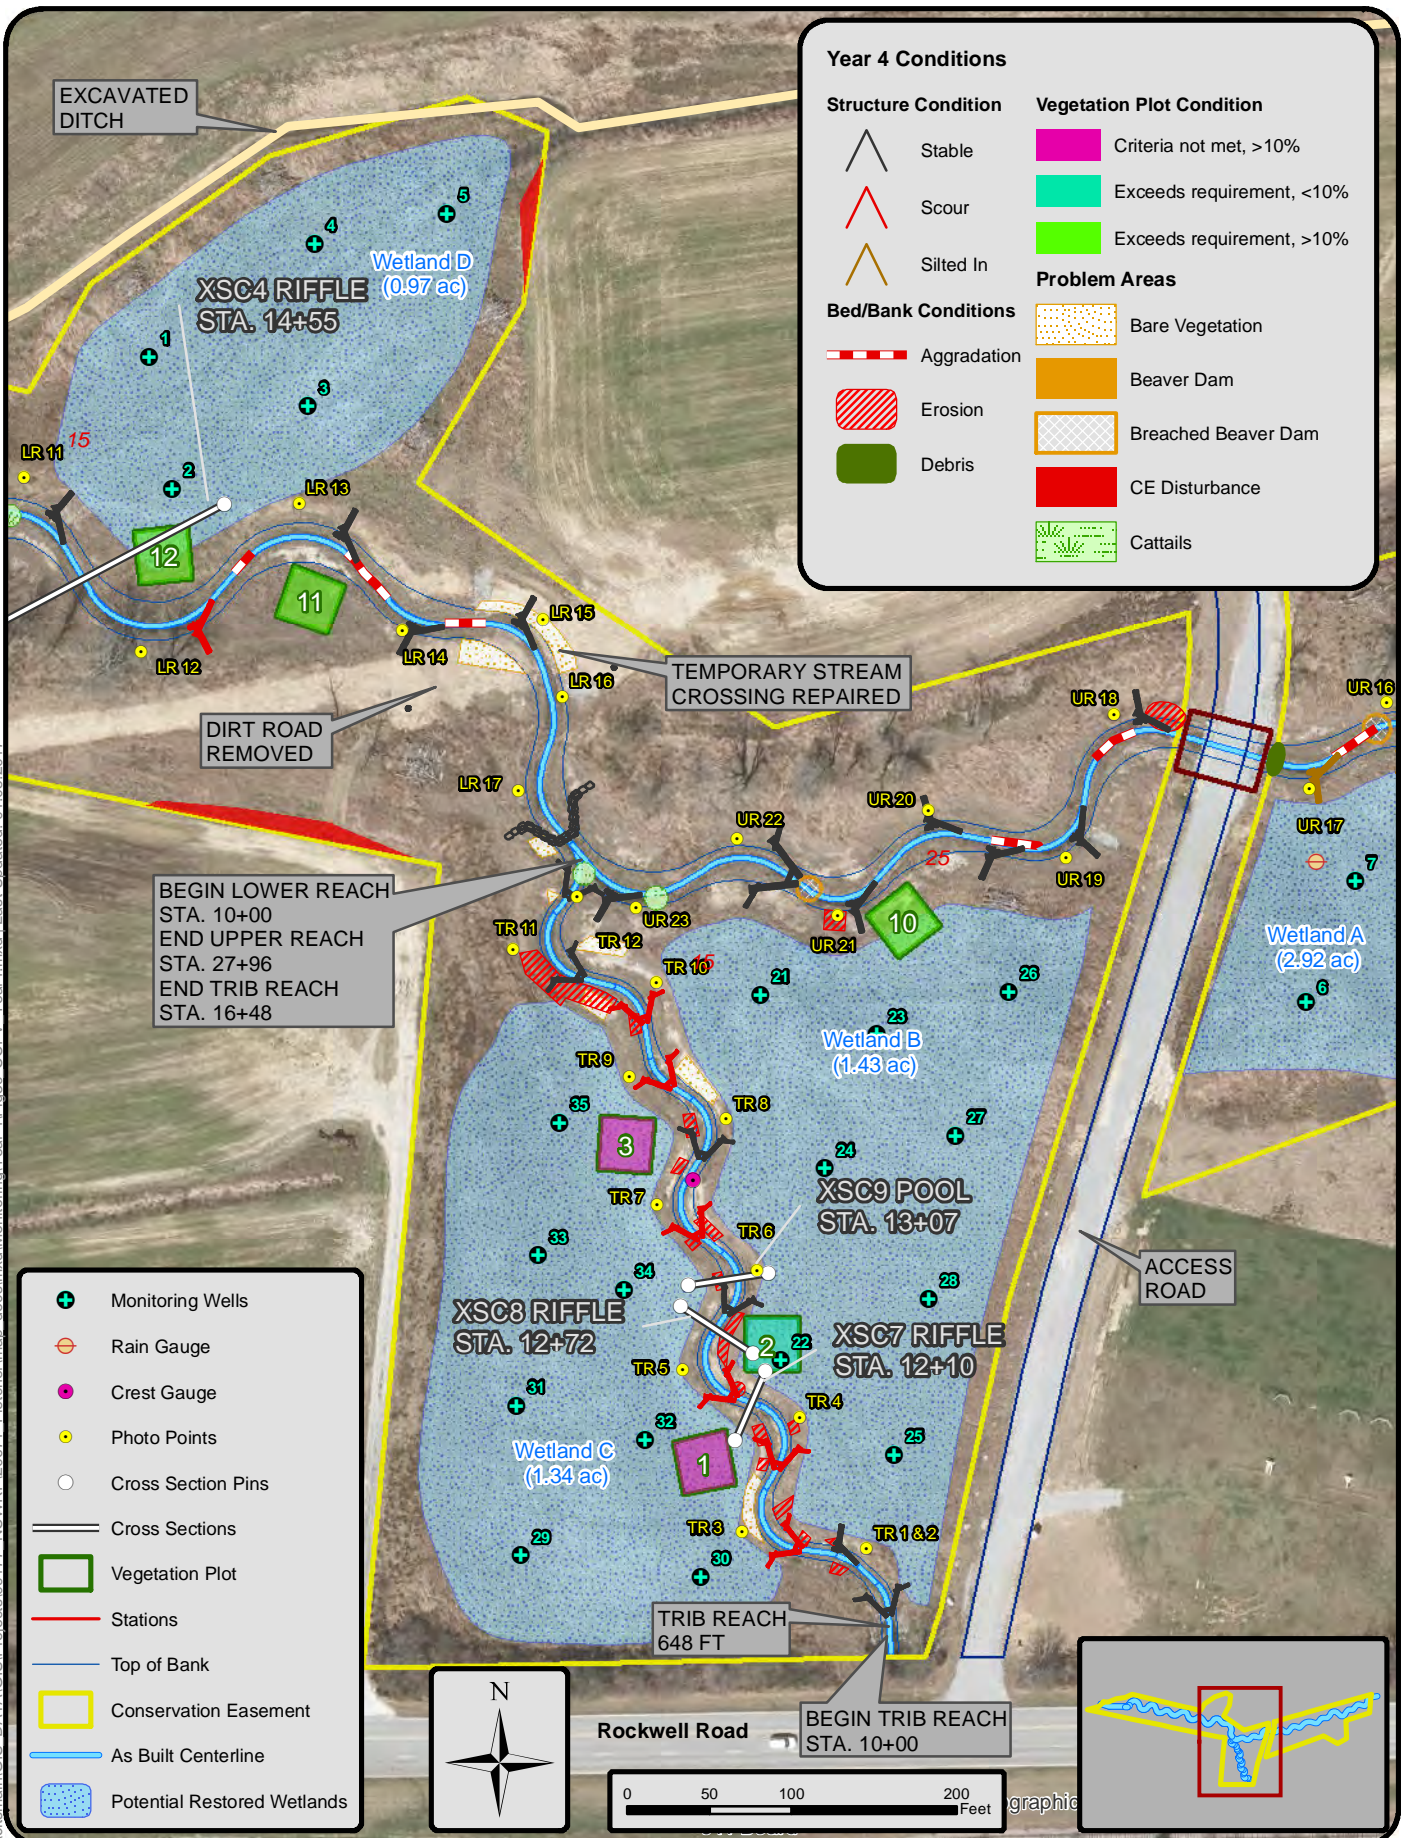
**Current Conditions Plan View**  
Figure 3c

Notable areas of concern occur on all project reaches. The greatest of these is the number of beaver dam occurrences on the Main Stem reaches and the structure failures along the Tributary Reach. During the monitoring event the Upper Reach above the permanent crossing was mostly ponded due to the beaver dams; however, the majority of those dams have been removed with the exception of one noted in December of 2016 during the downloading of the hydrologic monitoring wells. Also, as noted in 2014, over half of the log structures along the Tributary Reach had been eroded or are completely undermined. These structures are still undermined or have erosion issues; however, water levels were higher during monitoring and it appeared water was going over every structure rather than under as noted in 2014. The substrate along the Tributary remains clay and there doesn't appear to be any larger size particles moving into the reach. The most likely cause of the structure issues was the heavy rains received between May and December 2013.

The Lower Reach has an excavated ditch just outside and along the conservation easement boundary that appears to be potentially draining the proposed Wetland D. The wetland area is of concern due to the potential lack of hydrology. Also, beaver activity was noted on the Lower Reach for the first time since monitoring began. The only active beaver dam noted on the project reaches during a December 2016 site review occurred on the Lower Reach, along the straight section just above the confluence with Cane Creek.

The permanent stream crossing near Sta. 24+00 on the Upper Reach has evidence of past erosion at the access road culvert (and floodplain pipes) due to debris blockages. Additional damage to this crossing could occur if debris continues to obstruct the pipes; however, the removal of the upstream beavers and their dams may limit some of the debris that reaches this area. In addition to the permanent crossing on the Upper Reach, the beaver activity on this reach appeared to be impacting channel morphology, specifically in the loss of riffles and increased ponding of the majority of the reach. With removal of the dams in 2016, the upcoming monitoring event in 2017 may illustrate recovery of the riffles which had been lost or obscured due to ponding.

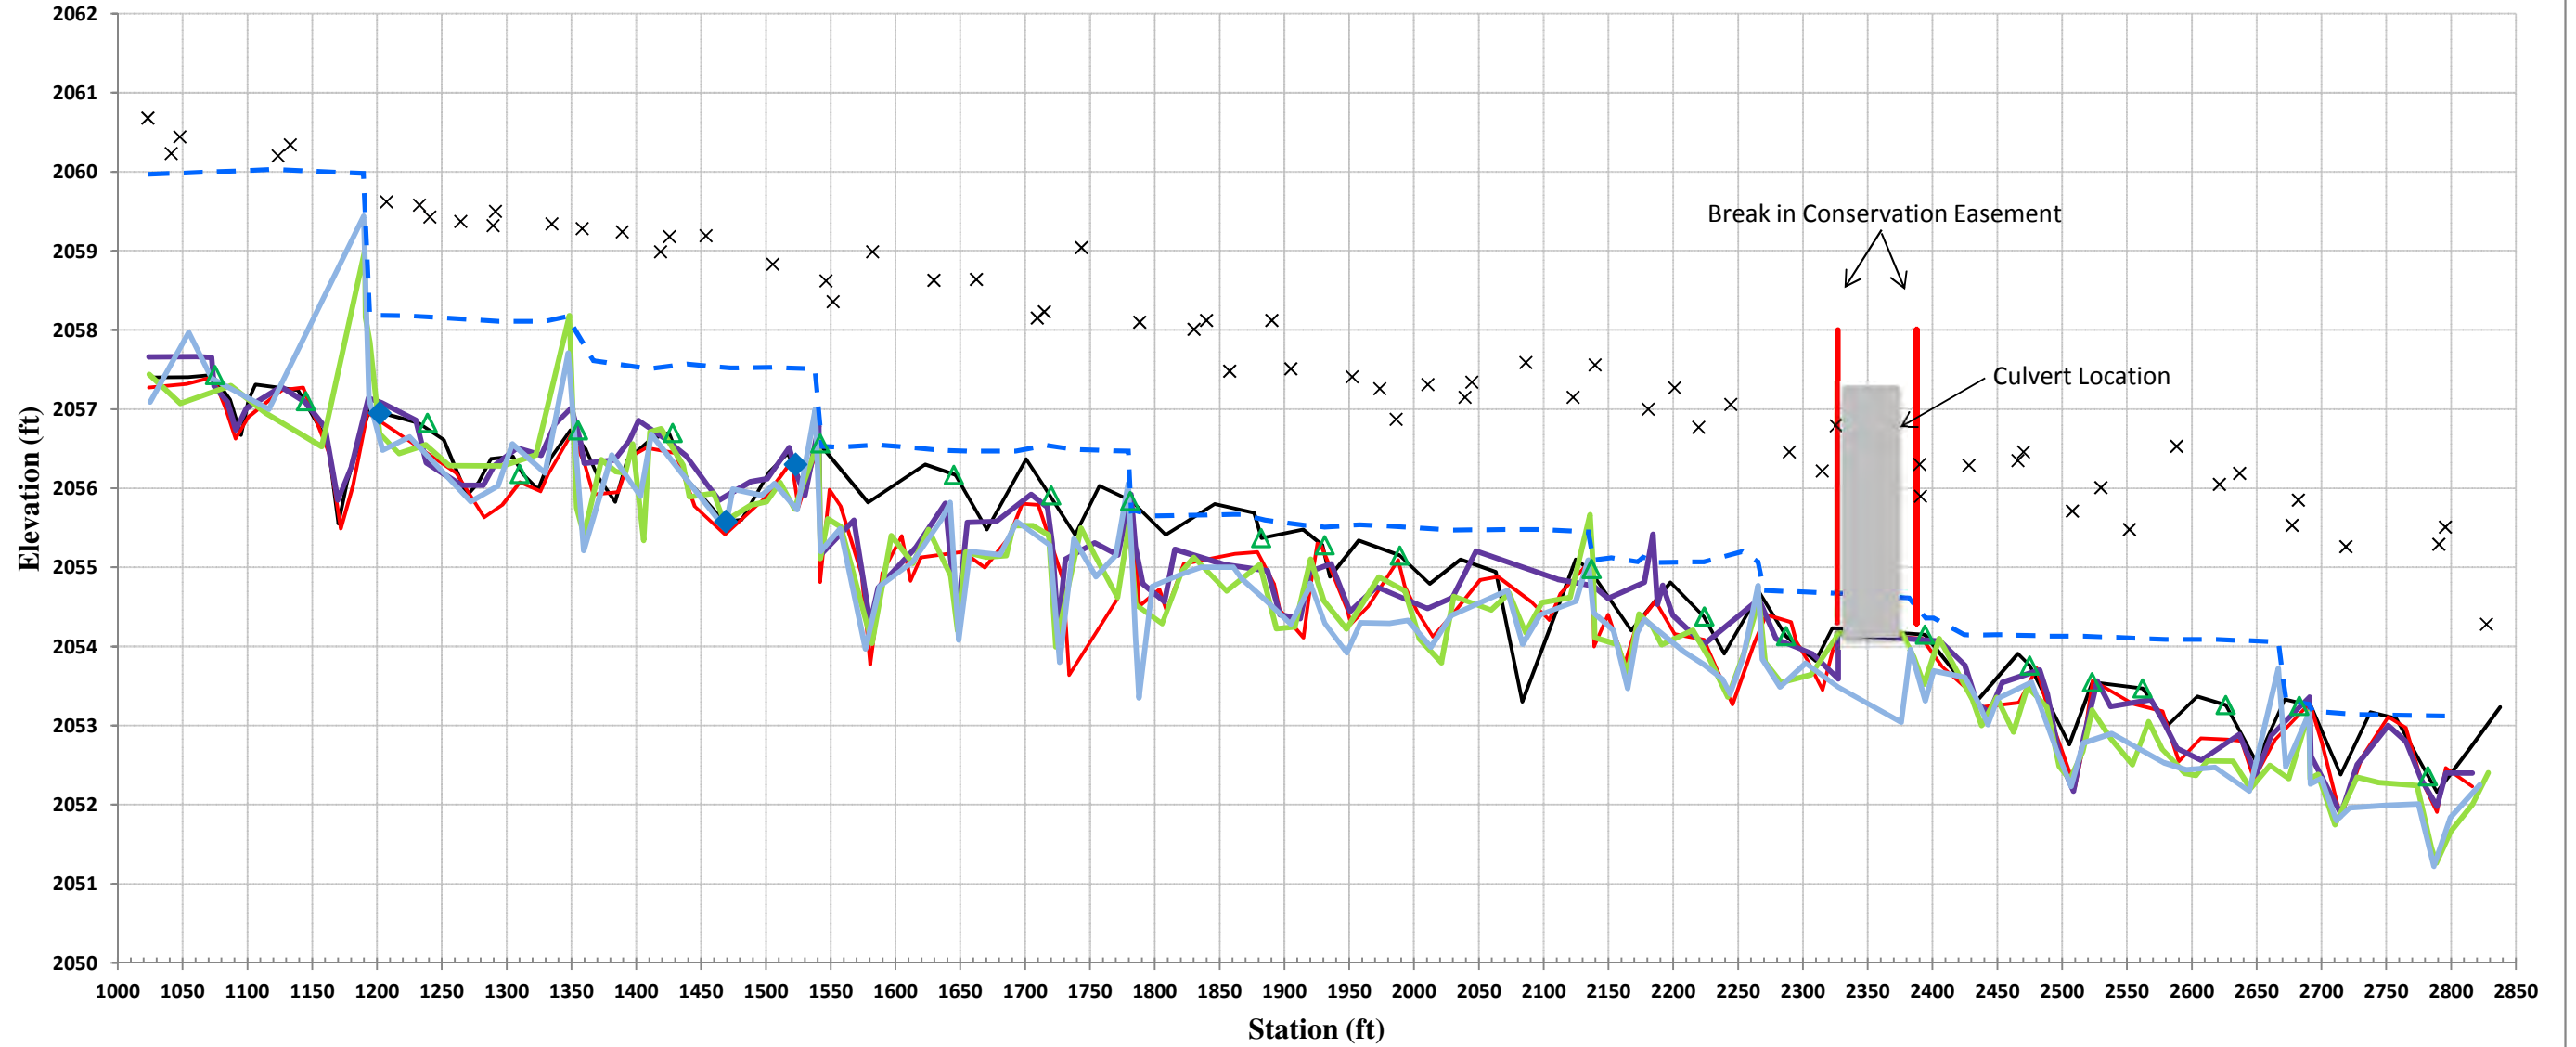
**Longitudinal Profile  
Fletcher - Upper Reach  
Project Number - 138  
Station 10+25.00 - 28+37.86**

The entire length of the reach was monitored by HDR using the VRS System. Multiple parameters were located including top of bank, thalweg, and water surface. In Year 4, the Upper Reach is still being impacted by beaver activity. As a result, there is a significant absence of riffle features as was the case in Year 3. The riffles observed, however, matched well with values from previous years.

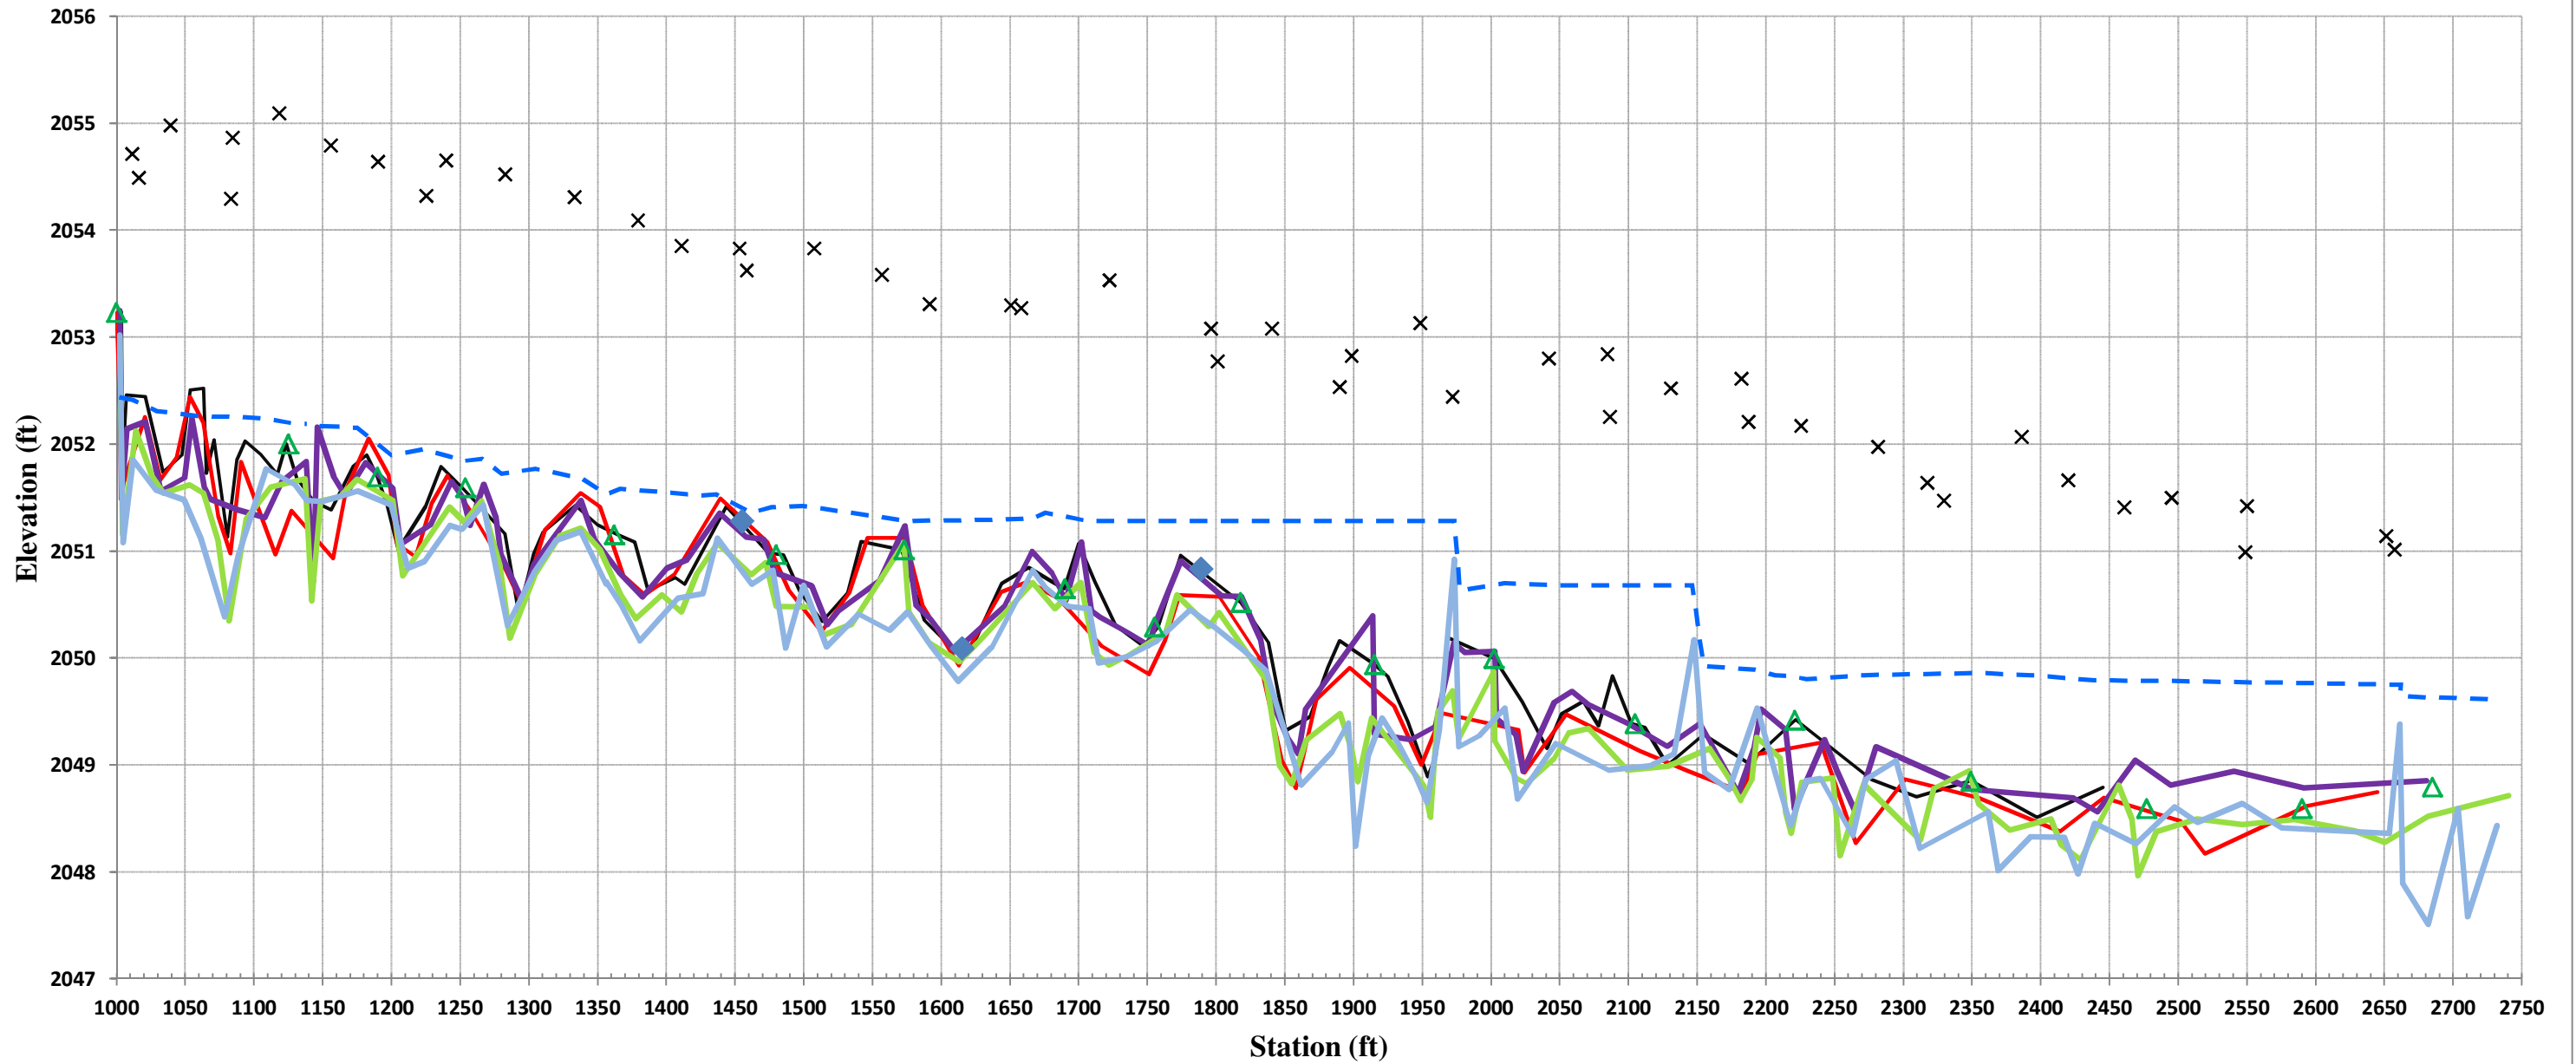
**Longitudinal Profile  
Fletcher - Lower Reach  
Project Number - 138  
Station 10+00.00 - 26+45.00**

Increased beaver activity was observed on the Lower Reach segment. This caused a decreased amount of riffle features observed due to water ponded by beaver dams. The water surface slope is also notably different than previous years due to beaver activity. Of the riffles and pools observed, the facet values were similar to the previous year. The overall profile facets are remaining stable.

Bankfull and water surface slopes remain consistent for the Upper and Tributary channel segments when compared to previous years of monitoring. The Lower Reach bankfull slope remains consistent with previous years but water surface slope shows some increase. In Year 4 the Lower Reach was the reach most impacted by beaver activity, whereas in Year 3 it was the Upper Reach. The beaver activity in the Lower Reach caused water surface to change dramatically at dam locations and then stay flat through large sections of the reach.

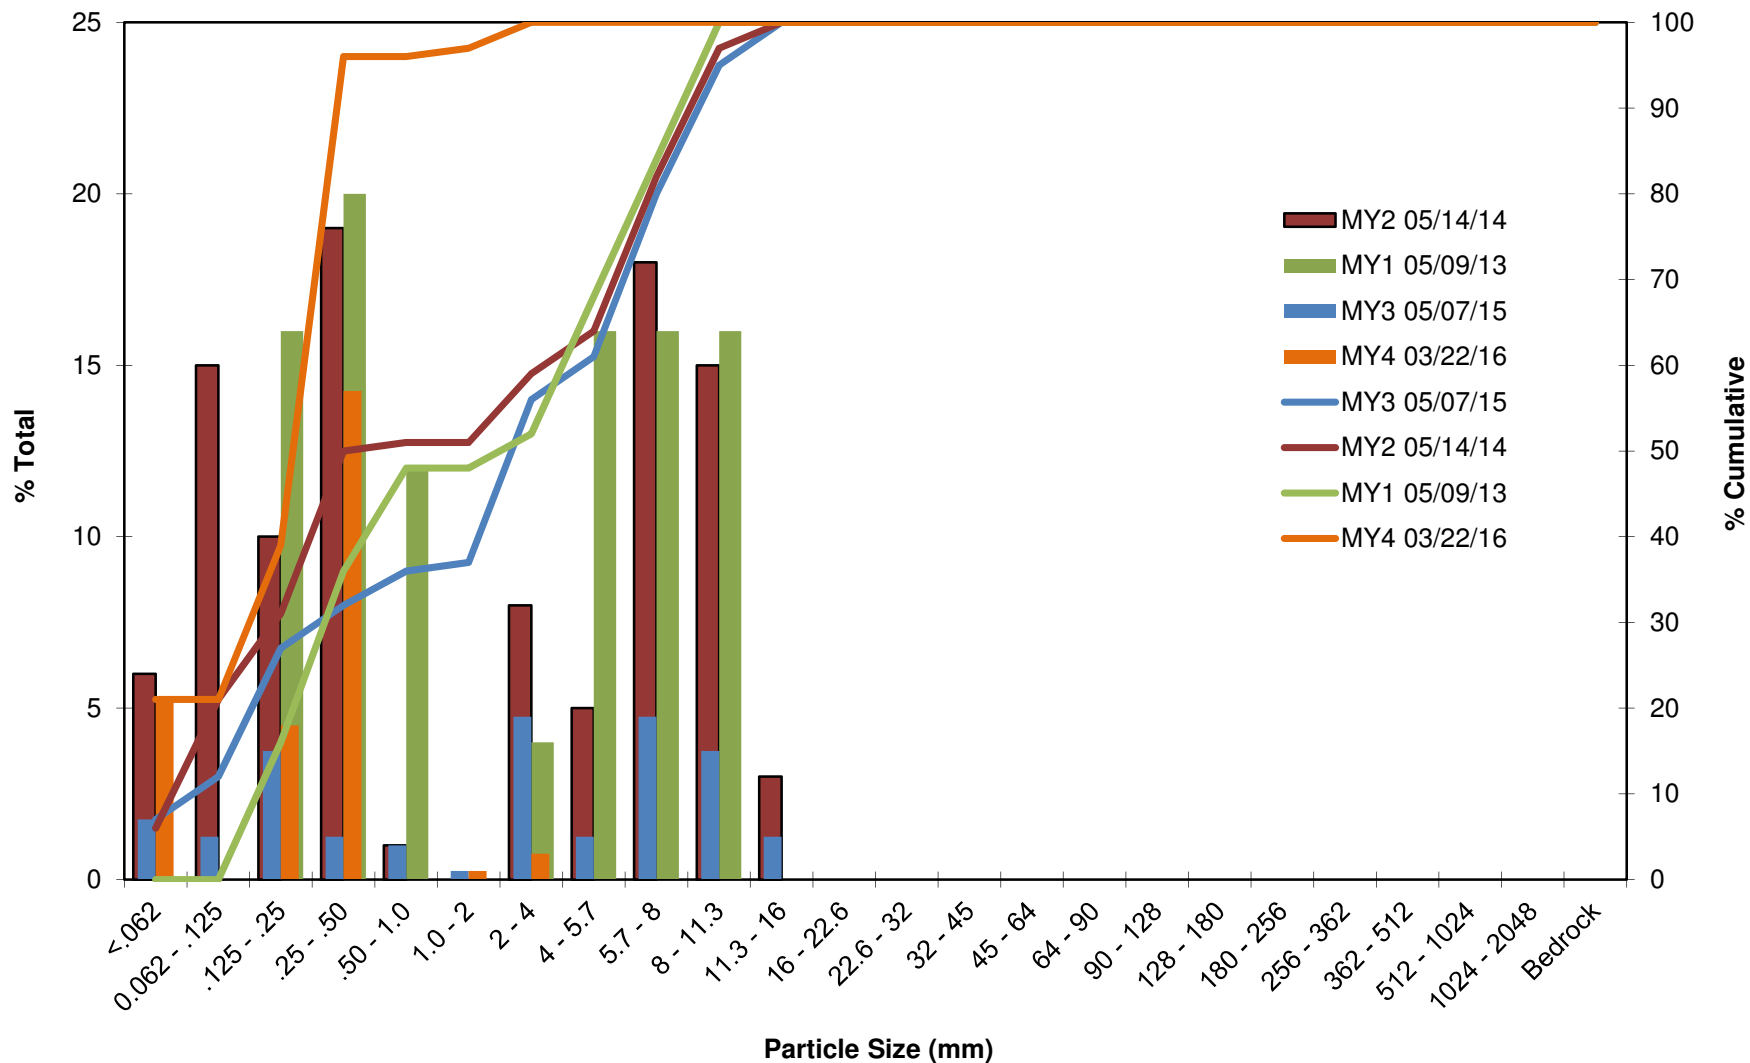
### Pebble count at XSC-4-Riffle

The Lower Reach cross sections, XSC4 and XSC6, show a smaller D50 in Year 4 compared to previous years. Deposition of finer material from beaver activity is the likely cause. The gravels seen in previous years are still present, as seen in the individual counts. However, enough smaller embedded material was seen this year that swayed the results toward more of a coarse sand.

The Lower Reach values for predicted movable particle size versus the D50 from pebble counts are similar, indicating stable conditions. For cross-section XSC4, the predicted movable particle size is 11mm as compared to the observed D50 of 7mm. Riffle XSC6 has a predicted movable particle size of 9mm compared to an observed D50 of 7mm.
