**Fletcher-Meritor Site
(UT to Cane Creek) Stream and Wetland Restoration
Project No: 138**

Monitoring Report Year 5 of 5

Henderson County, North Carolina

Construction Complete: May 2012
Data Collected: March, May, & November 2017
Report Submission: January 2018

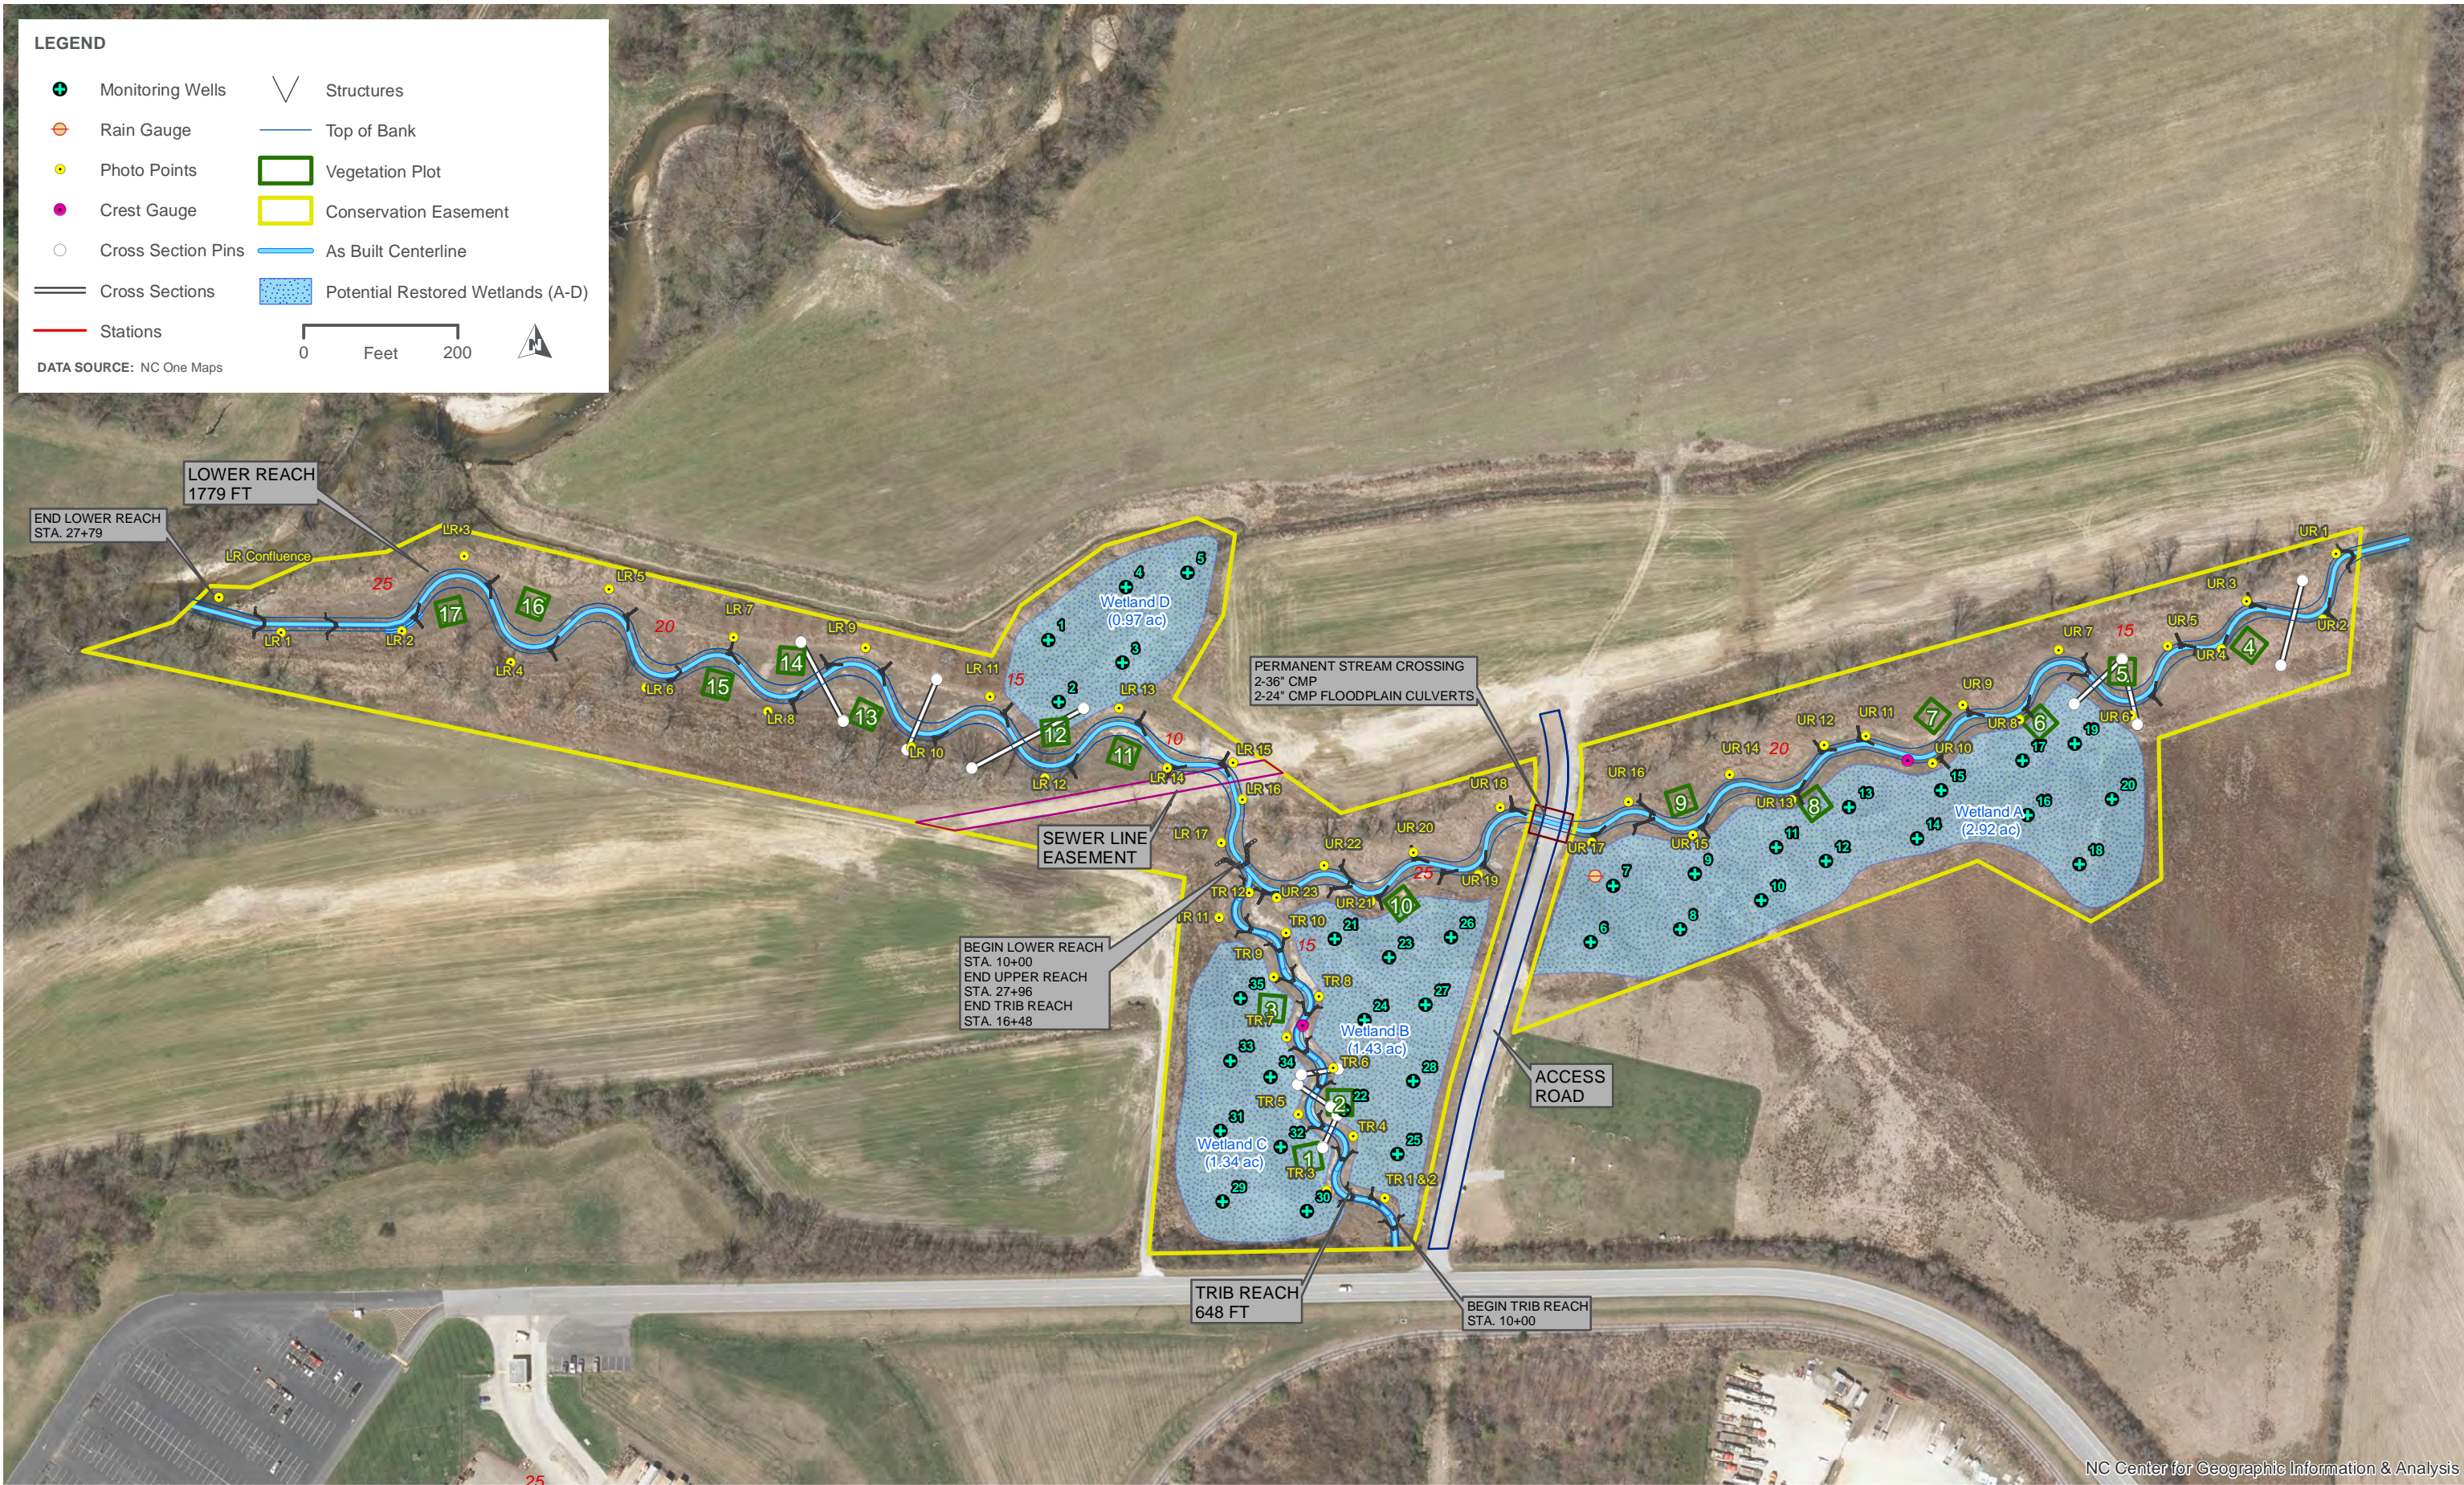
FIGURE 3A

Numerous locations along the reaches have been noted as having sparse vegetation during previous monitoring events; however, these areas are much smaller than in previous years. These areas are illustrated on the Current Condition Plan View (CCPV) in Appendix B. In addition to these locations, a large area of cattails (*Typha latifolia*) is growing within the upper wetland area. The cattails are not posing problems to the reaches currently; however, this location provides a seed source and should be watched. Cattails have created issues when stands grow within streams by out-competing other riparian herbaceous species and creating potential areas for aggradation. One location of multiflora rose (*Rosa multiflora*) was noted near vegetation plot 9. Butterfly bush (*Buddleja davidii*) is growing in the rock along the permanent crossing. No other invasive species were noted.

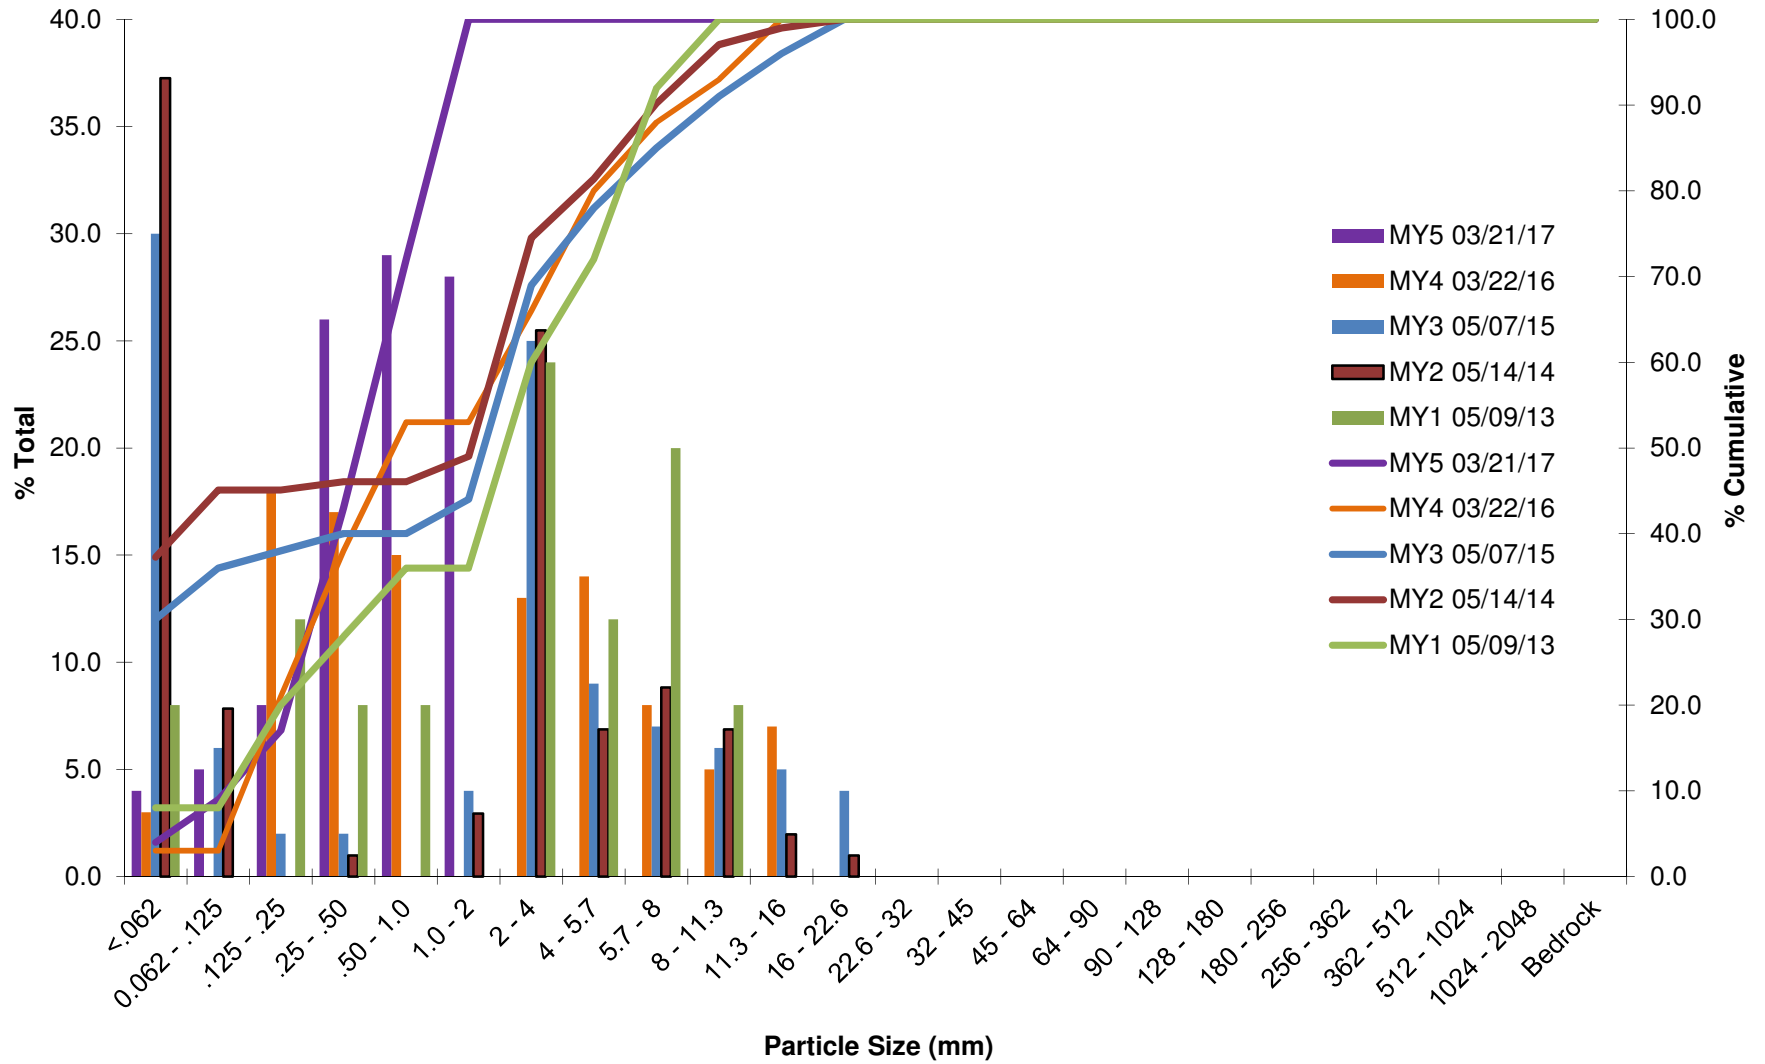
Pebble count at XSC-1-Riffle

The pebble count results from XSC1 and XSC3 were similar to those performed in the previous year. The D50 results showed sandy bed conditions. Based on counts over the past years, the bed material is decidedly a coarse sand in this portion of the stream.

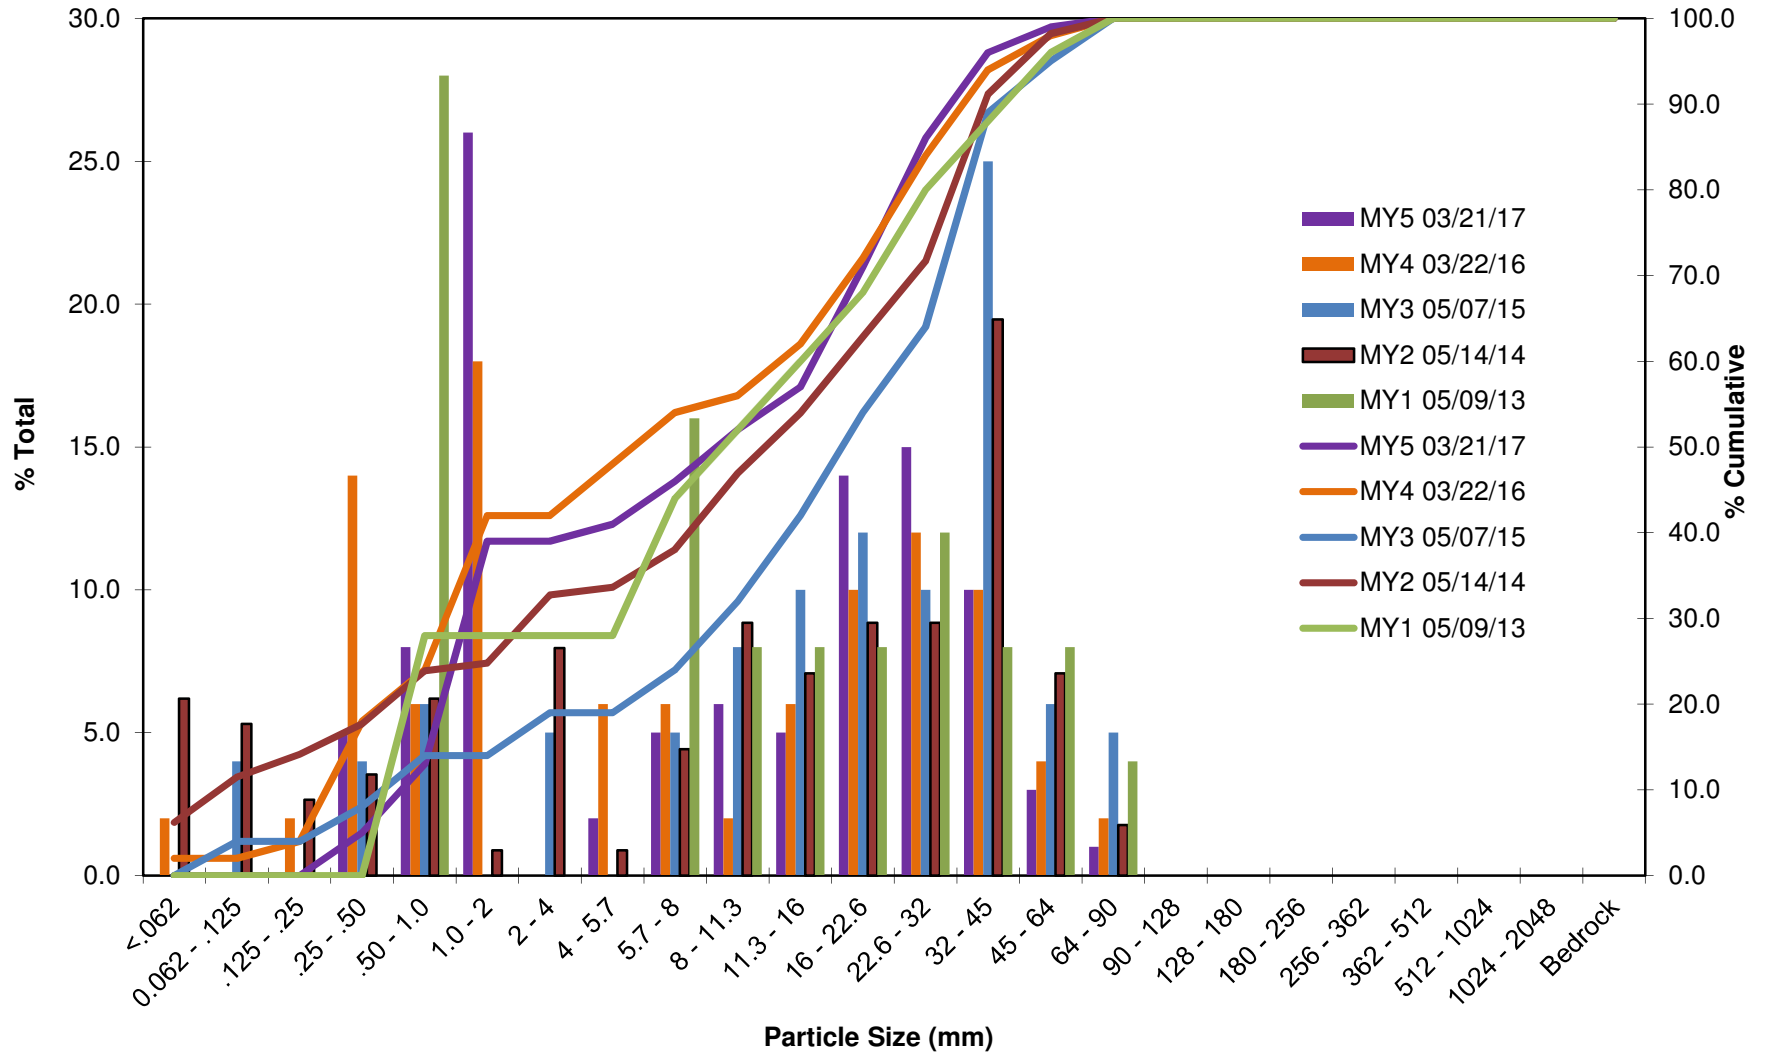
Pebble count at XSC-4-Riffle

The Lower Reach values for predicted movable particle size versus the D50 from pebble counts are similar, indicating stable conditions. For both riffle cross-sections (XSC4 and XSC6) the predicted movable particle size is 12mm as compared to the observed D50 of 10mm.
