**Fletcher-Meritor Site
(UT to Cane Creek) Stream and Wetland Restoration
Project No: 138**

Monitoring Report Year 6 of 6

Henderson County, North Carolina

Subject: Monitoring Year 6 (MY06) Report – Final Submittal
Fletcher-Meritor Site – DMS ID #138
DEQ Contract Number 004923

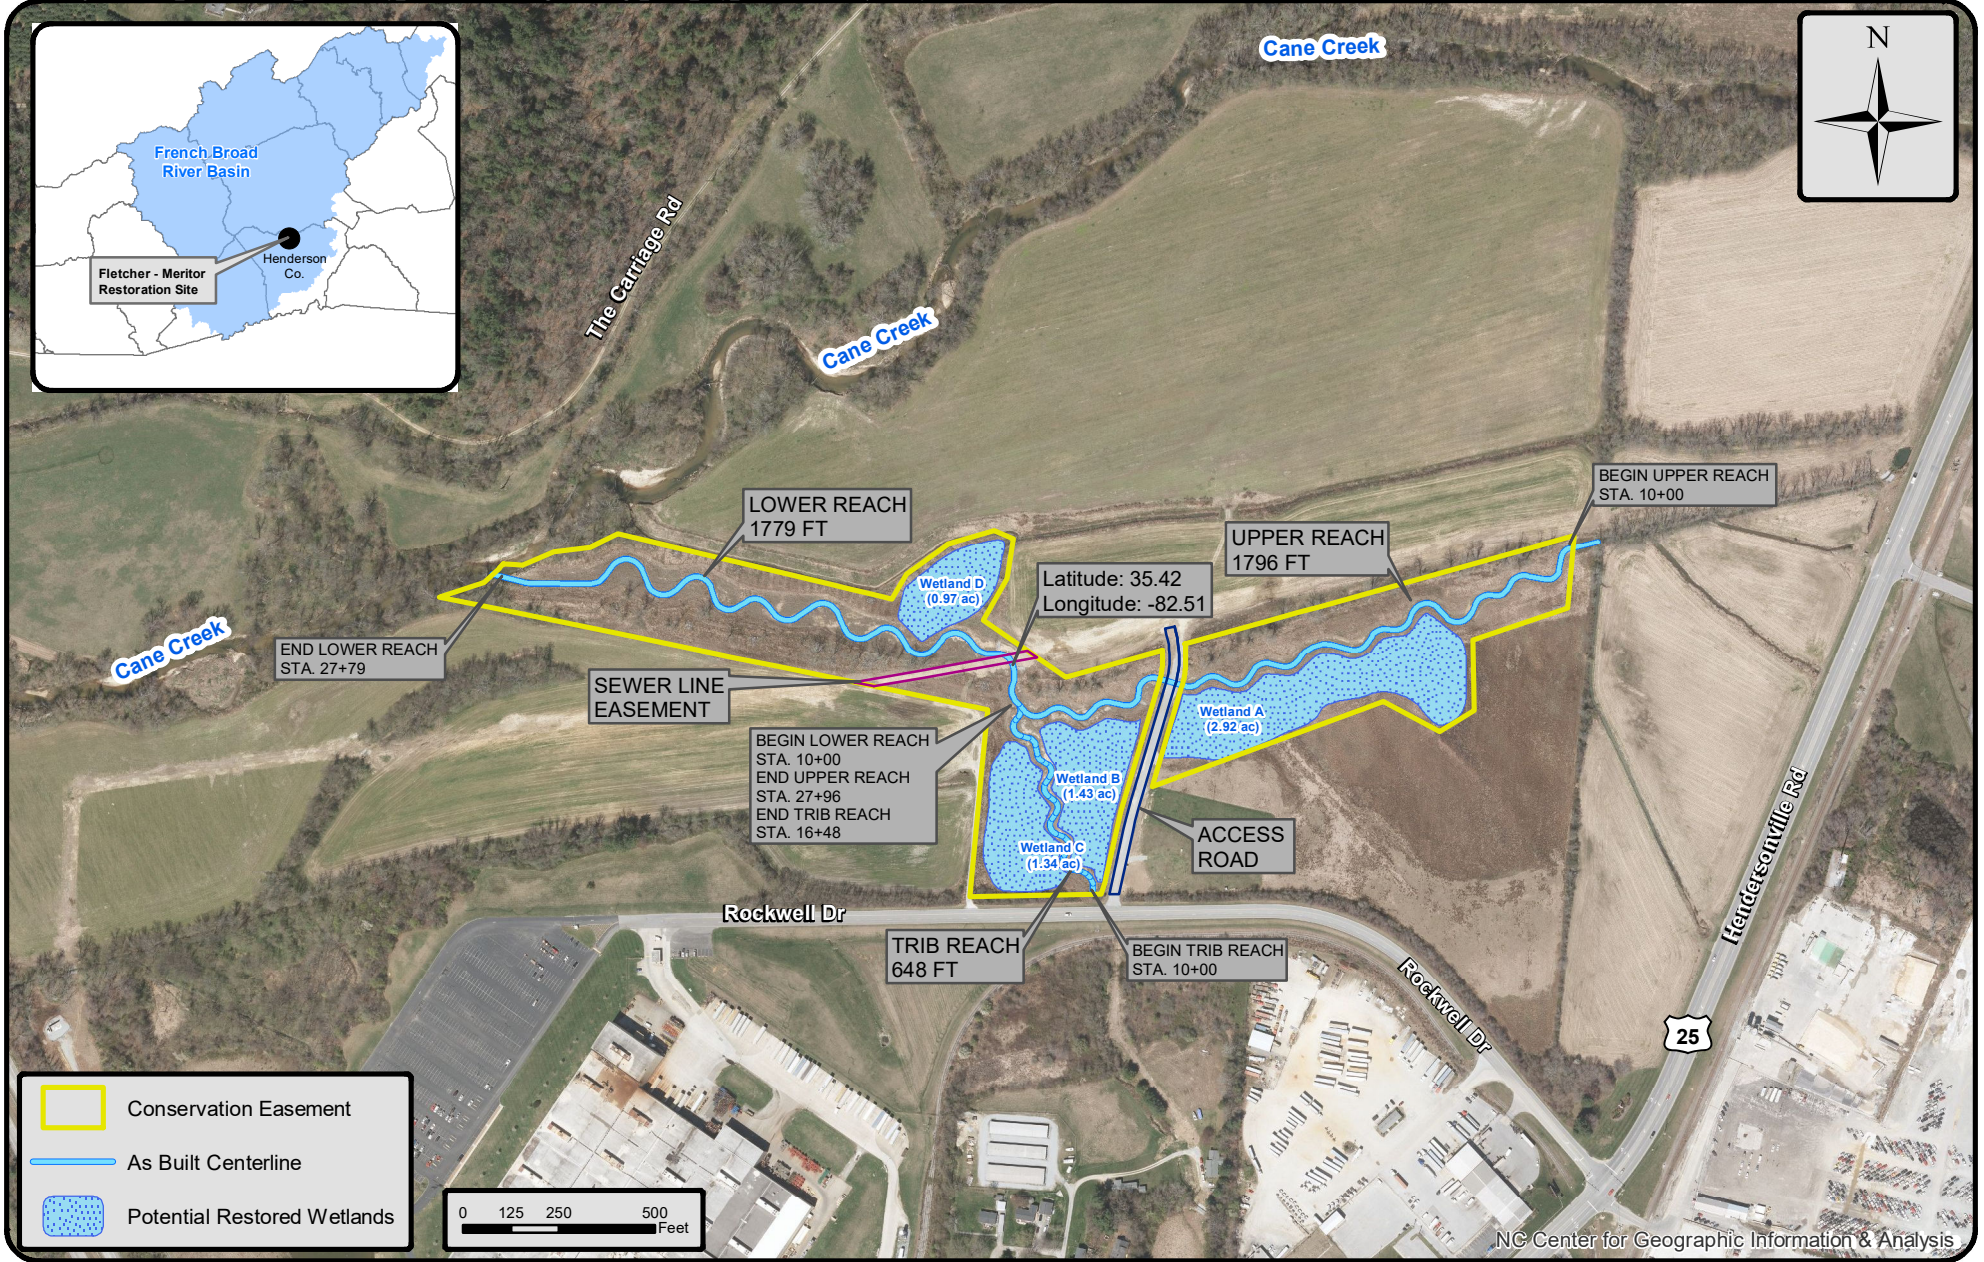
Asset Map
Figure 2

Asset map / Figure 2 – Cane Creek is incorrectly labelled as “Cone” Creek
Figure 2 has been revised and replaced for the final report.

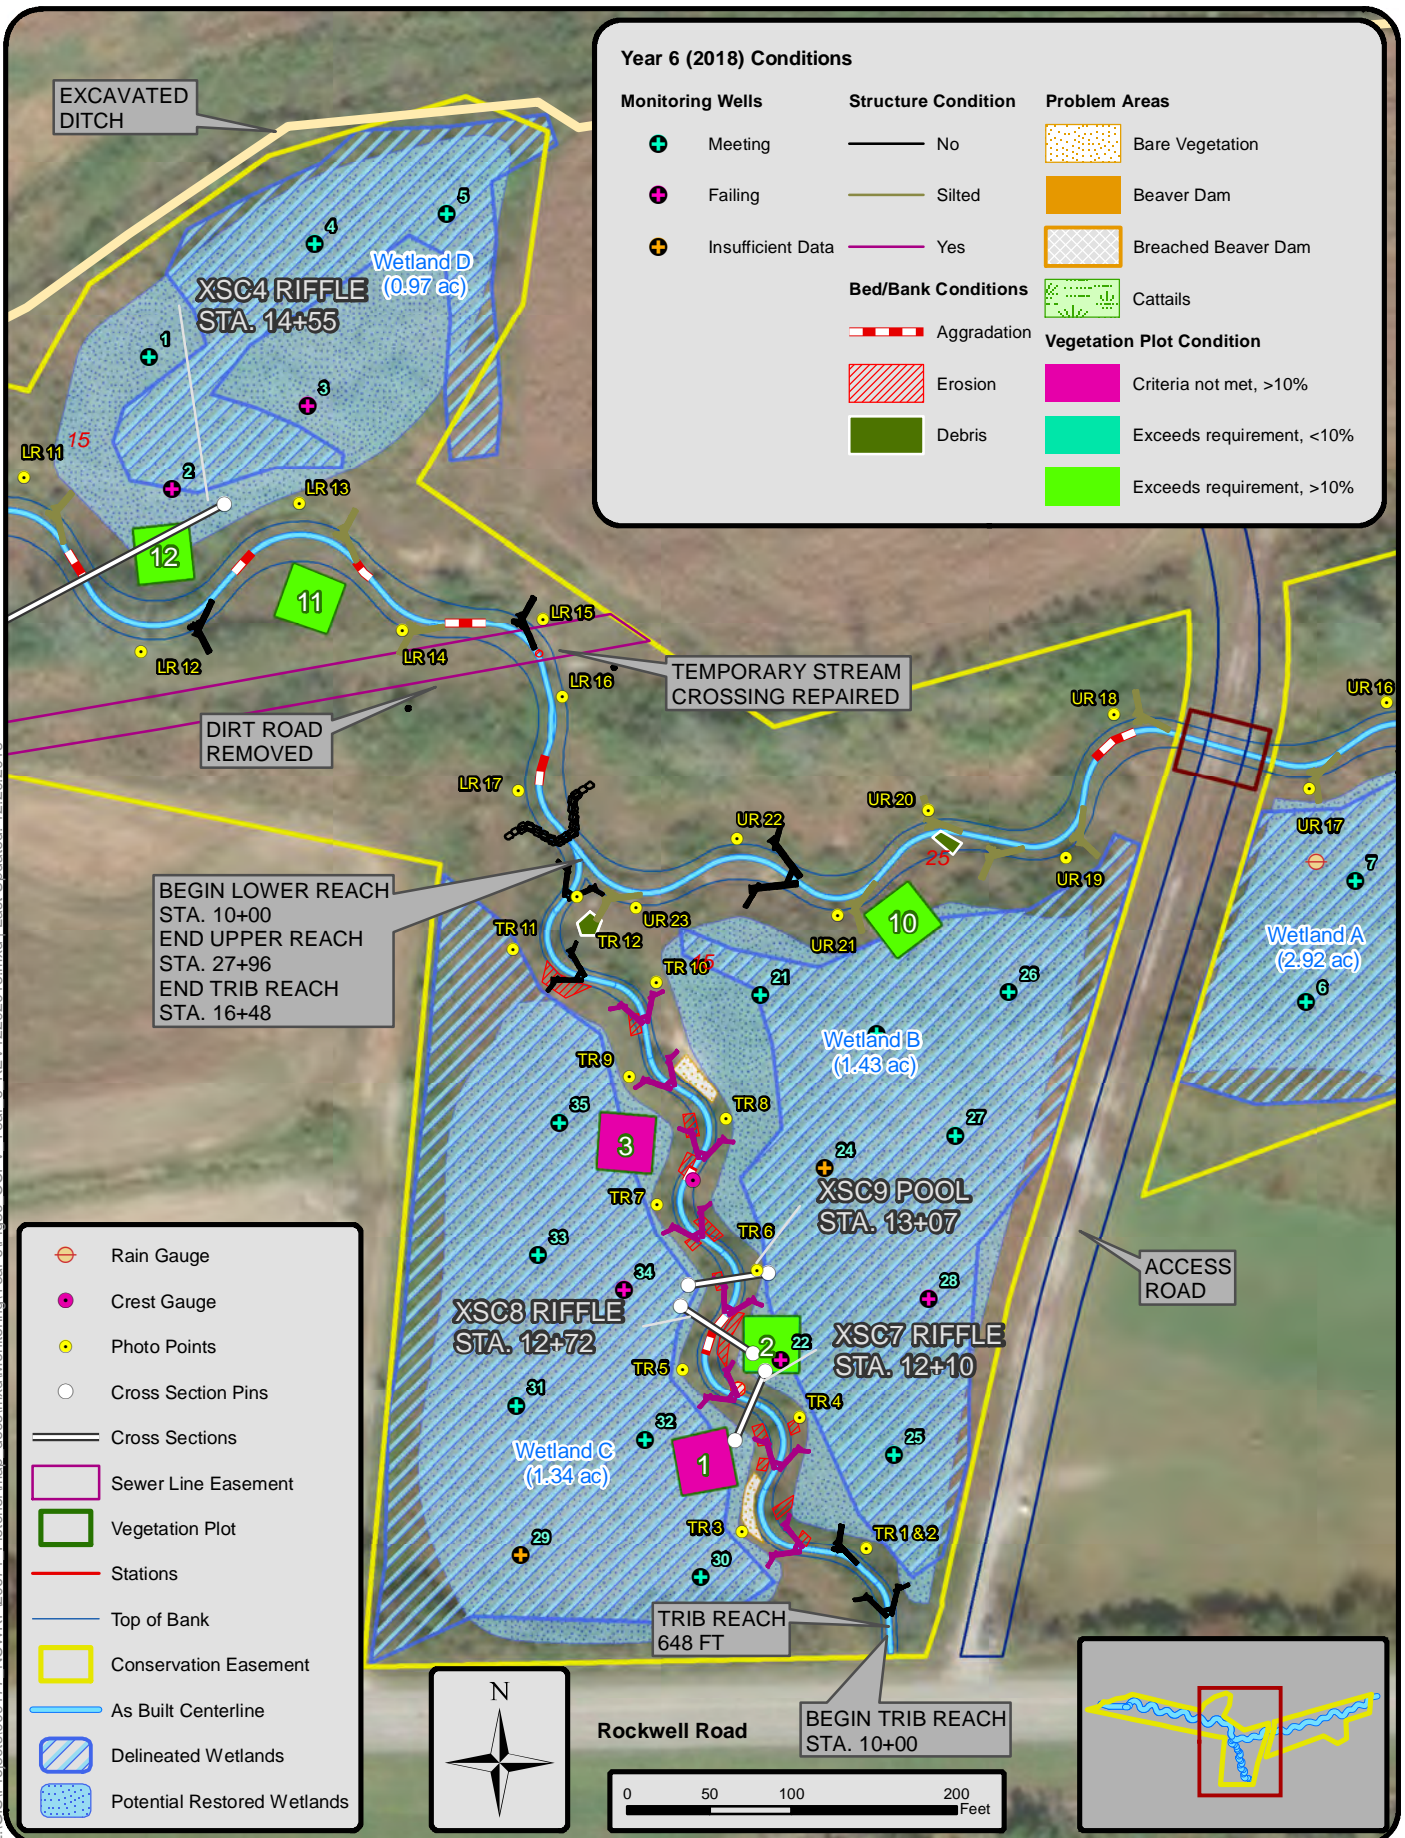
Current Conditions Plan View
Figure 3c

Figure 3c – Are the two mapped CE disturbances still a problem? Last time on site (summer 2018) these issues seem to have been rectified with additional signage. If there is no longer a concern, these polygons should be removed.

These polygons were removed as the additional signage has prevented encroachments.
