**Third Fork Creek Stream Restoration – NCEEP Project #139  
Durham, North Carolina**

**Second Annual Monitoring Report December 2006**

**THIRD FORK CREEK STREAM RESTORATION – NCEEP Project #139  
2006 MONITORING REPORT – YEAR 2**

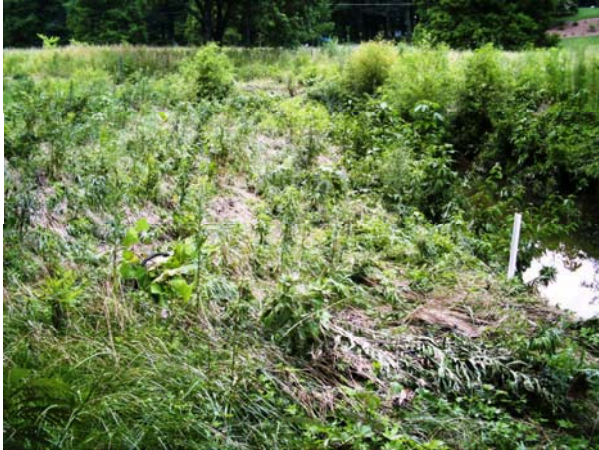
**On-site evidence of over-bank flow (26 June 2007)**

Two pressure transducers were observed during the initial evaluation in February. The serial numbers, brands and model numbers were recorded. A Solinst Levelogger 3001 reader was subsequently purchased and installed into a laptop. The laptop was brought to the site on 25 April 2006. The gauges had been removed from the PVC crest gauge pipes that held them. Neither gauge was found, after an extensive search, including inside the installed pipe. The upstream unit still had

its lock, the lower one had a broken top (above photo). **The units are presumed to have been removed by vandals.** On-site hydrologic data are therefore not available for the second annual monitoring. Qualitative evaluation (rack and drift lines and downed herbaceous and woody vegetation on the floodplain) indicated at least three events during 2006 (April, June, and September (above photo)).

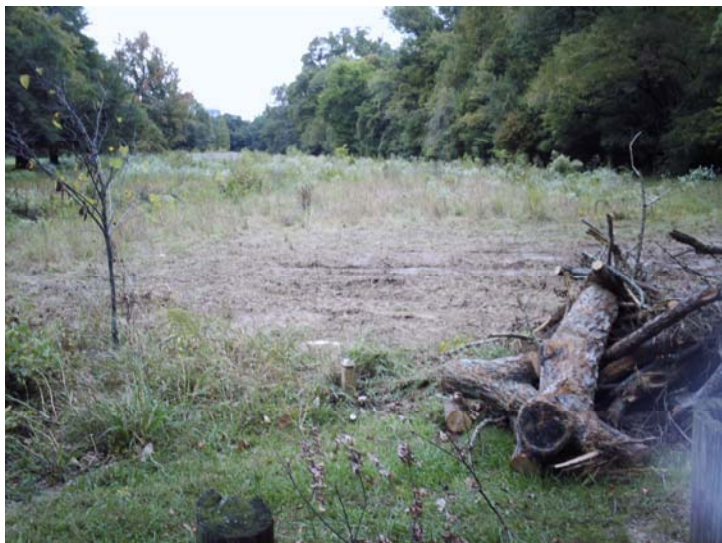
**VP1. Disturbed Area**

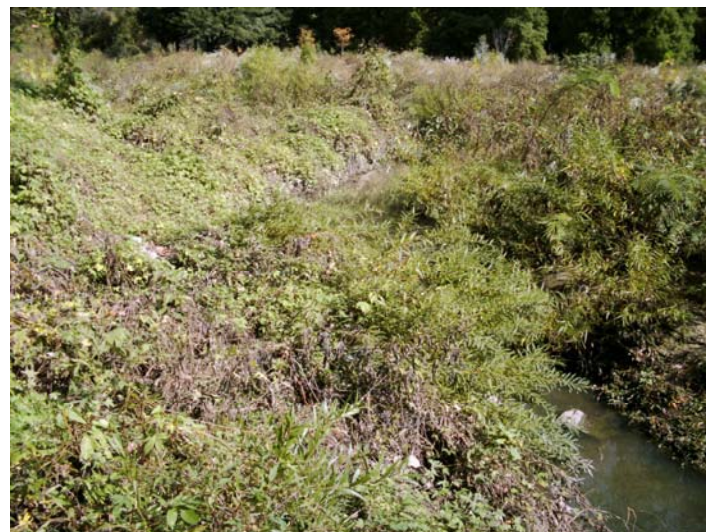
Feature/Issue	Station/Range	Probable Cause	Photo #
Exotic Invasive Vines	12+75 – 14+00	Colonization of floodplain by waterborne seeds	VP2&3
Exotic Invasive Woody Stems	12+75 – 14+00	Colonization by air and water borne seeds	VP4&5
Exotic Invasive vines	16+75 – 19+75	Colonization of floodplain by waterborne seeds	VP2&3
Exotic Invasive vines	20+75 – 22+40	Colonization of floodplain by waterborne seeds	VP2&3
Exotic Invasive vines	24+60 – 26+25	Colonization of floodplain by waterborne seeds	VP2&3

**VP2. Vines**

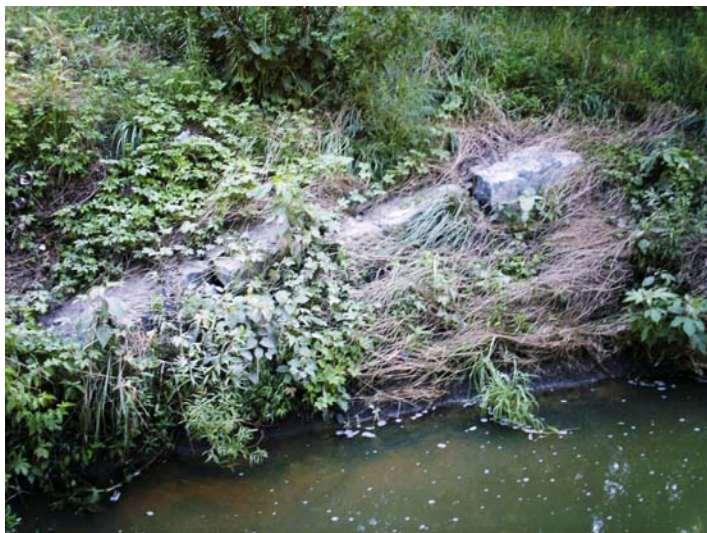
**VP3. Vines**

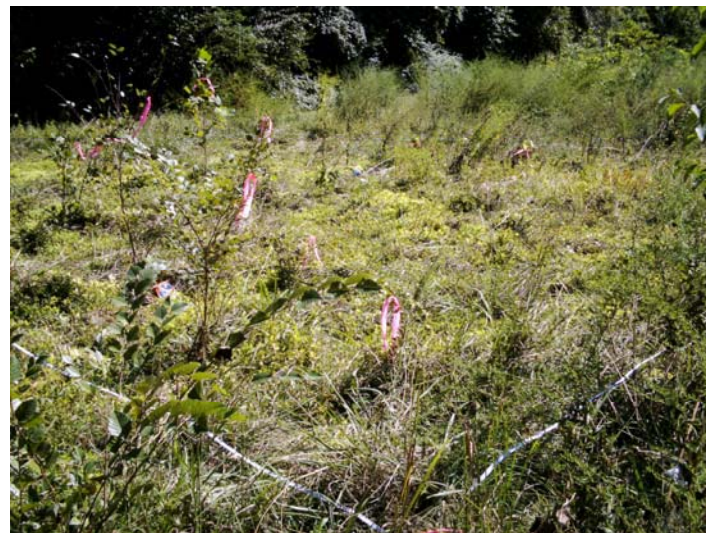
**VP4. Vines**

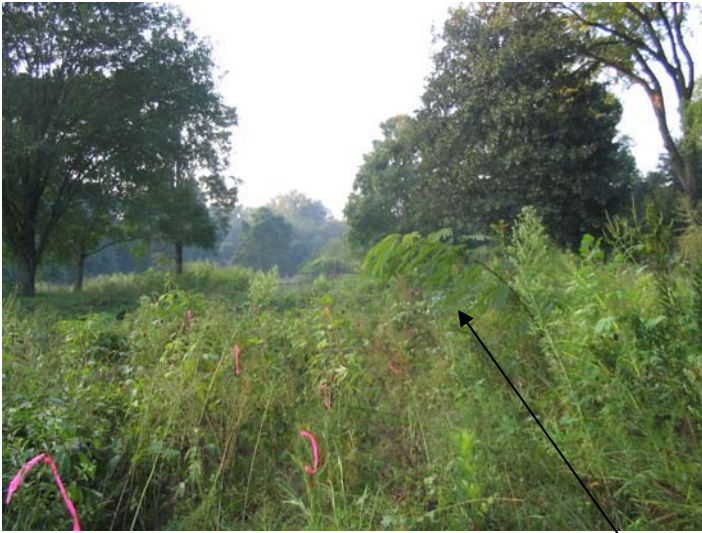
**VP5. Woody**

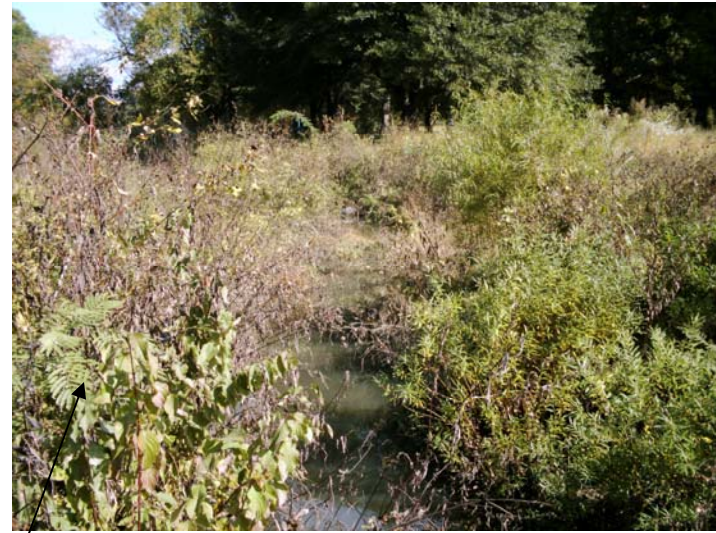
**VP6. Woody**

*Albizzia julibrissin*

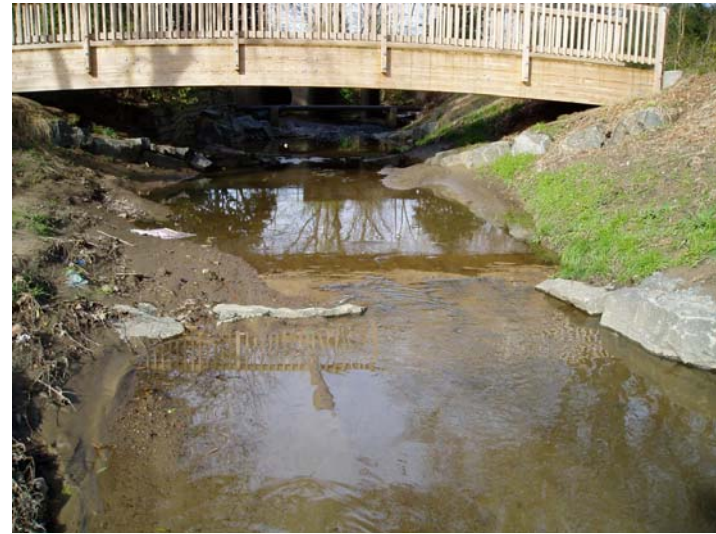
<b>Feature/Issue</b>	<b>Station</b>	<b>Probable Cause</b>	<b>Photo</b>
Aggradation (bar)	1057	Offsite/upstream	SP1
Aggradation (bar)	1080	Offsite/upstream	SP1
Vane backcut/scour	1090	Insufficient/no coarse backfill	SP4&5
Aggradation (pool)	1110	Offsite/upstream	SP2
Aggradation (pool)	1151	Offsite/upstream	SP2
Aggradation (bar)	1193	Offsite/upstream	SP1
Vane backcut/scour	1419	Insufficient/no coarse backfill	SP4&5
Bank undercut/slump	1517	No armor/rootwad	SP3
Vane backcut/scour	1783	Insufficient/no coarse backfill	SP4&5
Vane backcut/scour	2034	Insufficient/no coarse backfill, storm flow from UT	SP4&5
Vane backcut/scour	2146	Insufficient/no coarse backfill	SP4&5
Vane backcut/scour	2171	Insufficient/no coarse backfill	SP4&5
Bank undercut/slump	2502	No armor/rootwad	SP3
Bank undercut/slump	2632	No armor/rootwad	SP3
Vane backcut/scour	2704	Insufficient/no coarse backfill	SP4&5
Vane backcut/scour	2801	Insufficient/no coarse backfill	SP4&5

**SP2. Aggradation (pool)**

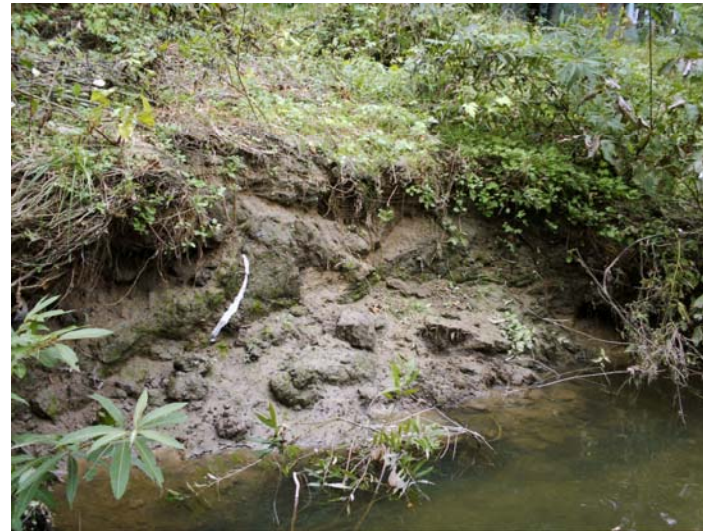
**SP3. Bank undercut/slump**

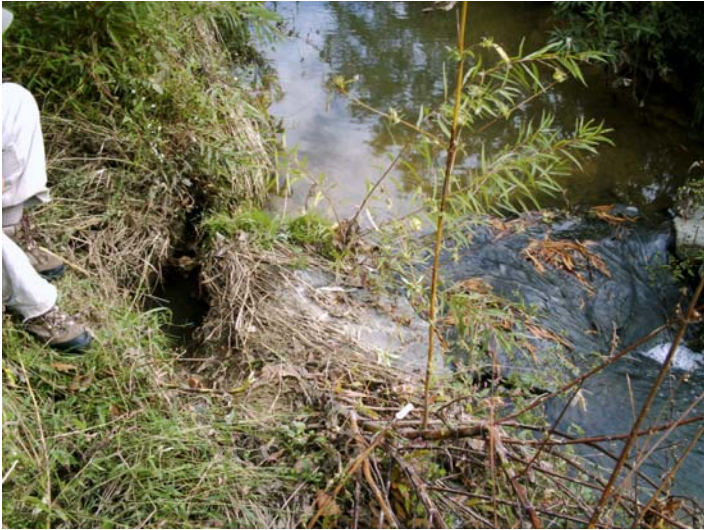
**SP4. Cross Vane Scour**

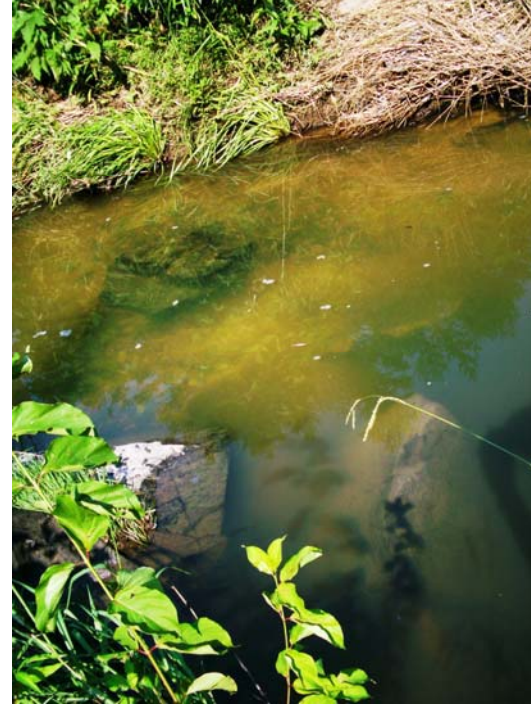
**SP5. Cross Vane Backcut**
