**Third Fork Creek Stream Restoration – NCEEP Project #139  
Durham, North Carolina**

**Third Annual Monitoring Report -- FINAL  
February 2008**

**THIRD FORK CREEK STREAM RESTORATION – NCEEP Project #139  
2007 MONITORING REPORT – YEAR 3**

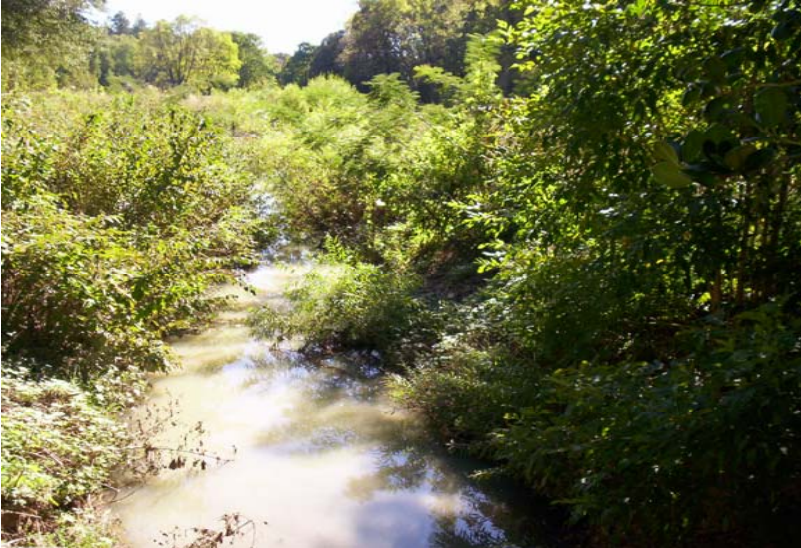
<b>Feature/Issue</b>	<b>Station/Range</b>	<b>Suspected Cause</b>	<b>Photo #</b>
Exotic Invasive Vines and Woody Stems	11+70-14+06	Colonization of floodplain by air and waterborne seeds	VP1
Exotic Invasive Vines	13+42-15+00	Colonization of floodplain by waterborne seeds	VP2
Exotic Invasive Woody Stems	13+57-35+25	Colonization by air and water borne seeds	VP3
Exotic Invasive Woody Stems	15+84-16+29	Colonization by air and water borne seeds	VP3
Exotic Invasive Vines	17+67-19+33	Colonization of floodplain by waterborne seeds	VP2
Exotic Invasive Vines	19+23-19+59	Colonization of floodplain by waterborne seeds	VP2
Exotic Invasive Woody Stems	19+32-19+42	Colonization by air and water borne seeds	VP3
Exotic Invasive Vines and Woody Stems	22+06-23+50	Colonization of floodplain by air and waterborne seeds	VP1
Exotic Invasive Woody Stems	26+84-27+50	Colonization by air and water borne seeds	VP3
Exotic Invasive Woody Stems	28+9-29+38	Colonization by air and water borne seeds	VP3

**VP1. Exotic Invasive Vines and Woody Stems**

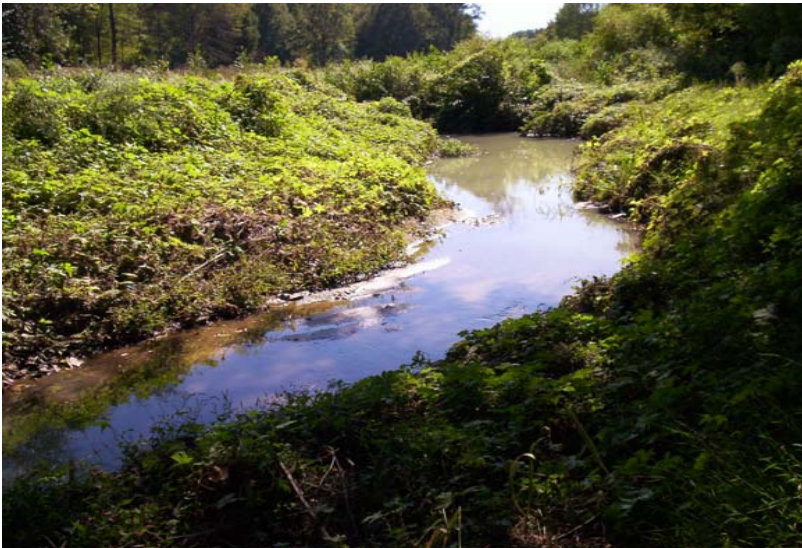
**VP2. Exotic Invasive Vines**

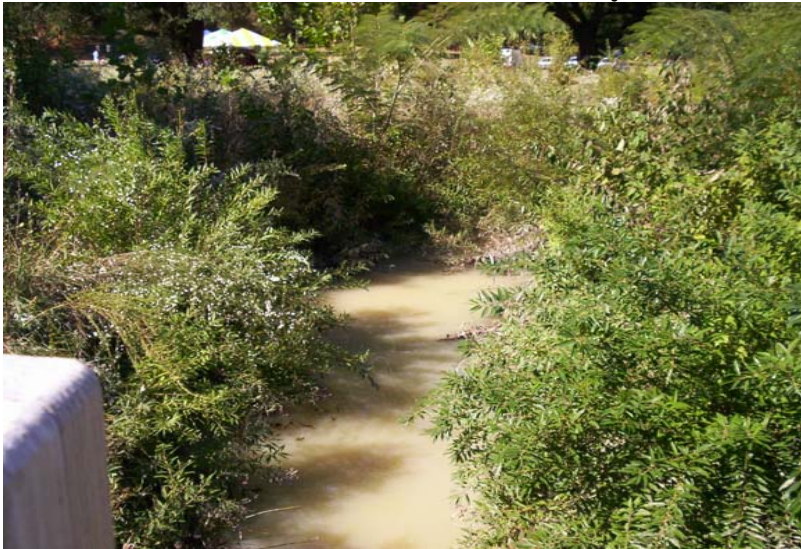
**VP3. Exotic Invasive Woody Stems**

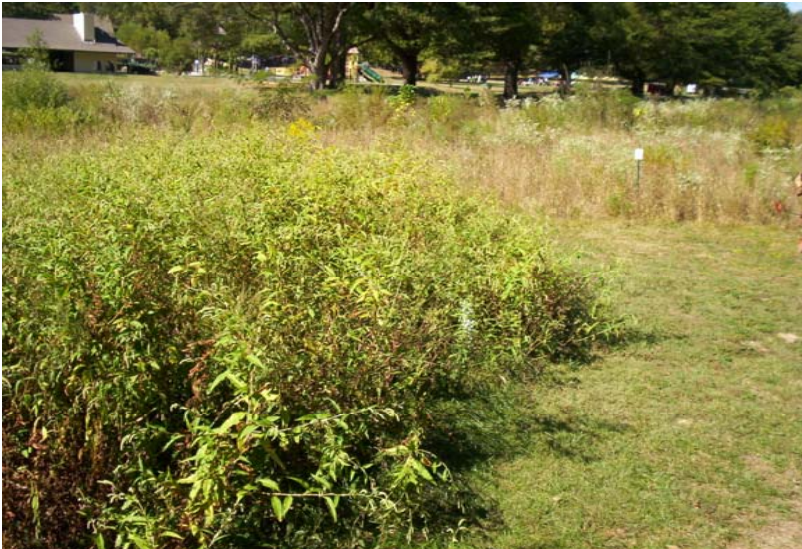
Disturbed area	30+14-30+85	Diseased tree removal by City of Durham maintenance crew – no replanting	VP4
Exotic Invasive Vines and Woody Stems	30+15-30+54	Colonization of floodplain by air and waterborne seeds	VP1
Exotic Invasive vines	30+28-30+90	Colonization of floodplain by waterborne seeds	VP2
Exotic Invasive Woody Stems	31+23-32+33	Colonization by air and water borne seeds	VP3
Exotic Invasive Woody Stems	31+44-32+38	Colonization by air and water borne seeds	VP3
Exotic Invasive Woody Stems	34+74-35+30	Colonization by air and water borne seeds	VP3
Exotic Invasive Woody Stems	35+51-35+72	Colonization by air and water borne seeds	VP3
Exotic Invasive Woody Stems	36+3-36+67	Colonization by air and water borne seeds	VP3
Exotic Invasive Woody Stems	37+44-38+37	Colonization by air and water borne seeds	VP3
Exotic Invasive Woody Stems	38+52-38+97	Colonization by air and water borne seeds	VP3
Exotic Invasive Woody Stems	38+97-39+14	Colonization by air and water borne seeds	VP3

**VP4. Disturbed Area - not replanted**

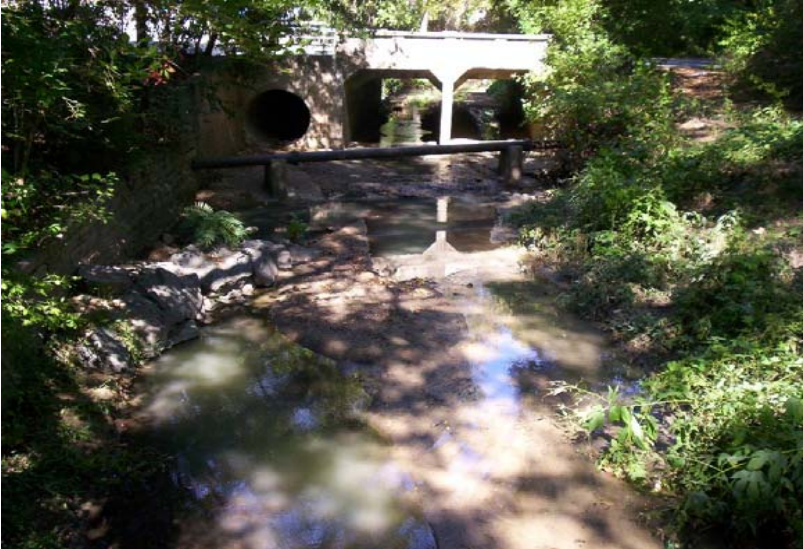
<b>Feature/Issue</b>	<b>Station</b>	<b>Probable Cause</b>	<b>Photo</b>
Aggradation (bar)	10+57	Offsite/upstream	SP1
Aggradation (pool)	10+68	Offsite/upstream	SP2
Aggradation (bar)	10+75	Offsite/upstream	SP1
Aggradation (pool)	11+10	Offsite/upstream	SP2
Headcut-stormwater dist.	14+29	Insufficient armor	SP5
Bank undercut/slump	25+85-26+19	No armor/rootwad	SP3
Vane backcut/scour	27+04	Insufficient/no coarse backfill	SP4
Aggradation (bar)	30+75	Offsite/upstream	SP1
Aggradation (bar)	31+48	Offsite/upstream	SP1
Bank undercut/slump	34+11-34+80	No armor/rootwad	SP3
Bank undercut/slump	35+46-35+75	No armor/rootwad	SP3
Bank undercut/slump	36+30-36+56	No armor/rootwad	SP3
Bank undercut/slump	37+12-37+87	No armor/rootwad	SP3
Bank undercut/slump	37+14-38+10	No armor/rootwad	SP3
Aggradation (pool)	38+14	Offsite/upstream	SP2
Vane backcut/scour	38+68	Insufficient/no coarse backfill	SP4

**SP1. Aggradation (bar)**

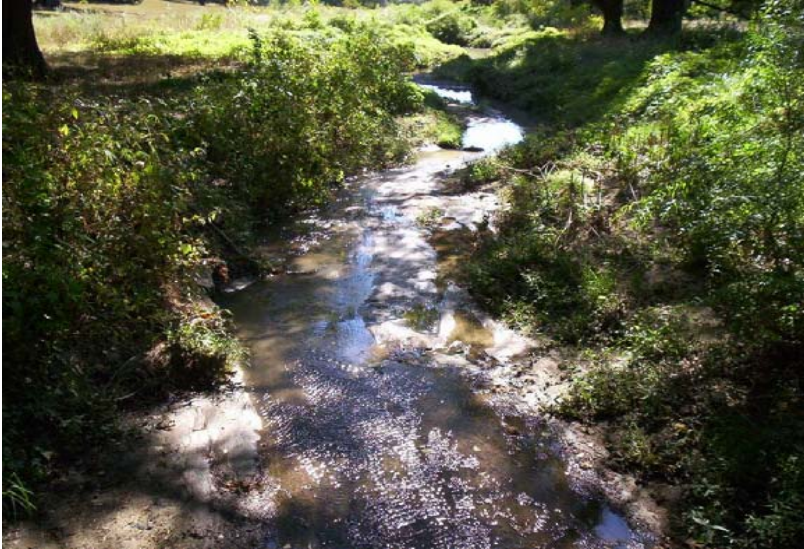
**SP2. Aggradation (pool)**

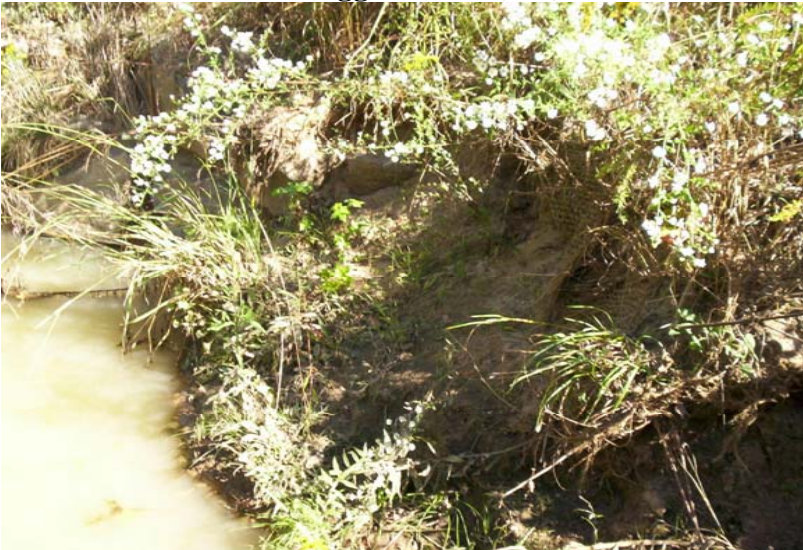
**SP3. Bank Undercut/Slump**

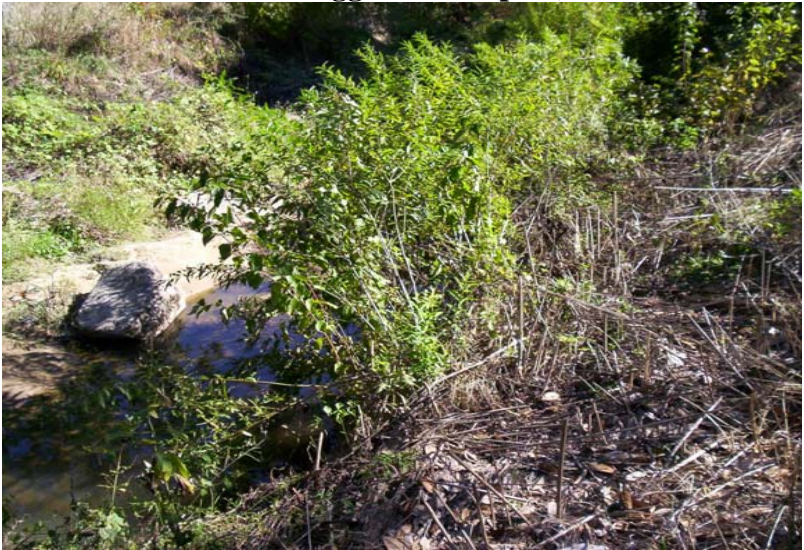
**SP4. Vane Backcut/Scour**
