**THIRD FORK/FOREST HILLS CREEK STREAM RESTORATION – NCEEP
Project #139**

**2008 MONITORING REPORT – YEAR 4 - FINAL
January 2009**

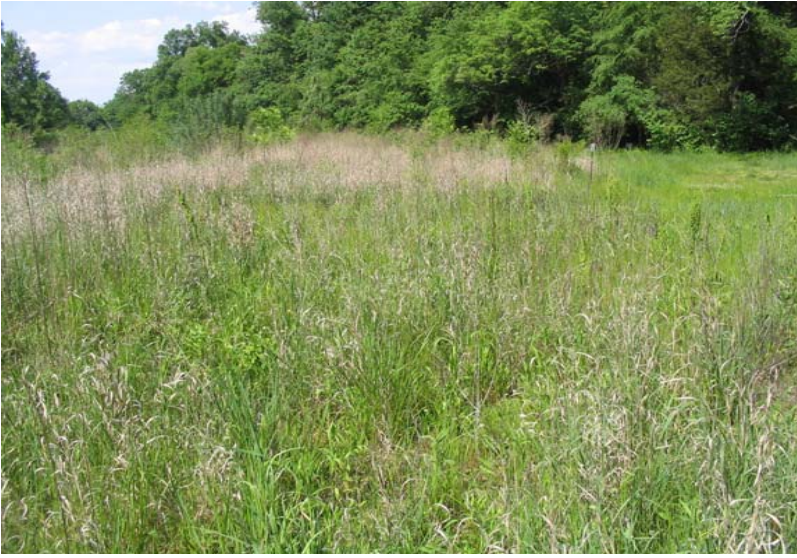
VP1 (7/18/2008)

Table 6. Vegetation Problem Areas – Third Fork Creek Stream Restoration			
EEP Project #139			
Feature/Issue	Station/Range	Probable Cause	Photo #
Compacted/ Disturbed	3014-3085	Disturbed area not replanted	VP1
Exotic invasives colonizing site	3430-3470	Introduction of waterborne seeds from offsite	VP2

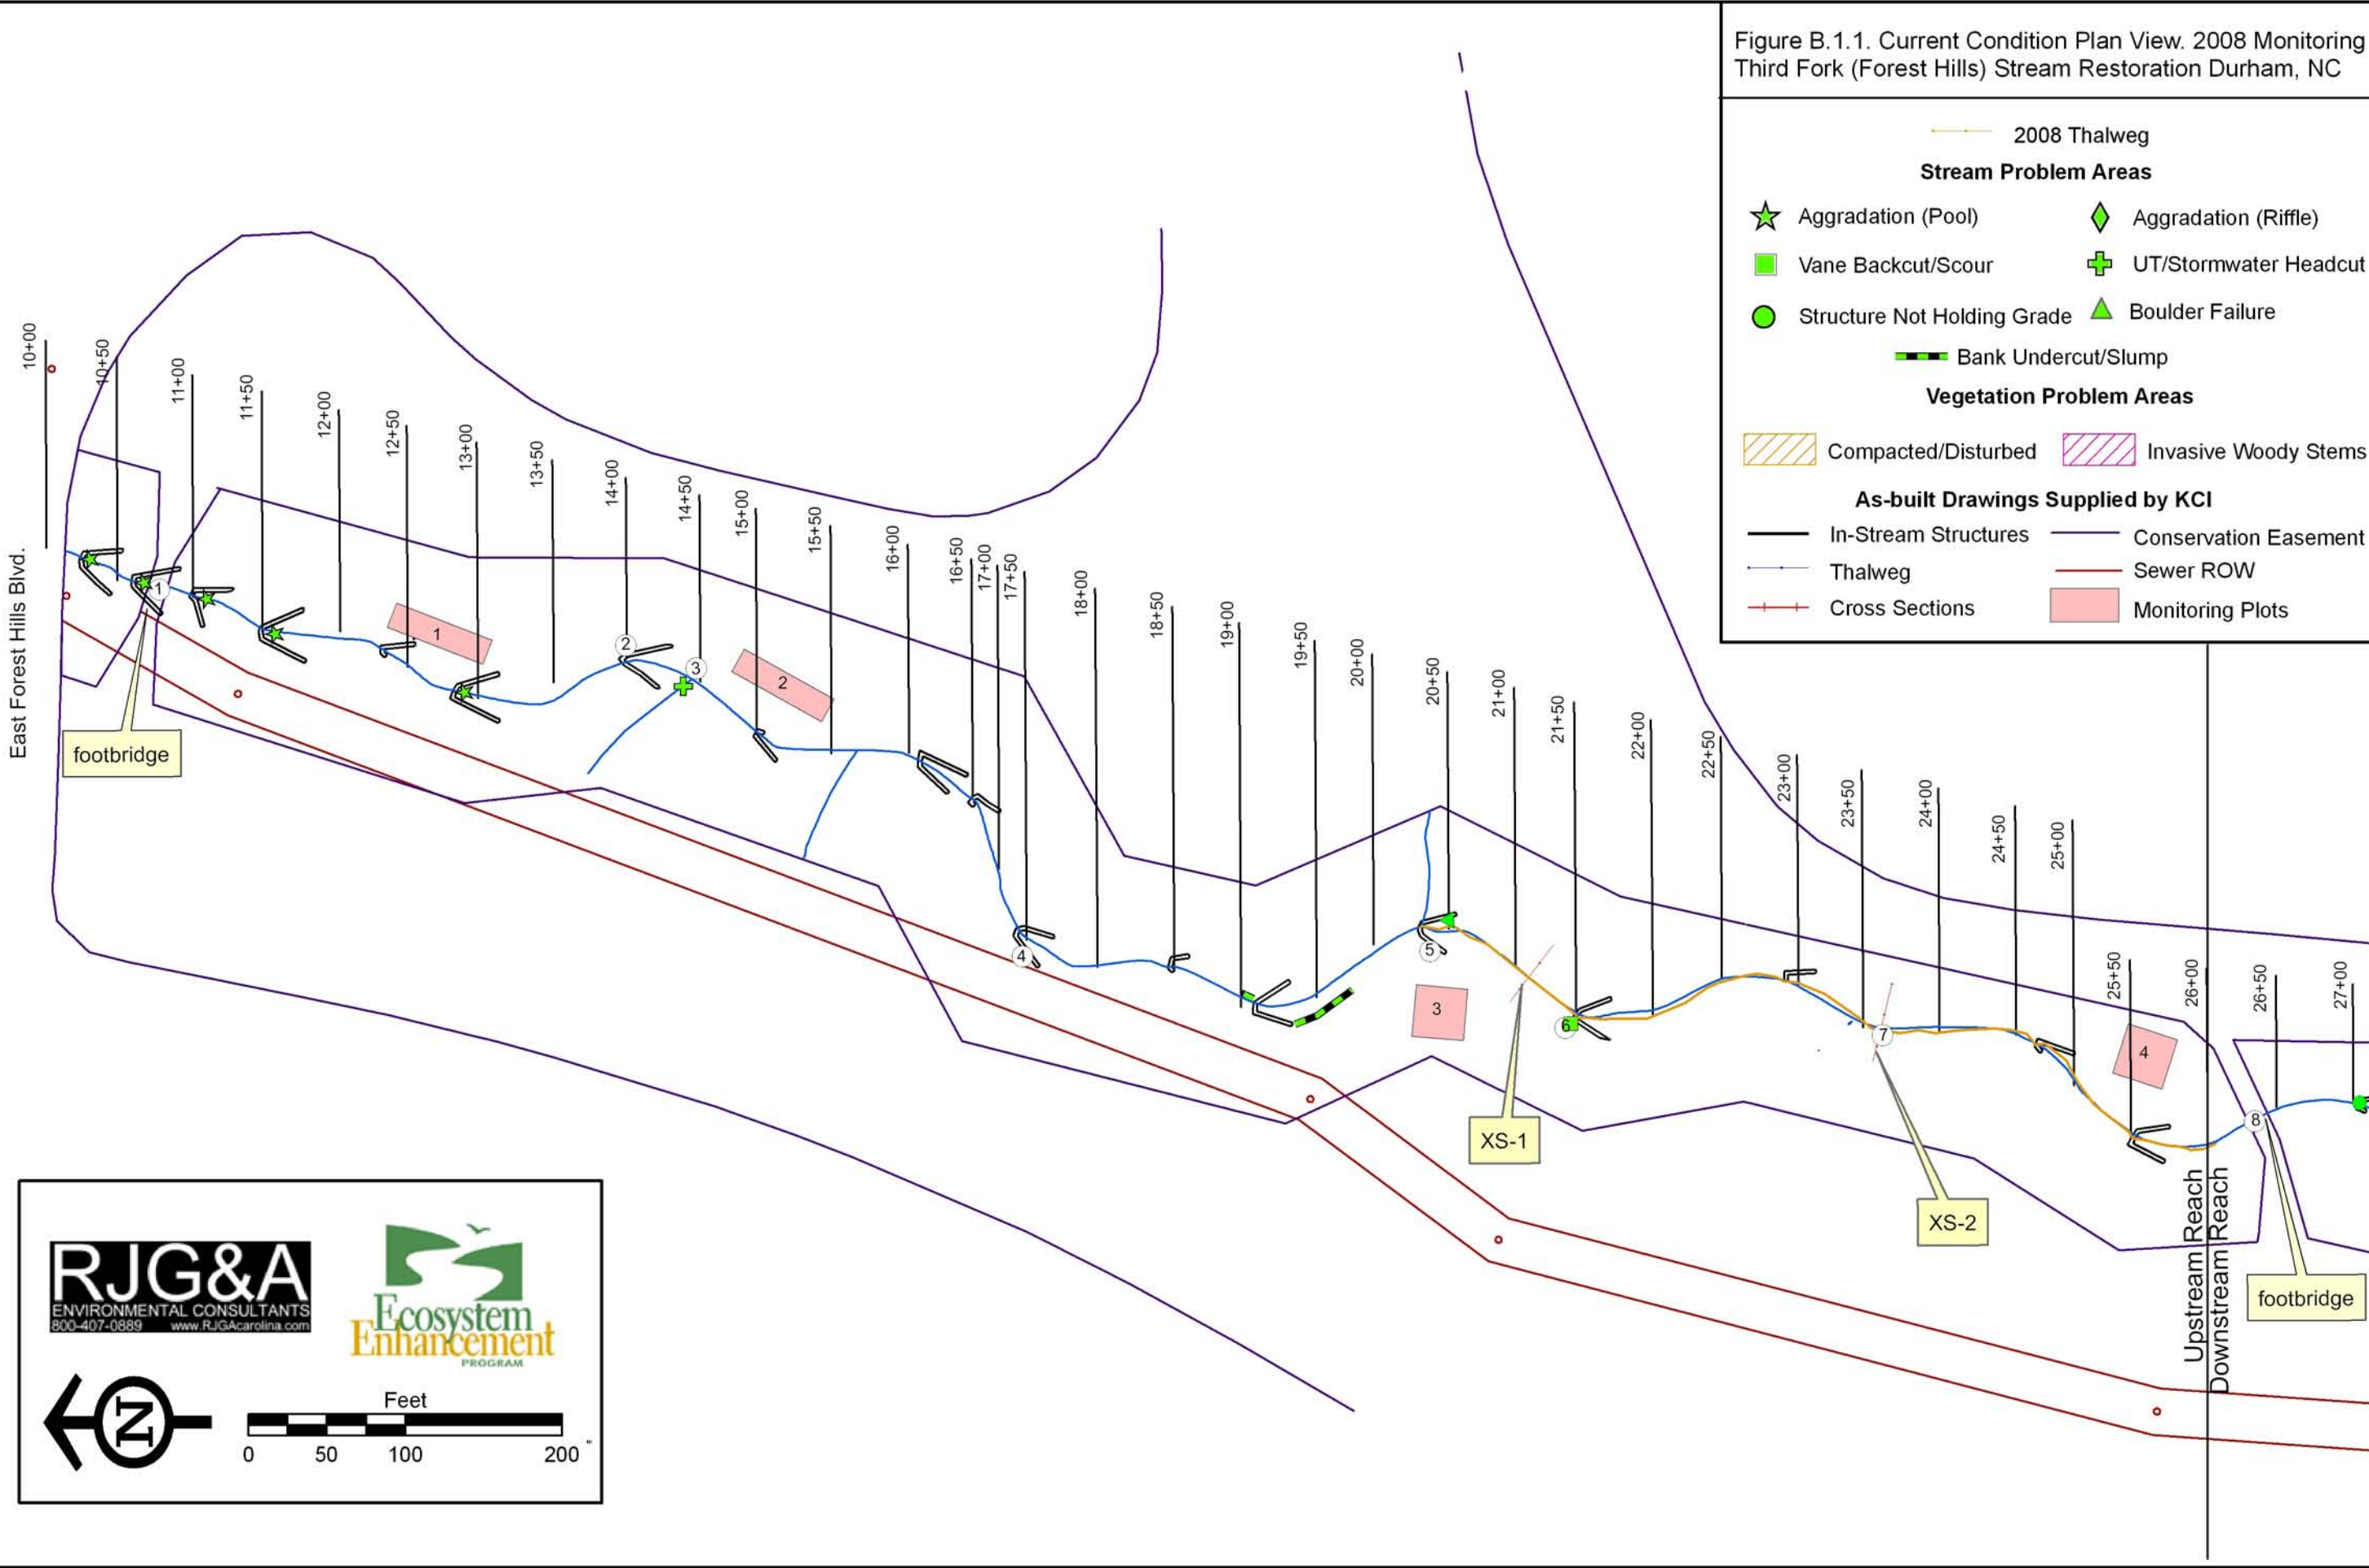
Figure B.1.1. Current Condition Plan View. 2008 Monitoring Third Fork (Forest Hills) Stream Restoration Durham, NC

Stream Problem Areas

- ★ Aggradation (Pool)
- ◆ Aggradation (Riffle)
- Vane Backcut/Scour
- ⊕ UT/Stormwater Headcut
- Structure Not Holding Grade
- ▲ Boulder Failure
- Bank Undercut/Slump

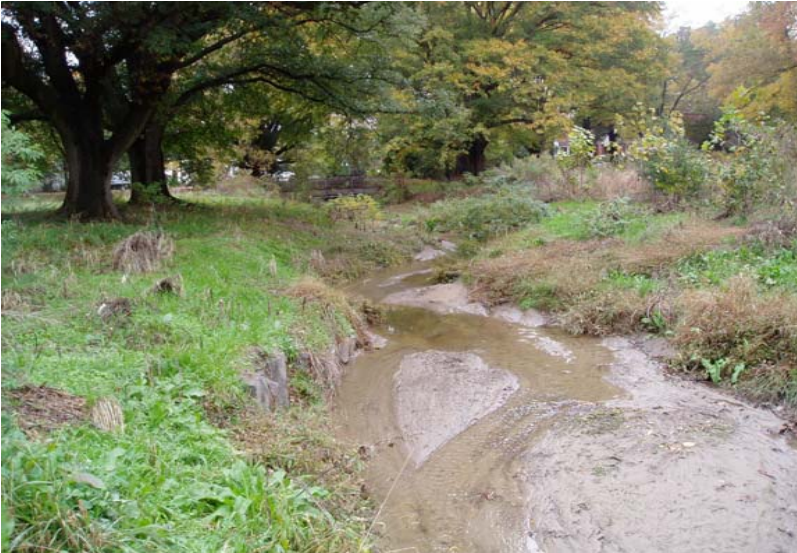
Feature/Issue	Station	Suspected Cause	Photo #
Aggradation (pool)	1025	Sediment from offsite/upstream	SP1
Aggradation (pool)	1068	Sediment from offsite/upstream	SP1
Aggradation (pool)	1110	Sediment from offsite/upstream	SP1
Aggradation (pool)	1158	Sediment from offsite/upstream	SP1
Aggradation (pool)	1290	Sediment from offsite/upstream	SP1
Headcut at UT/stormwater	1443	Insufficient armor	SP2
Bank undercut/slump	1900-1910	No armor/rootwad	SP3 & SP4
Bank undercut/slump	1930-1955	No armor/rootwad	SP3 & SP4
Boulder failure	2050	Unknown	SP5
Vane backcut/scour	2146	Insufficient/no coarse backfill	SP6
Structure not holding grade	2704	Undersized materials/poor installation	SP7
Aggradation (riffle)	3152	Sediment from offsite/upstream	SP8
Bank undercut/slump	3244-3255	No armor/rootwad	SP3 & SP4
Bank undercut/slump (left bank)	3410-3436	Willows on slumping bank have fallen into channel and are holding debris. Problem aggravated by high storm flows.	SP3 & SP4

SP1-Aggradation (pool) (10/28/2008)

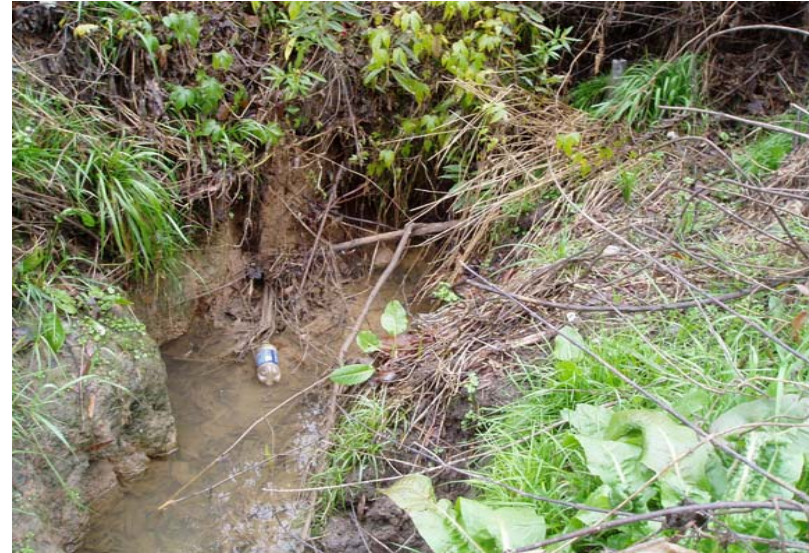
SP2-Headcut in UT/Stormwater (10/28/2008)

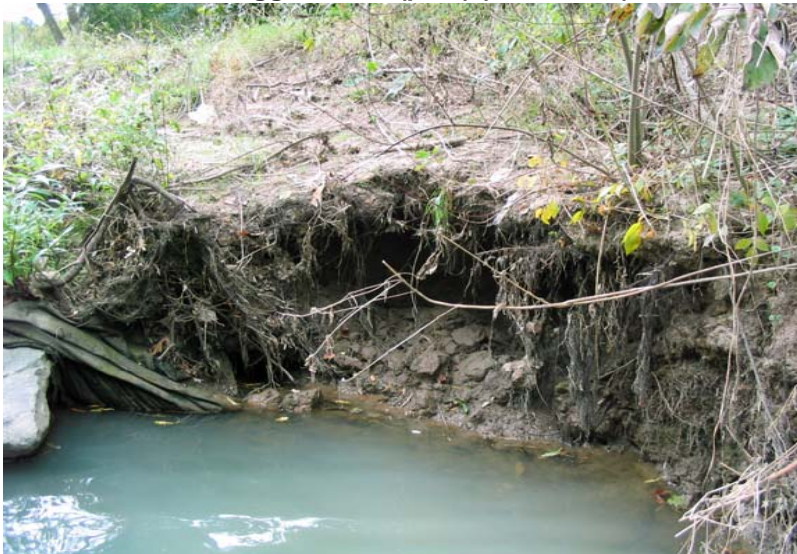
Bank undercut/slump (right bank)	3410-3450	No armor/rootwad	SP3 & SP4
Aggradation (riffle)	3460	Sediment from offsite/upstream	SP8
Vane backcut/scour	3490	Insufficient/no coarse backfill	SP6
Bank undercut/slump	3546-3576	No armor/rootwad	SP3
Aggradation (riffle)	3580	Sediment from offsite/upstream	SP8
Structure not holding grade	3620	Undersized materials/poor installation	SP7
Bank undercut/slump	3630-3657	No armor/rootwad	SP3
Aggradation (riffle)	3640	Sediment from offsite/upstream	SP8
Bank undercut/slump (right bank)	3710-3771	No armor/rootwad	SP3
Bank undercut/slump (left bank)	3715-3790	No armor/rootwad	SP3
Aggradation (riffle)	3770	Sediment from offsite/upstream	SP8
Bank undercut/slump	3800-3810	No armor/rootwad	SP3 & SP4
Structure not holding grade	3820	Undersized materials/poor installation	SP7
Bank undercut/slump	3850-3863	No armor/rootwad	SP3 & SP4

SP3-Bank undercut/scour (10/28/2008)

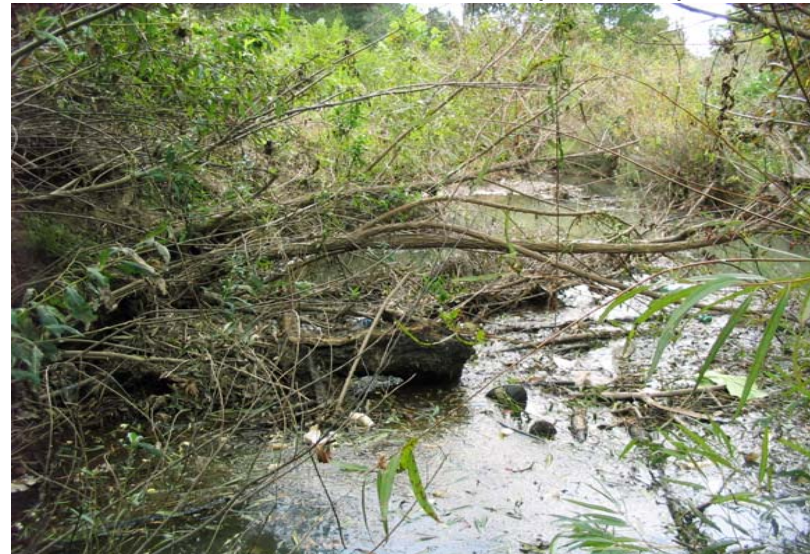
SP4-Bank slump resulting in choked channel (10/28/2008)

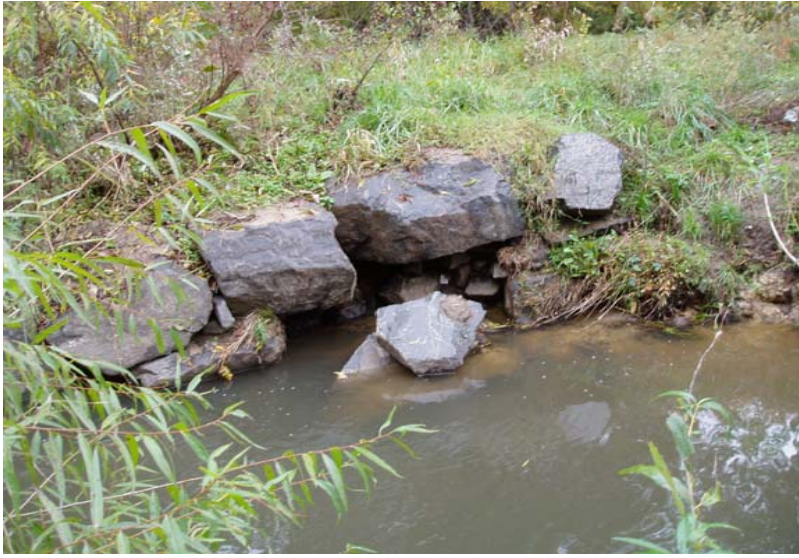
SP5-Boulder failure (10/28/2008)

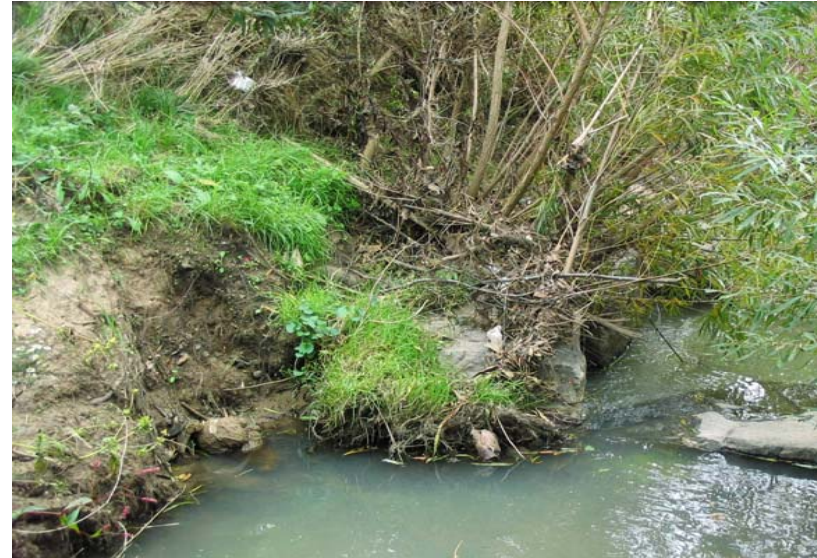
SP6-Vane backcut (10/28/2008)

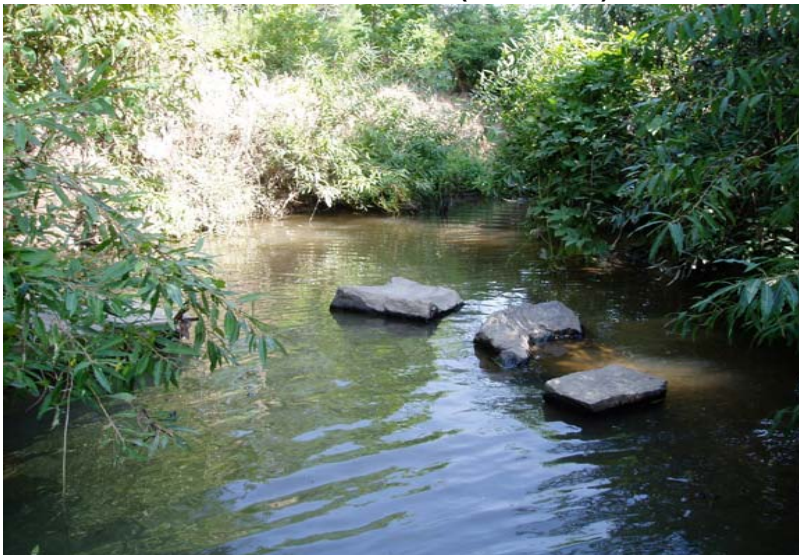
SP7-Structure not holding grade (10/28/2008)

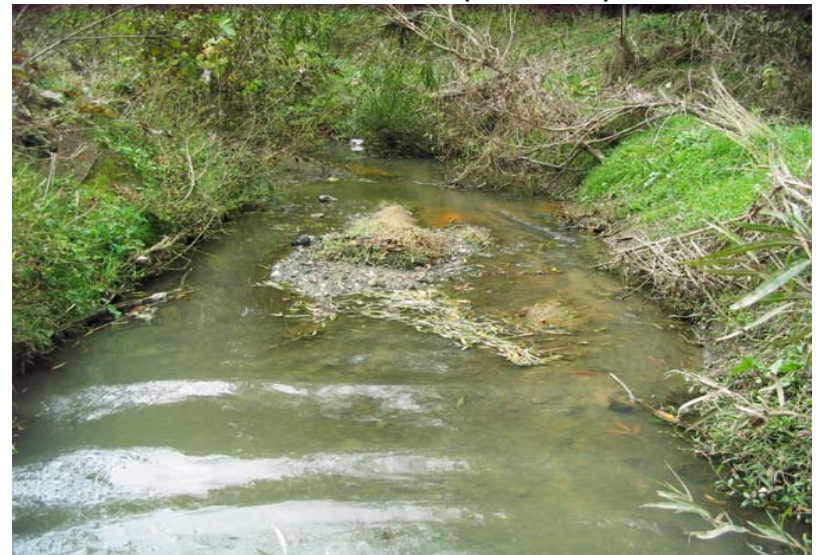
SP8-Aggradation (riffle) (10/28/2008)
