THIRD FORK/FOREST HILLS CREEK STREAM RESTORATION–Project #139
Fifth Annual Monitoring Report – 2009 – FINAL

January 2010

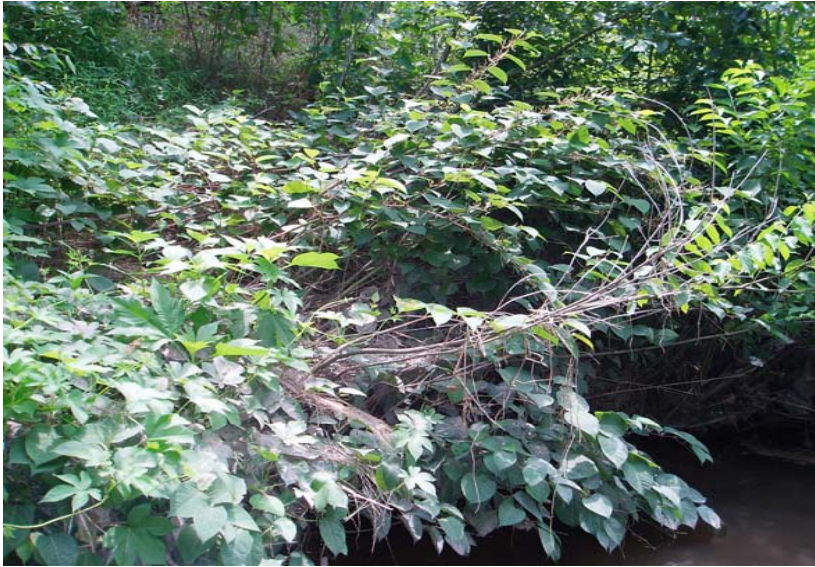
VP1 (7/17/2009)

A.1. Table 6. Vegetation Problem Area Table - Forest Hills/Third Fork Creek Stream Restoration - MY5 (2009) - Project #139			
Feature/Issue	Station/Range	Probable Cause	Photo #
<i>Reynoutria japonica</i> (Japanese knotweed), <i>Ampelopsis brevipedunculata</i> (porcelainberry), <i>Albizia julibrissin</i> (mimosa), <i>Melia azedarach</i> (chinaberry), <i>Pyrus calleryana</i> (callery pear), <i>Triadica sebifera</i> (Chinese tallow tree)	1000-4024	Introduction of waterborne seeds from offsite	VP1-shows Japanese hops and Japanese knotweed
Japanese hops (<i>Humulus japonicus</i>)	1145-1215	Introduction of waterborne seeds from offsite	VP1-VP4
Japanese hops (<i>Humulus japonicus</i>)	1205-1255	Introduction of waterborne seeds from offsite	VP1-VP4
Japanese hops (<i>Humulus japonicus</i>)	1235-1380	Introduction of waterborne seeds from offsite	VP1-VP4
Japanese hops (<i>Humulus japonicus</i>)	1335-1360	Introduction of waterborne seeds from offsite	VP1-VP4

Feature/Issue	Station/ Range	Probable Cause	Photo #
Japanese hops (<i>Humulus japonicus</i>)	3380-3465	Introduction of waterborne seeds from offsite	VP1-VP4
Japanese hops (<i>Humulus japonicus</i>)	3515-3540	Introduction of waterborne seeds from offsite	VP1-VP4
Japanese hops (<i>Humulus japonicus</i>)	3565-3580	Introduction of waterborne seeds from offsite	VP1-VP4
Japanese hops (<i>Humulus japonicus</i>)	3750-3780	Introduction of waterborne seeds from offsite	VP1-VP4

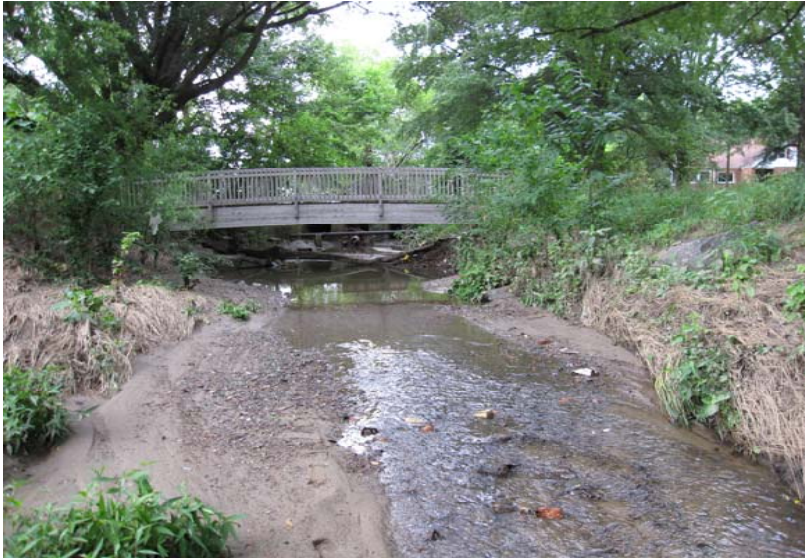
Feature/Issue	Station	Suspected Cause	Photo #
Aggradation (pool)	1025	Sediment from offsite/upstream	SP1
Aggradation (pool)	1110	Sediment from offsite/upstream	SP1
Aggradation (pool)	1158	Sediment from offsite/upstream	SP1
Right Bank Scour/Slump	1190-1205	No armor/rootwad	SP3 & SP4
Aggradation (pool)	1290	Sediment from offsite/upstream	SP1
Right Bank Scour/Slump	1345-1360	No armor/rootwad	SP3 & SP4
Left Bank Scour/Slump	1355-1367	No armor/rootwad	SP3 & SP4
Headcut at UT/stormwater	1443	Insufficient armor	SP2
Right Bank Scour/Slump	1900-1910	No armor/rootwad	SP3 & SP4
Right Bank Scour/Slump	1930-1960	No armor/rootwad	SP3 & SP4
Right Bank Scour/Slump	1940-1960	No armor/rootwad	SP3 & SP4
Right Bank Scour/Slump	2180-2186	No armor/rootwad	SP3 & SP4
Left Bank Scour/Slump	2222-2234	No armor/rootwad	SP3 & SP4
Right Bank Scour/Slump	2480-2485	No armor/rootwad	SP3 & SP4
Right Bank Scour/Slump	2530-2548	No armor/rootwad	SP3 & SP4

SP1-Aggradation (pool) (7/6/2009)

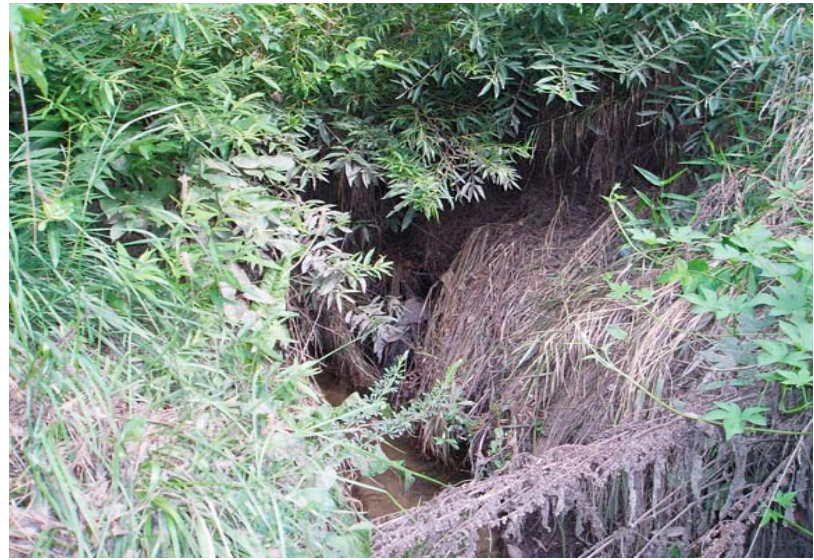
SP2-Headcut in UT/Stormwater (7/17/2009)

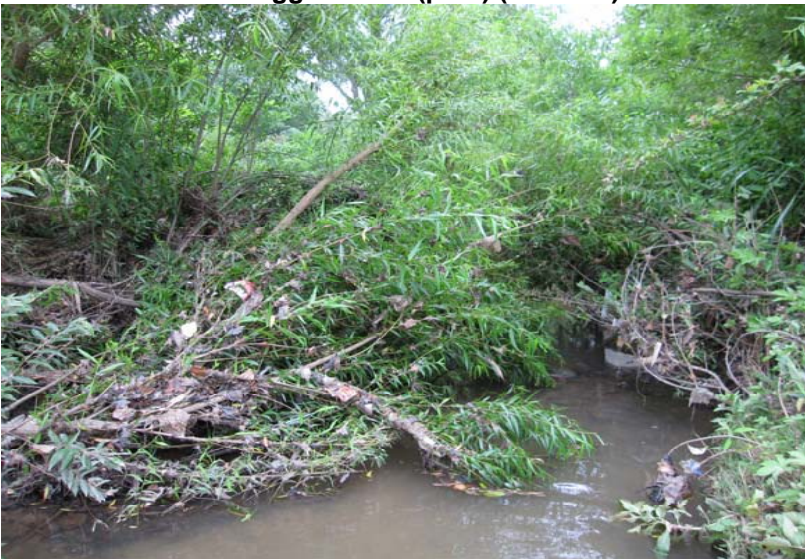
Right Bank Scour/Slump	3270-3285	No armor/rootwad	SP3 & SP4
Right Bank Scour/Slump	3410-3430	No armor/rootwad	SP3 & SP4
Left Bank Scour/Slump	3415-3440	No armor/rootwad	SP3 & SP4
Right Bank Scour/Slump	3525-3555	No armor/rootwad	SP3 & SP4
Left Bank Scour/Slump	3750-3780	No armor/rootwad	SP3 & SP4
Right Bank Scour/Slump	3800-3810	No armor/rootwad	SP3 & SP4
Left Bank Scour/Slump	3850-3863	No armor/rootwad	SP3 & SP4

SP3-Bank slump (7/6/2009)

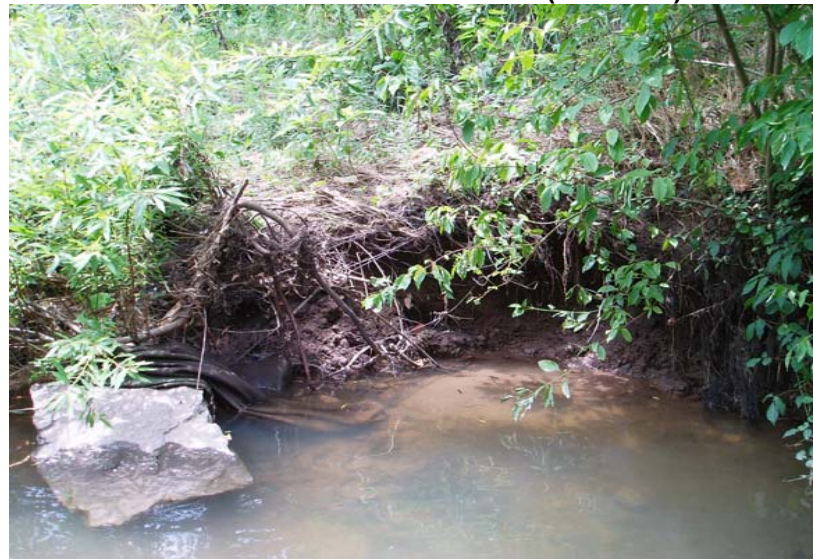
SP4-Bank scour (7/17/2009)
