As-built report for the Fosson Mitigation Site, Paint Fork Creek, Madison County

North Carolina Wildlife Resources Commission

October 30, 2000

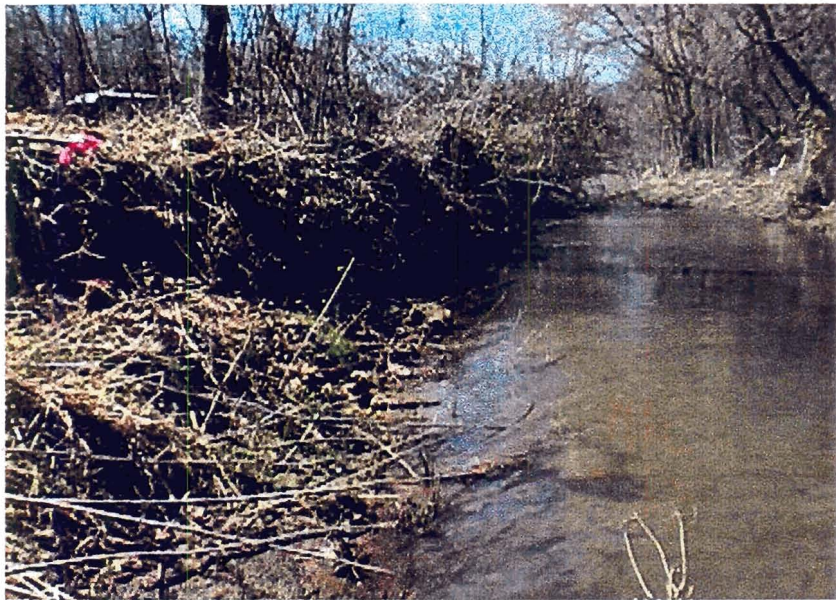
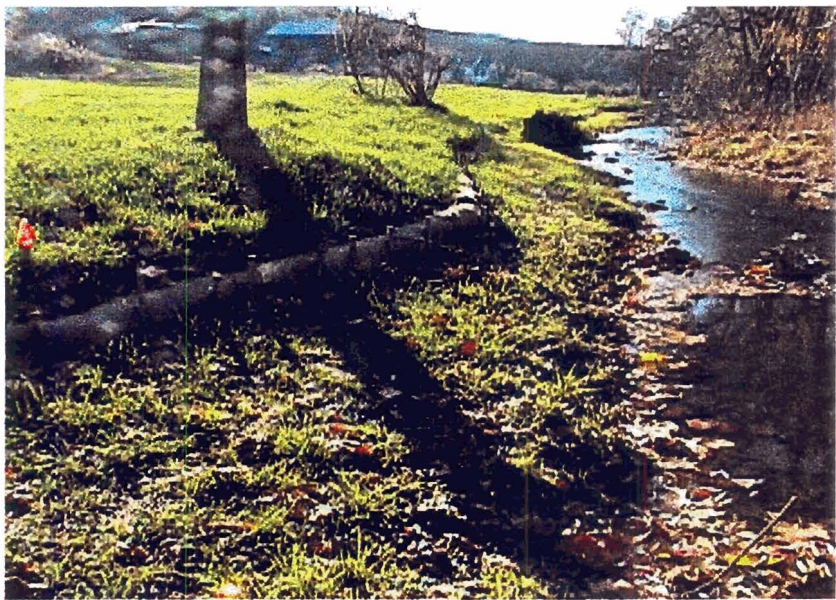
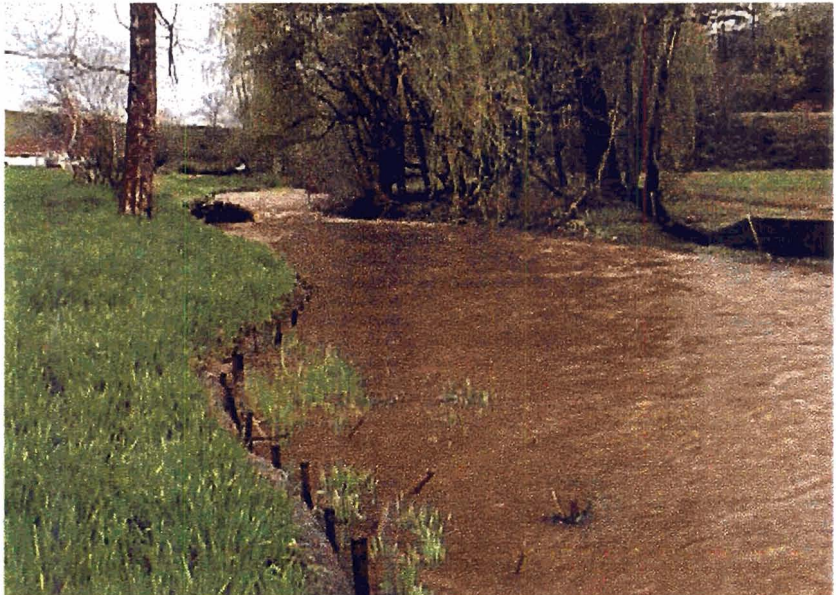
Downstream photo at same point before and after construction, showing sycamore for reference. Bottom photo shows same site during bankfull event.

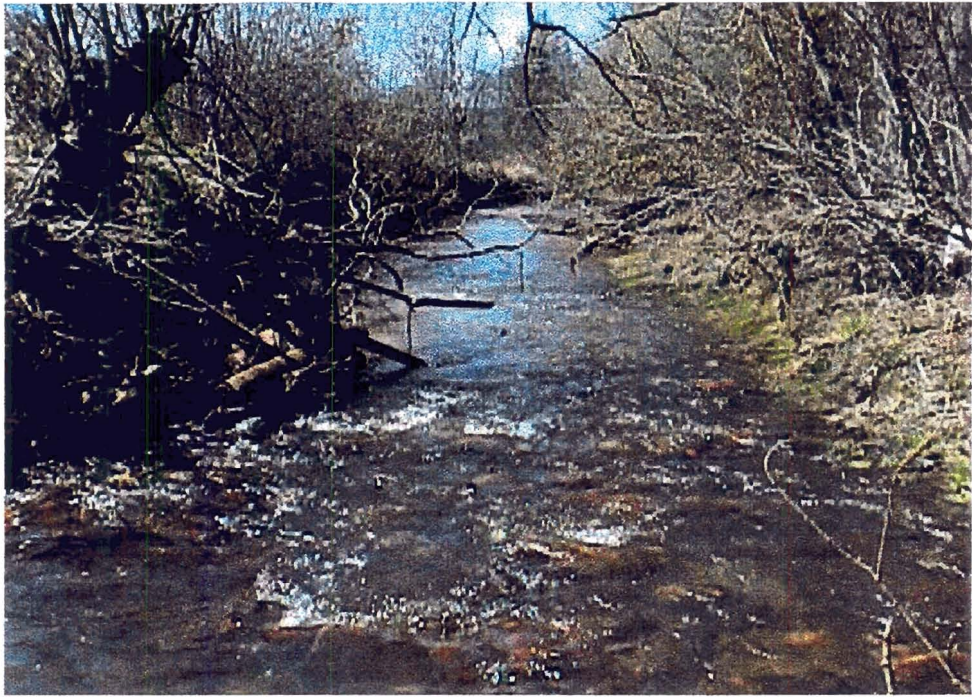
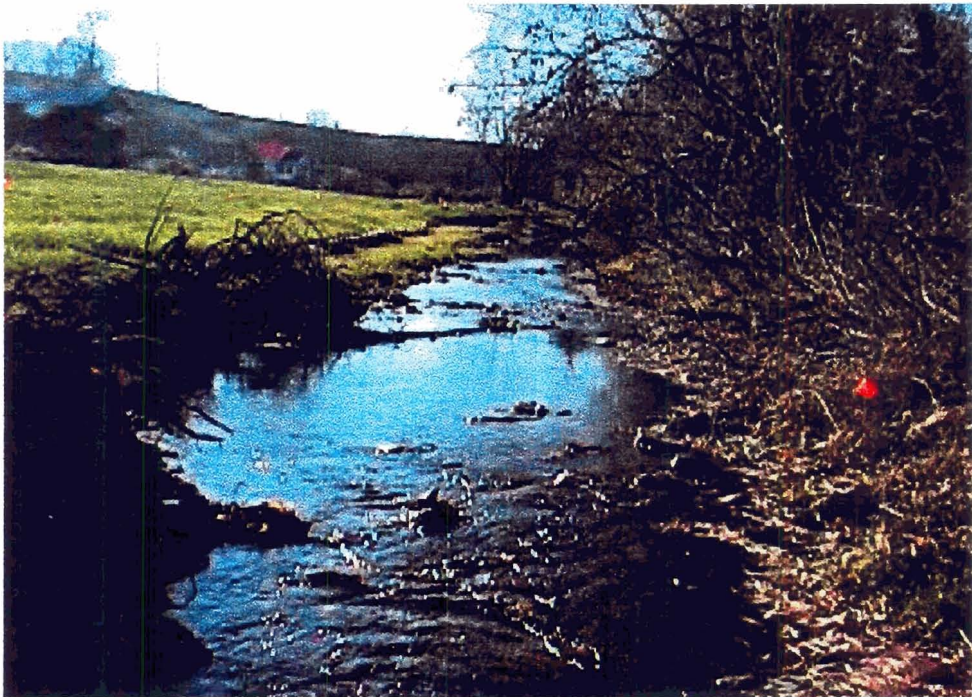
Downstream photo of same location showing lower rootwad revetment and banks before and after construction

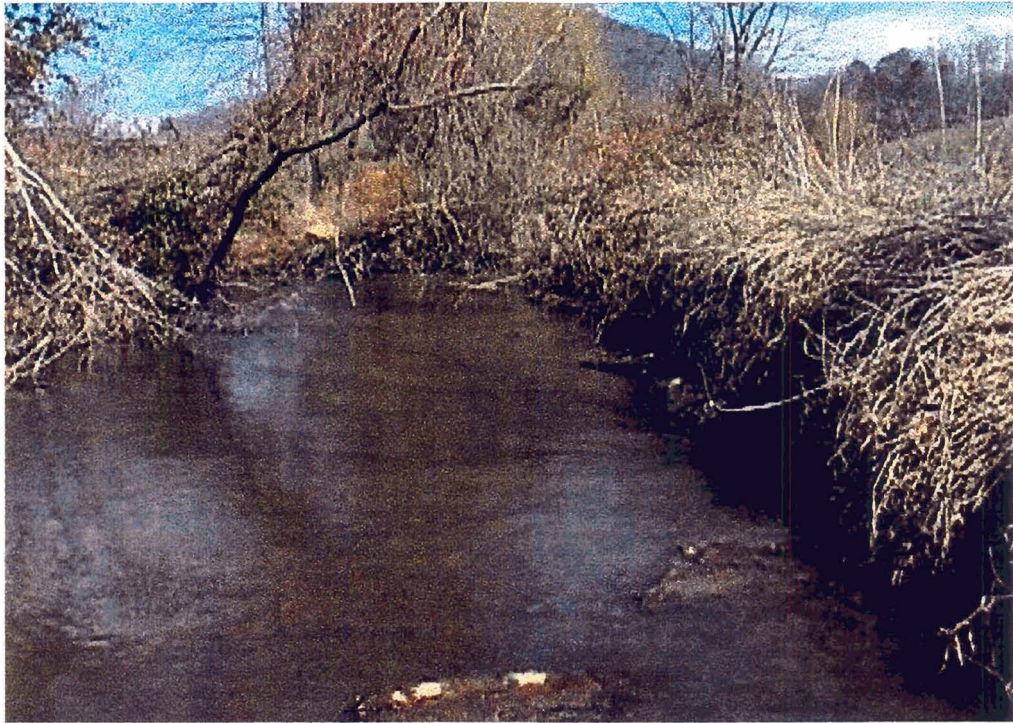
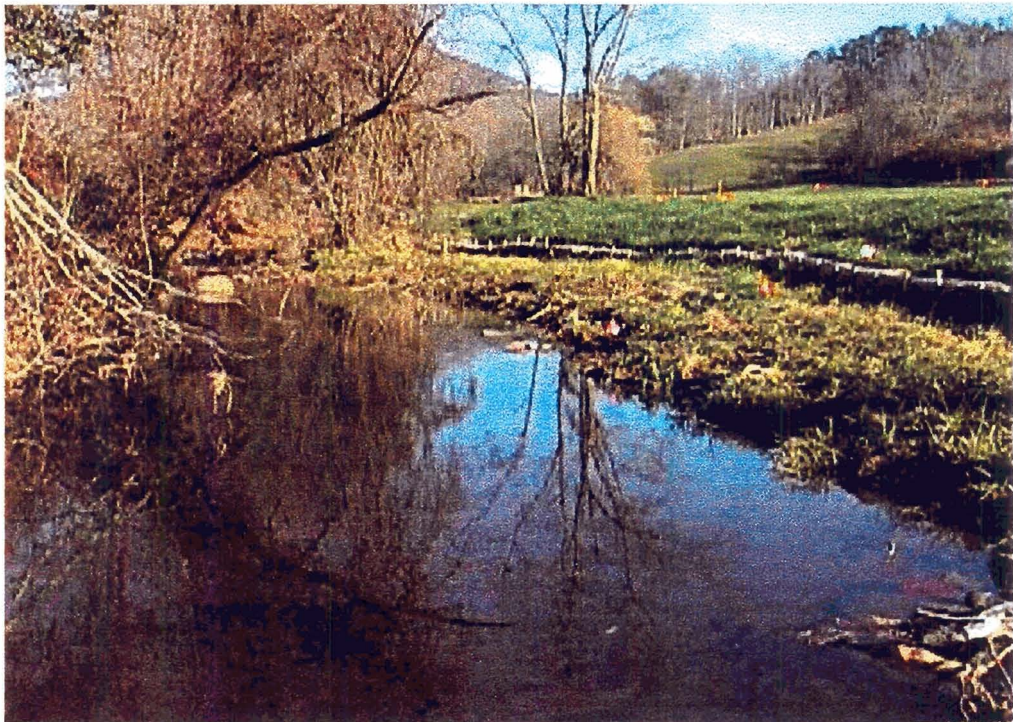
Upstream photo along lower end of site, showing the same location before and after construction. Note the willow tree and walnut trees (center top of photos) for reference. Vertical, eroding stream banks have been sloped and vegetated for greater stability.

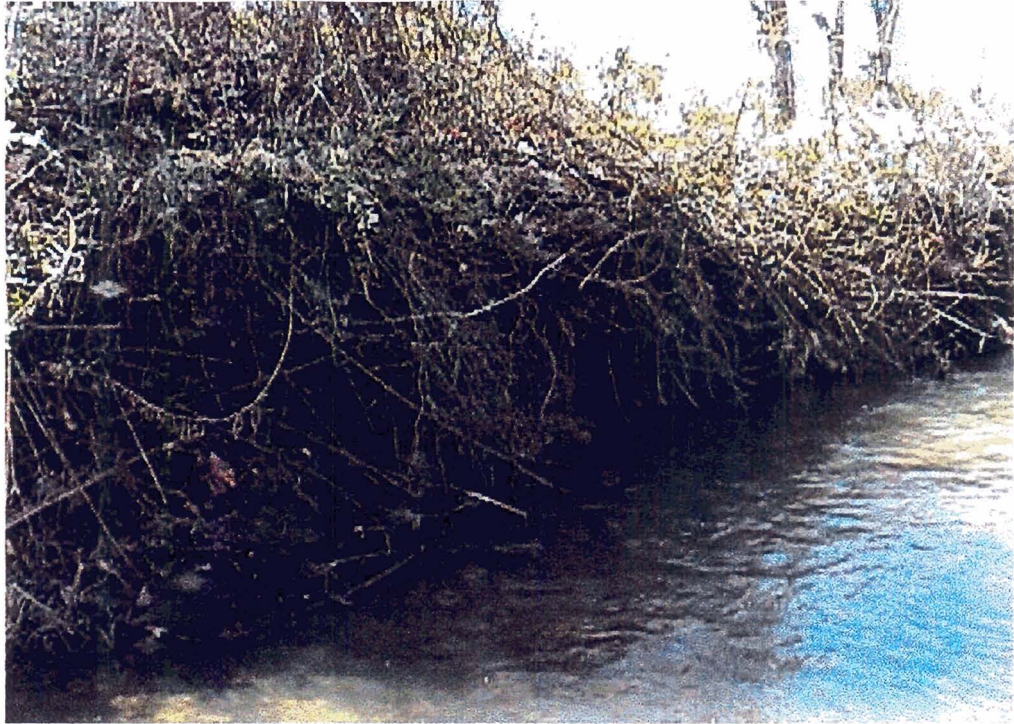
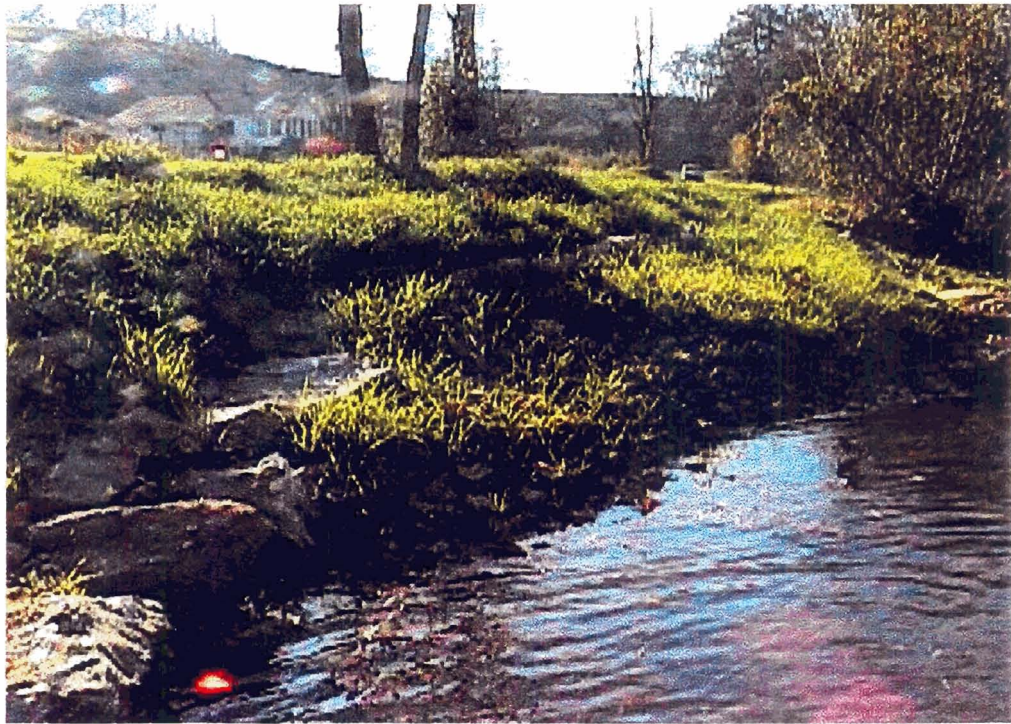
Photo downstream at same location before and after construction. Photos show the change in stream bank profile, stabilization with vegetation and erosion control materials and a rock vane constructed to direct flow toward the thalweg and reduce pressure on the near bank region.

Bedrock was the cause of erosion at two locations on the reach. The bedrock directed water against the south bank because it was lower on that side of the channel. This problem was addressed by constructing rock vanes that crossed the south ends of these seams and raised the water level on the south bank. This reduced the water velocity on this bank and stopped the erosion. Since these vanes were built on bedrock they were not able to create scour holes to enhance habitat. A J-hook vane was constructed upstream of the second bedrock seam to enhance pool formation in this area, as well as to begin moving water to the north side of the channel. Rootwad revetments were constructed at two sites toward the upper part of the reach (see the attached map for all structure locations). These revetments were constructed out of large hemlock log/root balls obtained off site. They were installed at sites along the bank where the water flow was directed into the bank. Unfortunately, due to the bedrock along this reach they could not be installed deep enough to provide high quality aquatic habitat. However, these revetments are diverting high flows off of the banks and deeper scour holes are developing below the revetments. Throughout the entire reach the interberm was maintained, enhanced or created as channel modifications were made. It was felt that this feature was developing naturally and benefited the stream by slowing high water. As this feature was enhanced or created it was seeded and protected with a jute erosion control fabric. The only structures installed along the unnamed tributary were floodplain benches at two bends. These were constructed to move the water flow off of high vertical banks. These benches were built with boulders and covered with soil. The area was then vegetated to provide a stable creek bank and footer to the high bank.
