ANNUAL REPORT FOR 2003

**Paint Fork Creek Stream Mitigation Site (Fosson Site)
Madison County
WBS Element 32573.4.1
TIP No. A-10WM**

Prepared By:
Office of Natural Environment & Roadside Environmental Unit
North Carolina Department of Transportation
December 2003

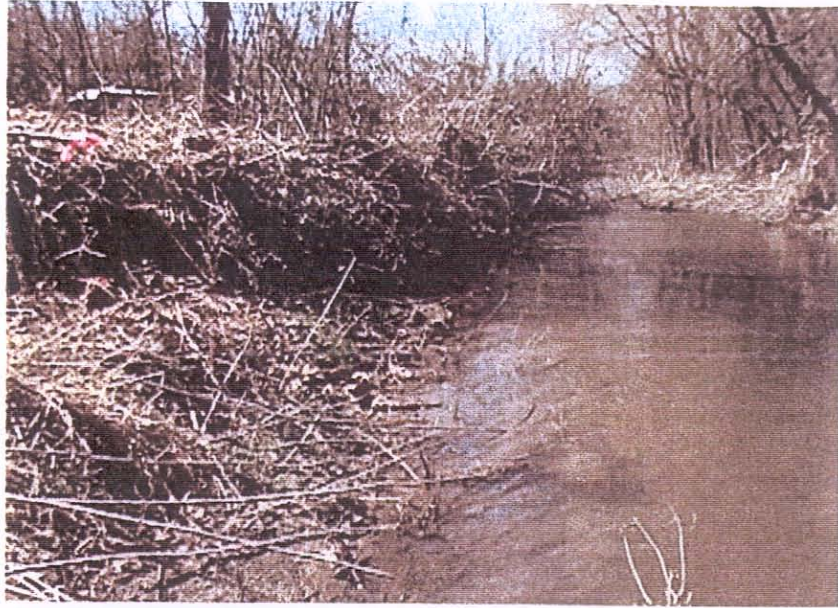
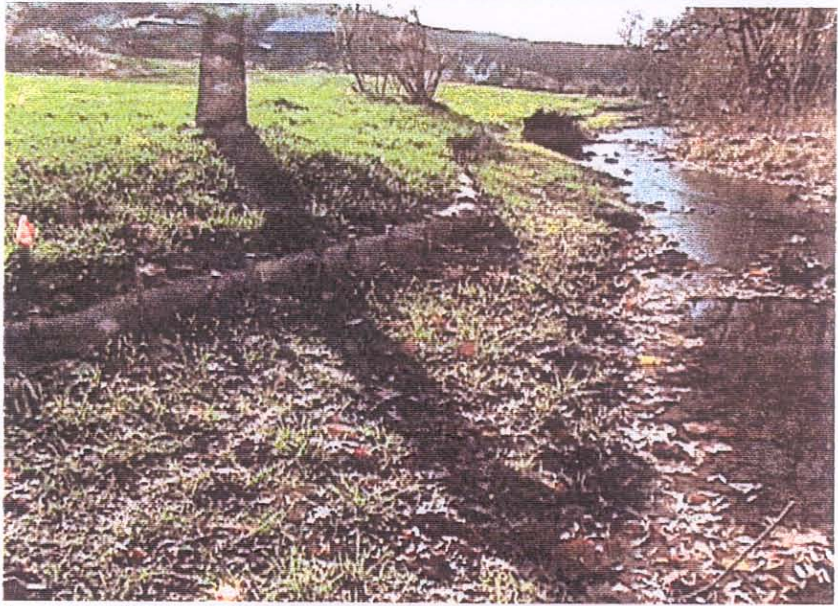
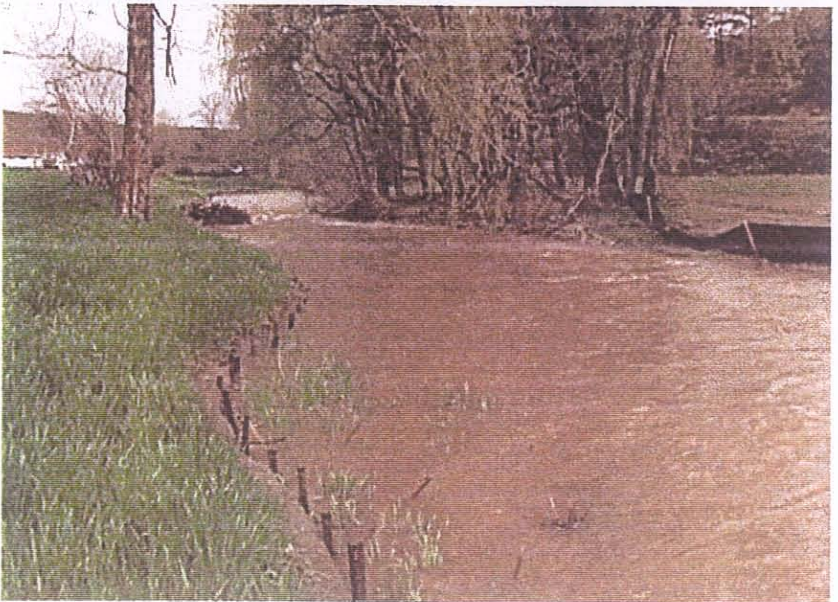
Downstream photo at same point before and after construction, showing sycamore for reference. Bottom photo shows same site during bankfull event.

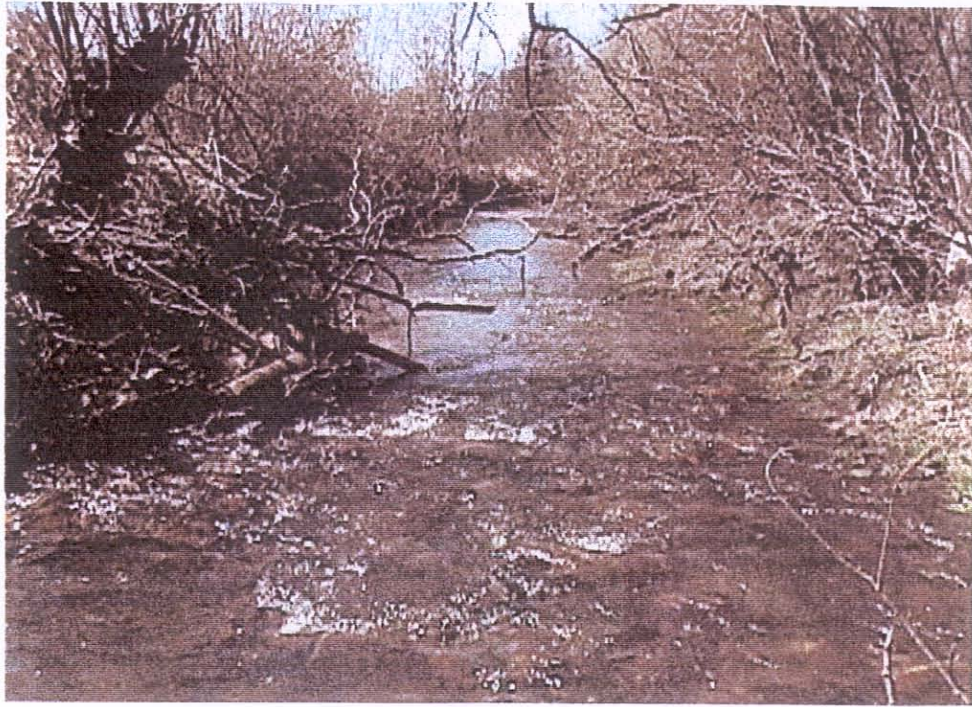
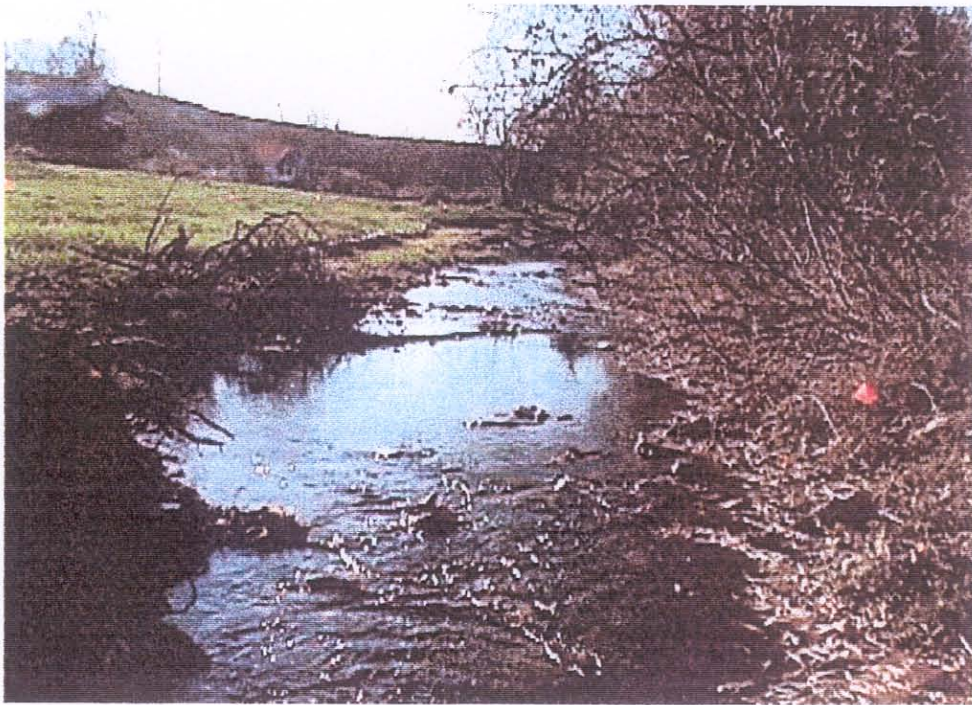
Downstream photo of same location showing lower rootwad revetment and banks before and after construction

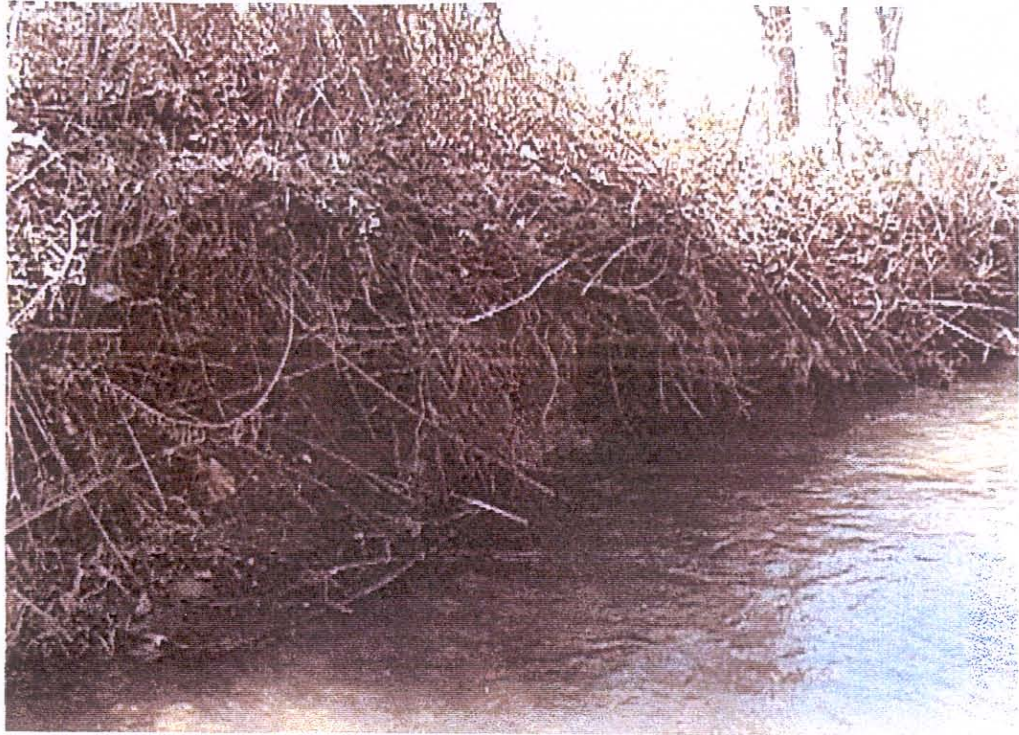
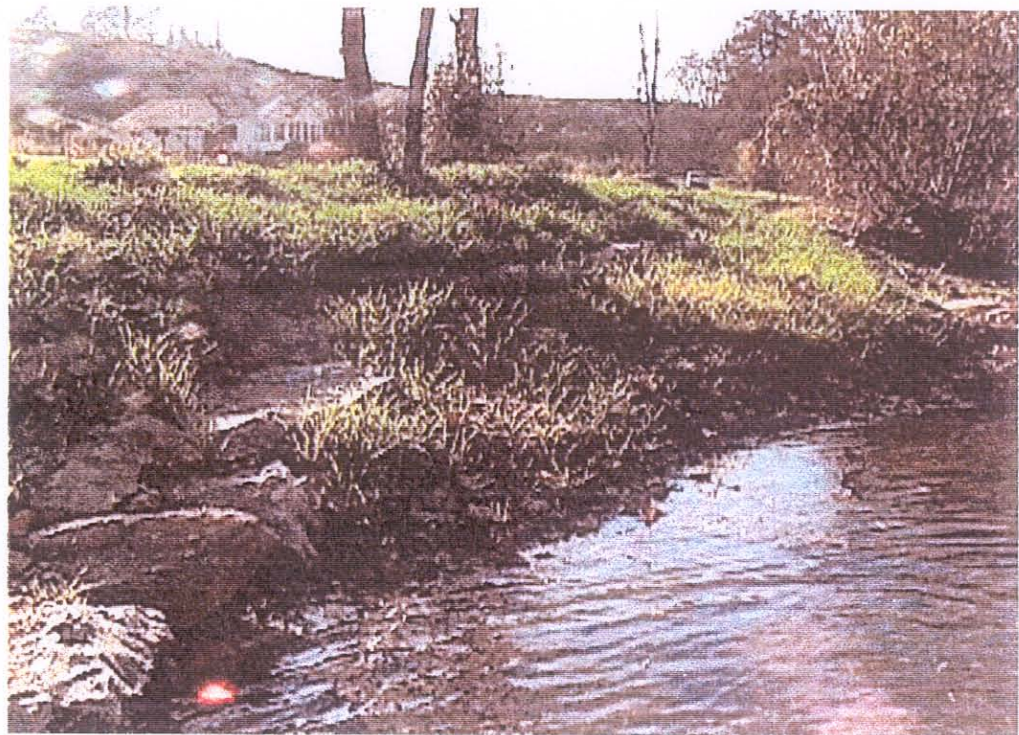
Photo downstream at same location before and after construction. Photos show the change in stream bank profile, stabilization with vegetation and erosion control materials and a rock vane constructed to direct flow toward the thalweg and reduce pressure on the near bank region.

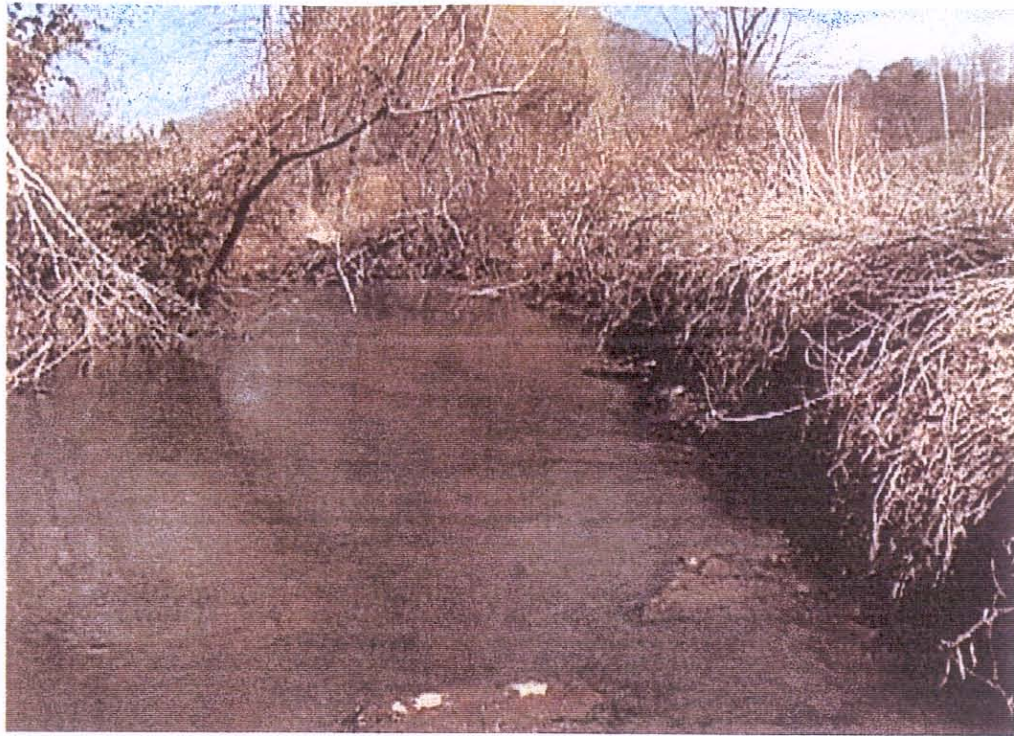
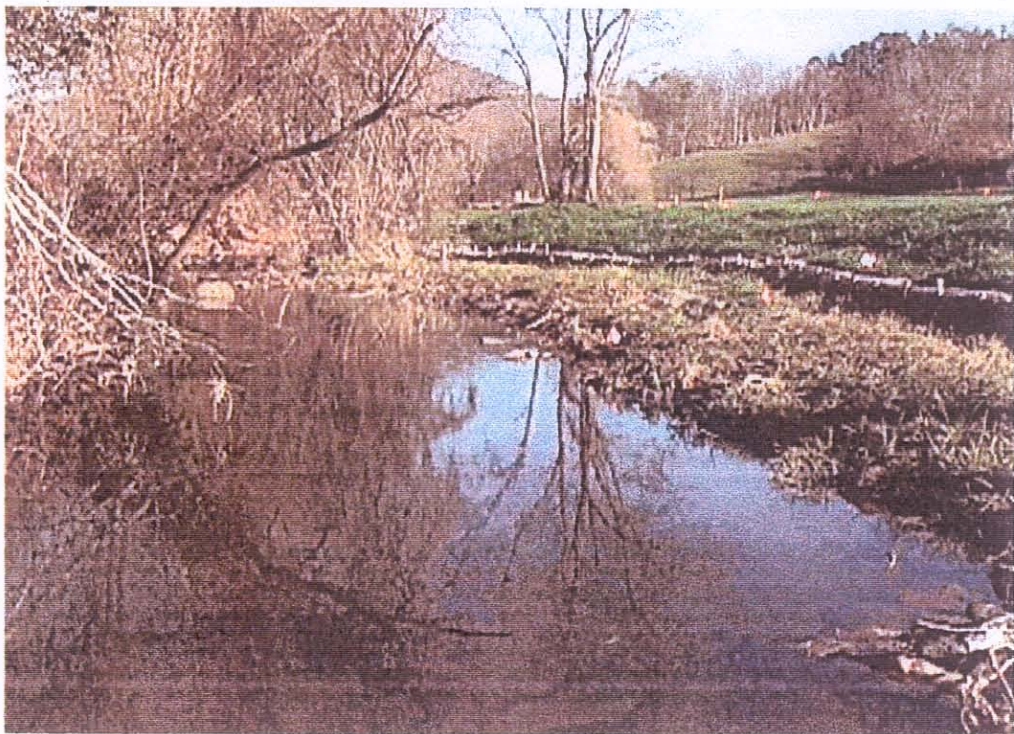
Upstream photo along lower end of site, showing the same location before and after construction. Note the willow tree and walnut trees (center top of photos) for reference. Vertical, eroding stream banks have been sloped and vegetated for greater stability.

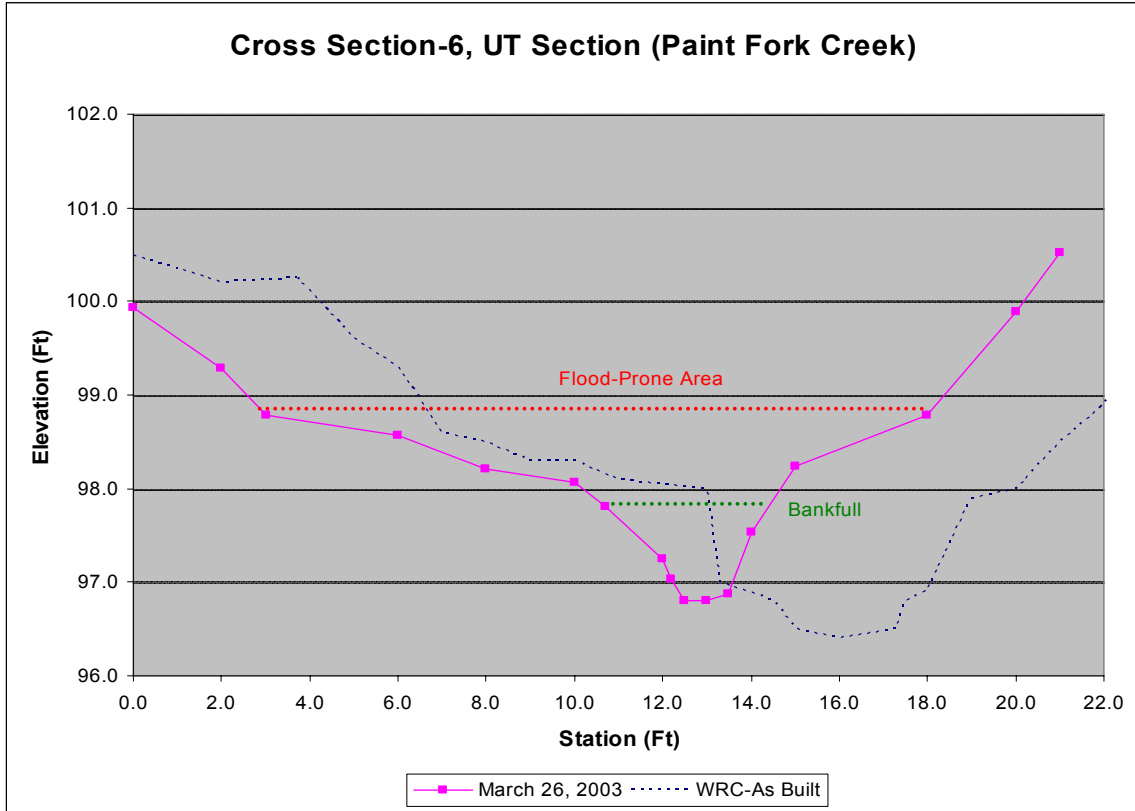
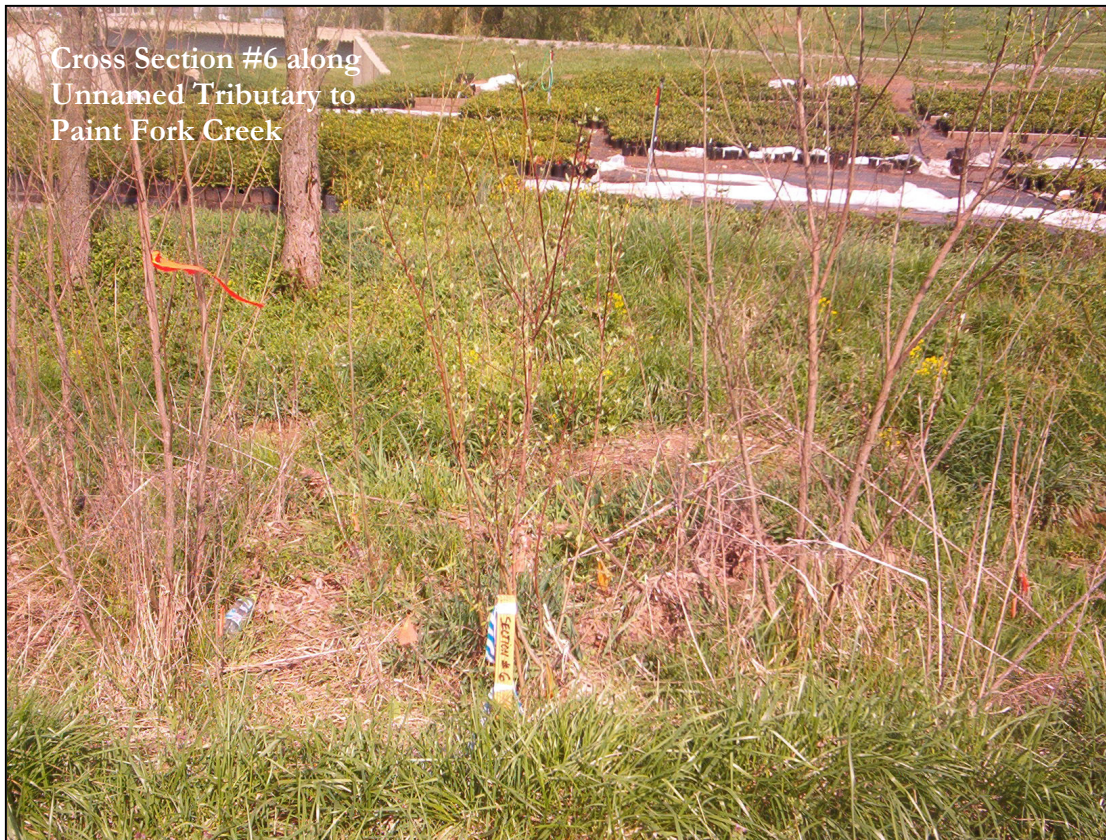
- ◆ Cross Section #6. Deposition was noted along channel. The banks remain stable. This area should be assessed during the next monitoring period to determine remedial actions, if necessary.
