ANNUAL REPORT FOR 2004

Paint Fork Creek Stream Mitigation Site (Fosson Site)
Madison County
WBS Element 32573.4.1
TIP No. A-10WM

Prepared By:
Office of Natural Environment & Roadside Environmental Unit
North Carolina Department of Transportation
January 2005

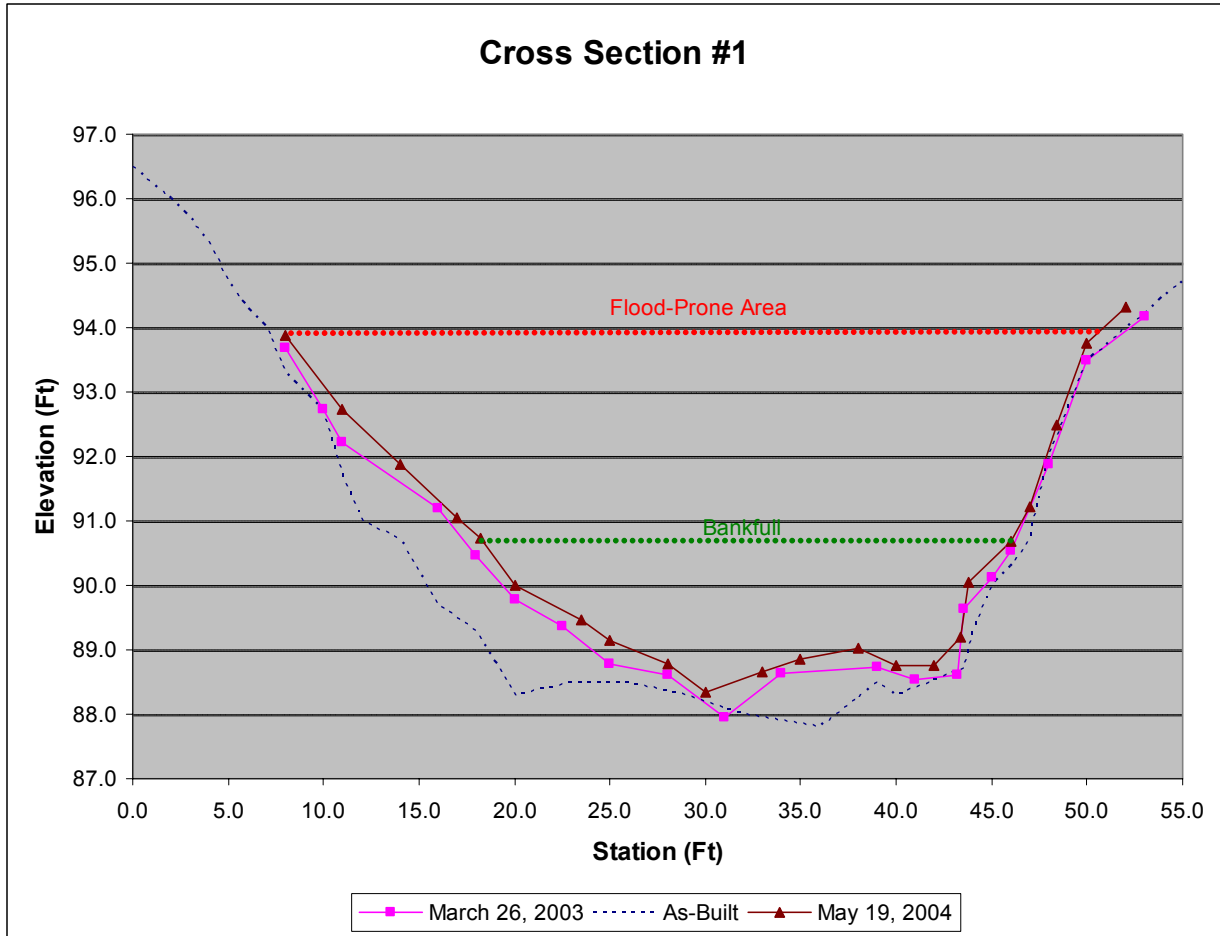
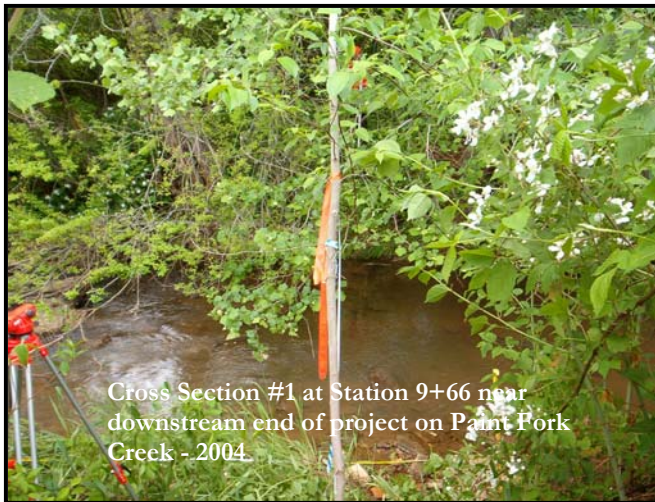
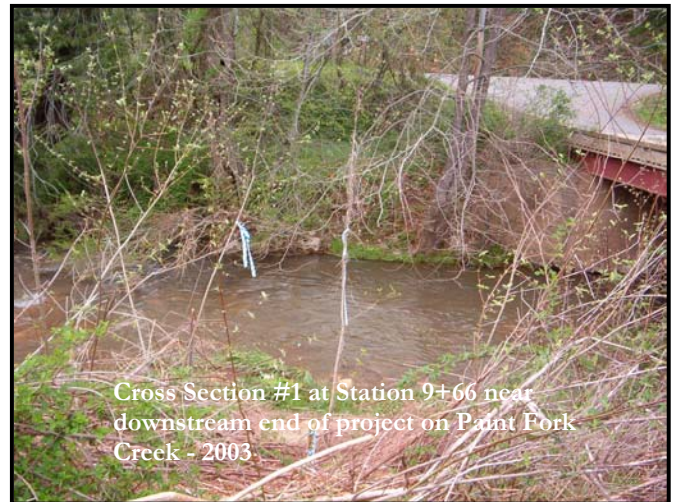
Cross-Section #1 Abbreviated Morphological Summary		
	2003	2004
Bankfull Cross Sectional Area (ft ²)	33.5	43
Maximum Bankfull Depth (ft)	2.2	2.4
Bankfull Mean Depth (ft)	1.3	1.5
Width/Depth Ratio	20.1	18.1
Entrenchment Ratio	1.5	1.4
Bankfull Width (ft)	26	27.9

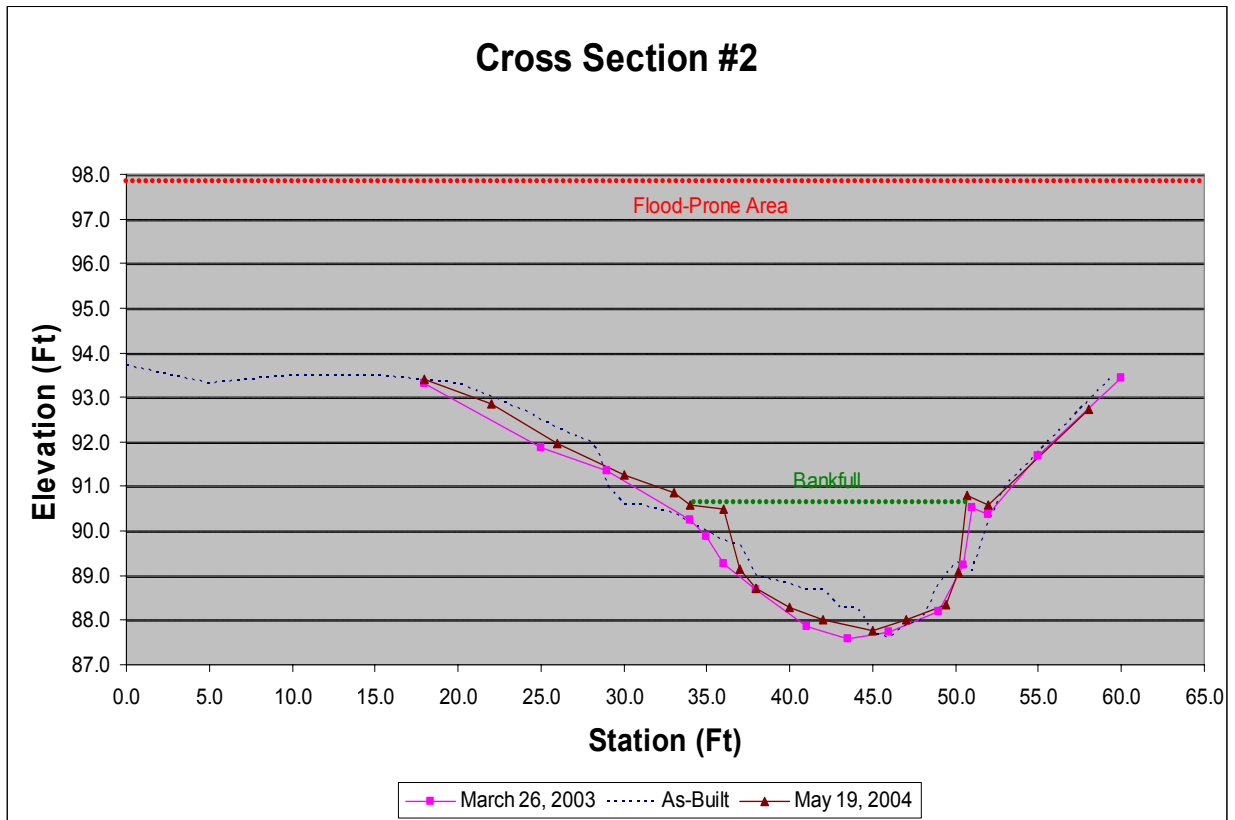
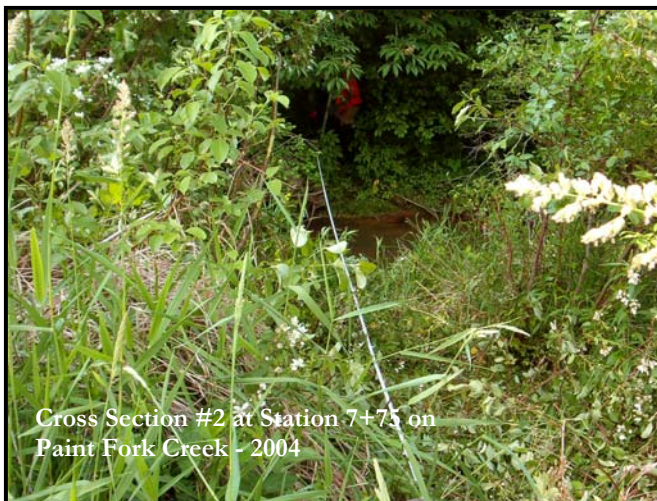
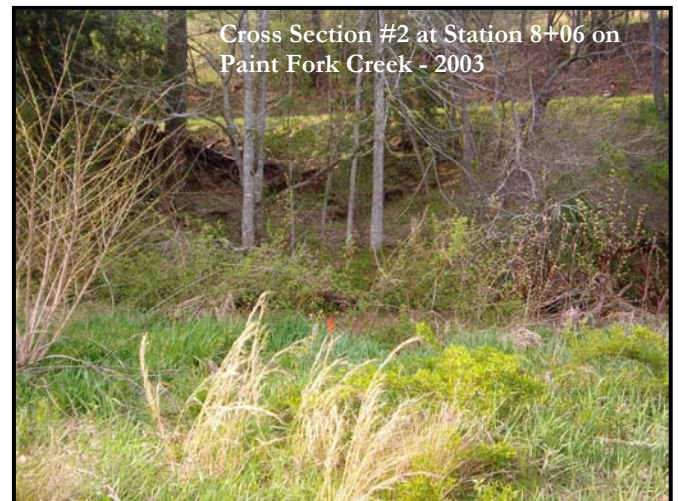
Cross-Section #2 Abbreviated Morphological Summary		
	2003	2004
Bankfull Cross Sectional Area (ft ²)	25.5	32.6
Maximum Bankfull Depth (ft)	2.3	2.8
Bankfull Mean Depth (ft)	1.6	2
Width/Depth Ratio	9.7	8.6
Entrenchment Ratio	2.2	2.4
Bankfull Width (ft)	15.8	16.7

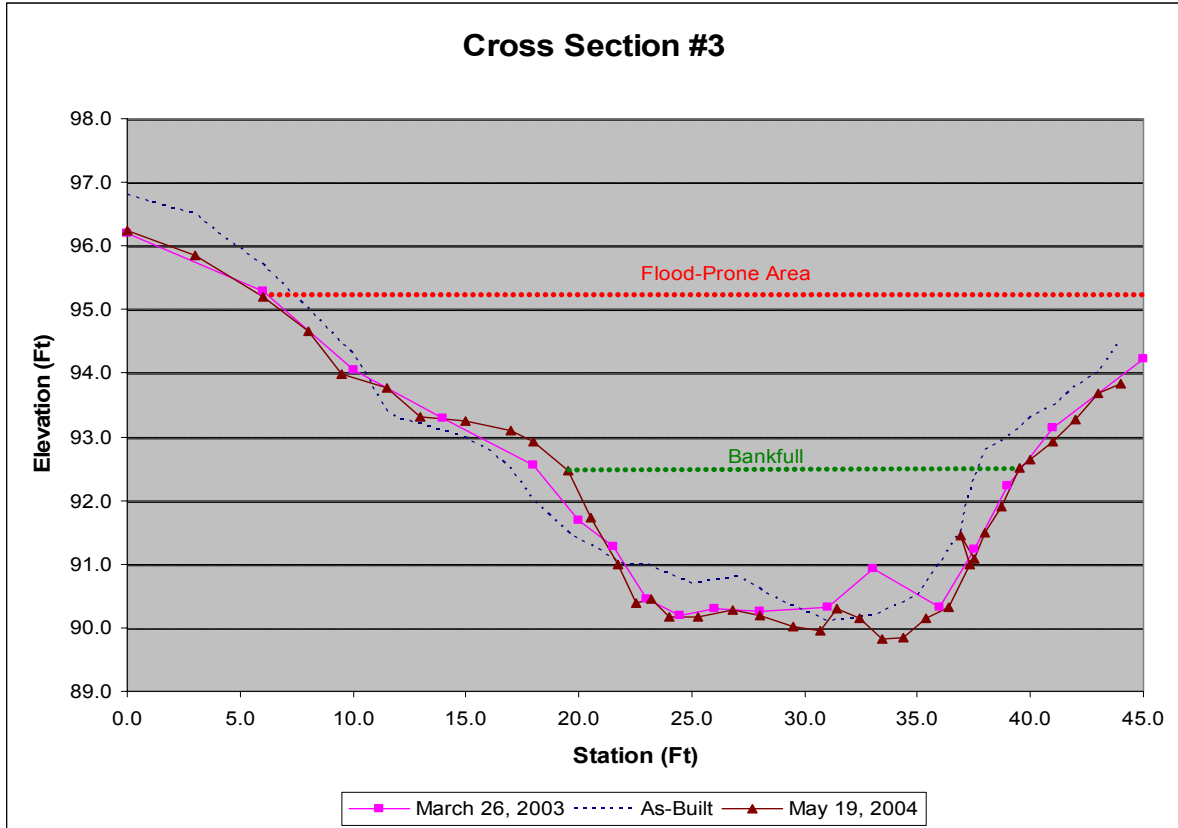
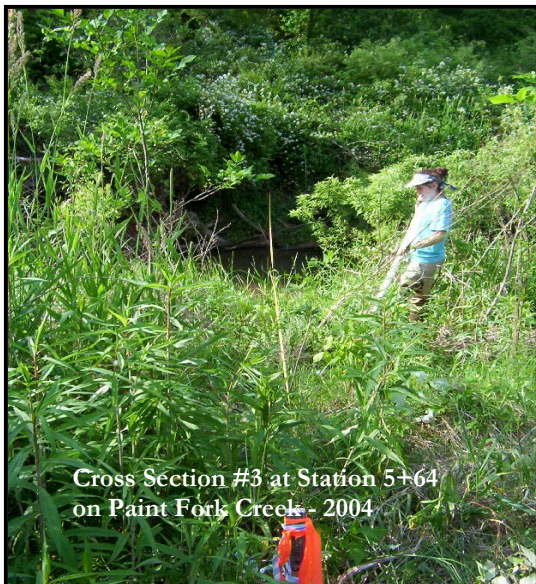
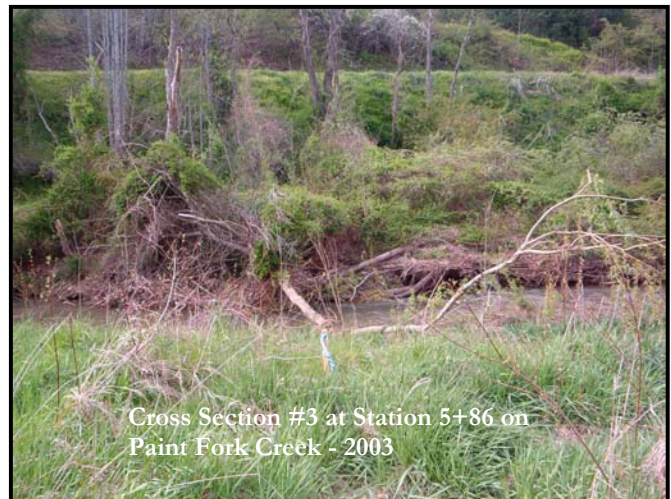
Cross-Section #3 Abbreviated Morphological Summary		
	2003	2004
Bankfull Cross Sectional Area (ft ²)	30	39.7
Maximum Bankfull Depth (ft)	2	2.3
Bankfull Mean Depth (ft)	1.5	1.5
Width/Depth Ratio	13.7	13.8
Entrenchment Ratio	1.8	2.3
Bankfull Width (ft)	20.3	20.2

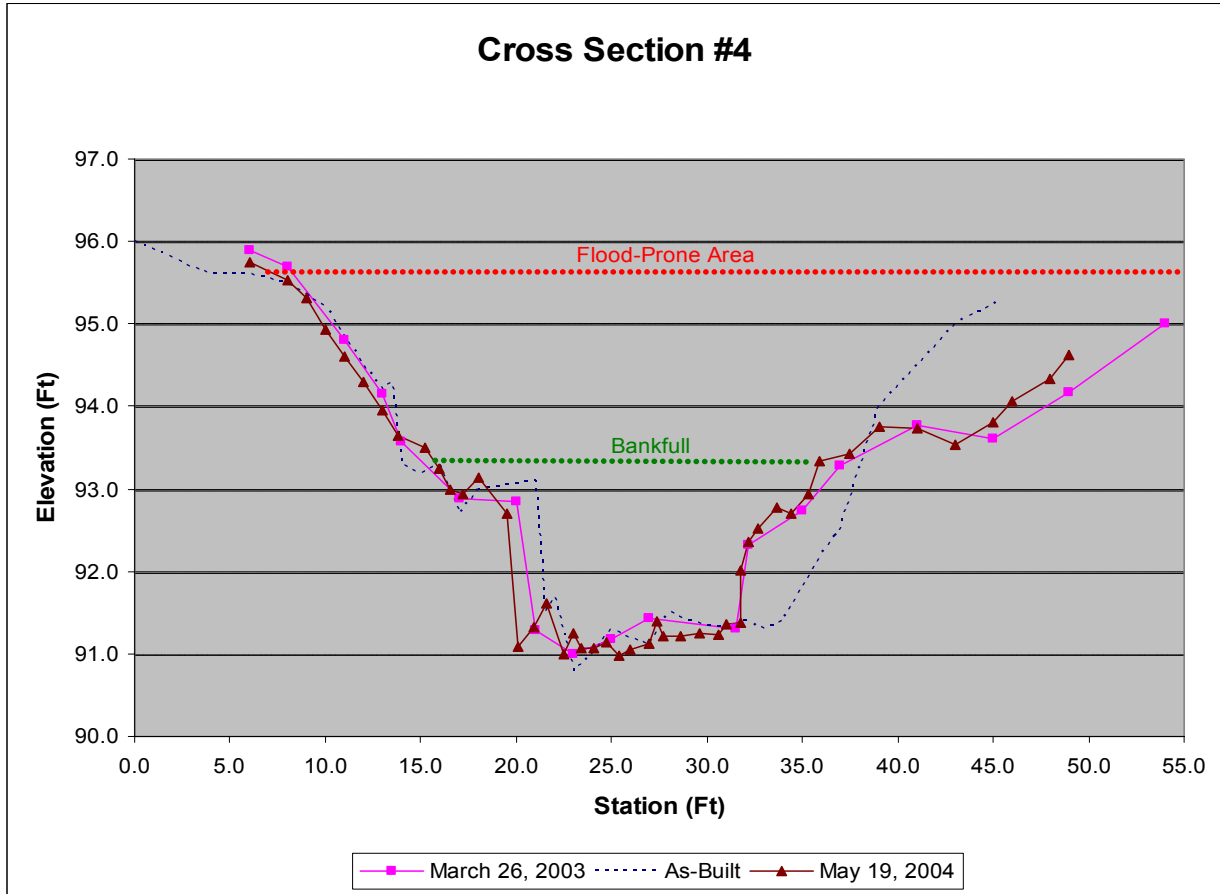
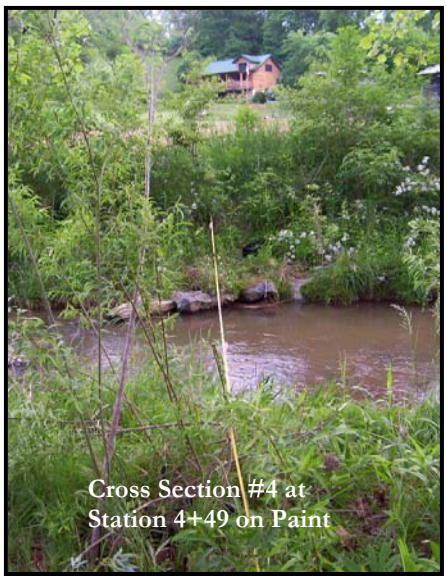
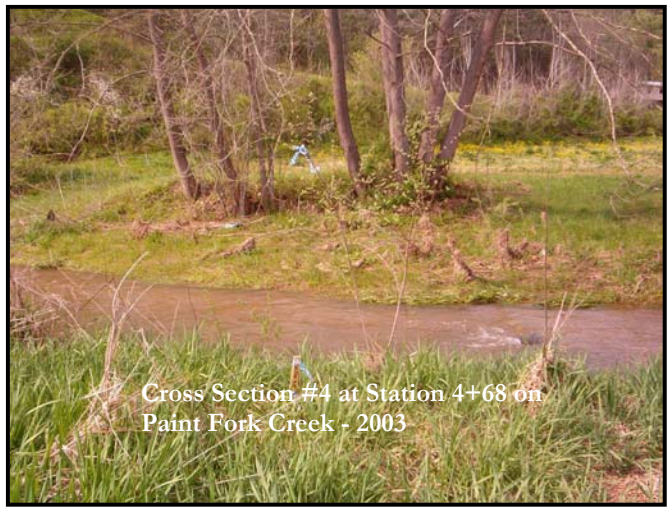
Cross-Section #4 Abbreviated Morphological Summary		
	2003	2004
Bankfull Cross Sectional Area (ft ²)	27.7	29.5
Maximum Bankfull Depth (ft)	2.3	2.3
Bankfull Mean Depth (ft)	1.3	1.5
Width/Depth Ratio	17	13.8
Entrenchment Ratio	2.7	2.3
Bankfull Width (ft)	21.7	20.2

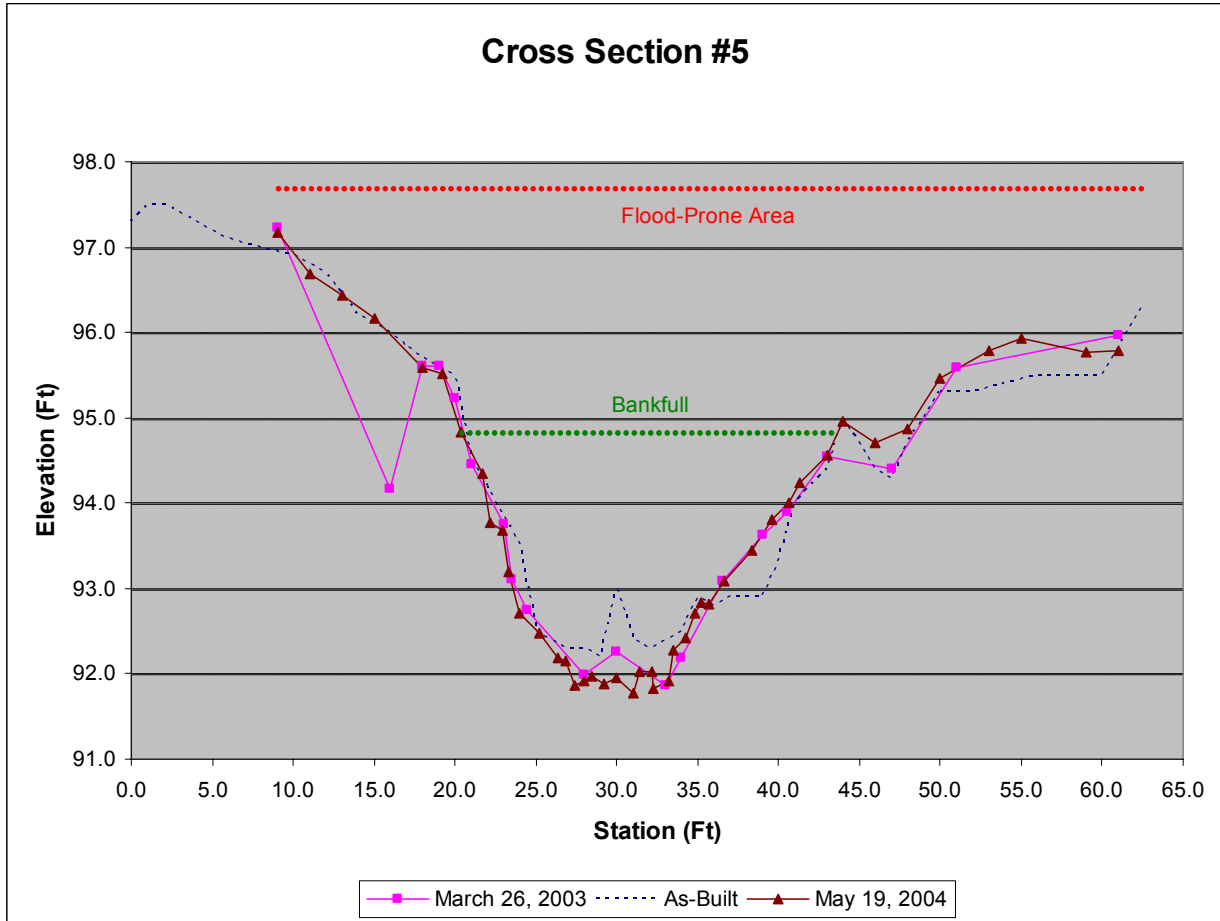
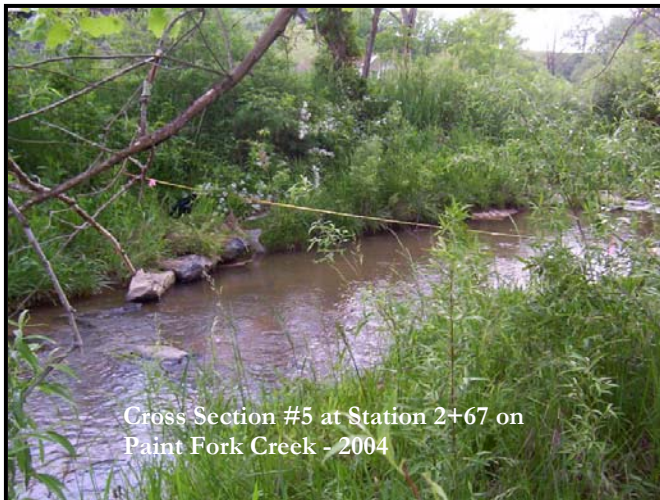
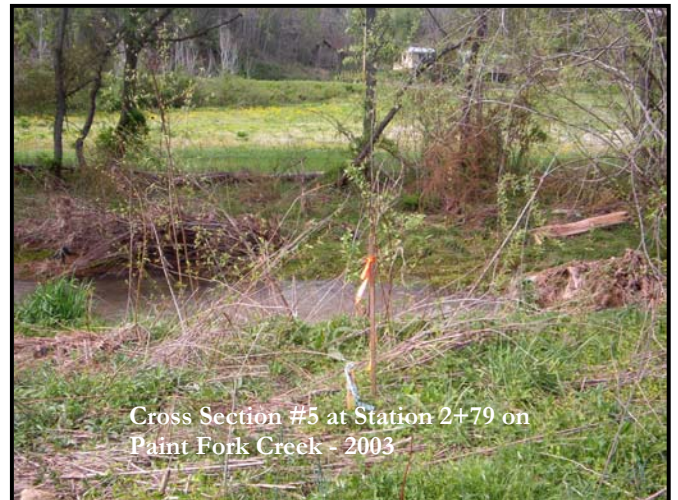
Cross-Section #5 Abbreviated Morphological Summary		
	2003	2004
Bankfull Cross Sectional Area (ft ²)	22.2	42.8
Maximum Bankfull Depth (ft)	2	3.1
Bankfull Mean Depth (ft)	1.2	1.7
Width/Depth Ratio	14.5	15.5
Entrenchment Ratio	2.8	2.4
Bankfull Width (ft)	17.9	25.8

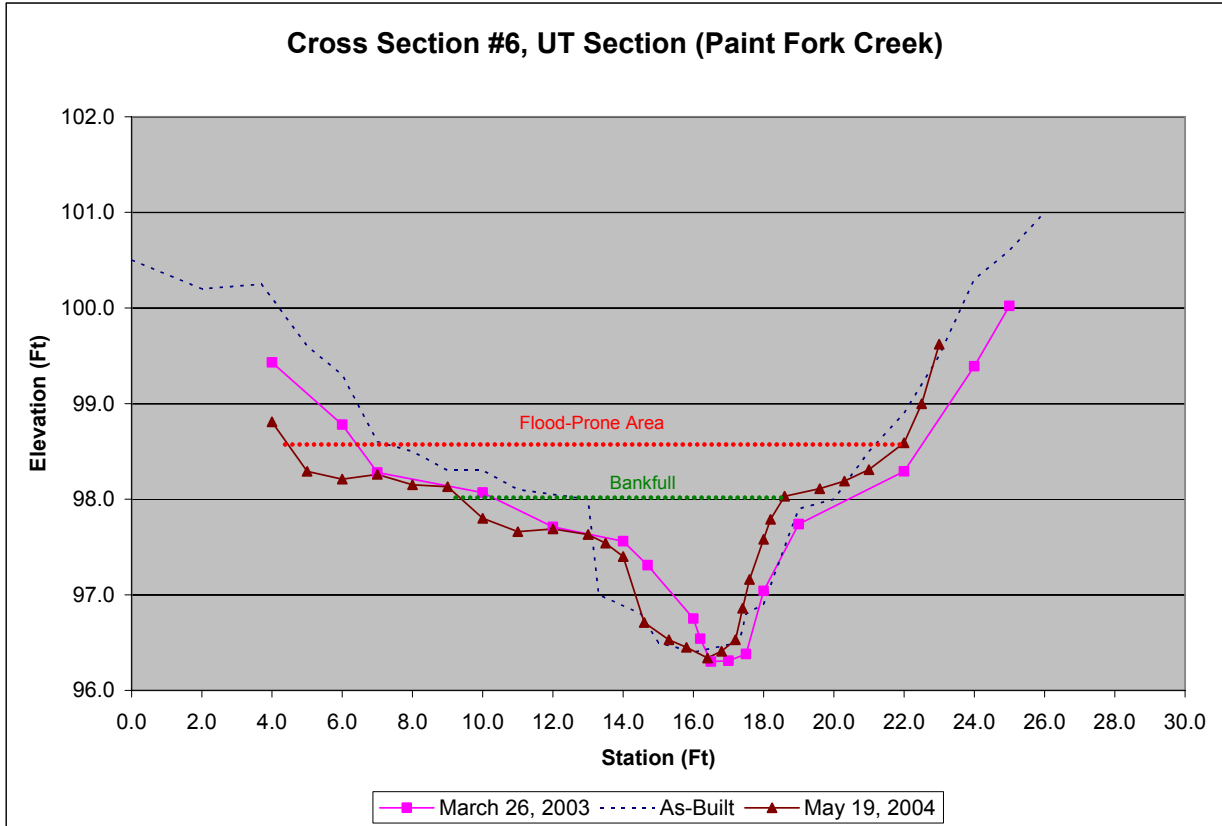
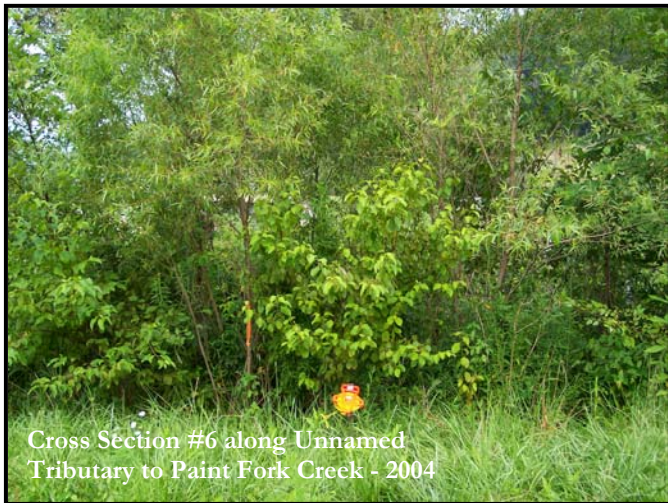
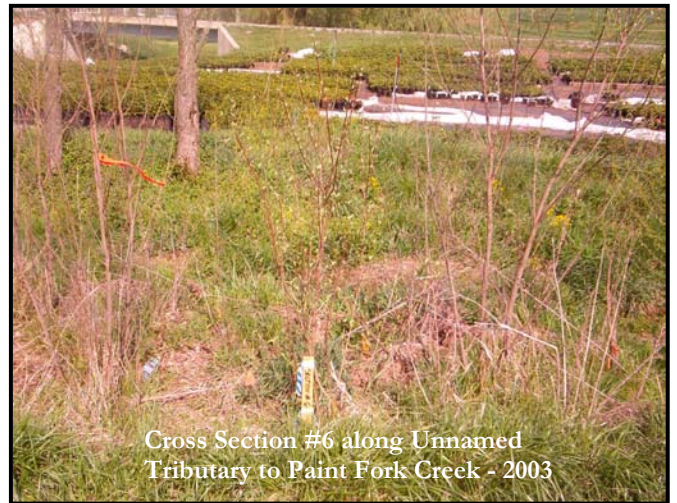
- ◆ Cross Section #6. Deposition was noted along channel in 2003. The banks have remained stable in 2004.

Cross-Section #6 Abbreviated Morphological Summary		
	2003	2004
Bankfull Cross Sectional Area (ft ²)	2.1	2.8
Maximum Bankfull Depth (ft)	1	1.2
Bankfull Mean Depth (ft)	0.6	0.7
Width/Depth Ratio	6.5	6.4
Entrenchment Ratio	4.1	4.2
Bankfull Width (ft)	3.7	4.3
