YEAR 3 MONITORING and CLOSEOUT REPORT
for the
FOSSON MITIGATION SITE
PAINFORK CREEK,
MADISON COUNTY, North Carolina

EEP PROJECT NUMBER 92702

December 2008

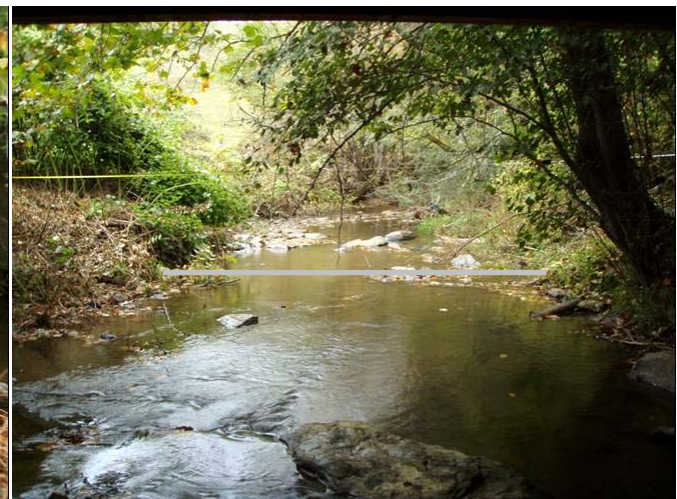
Cross-section 1 (Appendix Table A.1.1).—This cross-section transects a run. There has been little change in this cross-section from 1999 (as-built) through 2007 (MY3). Evidence of lateral channel movement (bank erosion) was not observed along either streambank. The left bank has aggraded slightly, most likely due to suspended sediments being trapped by the riparian vegetation. This aggradation has resulted in the decrease of bankfull width when compared to previous years monitoring values. Unlike the other main stem cross-sections, cross-section 1 was determined to be a Bc stream type. This is due to moderate entrenchment ratio (1.6) present at this cross-section.

Cross-section 1, upstream to downstream, October 2007.

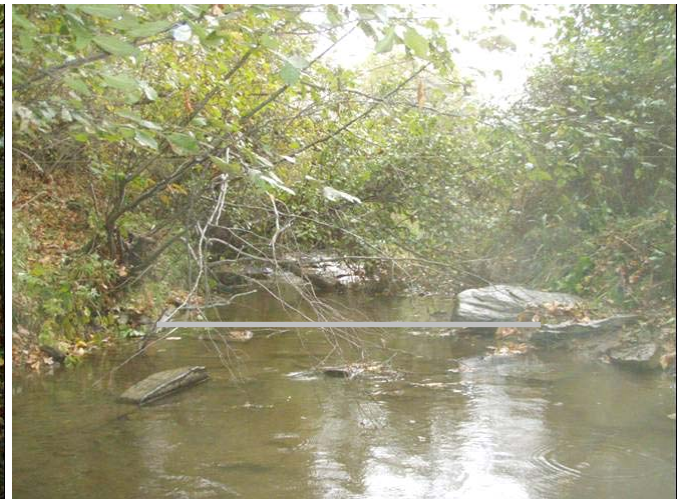
Cross-section 2 (Appendix Table A.1.2).—This cross-section transects a run. The left and right banks of this cross-section have remained stable during the eight years following construction. The planted vegetation on the left bank is well established; the riparian buffer on the right bank, between SR 1530 and the stream channel, is well established with mature trees. The thalweg has experienced little to no change. Unlike the other 4 cross-sections, the

width/depth ratio at this cross-section has been <12 during each of the monitoring surveys and is the reason for the E stream type classification at this location.

Cross-section 2, upstream to downstream, October 2007.

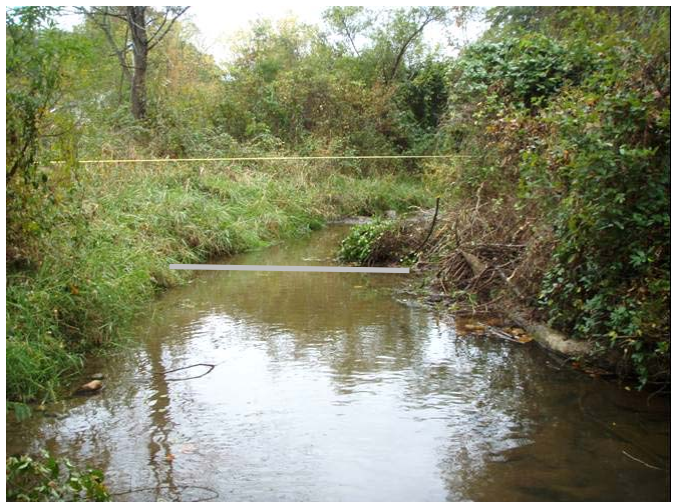
Cross-section 3 (Appendix Table A.1.3).—This cross-section transects a pool. The thalweg at cross-section 3 has shown no evidence of change over the eight years since project construction. Aggradation of the left bank has occurred, most likely due to vegetation trapping sediments during high flows, and a stable bench is present. The left and right banks are stable and well vegetated. This cross-section was noted as being a run feature in earlier surveys; however, it now contains characteristics more typical of a pool feature. The cross-section is located in a slight meander and the thalweg would be deeper and located closer to the left bank if not for the bedrock channel bed.

Cross-section 3, upstream to downstream, October 2007.

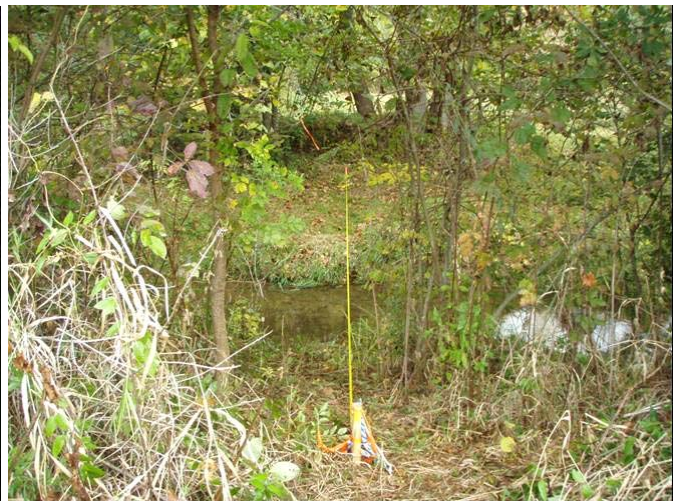
Cross-section 4 (Appendix Table A.1.4).—This cross-section transects a riffle. The thalweg at cross-section 4 has remained relatively stable following construction with only slight deepening (≈ 0.5 ft) since MY2, but the right and left channel banks have changed over the 8-year period since construction. The left bank has degraded ≈ 1.5 ft, whereas the right bank has experienced ≈ 5.0 ft of aggradation forming a stable bench that defines the bankfull channel. Currently, both the left and right channel banks are stable and well vegetated with woody species.

Cross-section 4, left bank to right bank, October 2007.

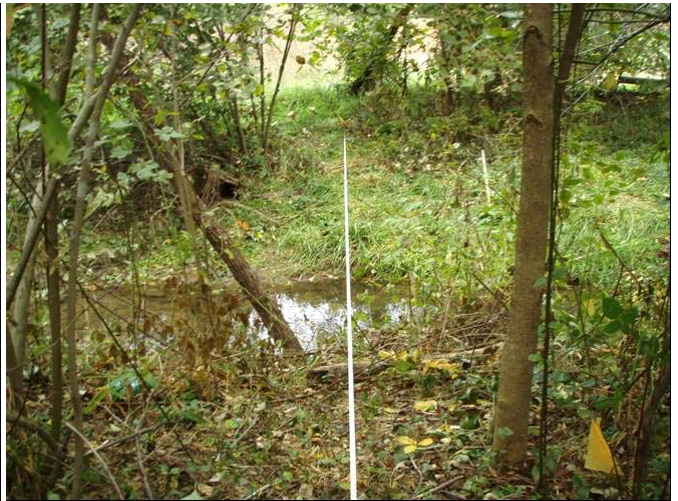
Cross-section 5 (Appendix Table A.1.5).—This cross-section transects a run. The thalweg at cross-section 5 is situated near the center line of the channel, very similar to its location when compared with previous surveys. The left channel bank appears to have degraded slightly (≈ 0.5 ft) since project completion. The right channel bank has aggraded ≈ 1.0 ft since the as-built survey was conducted in 1999. Both the left and right channel banks appeared well vegetated and stable during the MY3 survey.

Cross-section 5, left bank to right bank, October 2007.

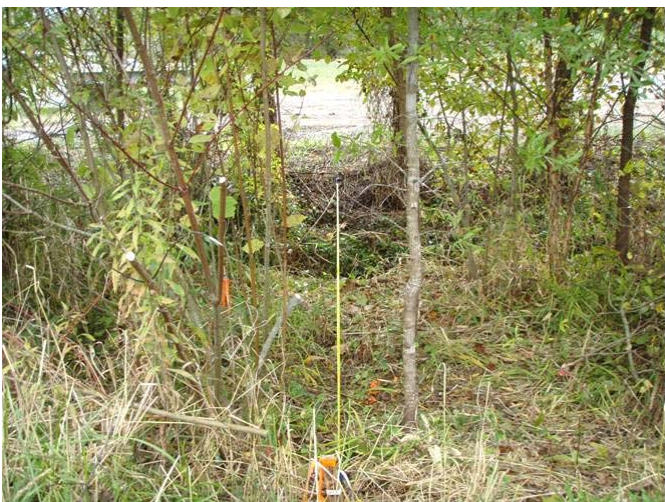
Cross-section 6 unnamed tributary (Appendix Table A.1.6).—This cross section transects a run and is the only cross-section on the unnamed tributary. This tributary is the common boundary between the Fosson property and the adjacent landowner. The channel bed aggraded ≈ 0.5 ft between the as-built survey and the MY1 survey. The channel bed has remained at its current elevation since MY1. The left and right channel banks show no indication of lateral movement since MY1; however, aggradation did occur on both sides of the channel following the as-built survey. The left bank is stable, and woody vegetation has become established. The right bank is also stable at this location. However, at various other locations along the right bank, the bank is vertical, sloughing, and unstable. Unfortunately, the right bank is outside the project boundary and therefore was not addressed during project construction. A bench was excavated on the left bank at the bankfull elevation during construction and is likely the reason the stream type changed from a G to an E at this cross-section.

Cross-section 6, left bank to right bank, October 2007.

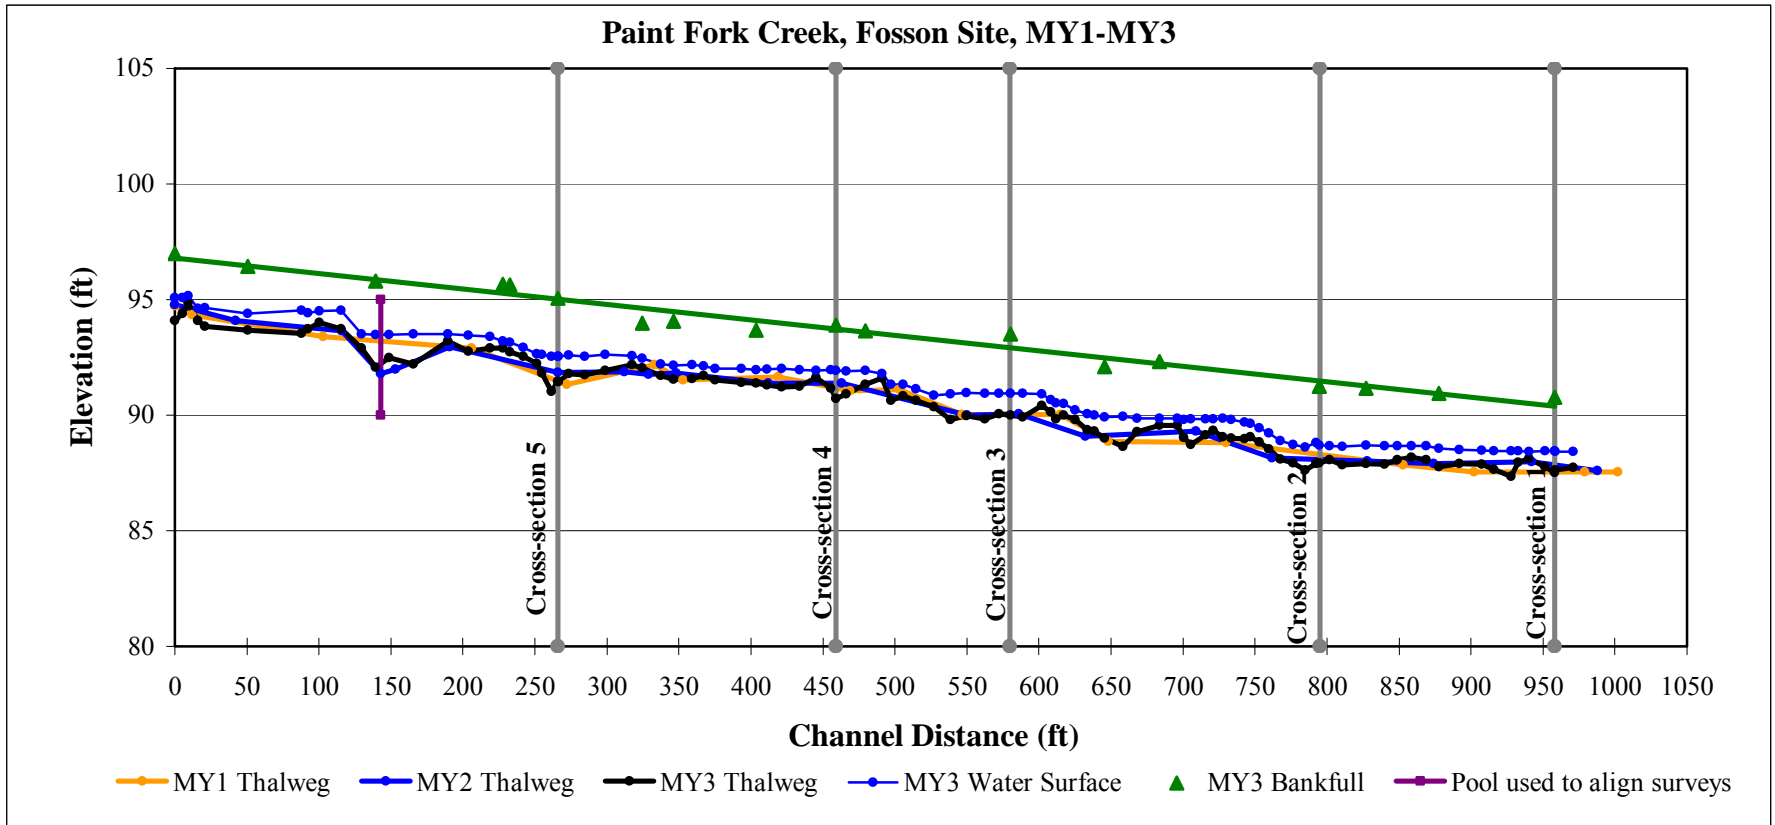
The longitudinal profile of the entire Paint Fork Creek project reach was surveyed (sta. 0+00 to sta. 9+71; Appendix A.2.). Elevations of the stream bed, water surface, bankfull indicators, and top of the low banks were captured. Channel sinuosity was 1.2, and the average water surface slope was 0.006 ft/ft (Exhibit Table 3). The MY3 longitudinal profile survey data

revealed the thalweg and both channel banks were stable and had minimal aggradation, degradation, and lateral movement occurring along the entire reach.

Longitudinal Profile.—Channel sinuosity and the water surface slope, representative of a C stream type, have been maintained since project completion. Although sinuosity is on the low end for a C type channel, evidence of the channel attempting to increase its sinuosity (laterally extend) has not been observed. It is unlikely that lateral extension will occur given that the left and right bank vegetation is well established. The presence of a bedrock seam, throughout most of the project reach, provides a natural form of grade control, eliminating the concern of potential head-cutting and resulting change of channel slope. Overall, the channel thalweg has remained stable with little aggradation, degradation, or lateral movement.

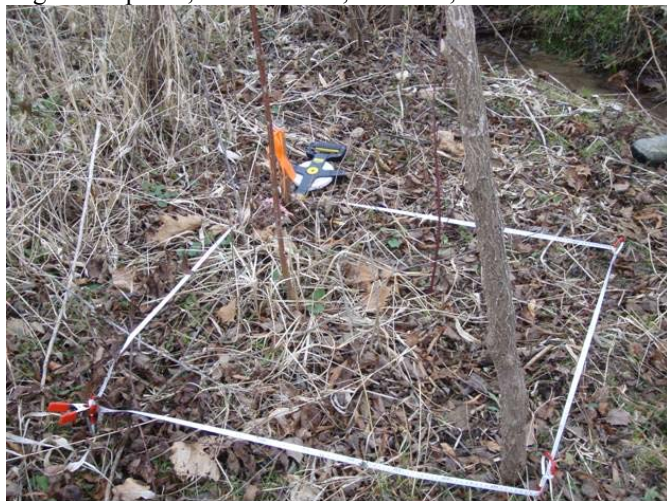
Vegetation Plot 1 unnamed tributary.—One black willow and two silky dogwoods were observed during MY3, with one of the silky dogwood recruited since MY2. The herbaceous layer consisted of a goldenrod *Solidago* sp. mixed with tall fescue *Festuca* sp.

Vegetation plot 1, unnamed tributary, left bank, January 2008.

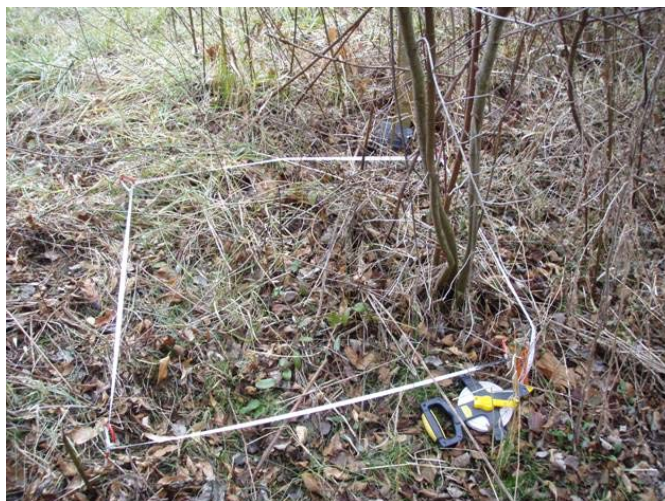
Vegetation Plot 3.—Woody stem density was unchanged in Vegetation Plot 3 from MY2 to MY3. One silky dogwood was observed in the plot. The herbaceous layer consisted of goldenrod mixed in with tall fescue.

Vegetation plot 3, left bank, January 2008.

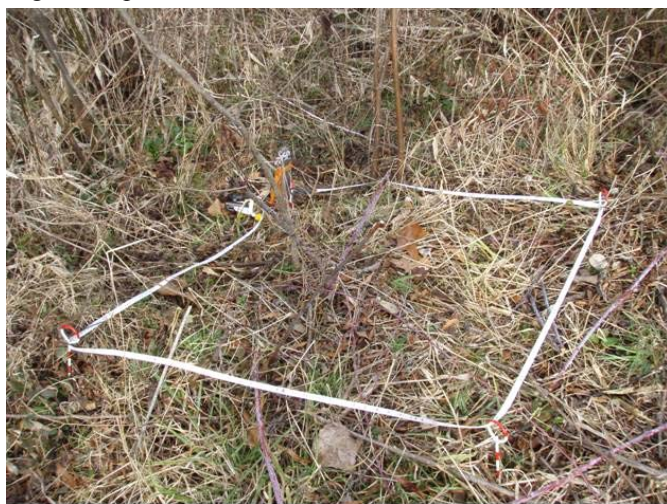
Vegetation Plot 5.—One staghorn sumac *Rhus typhina* naturally recruited into this plot since the MY2 survey. Reed canary grass, goldenrod, and blackberry were observed in the herbaceous layer.

Vegetation plot 5, left bank, January 2008.
