MONITORING YEAR 1 ANNUAL REPORT Final

FOUST CREEK MITIGATION SITE

Alamance County, NC

DMS Project Number 95715

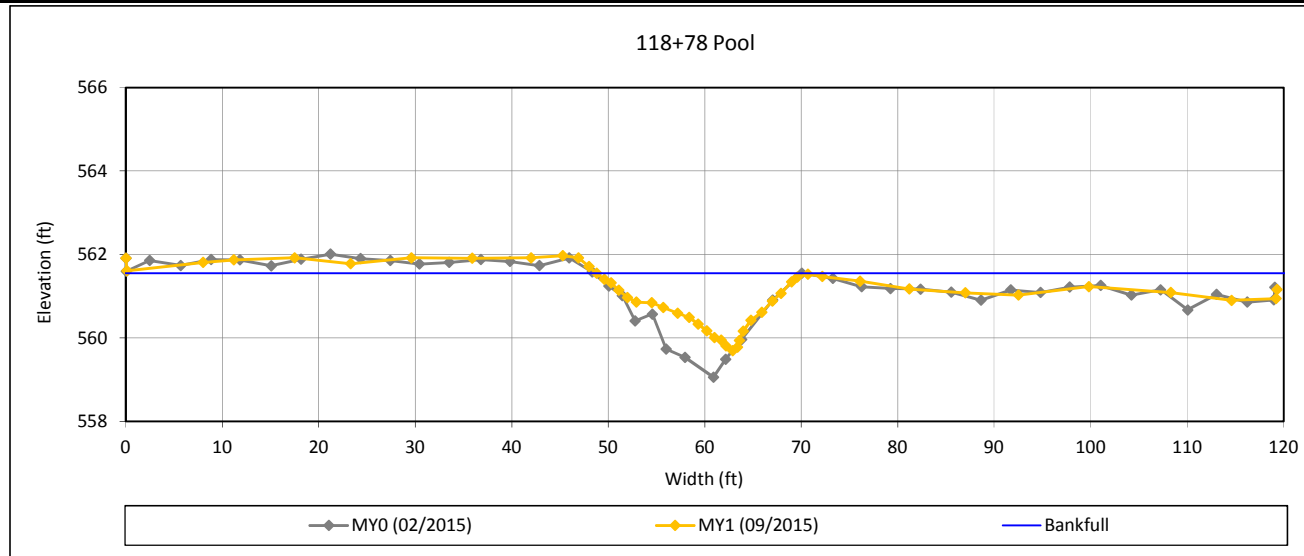
Cross Section 2- Foust Creek Reach 2

All streams within the Site are stable and functioning as designed. There is some deposition on Foust Creek at cross section 2. This area will be monitored for any future issues and a maintenance plan will be prepared if necessary. The average stem density for the Site is on track to meeting the MY7 success criteria; all individual vegetation plots meet the MY1 success criteria as noted in the CCPV map. There has been at least one documented bankfull event recorded by the crest gages on both of the streams on the Site. A total of 9 out of 10 groundwater gages met the wetland hydrology success criteria, and the tenth was close to meeting.
