MONITORING YEAR 2 ANNUAL REPORT Final

FOUST CREEK MITIGATION SITE

Alamance County, NC
NCDEQ Contract 004954
DMS Project Number 95715

Data Collection Period: March 2016 - October 2016
Draft Submission Date: November 18, 2016
Final Submission Date: December 2, 2016

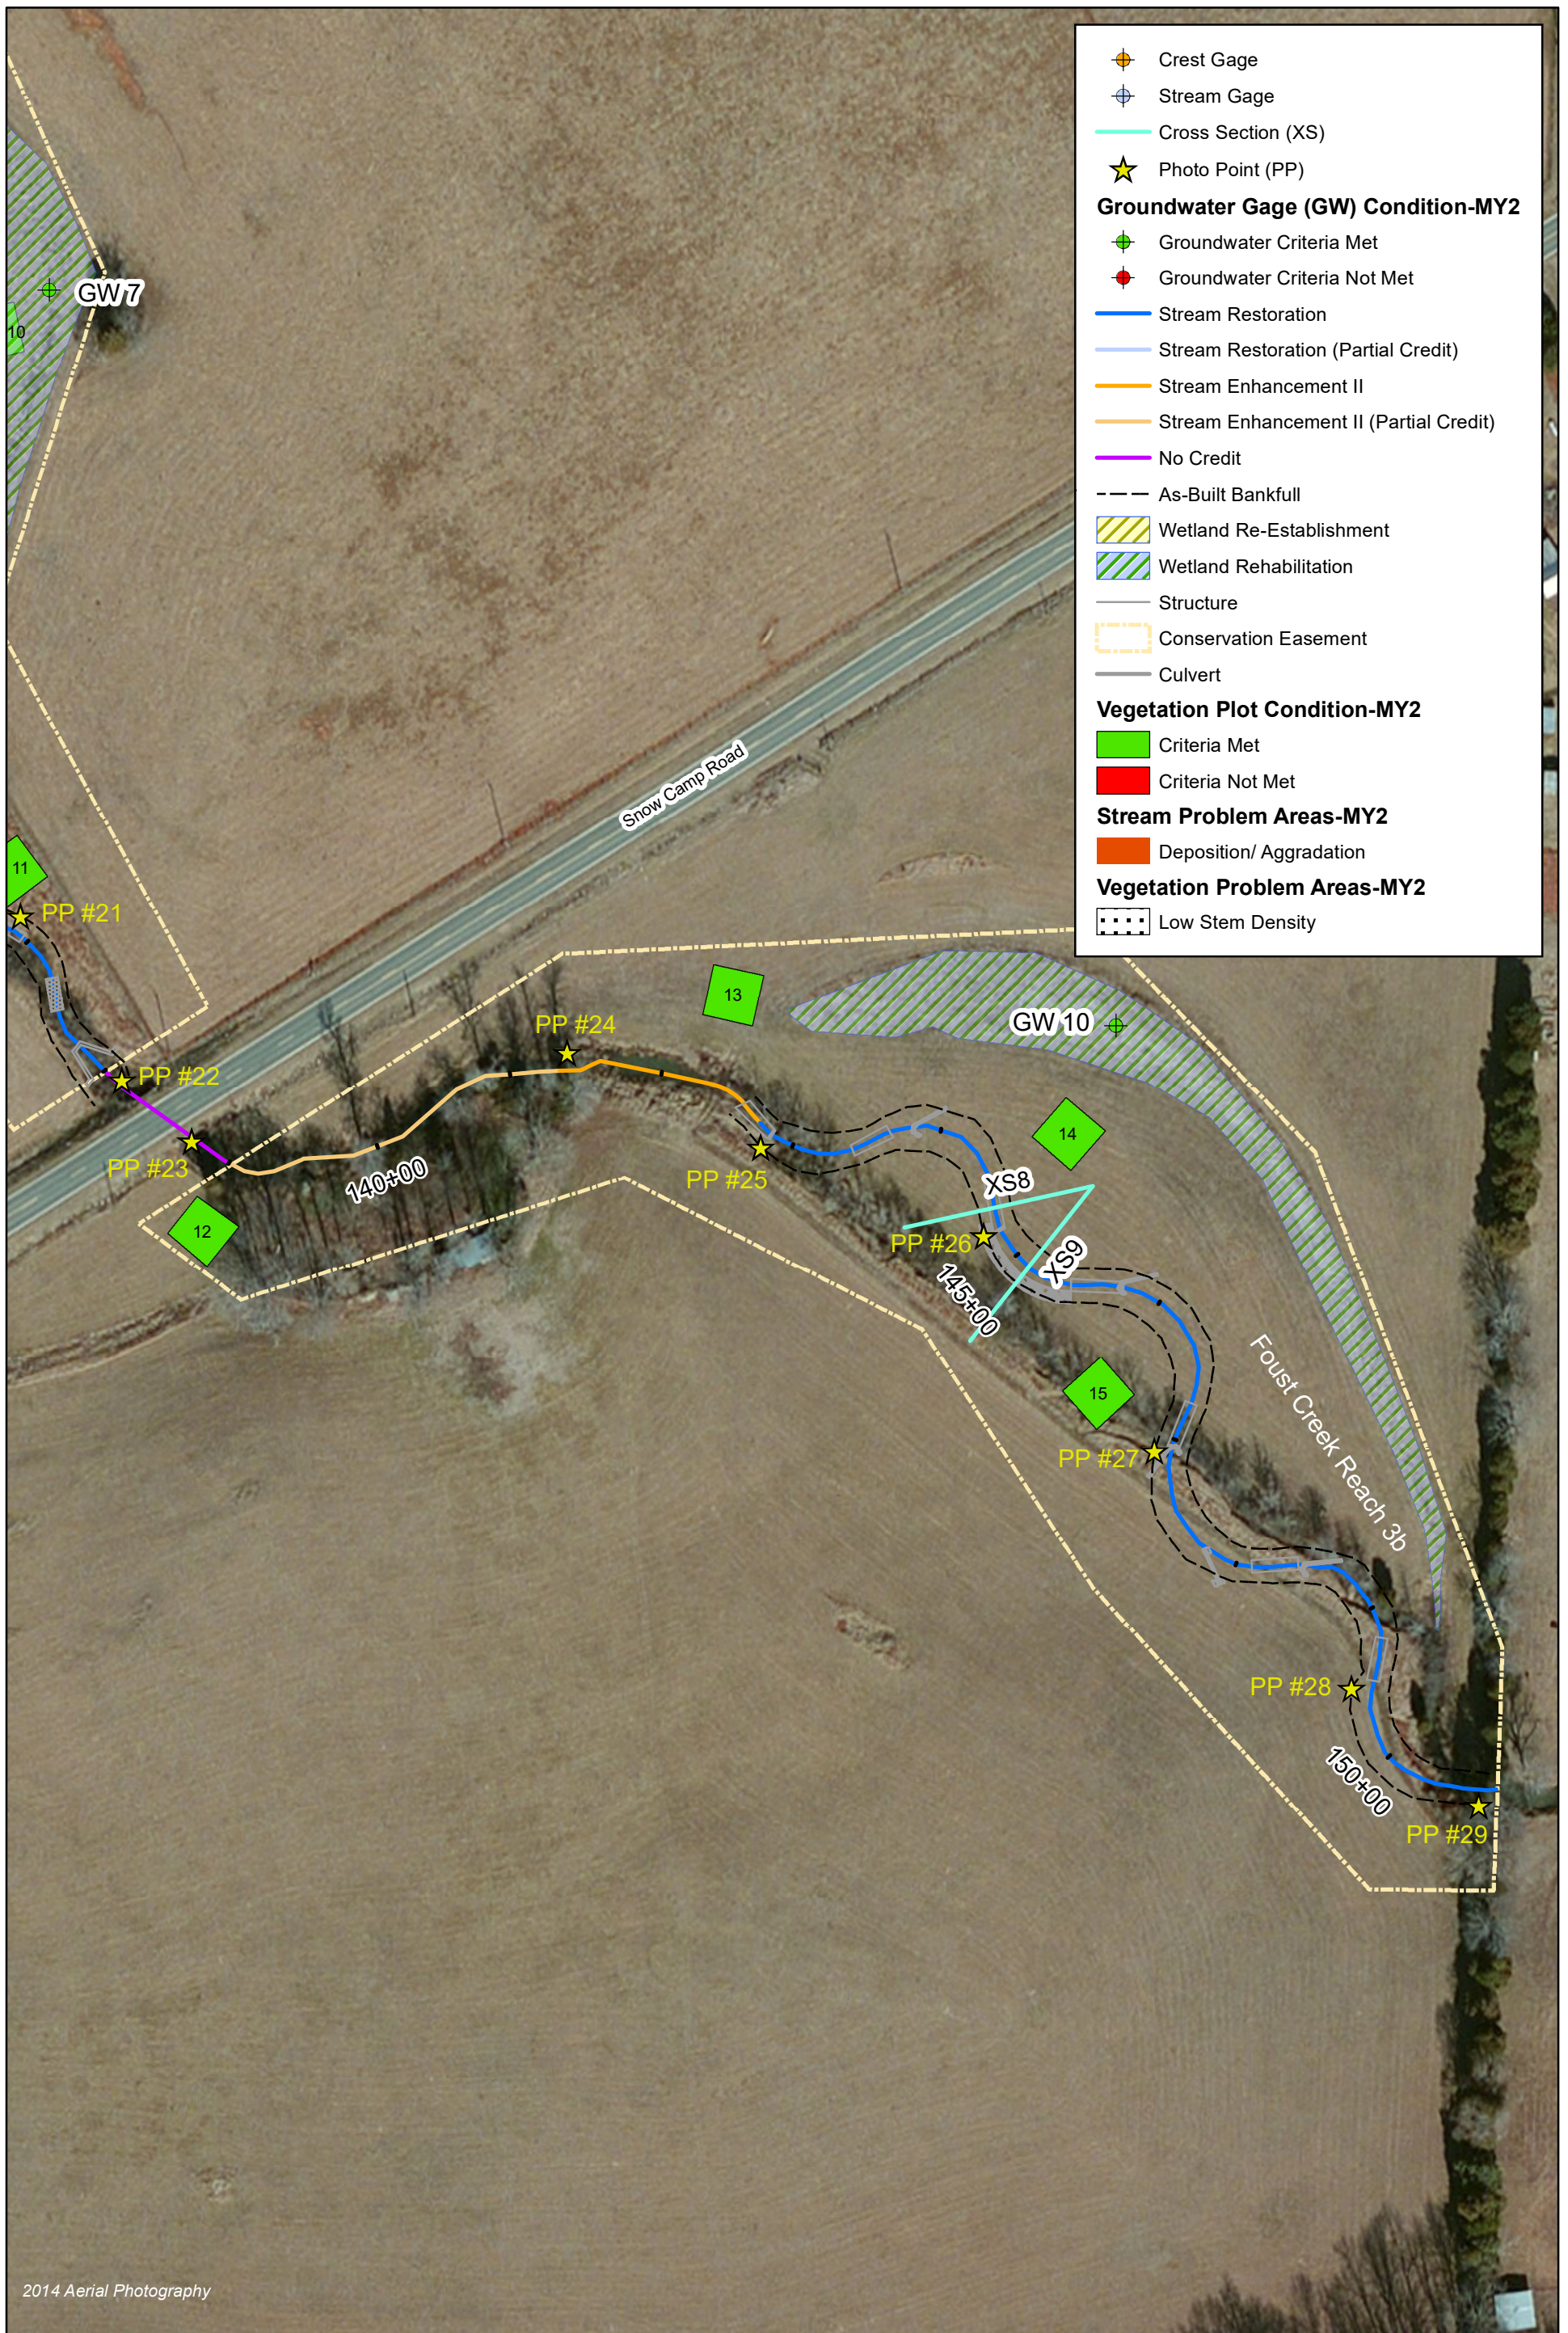
Figure 3.3 Integrated Current Condition Plan View
 (Sheet 3 of 3)
 Foust Creek Stream Restoration Site
 DMS Project No. 95715
 Monitoring Year 2 - 2016
 Alamance County, NC

Low planted stem density was observed around vegetation plots six and seven. These areas stay wet for most of the year and trees have not become well established in the wet conditions. Supplemental planting will be performed in these areas with native tree species that are more tolerant of the wetter conditions. See Current Condition Plan View (CCPV) map in Appendix 2 for areas of low stem density that will have supplemental planting completed in the winter of 2016/2017.

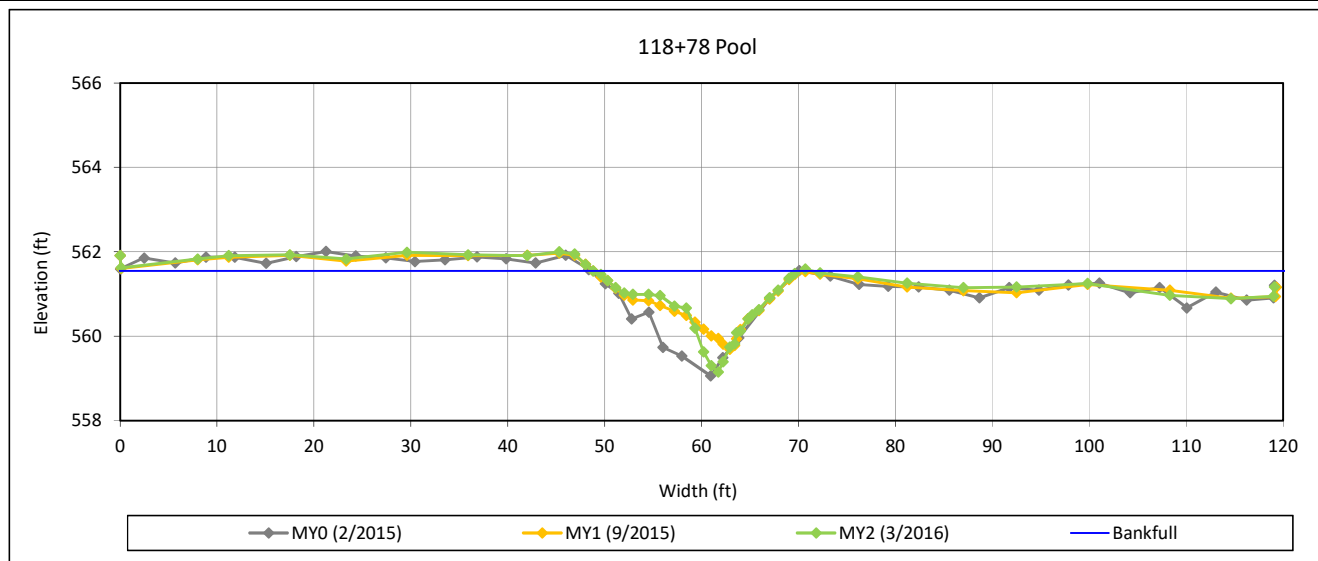
Cross Section 2- Foust Creek Reach 2

All streams within the Site are stable and functioning as designed. The deposition that was on Foust Creek at cross section 2 during MY1 has begun to flush out. This area will be monitored for any future issues and a maintenance plan will be prepared if necessary. The average stem density for the Site is on track to meeting the MY7 success criteria; 15 of 17 vegetation plots meet the MY2 success criteria as noted in the CCPV map. The other two plots meet success criteria when volunteer trees were counted. Supplemental tree planting will be completed during the winter of 2016/2017. Both streams on site have recorded at least one bankfull event. A total of 9 out of 10 groundwater gages met the wetland hydrology success criteria.
