MONITORING YEAR 3 ANNUAL REPORT Final

FOUST CREEK MITIGATION SITE

Alamance County, NC

DMS Project Number 95715

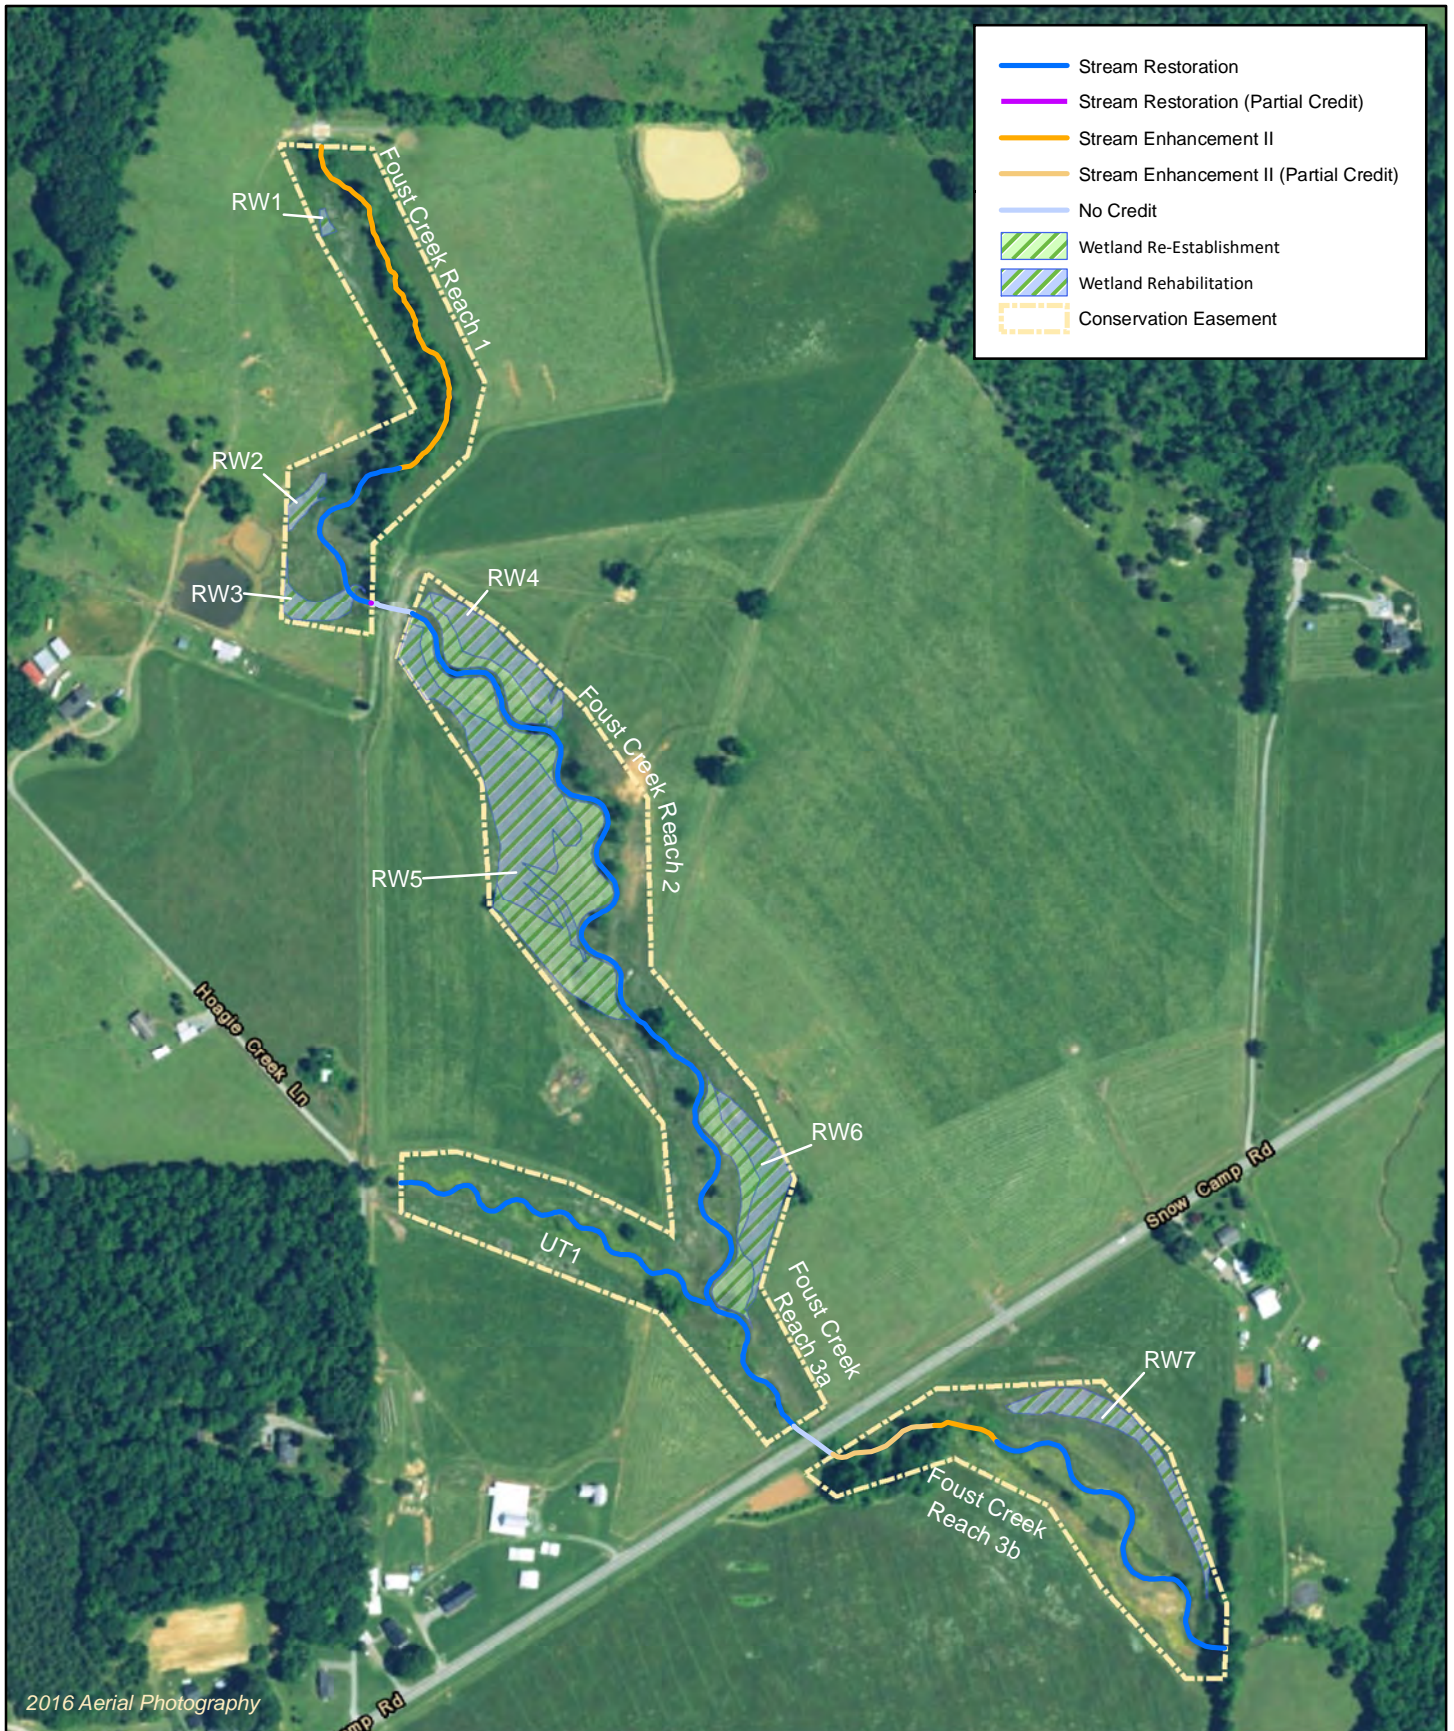
Figure 2 Project Component/ Asset Map
 Foust Creek Mitigation Site
 DMS Project No. 95715
 Monitoring Year 3 - 2017
 Alamance County, NC

The color for Stream Restoration (Partial Credit) was changed to make it stand out on Figures 2, 3.0, 3.1, 3.2, and 3.3. This section of stream is only 14 feet long which makes it hard to see at a large scale.

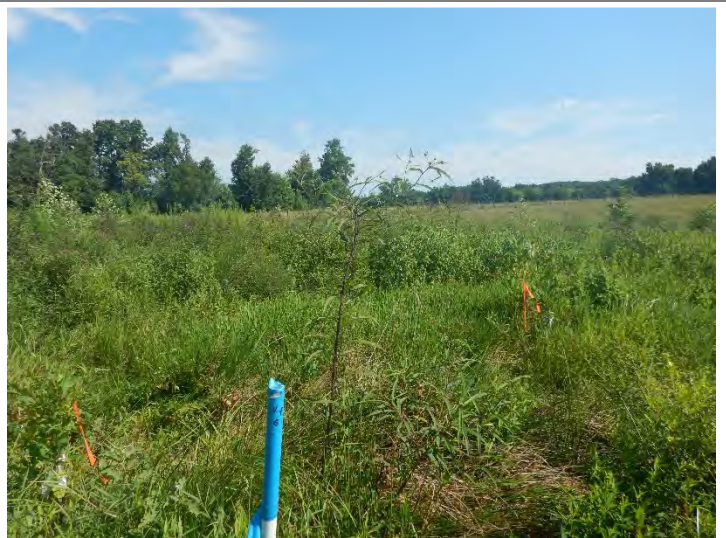
VEG PLOT 6 (8/3/2017)

Supplemental planting was performed around vegetation plots six and seven at the beginning of MY3 as described in section 1.2.1 above. These areas stay wet for most of the year and the planted trees have not become well established in the wet conditions. However, volunteer species including green ash, buttonbush, boxelder, and red maple are beginning to establish in these areas. These areas will continue to be monitored during subsequent monitoring years and a maintenance plan will be established if deemed necessary.

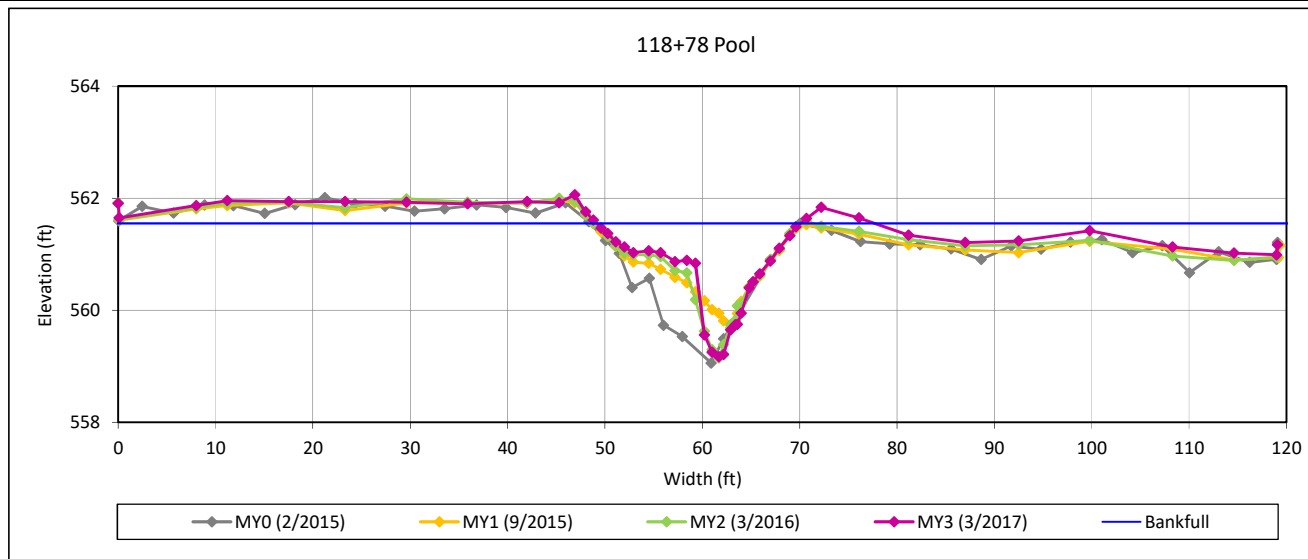
Cross Section 2- Foust Creek Reach 2

Depositional areas have been previously noted for Foust Creek at cross section 2. Deposition and sediment transport within this reach appear to have reached a point of equilibrium since MY1. Deposition within this area will continue to be monitored during subsequent monitoring years.

All streams within the Site are stable and functioning as designed. The deposition that was on Foust Creek at cross section 2 during MY1 has continued to flush out. This area will be monitored for any future issues. The average stem density for the Site is on track to meeting the MY7 success criteria; 15 of 17 vegetation plots meet the MY3 success criteria as noted in the CCPV map. The other two plots meet success criteria when volunteer trees were counted. Both streams on site have recorded at least one bankfull event and UT1 has recorded flow for a portion of the year. A total of 9 out of 10 groundwater gages met the wetland hydrology success criteria.
