MONITORING YEAR 4 ANNUAL REPORT FINAL

FOUST CREEK MITIGATION SITE

Alamance County, NC

DMS Project Number 95715

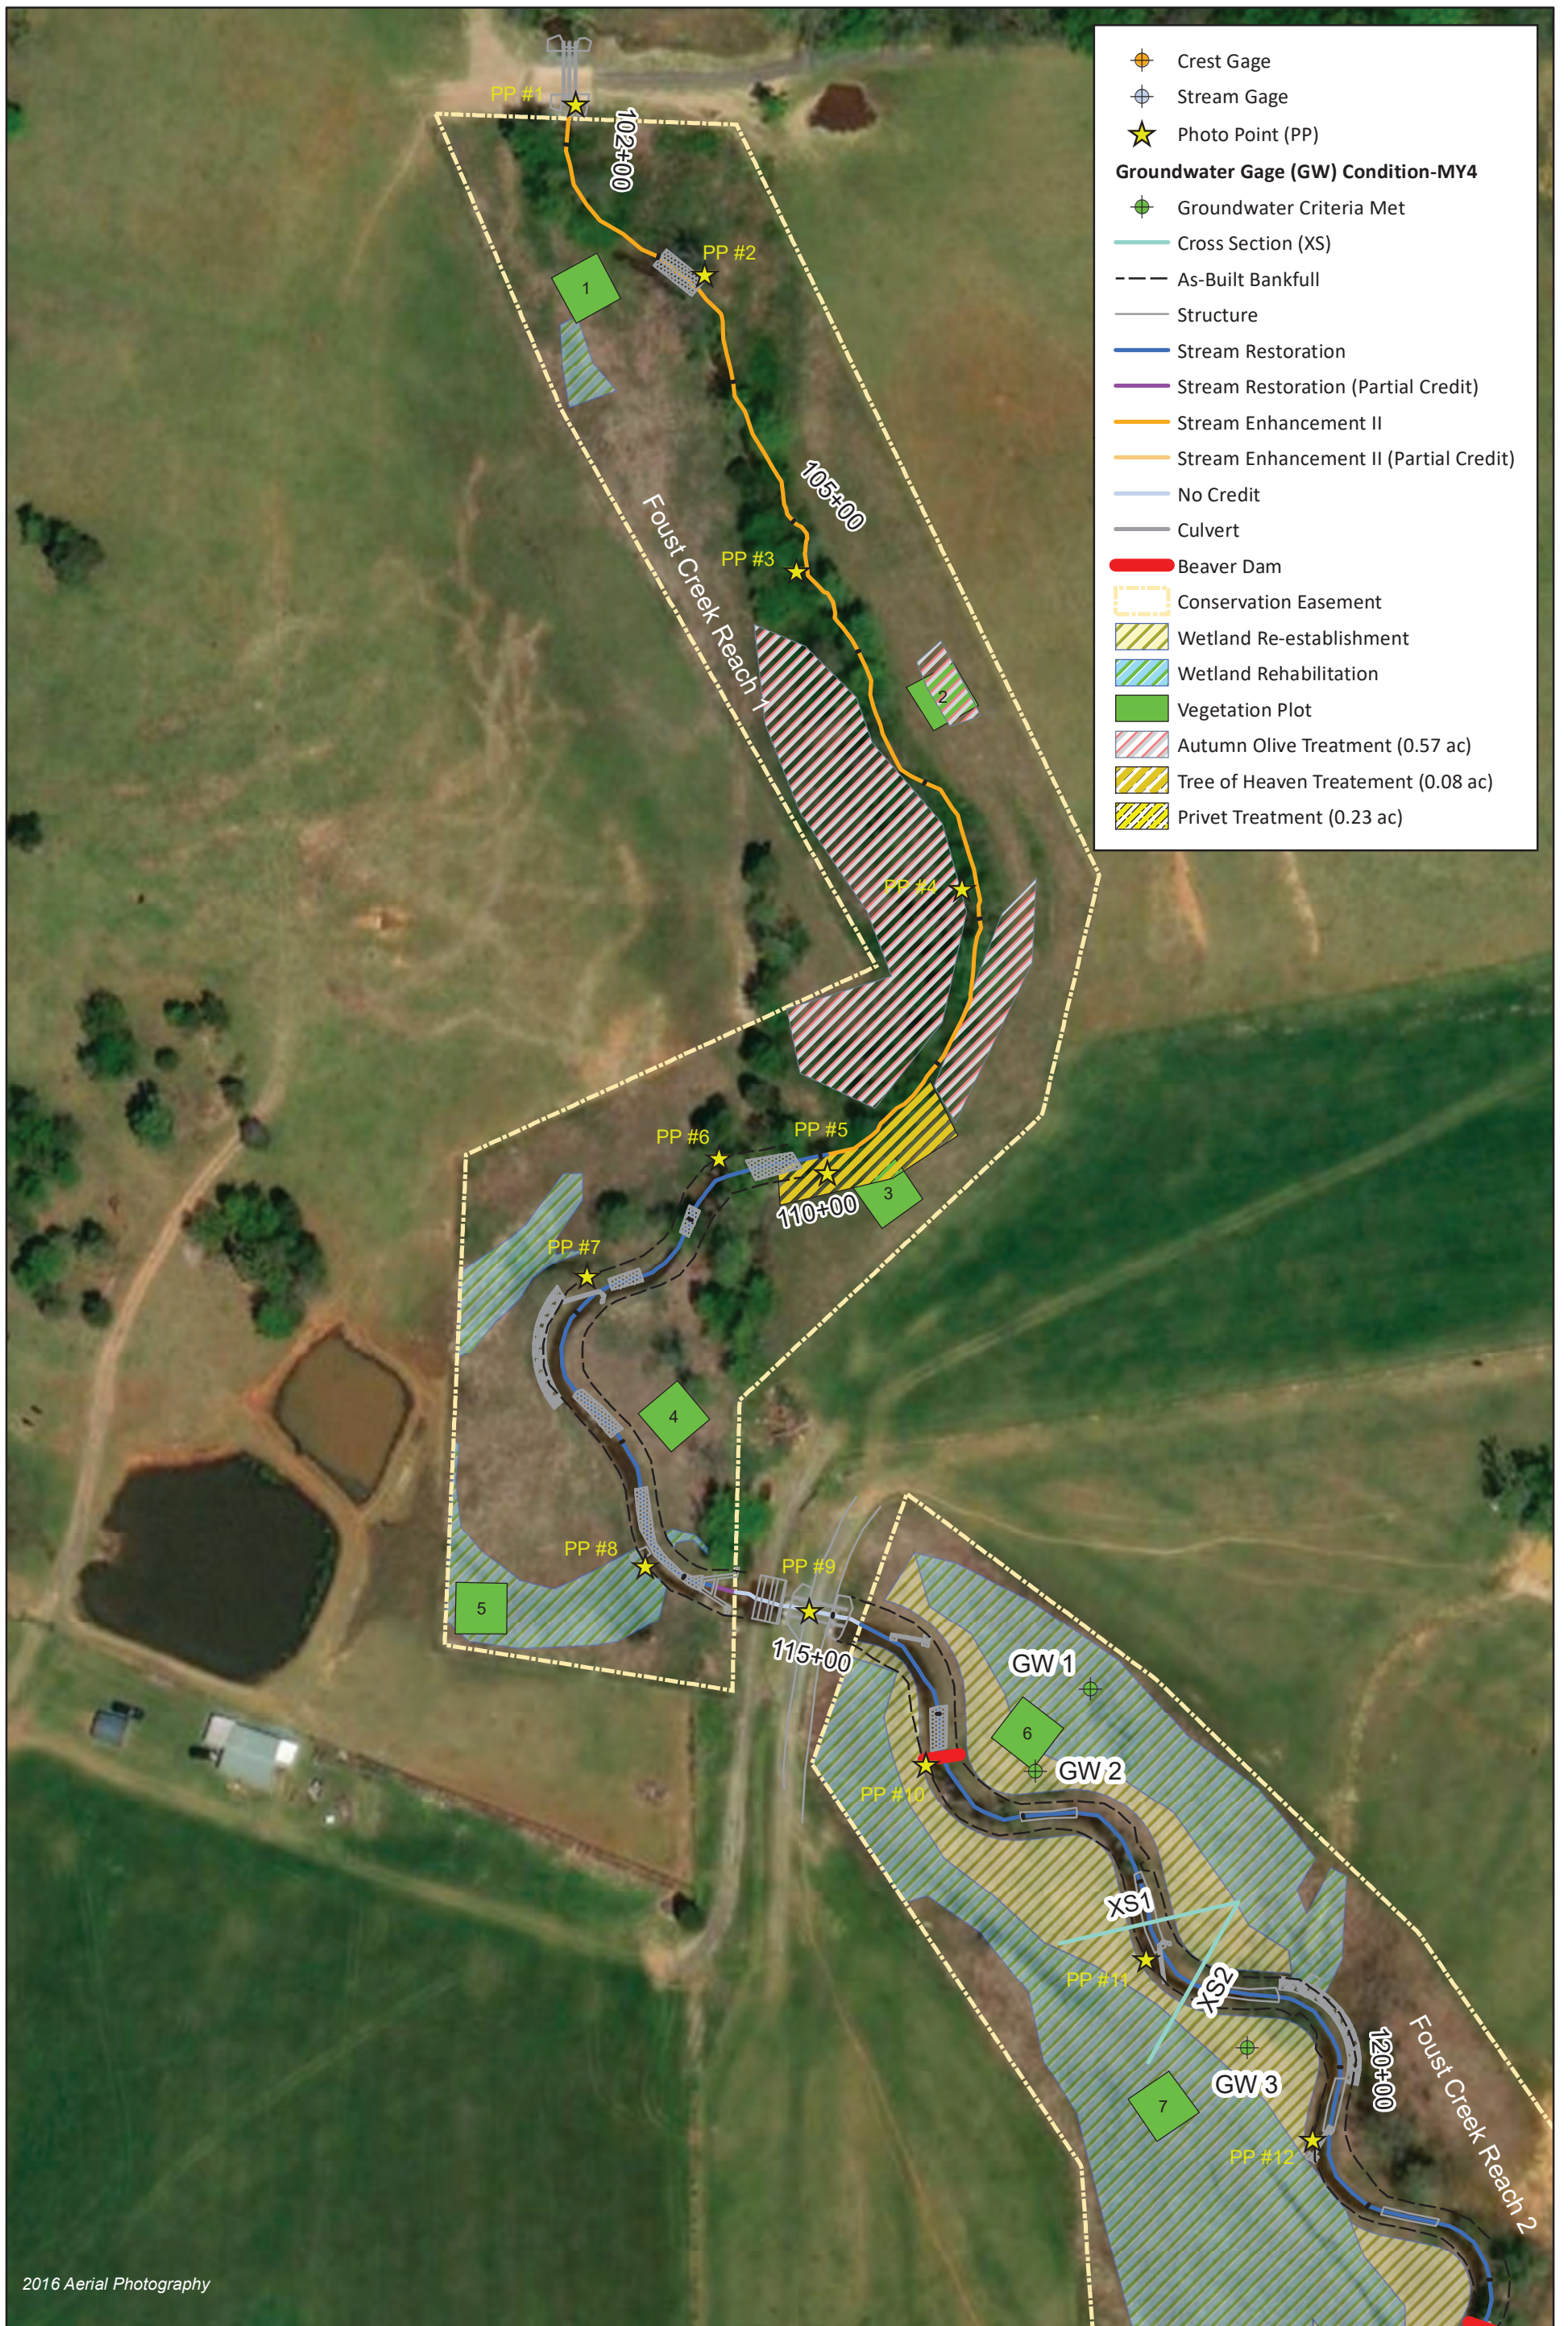
Figure 3.1 Integrated Current Condition Plan View (Sheet 1 of 3)

Concentrated populations of Chinese privet (*Ligustrum sinense*), tree of heaven (*Ailanthus altissima*), and autumn olive (*Eleagnus umbellata*) were observed during MY4 (Figure 3.1, Figure 3.3). The autumn olive and tree of heaven populations were located adjacent to Foust Creek Reach 1. The Chinese privet population consisted of re-sprouts from a previous treatment located in the northwestern portion of the easement adjacent to Foust Creek Reach 3b. Stems of autumn olive and Chinese privet larger than one inch in diameter were treated with triclopyr or glyphosate, respectively, using the cut stump method. Stems smaller than one inch in diameter were treated via foliar application of the same respective herbicides. Tree of heaven was treated with triclopyr using the hack and squirt method. All treatment occurred during September 2018.

During October of MY4, beaver dams were observed in Foust Creek Reach 2 (Figure 3.1, Figure 3.2). The USDA has been contracted to remove the beaver and clear the dams from the stream.

The invasive species populations described above in section 1.2.2 will continue to be monitored and treated as necessary. Beaver will be removed from the Site and streams will be monitored for any beaver activity in subsequent monitoring years.
