**MONITORING YEAR 5  
ANNUAL REPORT**  
Final

**FOUST CREEK MITIGATION SITE**

Alamance County, NC

DMS Project Number 95715

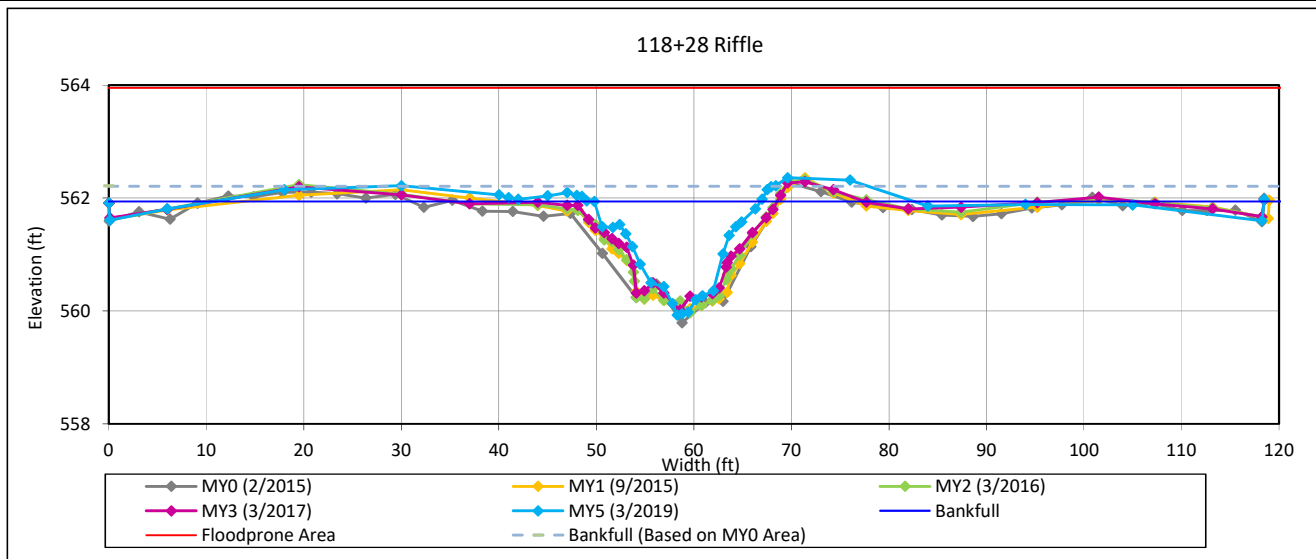
#### Cross Section 1- Foust Creek Reach 2

17.6	x-section area (ft.sq.)
17.0	width (ft)
1.0	mean depth (ft)
2.0	max depth (ft)
17.8	wetted perimeter (ft)
1.0	hyd radi (ft)
16.5	width-depth ratio
150.0	W flood prone area (ft)
8.8	entrenchment ratio
< 1.0	low bank height ratio

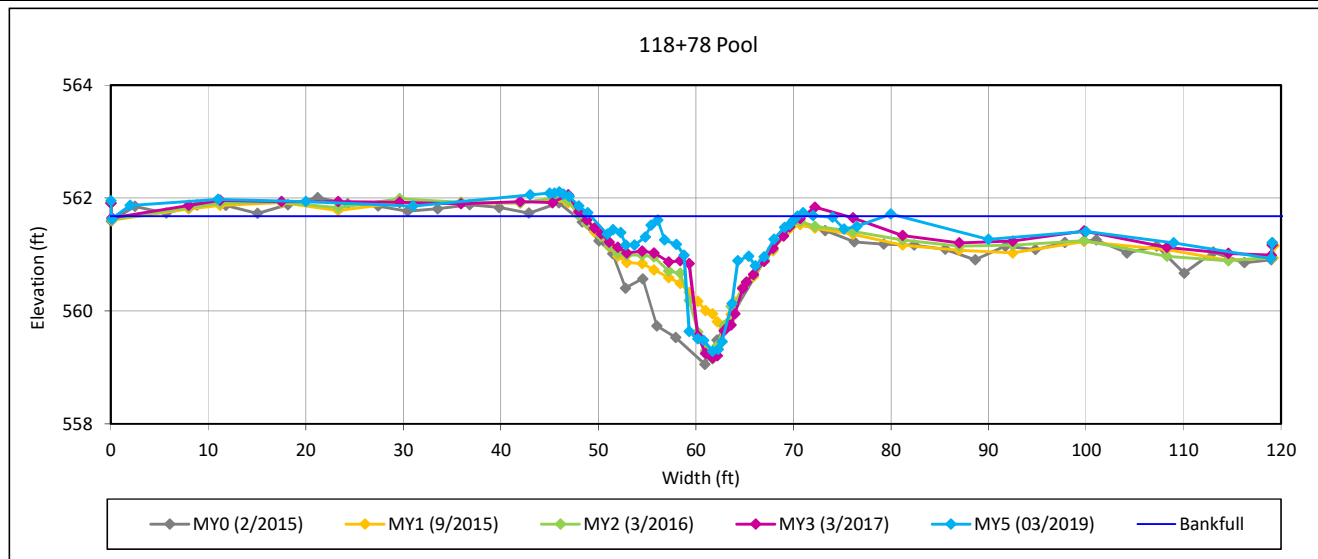
#### Cross Section 2- Foust Creek Reach 2

17.3	x-section area (ft.sq.)
21.2	width (ft)
0.8	mean depth (ft)
2.4	max depth (ft)
23.1	wetted parimeter (ft)
0.7	hyd radi (ft)
26.0	width-depth ratio

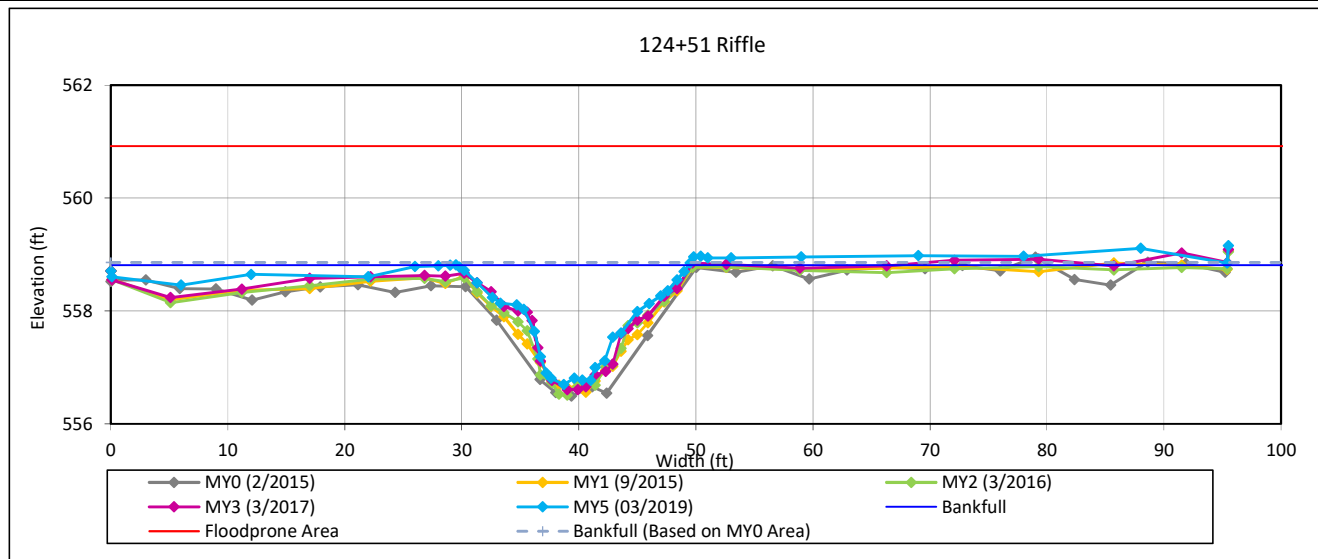
**Cross Section 3- Foust Creek Reach 2**

20.4	x-section area (ft.sq.)
19.8	width (ft)
1.0	mean depth (ft)
2.1	max depth (ft)
20.5	wetted parimeter (ft)
1.0	hyd radi (ft)
19.2	width-depth ratio
150.0	W flood prone area (ft)
7.6	entrenchment ratio
< 1.0	low bank height ratio

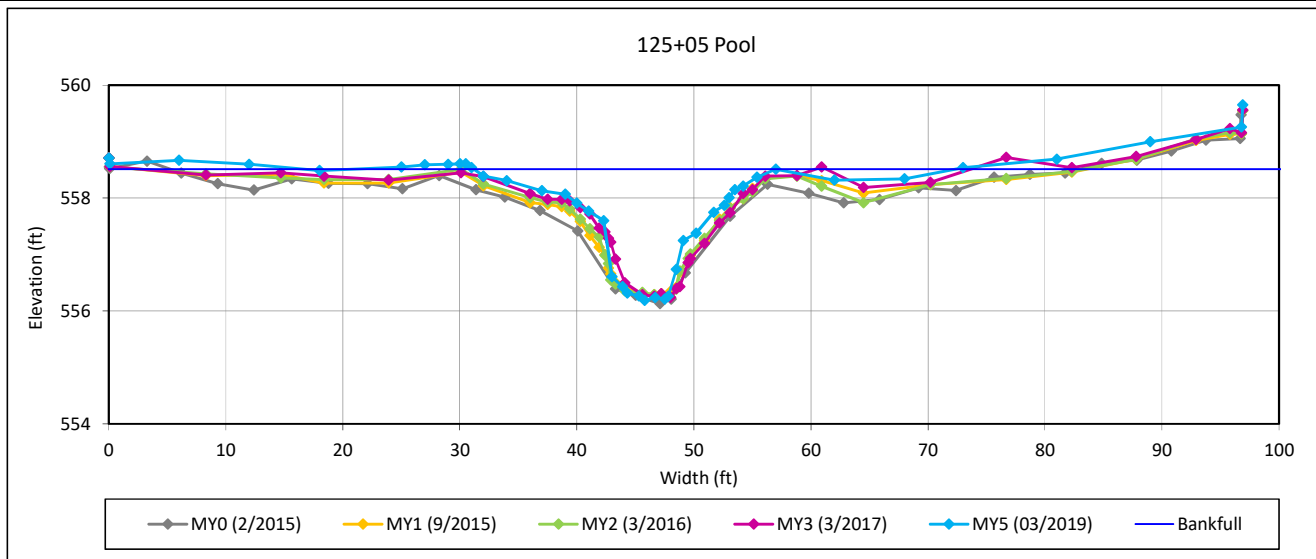
#### Cross Section 4- Foust Creek Reach 2

21.8	x-section area (ft.sq.)
21.8	width (ft)
1.0	mean depth (ft)
2.3	max depth (ft)
22.8	wetted parimeter (ft)
1.0	hyd radi (ft)
21.8	width-depth ratio

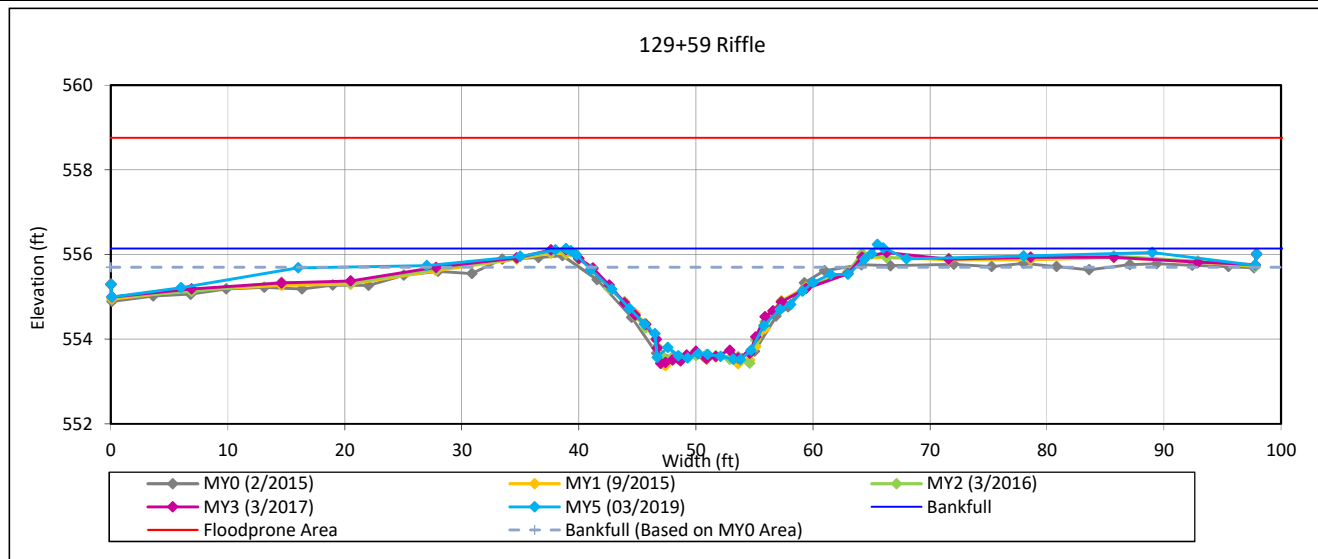
#### Cross Section 5- Foust Creek Reach 2

38.4	x-section area (ft.sq.)
26.1	width (ft)
1.5	mean depth (ft)
2.6	max depth (ft)
27.2	wetted parimeter (ft)
1.4	hyd radi (ft)
17.8	width-depth ratio
150.0	W flood prone area (ft)
5.7	entrenchment ratio
1.2	low bank height ratio

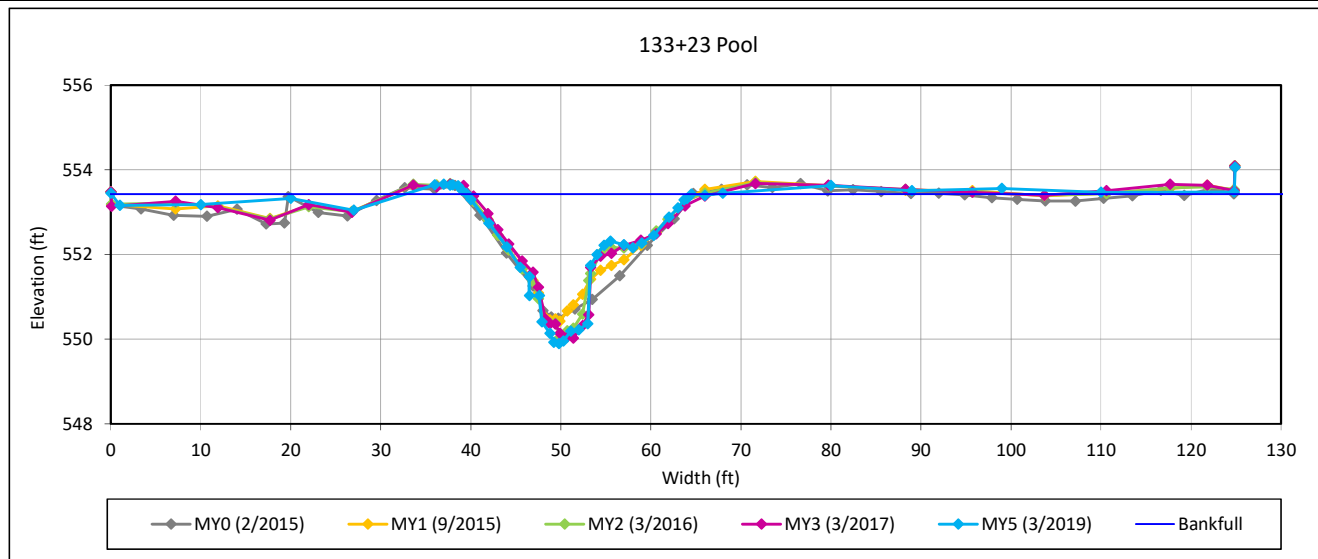
**Cross Section 6- Foust Creek Reach 2**

38.3	x-section area (ft.sq.)
25.0	width (ft)
1.5	mean depth (ft)
3.5	max depth (ft)
27.5	wetted parimeter (ft)
1.4	hyd radi (ft)
16.3	width-depth ratio

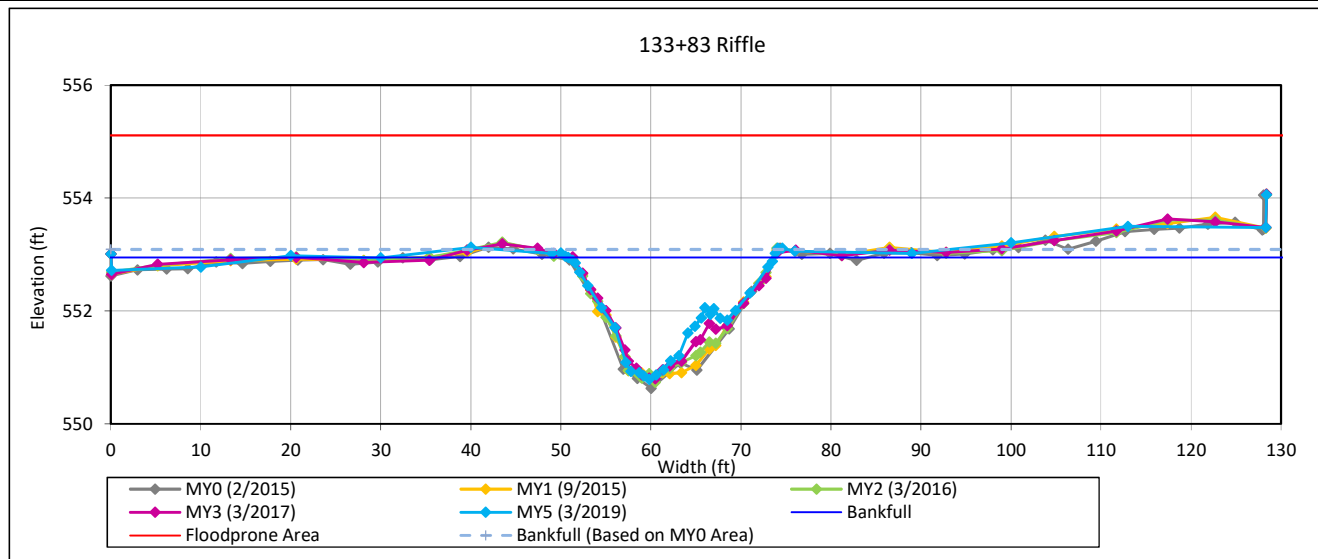
#### Cross Section 7- Foust Creek Reach 2

26.1	x-section area (ft.sq.)
22.9	width (ft)
1.1	mean depth (ft)
2.2	max depth (ft)
23.5	wetted parimeter (ft)
1.1	hyd radi (ft)
20.0	width-depth ratio
150.0	W flood prone area (ft)
6.6	entrenchment ratio
< 1.0	low bank height ratio

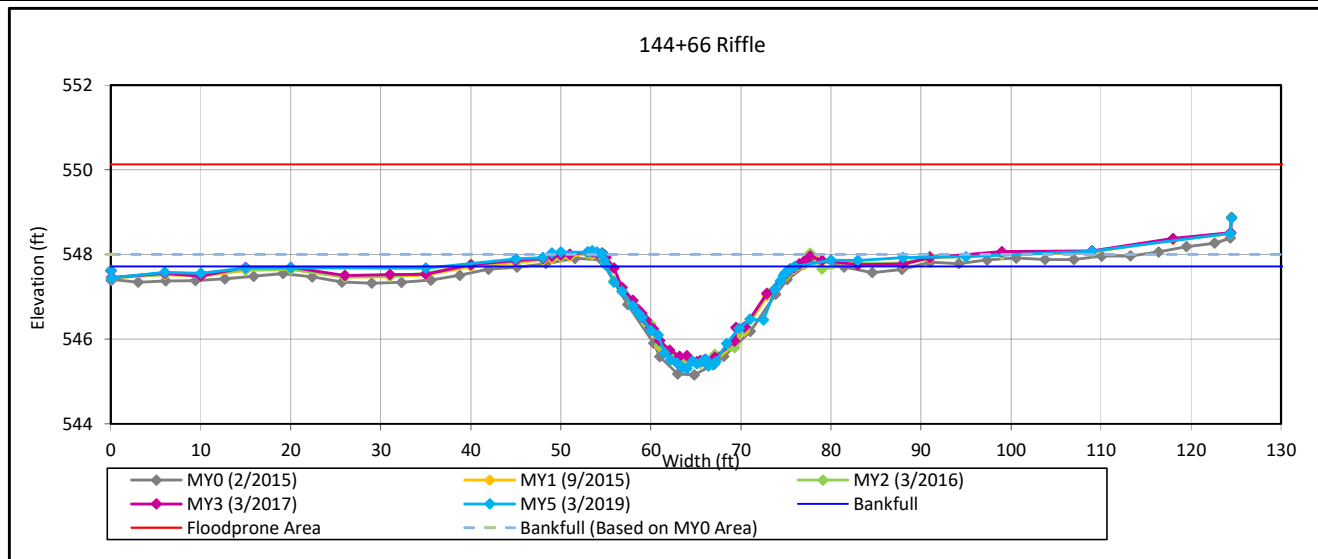
**Cross Section 8- Foust Creek Reach 3B**

29.3	x-section area (ft.sq.)
20.9	width (ft)
1.4	mean depth (ft)
2.4	max depth (ft)
21.8	wetted parimeter (ft)
1.3	hyd radi (ft)
14.9	width-depth ratio
150.0	W flood prone area (ft)
7.2	entrenchment ratio
< 1.0	low bank height ratio

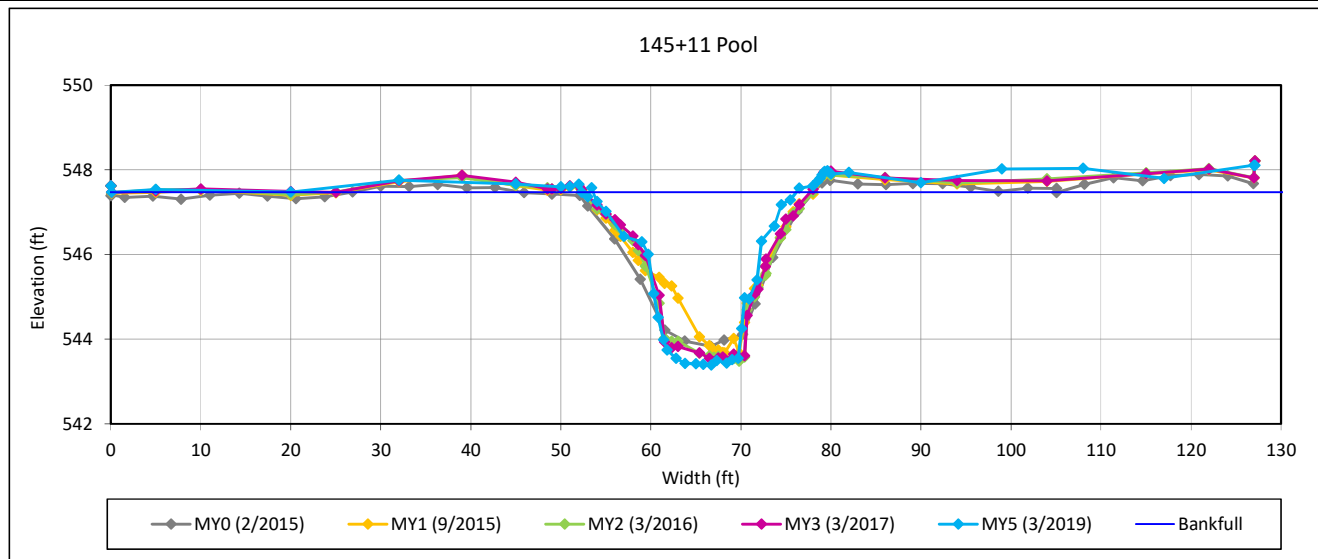
#### Cross Section 9- Foust Creek Reach 3B

50.9	x-section area (ft.sq.)
23.4	width (ft)
2.2	mean depth (ft)
4.1	max depth (ft)
26.5	wetted parimeter (ft)
1.9	hyd radi (ft)
10.8	width-depth ratio

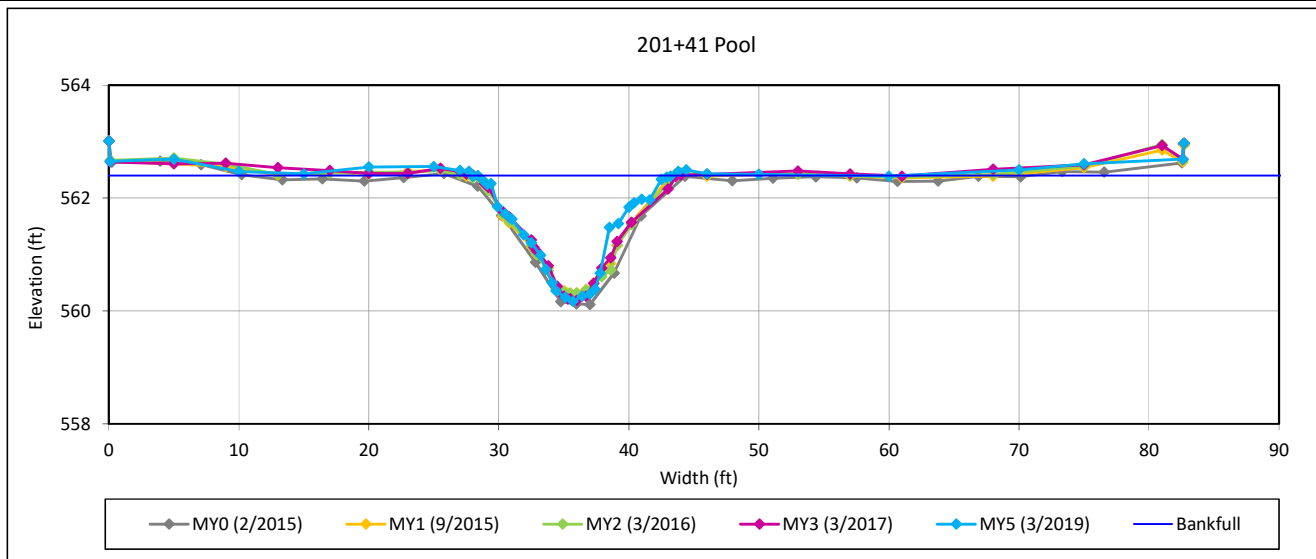
#### Cross Section 10-UT1

15.8	x-section area (ft.sq.)
14.8	width (ft)
1.1	mean depth (ft)
2.2	max depth (ft)
15.9	wetted parimeter (ft)
1.0	hyd radi (ft)
13.9	width-depth ratio

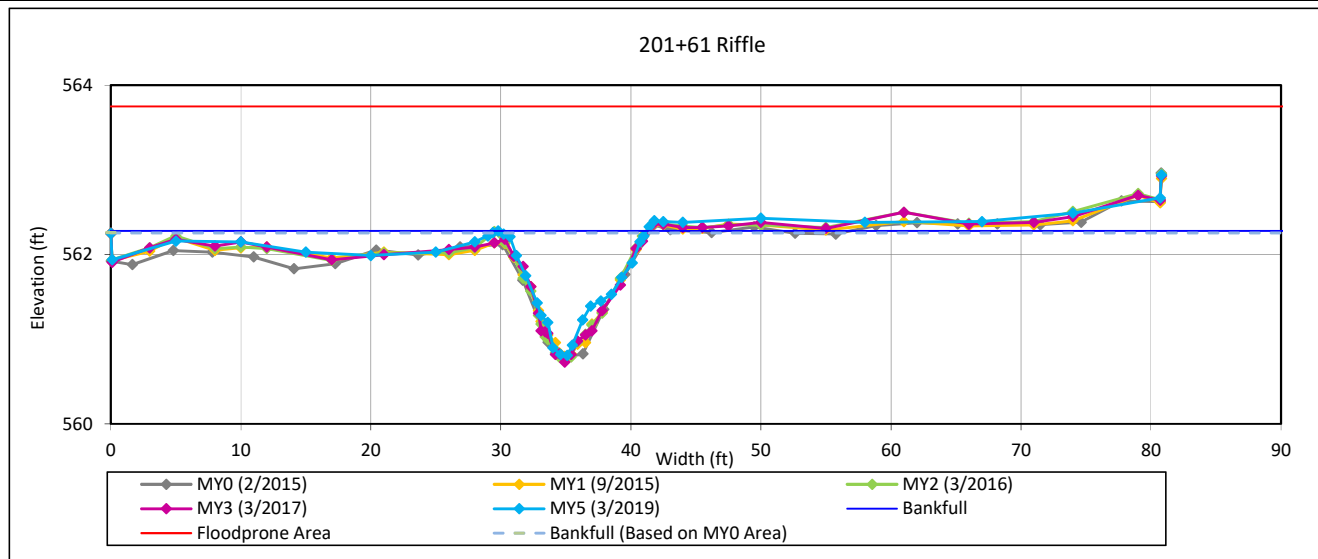
#### Cross Section 11-UT1

8.4	x-section area (ft.sq.)
11.6	width (ft)
0.7	mean depth (ft)
1.5	max depth (ft)
12.1	wetted perimeter (ft)
0.7	hyd radi (ft)
16.0	width-depth ratio
150.0	W flood prone area (ft)
12.9	entrenchment ratio
1.0	low bank height ratio

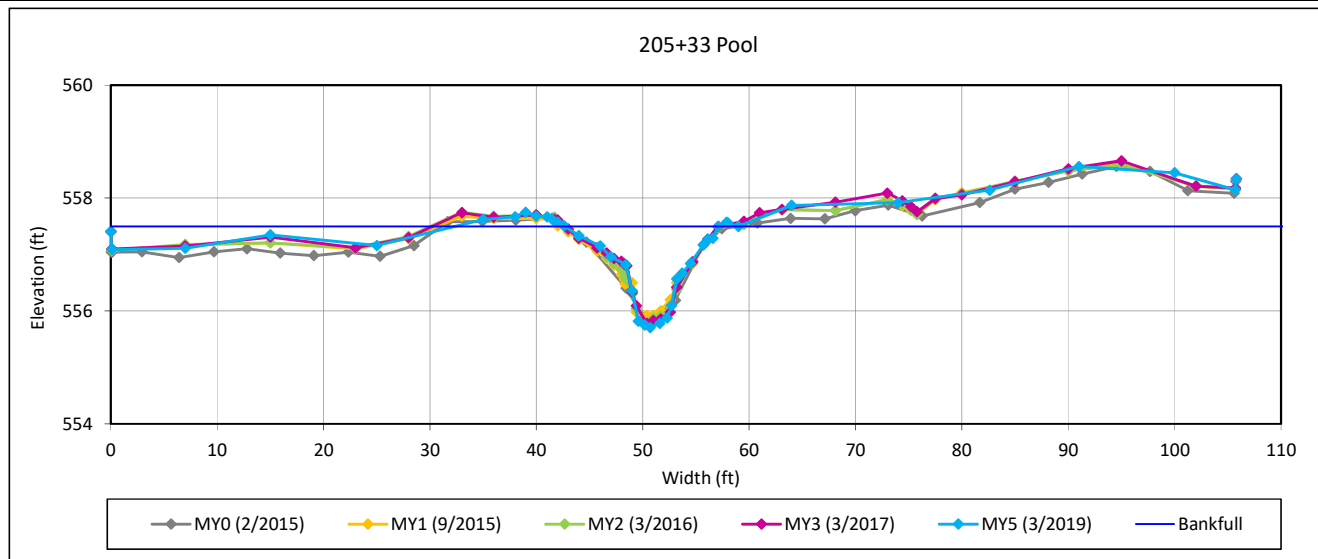
#### Cross Section 12-UT1

11.1	x-section area (ft.sq.)
14.4	width (ft)
0.8	mean depth (ft)
1.8	max depth (ft)
15.2	wetted parimeter (ft)
0.7	hyd radi (ft)
18.8	width-depth ratio

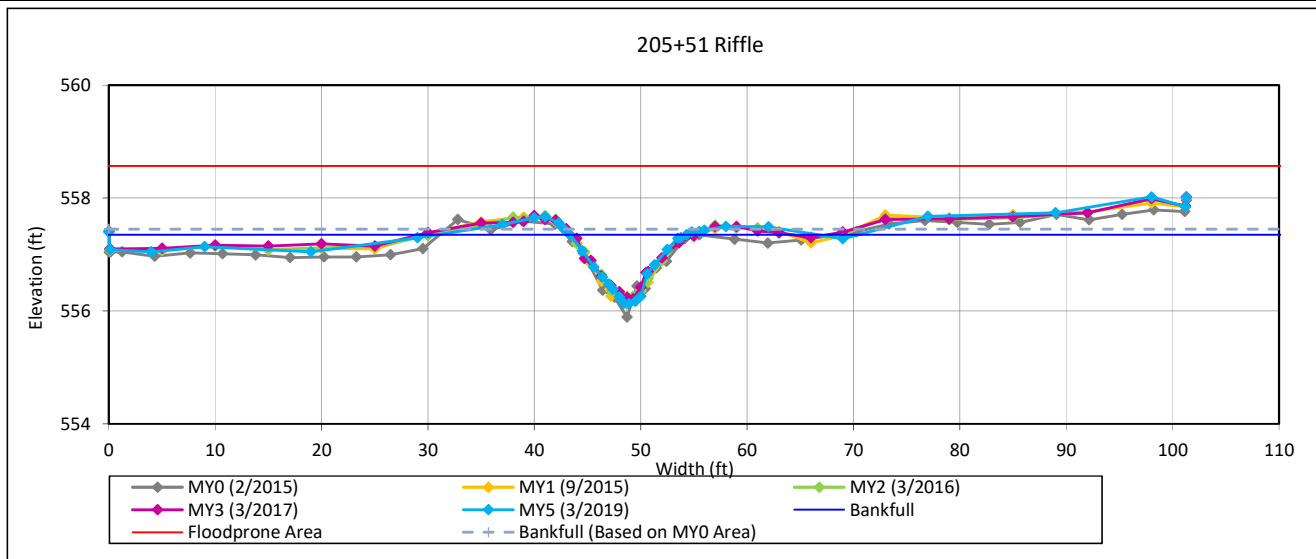
#### Cross Section 13-UT1

6.6	x-section area (ft.sq.)
11.0	width (ft)
0.6	mean depth (ft)
1.2	max depth (ft)
11.3	wetted perimeter (ft)
0.6	hyd radi (ft)
18.2	width-depth ratio
150.0	W flood prone area (ft)
13.7	entrenchment ratio
< 1.0	low bank height ratio
