MONITORING YEAR 6 ANNUAL REPORT FINAL

FOUST CREEK MITIGATION SITE

Alamance County, NC

DMS Project Number 95715

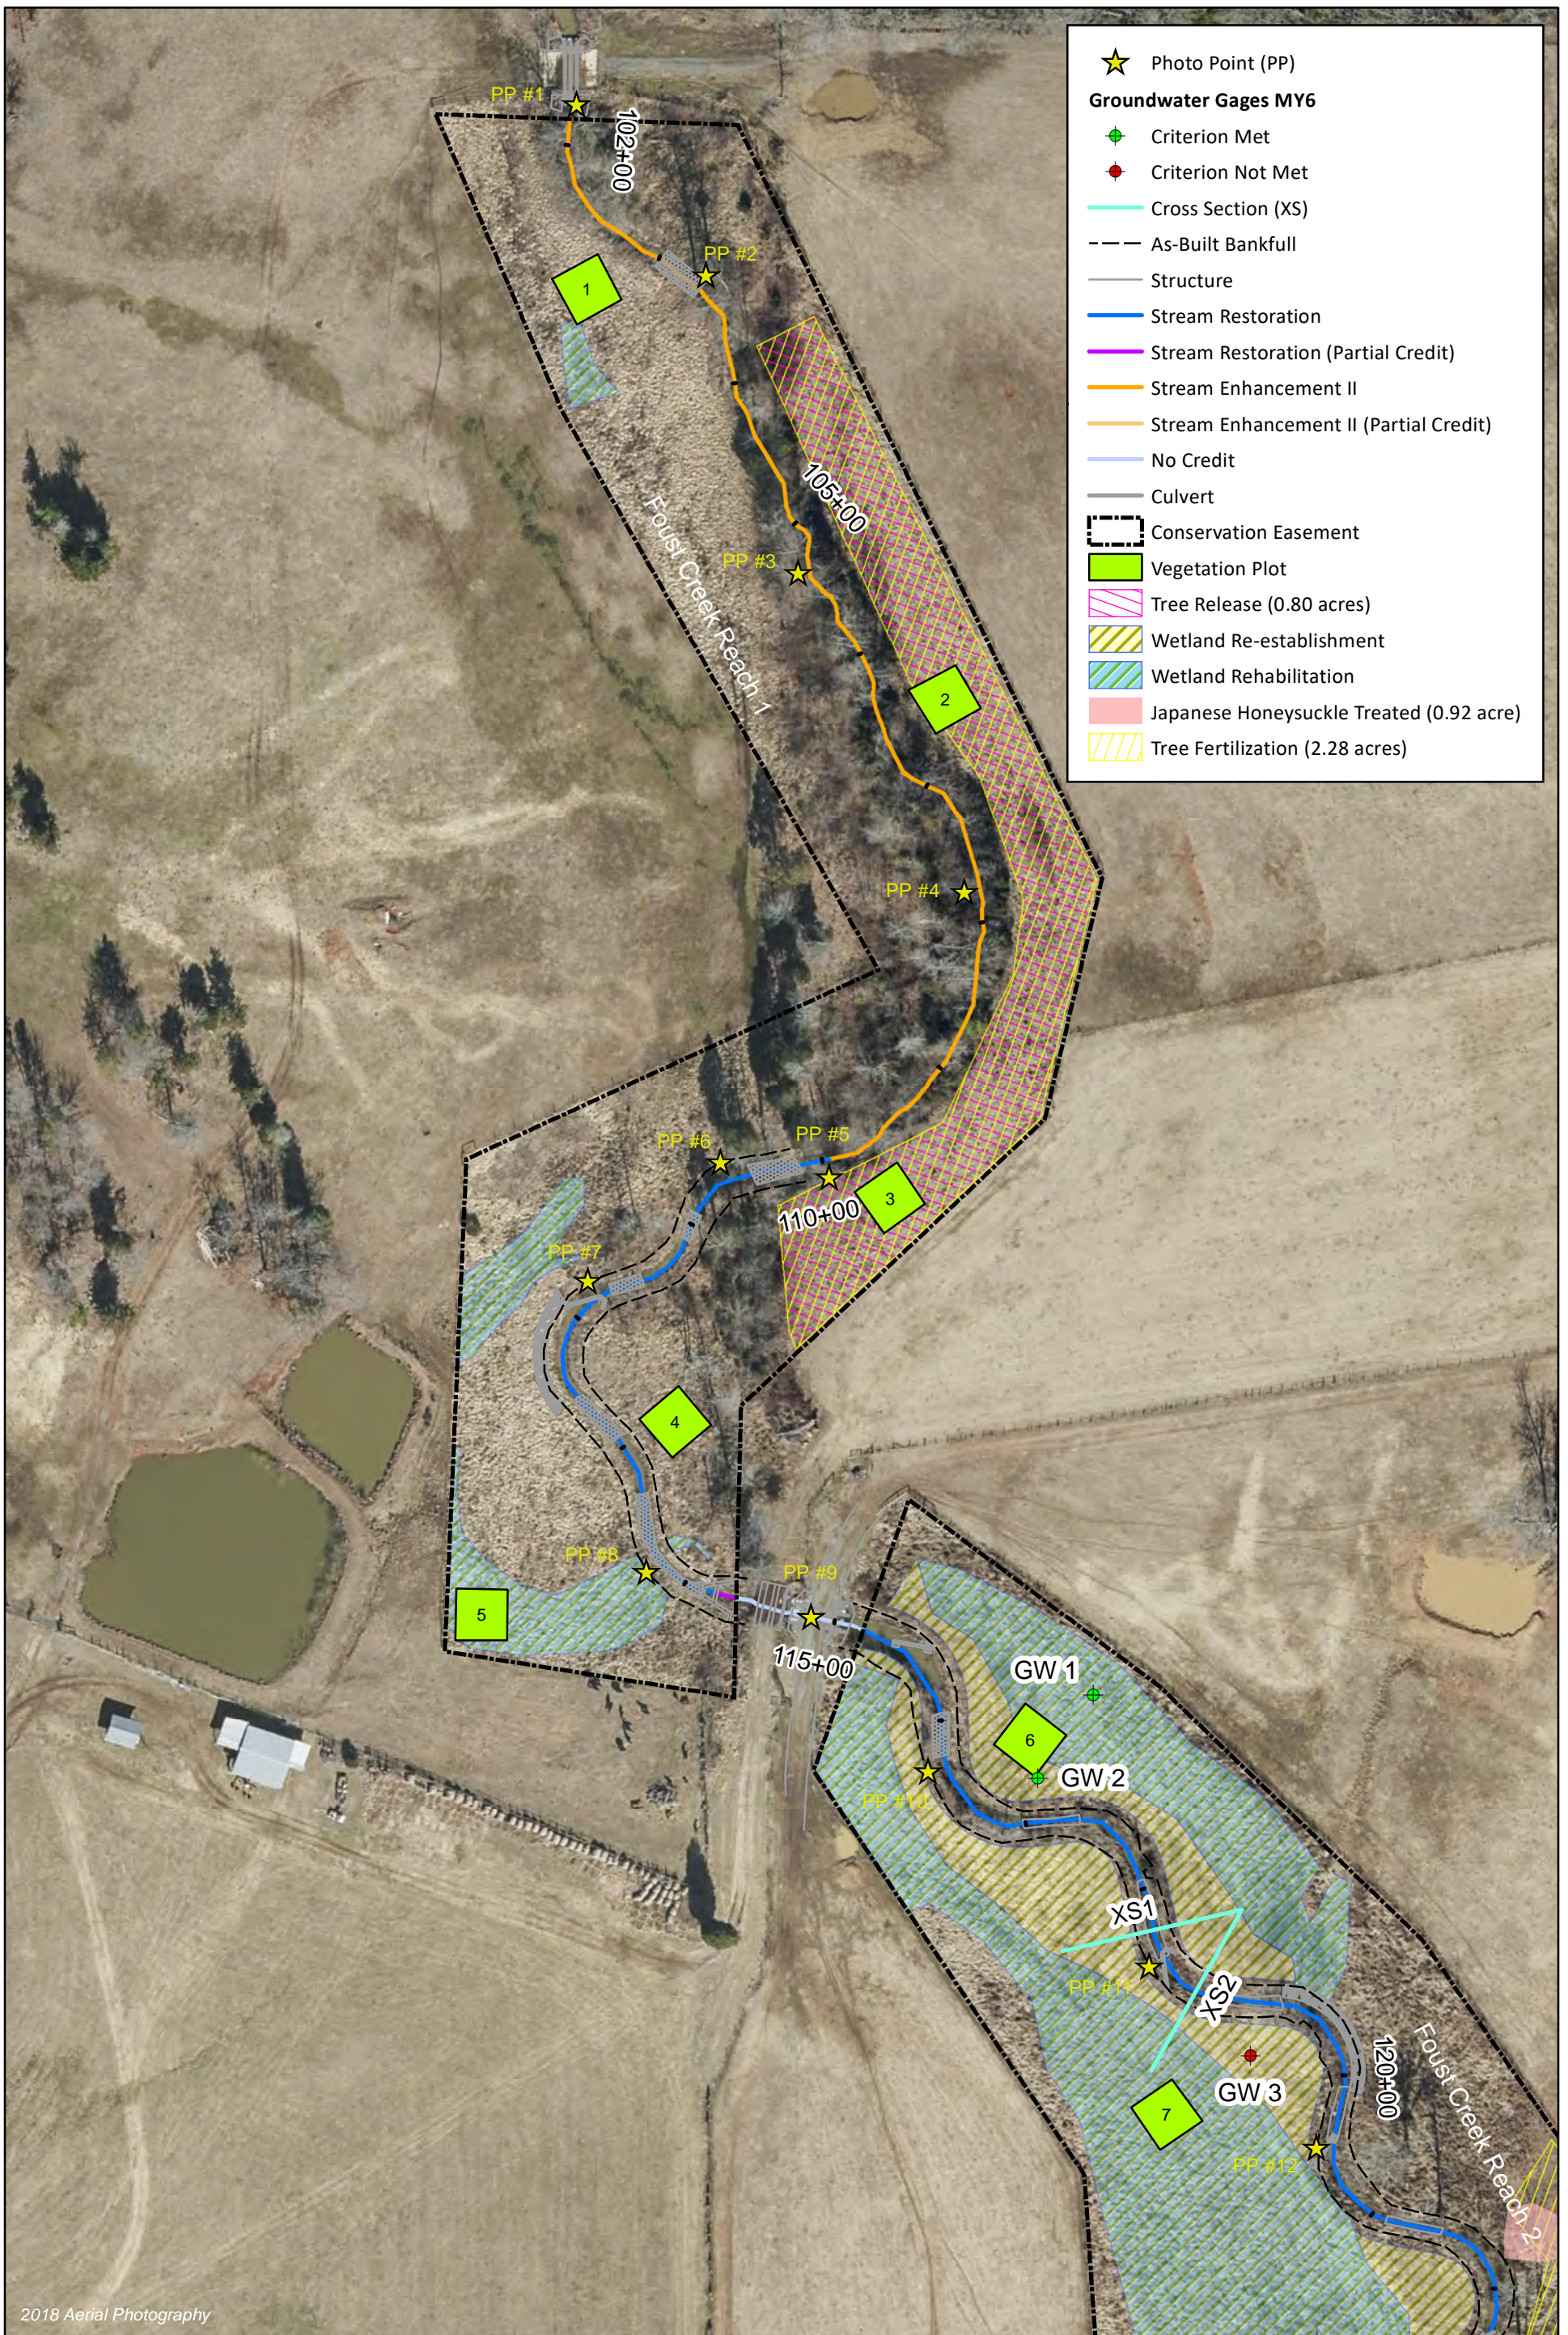
Figure 3.1 Integrated Current Condition Plan View
(Sheet 1 of 3)

Concentrated populations of Japanese honeysuckle (*Lonicera japonica*) covering a total of 0.92 acres were treated during February 2020 using a foliar herbicide application. Scattered stems of Chinese privet (*Ligustrum sinense*) and autumn olive (*Elaeagnus umbellata*) were also treated throughout the Site during February 2020. Tree growth rates were limited by deficient soil nutrition within areas on the left side of Foust Creek Reach 1, the left side of Foust Creek Reach 2, left side of Foust Creek Reach 3a as well as on the right of Foust Creek Reach 3b totaling 2.28 acres. A mixture of humic organic matter and fertilizer was added around the base of planted stems within these areas during April 2020. Tree growth on the left side of Foust Creek Reach 1 was also suppressed by competition with tall fescue (*Schedonorus arundinaceus*). A tree release treatment was conducted in this area (0.80 acre) during August 2020 which included a herbicide treatment of competing vegetation within approximately 3 feet of desirable woody stems. During November 2020, vigorous new growth on trees within treated was observed (Figures 3.1-3.3, Table 6).

The Site will continue to be monitored and treated for invasive species as necessary. Areas treated for Japanese honeysuckle during MY6 are expected to require additional treatment during spring of 2021. Areas that had a tree growth enhancement treatment during MY6 will be observed in the spring to determine if additional management actions are necessary.
