# **Year 1 Monitoring Report**

## **Freedom Park Stream Restoration**

**February 2006**

**S&EC Project No. 9443.D1**  
**EEP Project No. 00032**

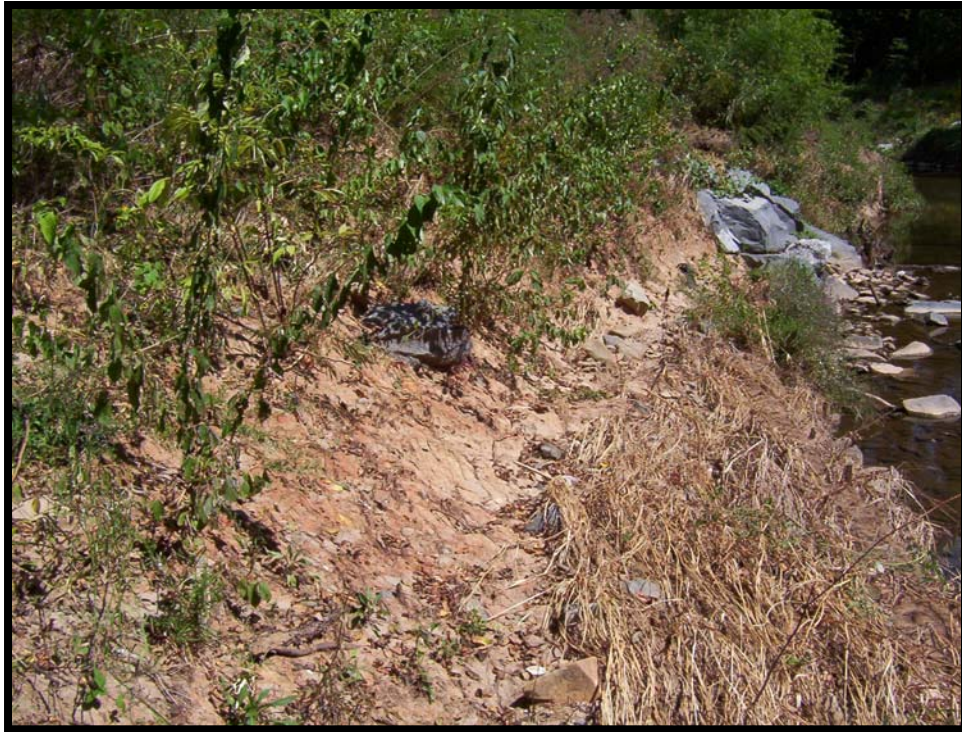
Upon inspection on September 12, 2005, it was noted that several areas along the banks of Little Sugar Creek and its floodplain have suffered localized loss of vegetation. It is suspected that overbank flows occurred before the newly planted vegetation had sufficient time to establish a root system capable of withstanding flood flow. Other areas may have compacted soils causing poor vegetative success. There are several areas with exposed soil as indicated on the problem area plan view as "Bare Bank."

Photo 1—Typical Bare Bank

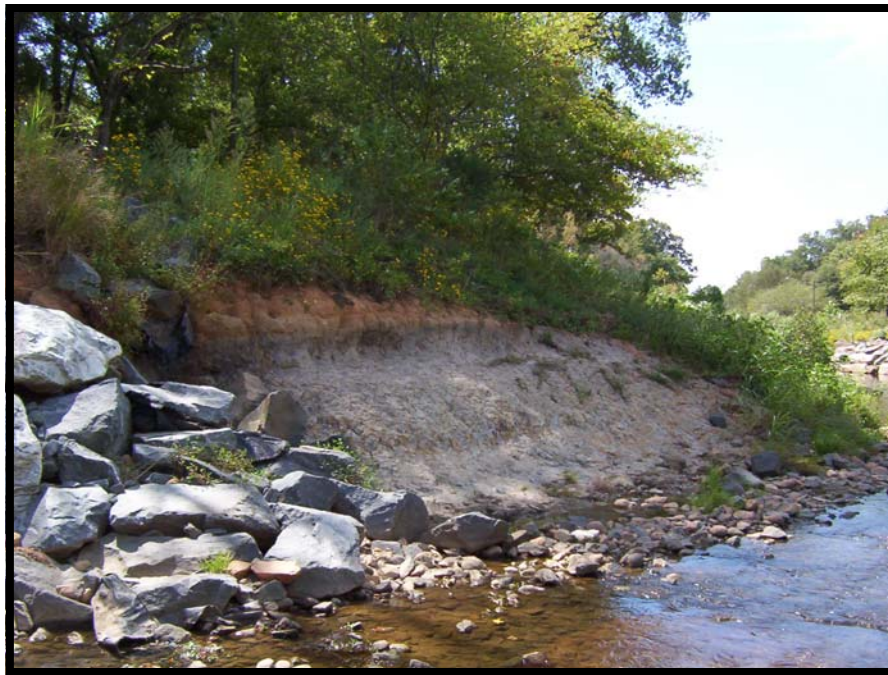
<b>Feature Issues</b>	<b>Station numbers</b>	<b>Suspected Cause</b>	<b>Photo number</b>
Bank Scour	10+47 to 11+17	Excessive bank shear stress	Stream Problem Areas 1-3
	13+39 to 13+94	Resultant from floodplain drainage	
	20+66 to 21+82	Excessive bank shear stress

Photo 1— Typical Bank Scour

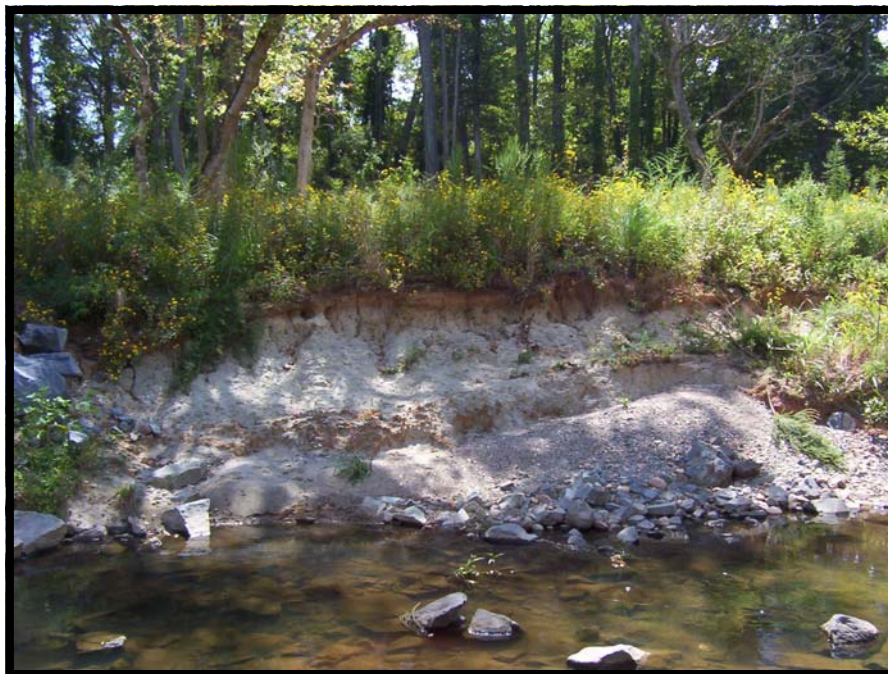
Photo 2—Typical Bank Scour

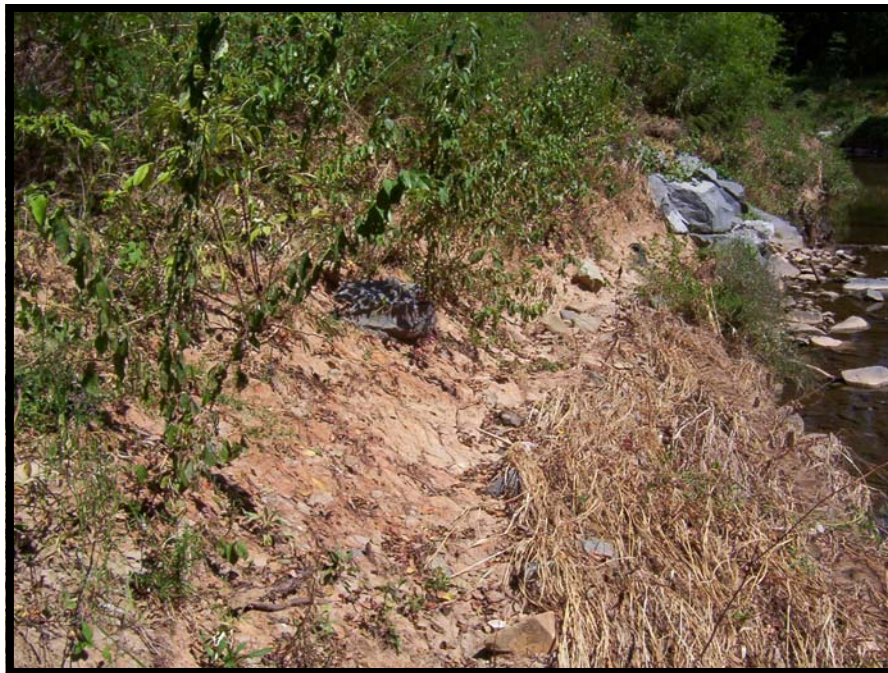
Photo 3—Typical Bank Scour
