Freedom Park (Little Sugar Creek) Final Monitoring Report Year 2 of 5 (2006)

Mecklenburg County, North Carolina

Project ID No. 141

January 2007

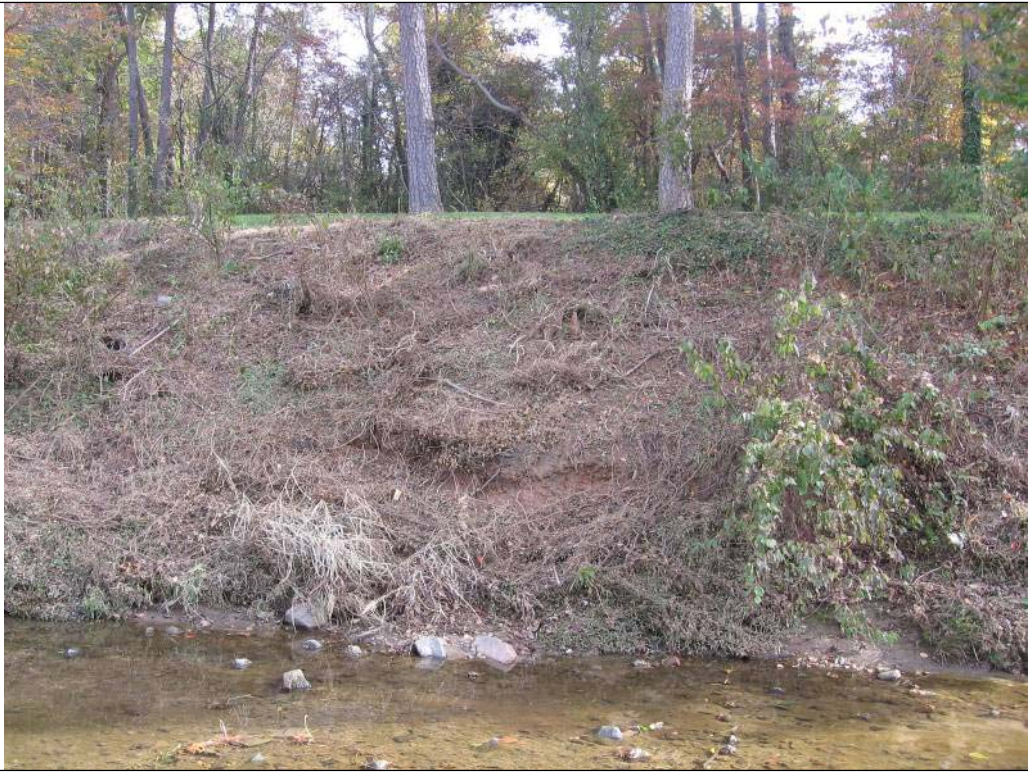
Feature/Issue	Station # / Range	Probable Cause	Photo #
Bare Bank	410 - 1,140 (Both Banks)	Excessive bank stresses during yearly flooding events	VP 2
	1,690 - 1,750 (Left Bank)		
	2,065 - 2,350 (Both Banks)		
Bare Bench	--	--	--
Bare Flood Plain	1,250 - 1,580 (Left Floodplain)	Cleared area exhibiting successional growth including invasives from Local source colonization after bank scour	VP 4
	35 - 1,030 (Both Banks)		
Invasive/Exotic Populations	1,240 - 1,860 (Left Bank)		
	1,250 - 1,580 (Left Floodplain)	Cleared area exhibiting successional growth including invasives from local sources	VP 4
	1,950 - 2,190 (Left Bank)		VP 3
	2,210 - 2,380 (Right Bank)		VP 1
	2,680 - 3,065 (Left Bank)		
	2,690 - 3,555 (Right Bank)		
	3,555 - 3,790 (Left Bank)

VP 2: Bare Bank

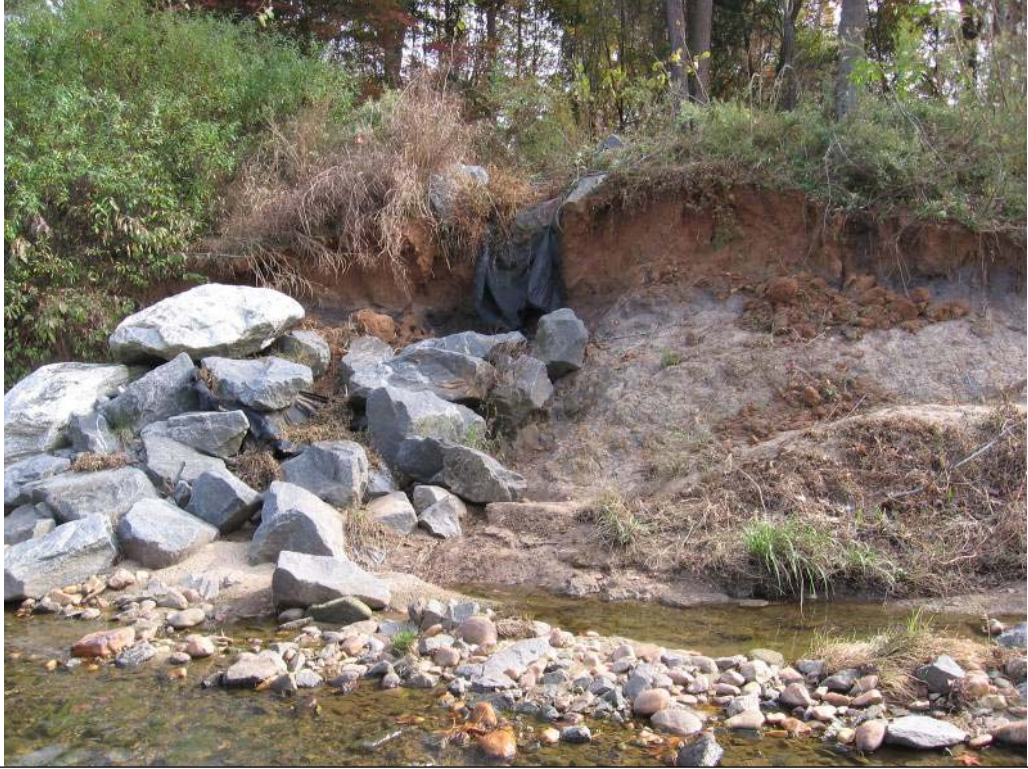
SP 1: Scout on left bank with failing rock stabilization

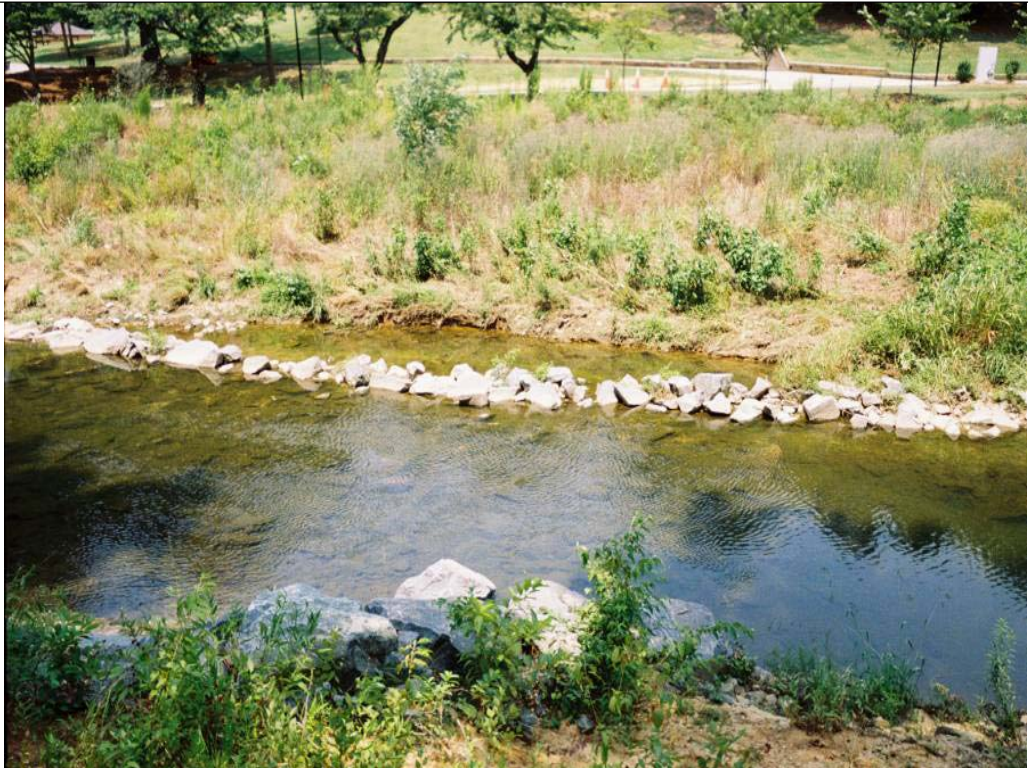
SP 2: Scour behind boulder toe protection

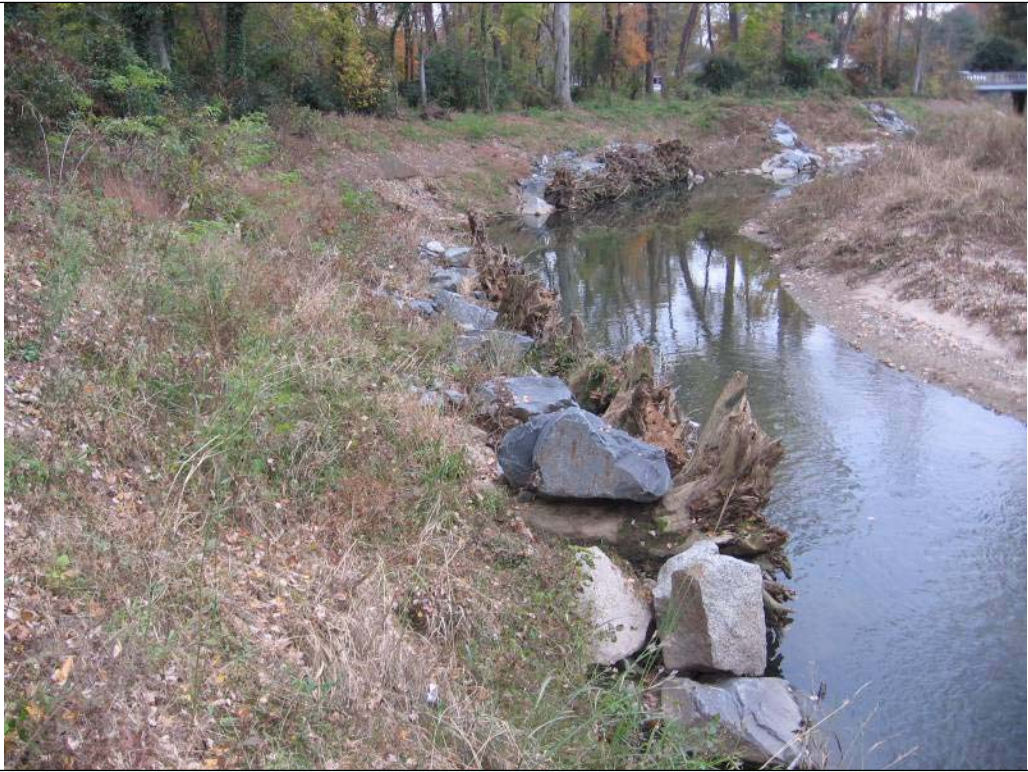
3450	Scour behind toe protection (Right Bank)	Excessive shear stresses	SP 6
		4,030 - 4,070	Scour (Left Bank) - Possibly displaced root wads	Excessive shear stresses	SP 7
Engineered structures - back or arm scour Etc.		1,260	Missing header rock	Excessive shear stresses	
		1,960	Missing structure	Excessive shear stresses	
		2,660	Arm boulder collapse	Excessive shear stresses	
		3,950 - 4,140	Scour behind root wads	Excessive shear stresses	SP 3

SP 3: Scour behind root wads

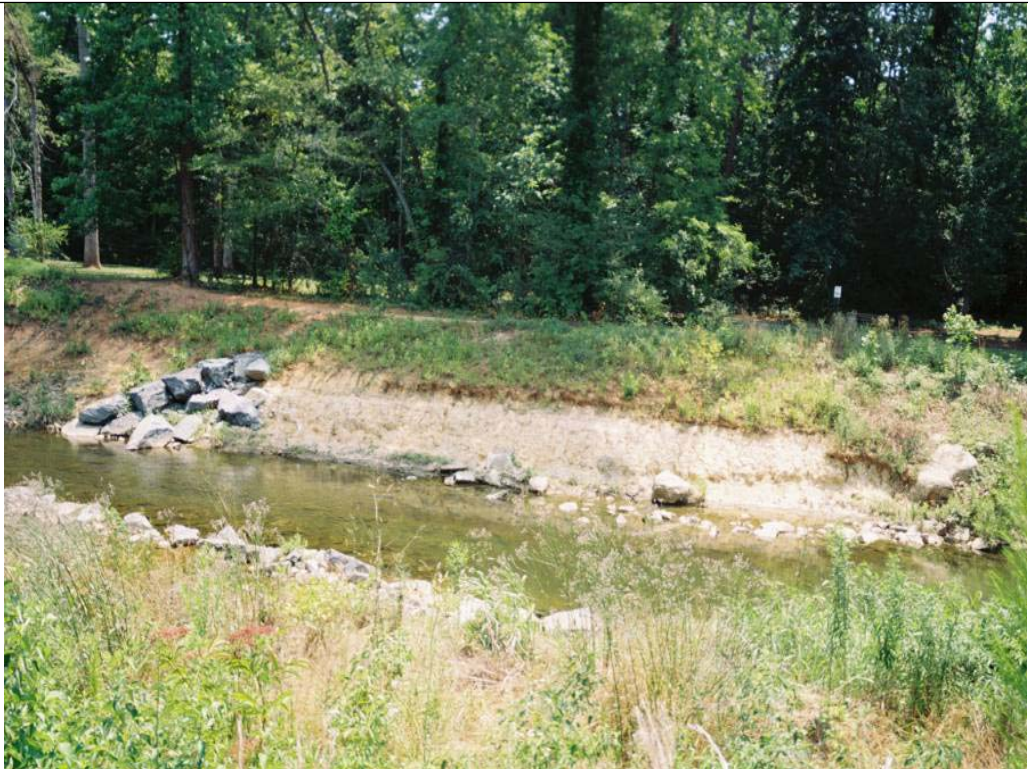
SP 4: Bare left bank

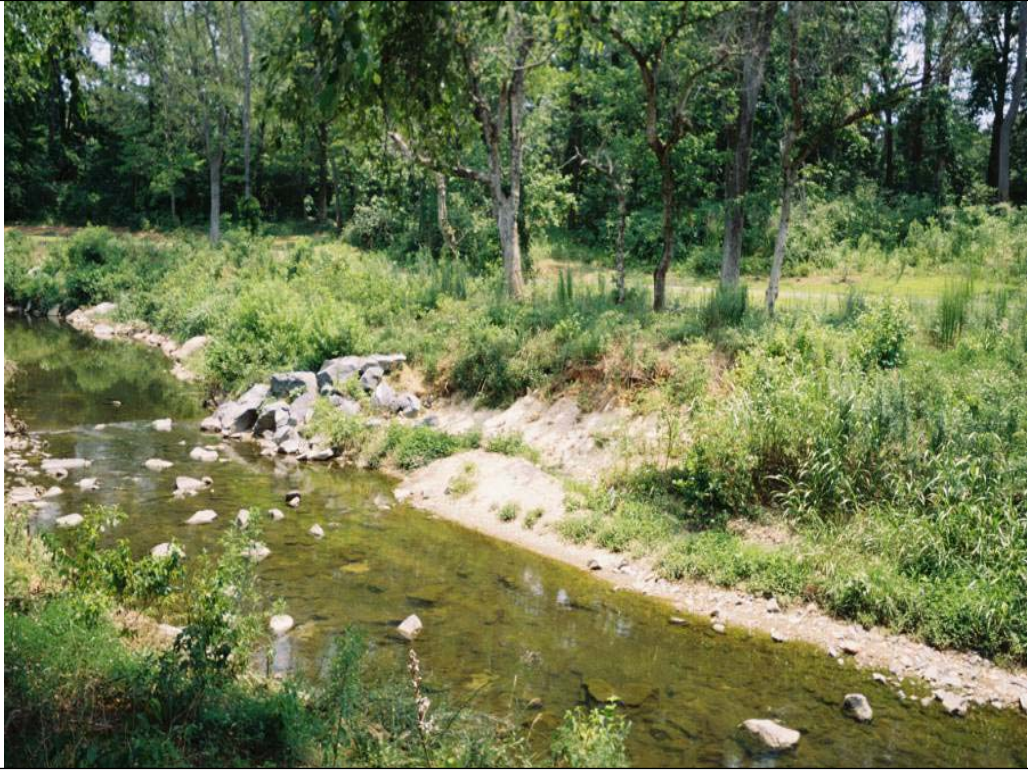
SP 5: Scour on left bank

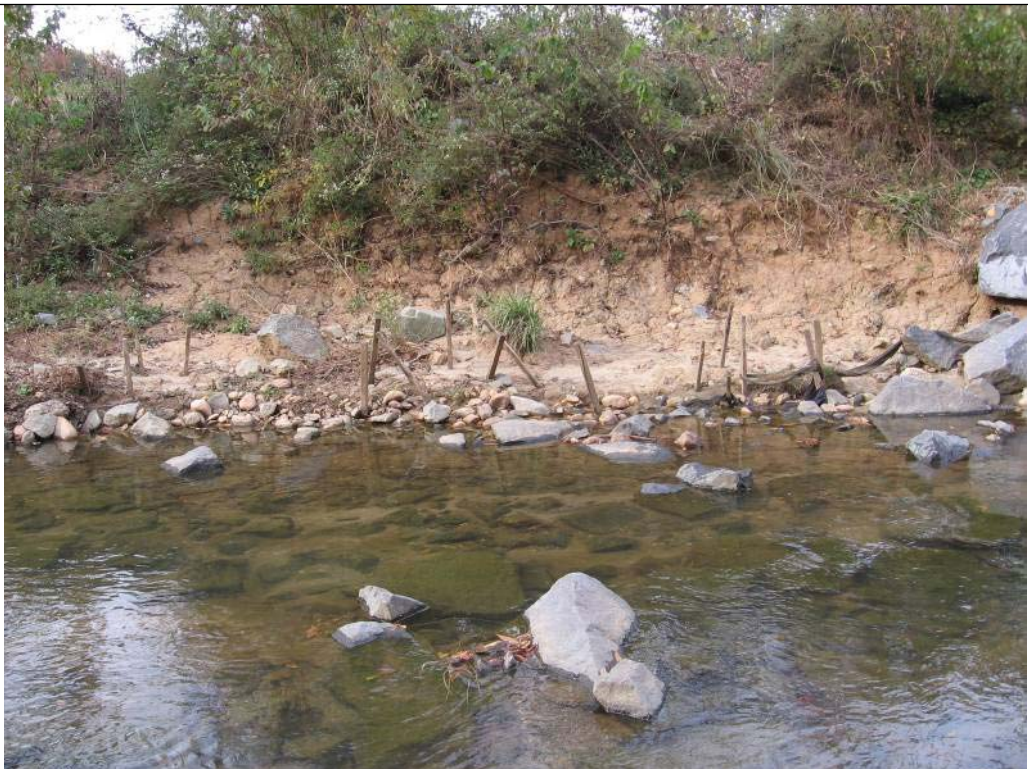
SP 6: Scour on Right Bank

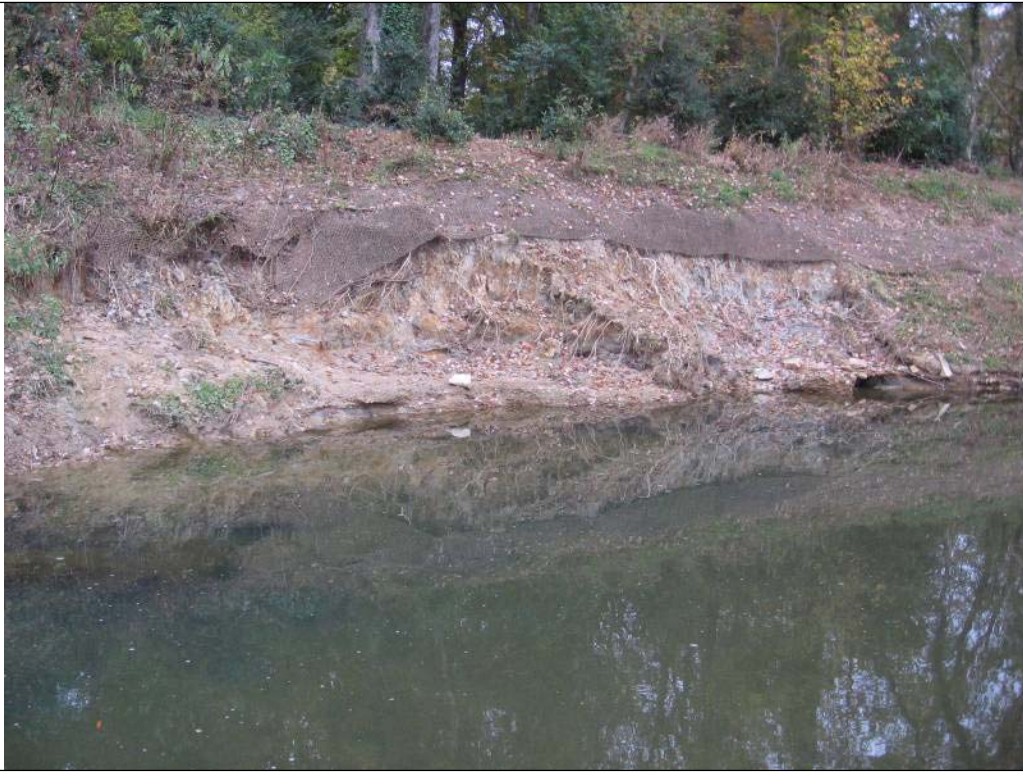
SP 7: Scour between root wads – possible displacement of root wads
